Re: Violation Letter
Racer Trust Surface Impoundment
INR000021436
Indianapolis, Marion County

Type of Inspection: Compliance Evaluation Inspection

**HAZARDOUS WASTE
INSPECTION REPORT**
INDIANA DEPARTMENT OF
ENVIRONMENTAL MANAGEMENT

Photo Table: Racer Trust Surface Impoundment

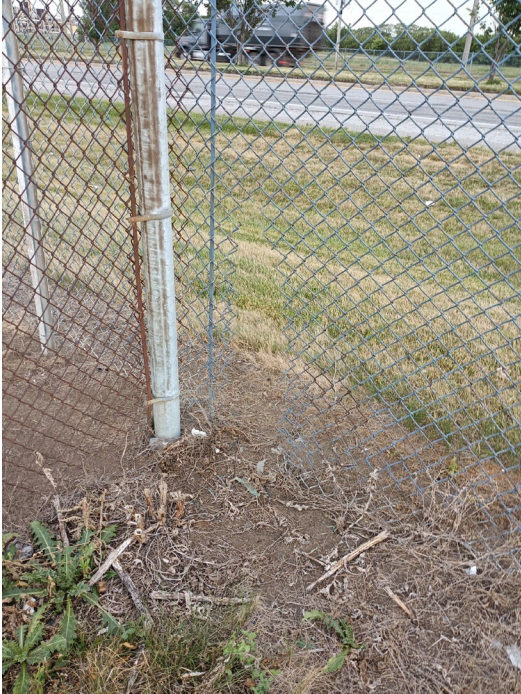
A hole was observed in the northwest corner of the perimeter fence by a overhead electrical pole and transformer. See photo #1.

Number	1
	Description	Hole in northwest corner of perimeter fence by overhead electrical pole and transformer.
	Photographer	Matthew Peterschmidt
	Facility Name	Racer Trust Surface Impoundment
	Photo Date	06/25/2024
	Others	Emma TerBeek Arcadis U.S., Inc.

Repair hole in security fence and submit evidence of repair to this office within 30 days of receipt of this report.

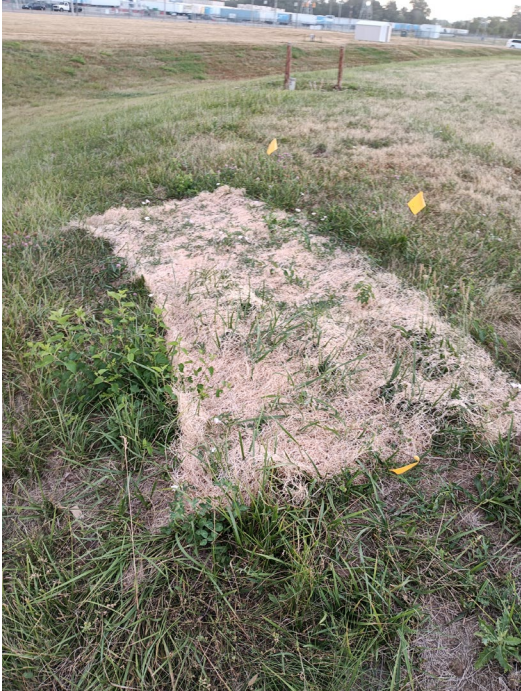
Occasionally, mowers scalp small sections of the cap. Once observed, these sections are re-seeded to cover bare spots. See photos 2, 4, and 8. Vegetative growth was observed along the west side perimeter fence line. This growth comes from Rolls Royce property and has not impacted the fence integrity at the time of inspection. The site does spray to control vegetative growth along the perimeter fence. See photo #5.

Number	2
	Description	Reseeded area northwest corner on cap.
	Photographer	Matthew Peterschmidt
	Facility Name	Racer Trust Surface Impoundment
	Photo Date	06/25/2024
	Others	Emma TerBeek Arcadis U.S., Inc.

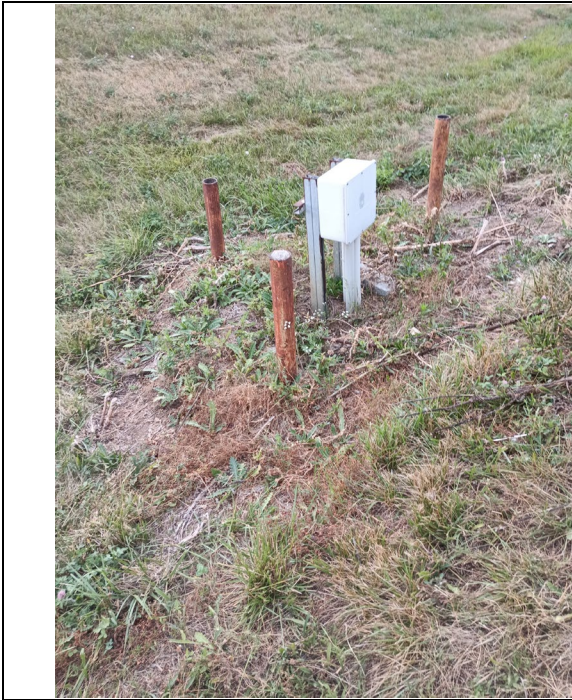
Number	3
Description	Extraction well 210 power box
Photographer	Matthew Peterschmidt
Facility Name	Racer Trust Surface Impoundment
Photo Date	06/25/2024
Others	Emma TerBeek Arcadis U.S., Inc.

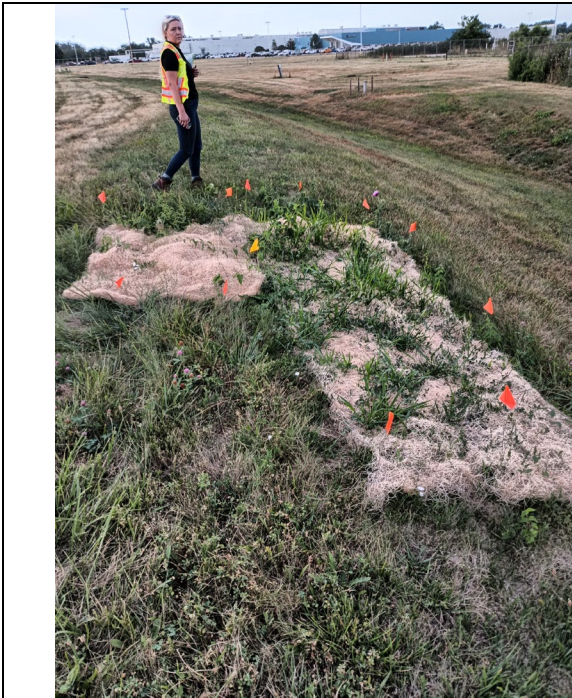
Number	4
Description	Reseeded area west side on cap.
Photographer	Matthew Peterschmidt
Facility Name	Racer Trust Surface Impoundment
Photo Date	06/25/2024
Others	Emma TerBeek Arcadis U.S., Inc.

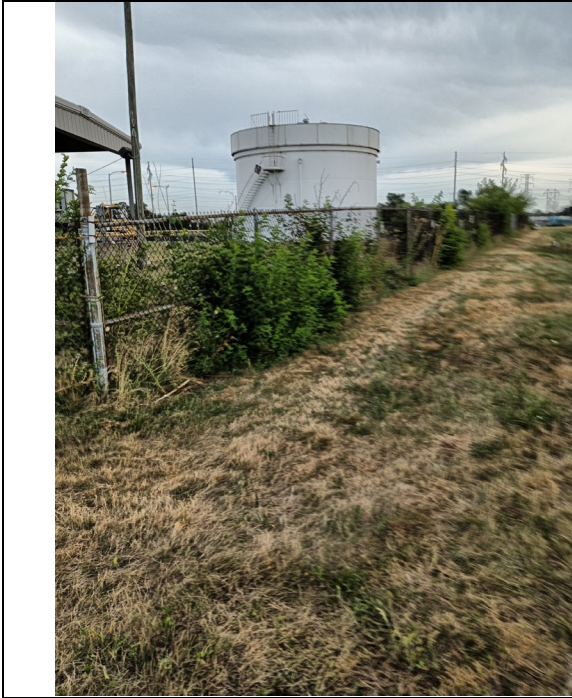
Number	5
Description	Vegetation on west side perimeter fence
Photographer	Matthew Peterschmidt
Facility Name	Racer Trust Surface Impoundment
Photo Date	06/25/2024
Others	Emma TerBeek Arcadis U.S., Inc.

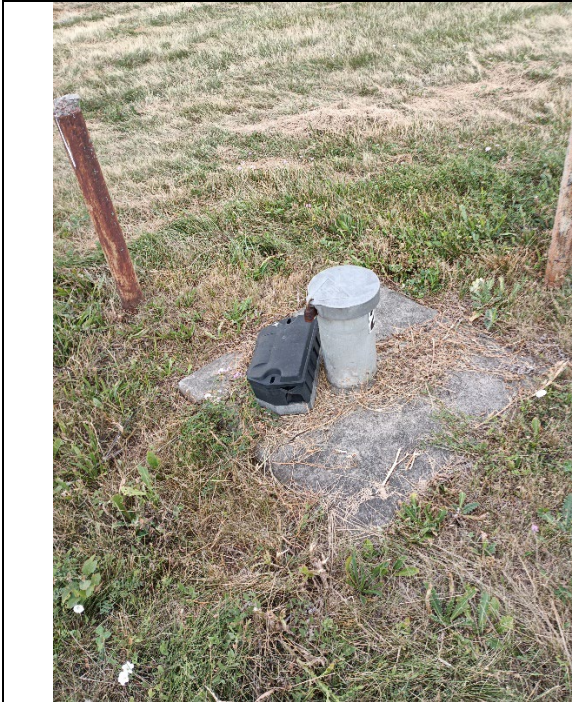
Number	6
Description	Monitoring well 205A with vole bait container
Photographer	Matthew Peterschmidt
Facility Name	Racer Trust Surface Impoundment
Photo Date	06/25/2024
Others	Emma TerBeek Arcadis U.S., Inc.

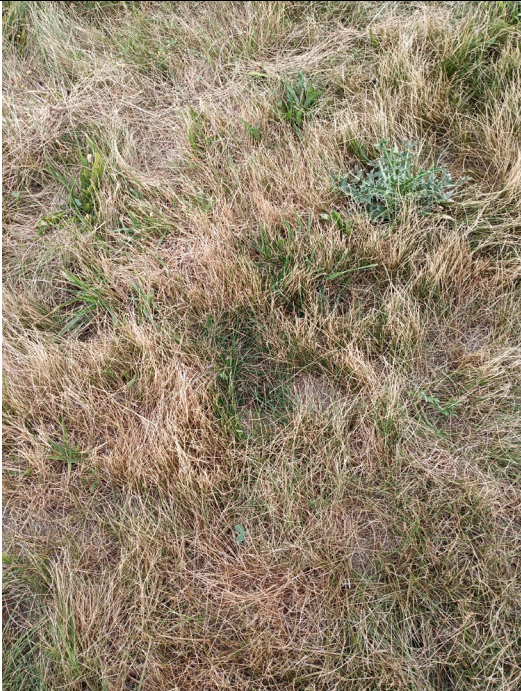
Number	7
	Description	Vole network south end midway between monitoring wells 205A and 204A
	Photographer	Matthew Peterschmidt
	Facility Name	Racer Trust Surface Impoundment
	Photo Date	06/25/2024
	Others	Emma TerBeek Arcadis U.S., Inc.

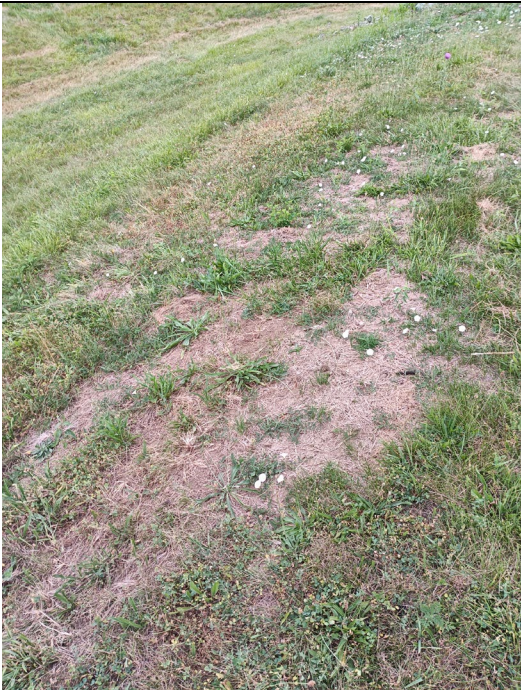
Number	8
	Description	Bare spot on south cap south of monitoring well 204A
	Photographer	Matthew Peterschmidt
	Facility Name	Racer Trust Surface Impoundment
	Photo Date	06/25/2024
	Others	Emma TerBeek Arcadis U.S., Inc.

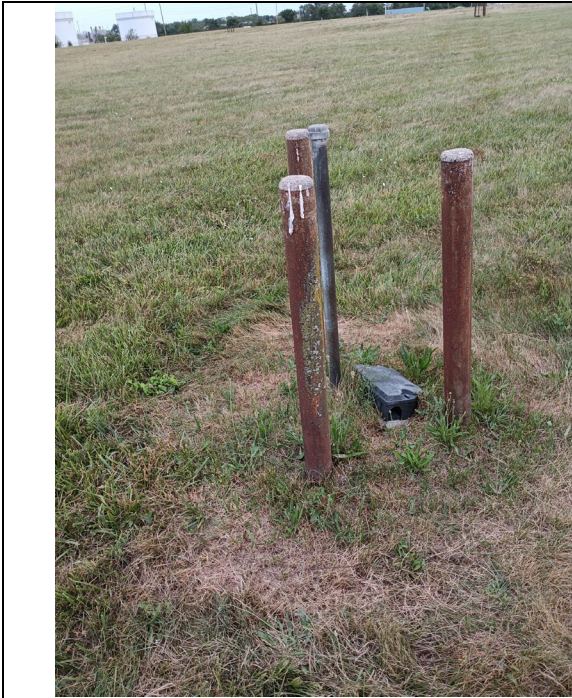
Number	9
Description	Settlement monument M8
Photographer	Matthew Peterschmidt
Facility Name	Racer Trust Surface Impoundment
Photo Date	06/25/2024
Others	Emma TerBeek Arcadis U.S., Inc.

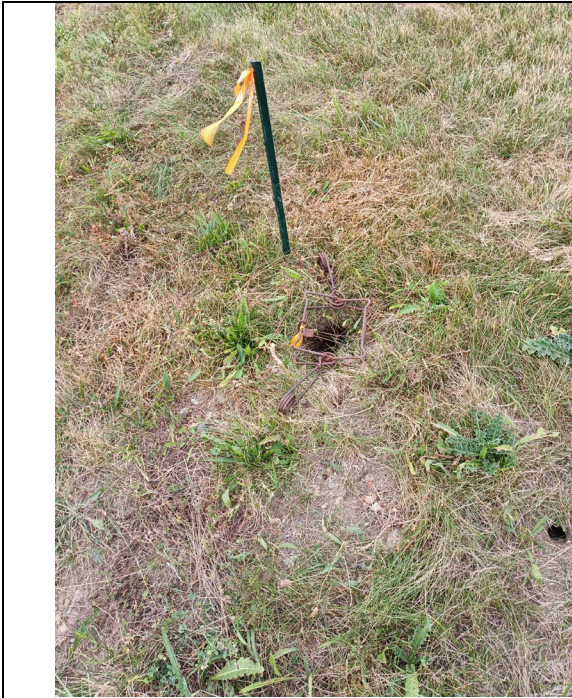
The facility has a contract with a professional exterminator who provides pest control services at the site. The exterminator has multiple traps set throughout the facility for voles and groundhogs. Groundhogs occasionally create holes in the fence surrounding the site so the fence around the facility is maintained regularly and, in several places, had been patched prior to my inspection. A recent, un-repaired hole in the perimeter fence was observed in the northwest corner of the site, though this hole appears to have been man-made. See photo #1. The exterminator has also placed several vole traps around the cap near the observed vole activity. During my inspection I observed some vole networks that had vole traps in the vicinity and several groundhog holes that were equipped with traps. See photos 6,7, and 9 through 14. Animal activity has decreased year over year and the site is actively maintaining mitigation efforts.

Number	10
Description	Groundhog hole and trap, also vole holes on east side cap
Photographer	Matthew Peterschmidt
Facility Name	Racer Trust Surface Impoundment
Photo Date	06/25/2024
Others	Emma TerBeek Arcadis U.S., Inc.

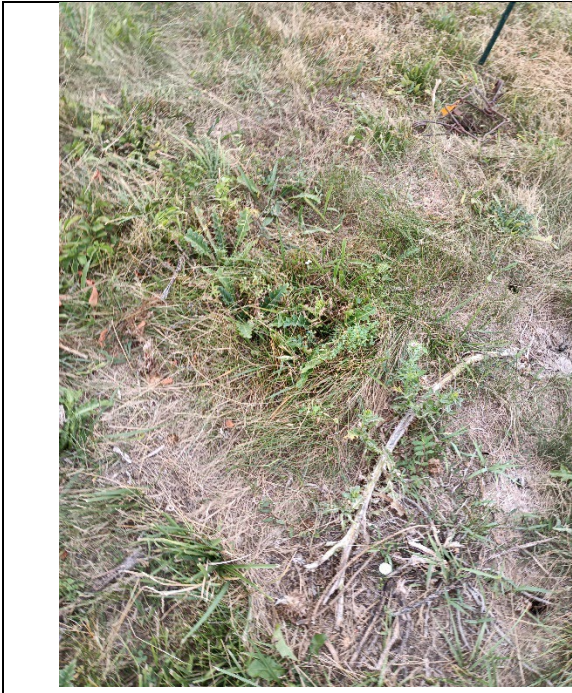
Number	11
Description	Ground hog hole and trap, vole holes on east side cap west of extraction well 203
Photographer	Matthew Peterschmidt
Facility Name	Racer Trust Surface Impoundment
Photo Date	06/25/2024
Others	Emma TerBeek Arcadis U.S., Inc.

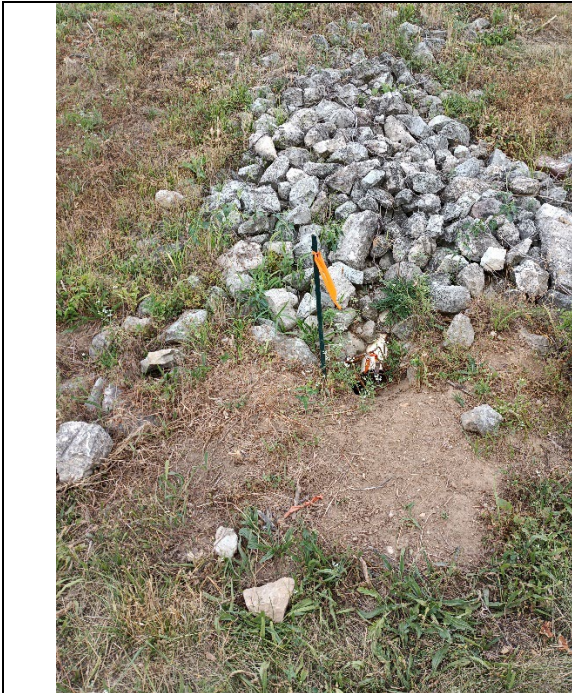
Number	12
Description	Ground hog hole and trap in drain middle of east side
Photographer	Matthew Peterschmidt
Facility Name	Racer Trust Surface Impoundment
Photo Date	06/25/2024
Others	Emma TerBeek Arcadis U.S., Inc.

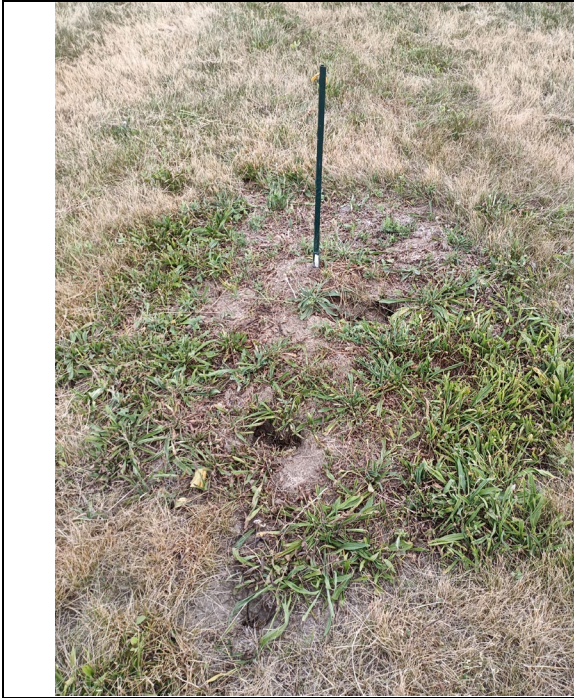
Number	13
Description	Ground hog holes in need of bentonite refilling east side cap west of monitoring well 202 A
Photographer	Matthew Peterschmidt
Facility Name	Racer Trust Surface Impoundment
Photo Date	06/25/2024
Others	Emma TerBeek Arcadis U.S., Inc.

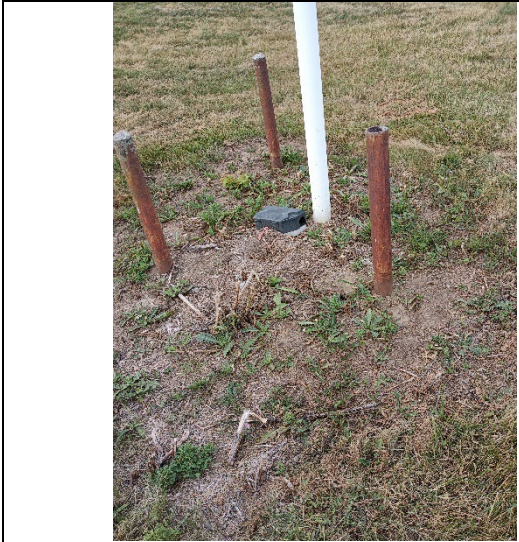
Number	14
Description	East side gas vent near middle of cap
Photographer	Matthew Peterschmidt
Facility Name	Racer Trust Surface Impoundment
Photo Date	06/25/2024
Others	Emma TerBeek Arcadis U.S., Inc.
