INDIANA DEPARTMENT OF ENVIRONMENTAL MANAGEMENT

Re: **Inspection Summary Letter**
Emerson Avenue Landfill
SW ID: 49-02
Beech Grove, Marion County

Name of registration or Tempo (RM): Emerson Avenue Landfill (AI ID: 24985)	Location: 2700 South Emerson Avenue, Beech Grove, Indiana	Type of Inspection: Compliance Assistance
County: Marion County	Permit #: SW ID: 49-02	Permit Expires: Closed

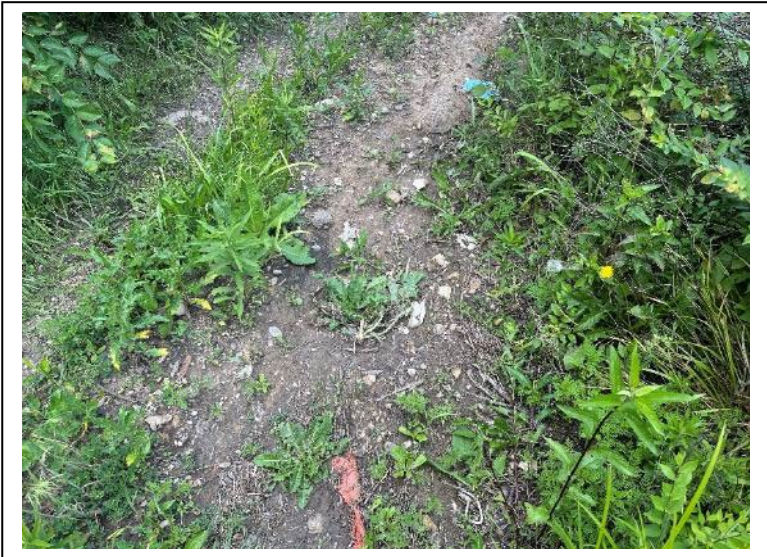
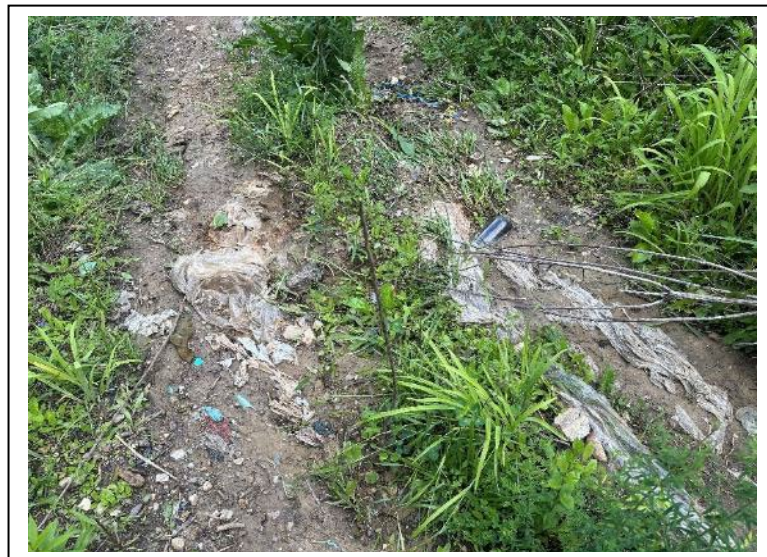
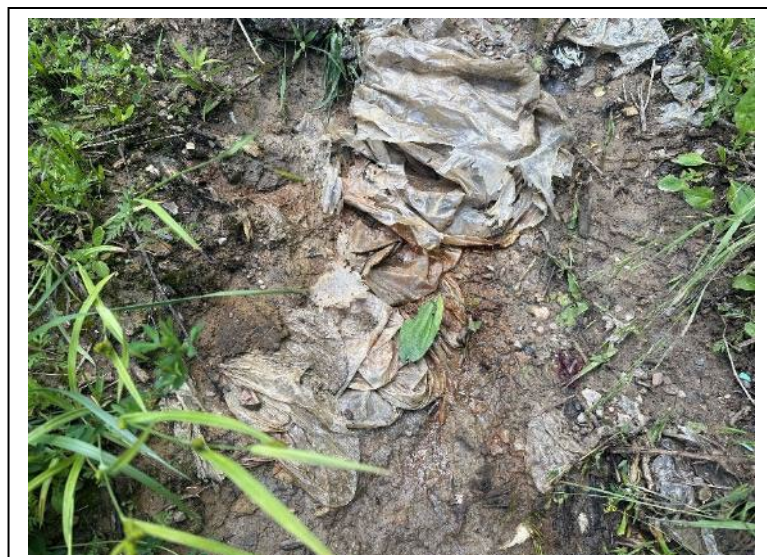
The inspection walkthrough began by walking to the northernmost corner of the landfill where a large erosion gully was observed during previous inspections. IDEM staff observed exposed waste on the access road to Lick Creek (*see attached photo log – photos 1-3*). A large erosion gully, approximately 5-feet deep was observed on the east side of the access road (*see attached map – leachate seep 1*). At the time of the inspection, IDEM staff observed leachate and exposed waste in the gully, along with the presence of landfill gas odor (*see attached photo log – photos 4-9*). IDEM staff followed the flow of water through the gully and into Lick Creek where more exposed waste was observed (*see attached photo log – photos 10 & 11*). IDEM staff informed Mayor Coffman that waste migrating off site should be addressed immediately and that violations may occur if the issue is not corrected.

Exposed waste on the access path to Lick Creek on the north corner of the landfill.

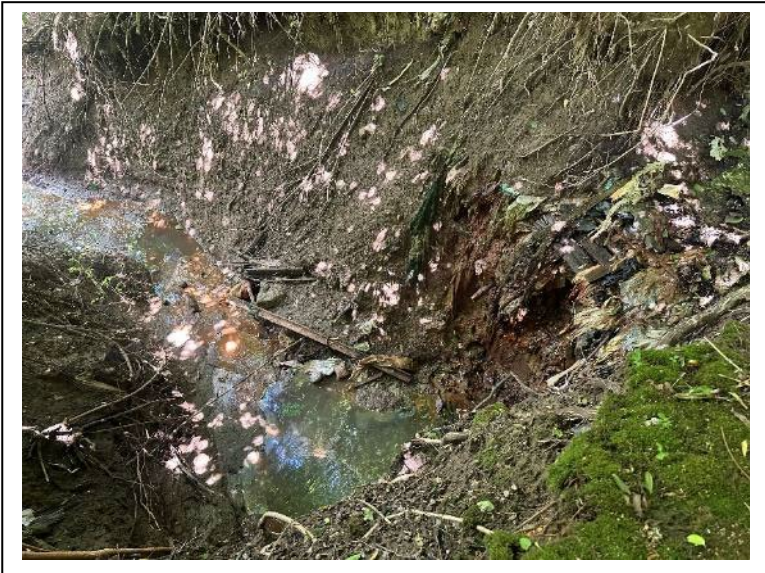
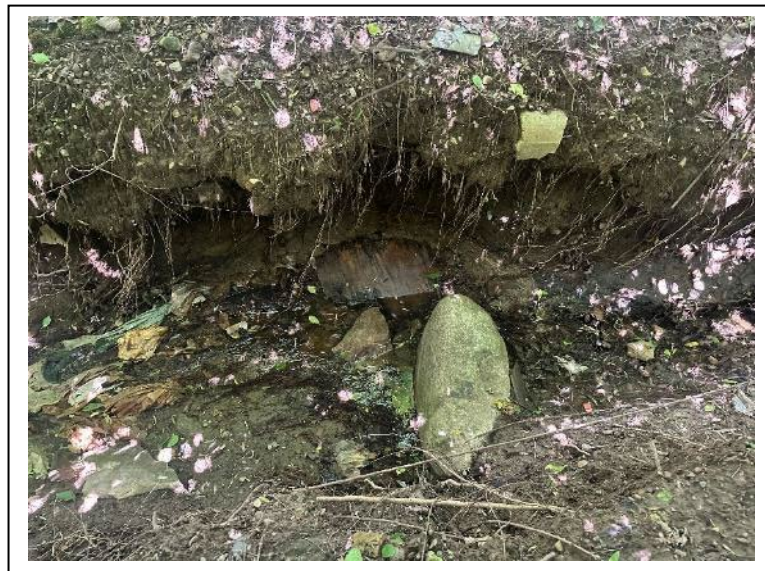
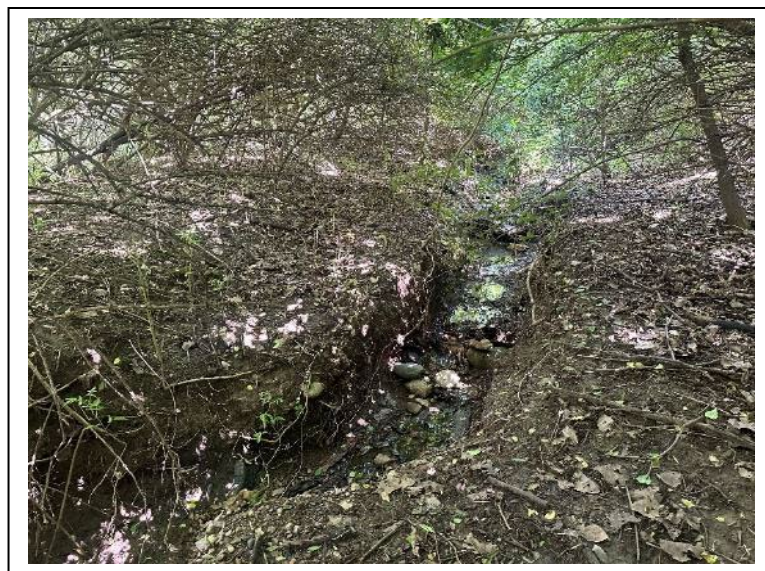
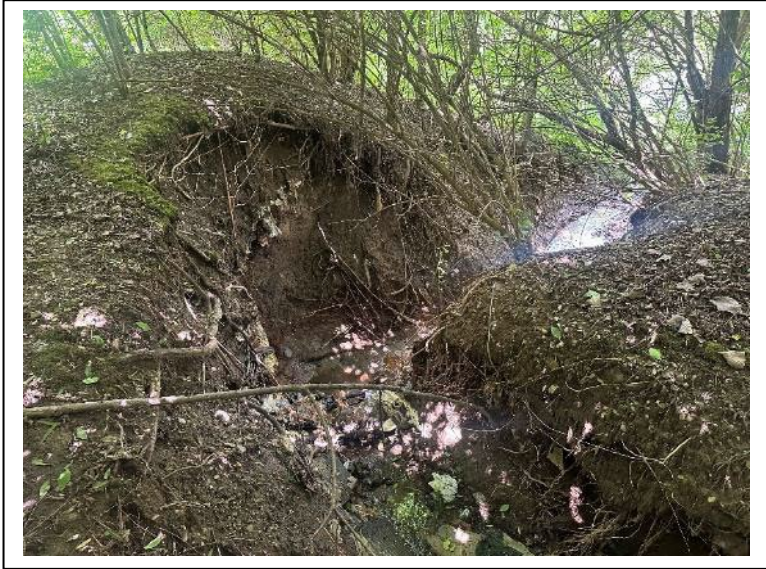
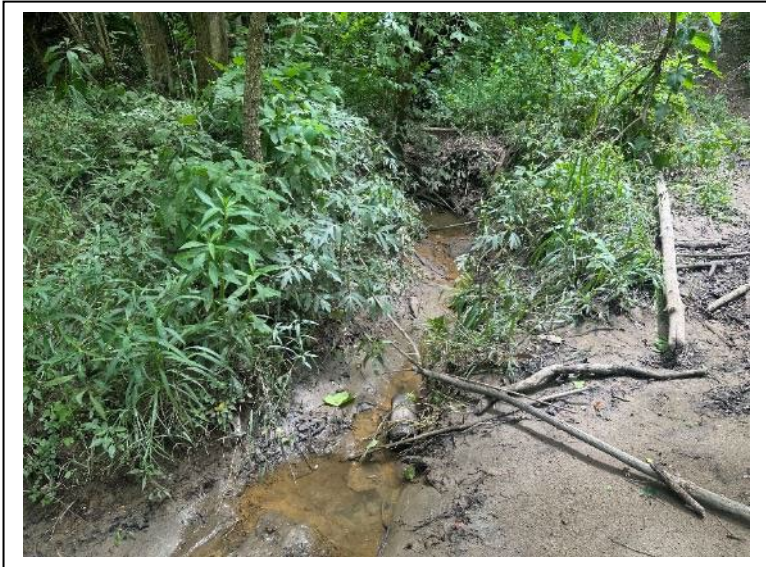
Large gully with exposed waste and leachate on the north corner of the landfill.

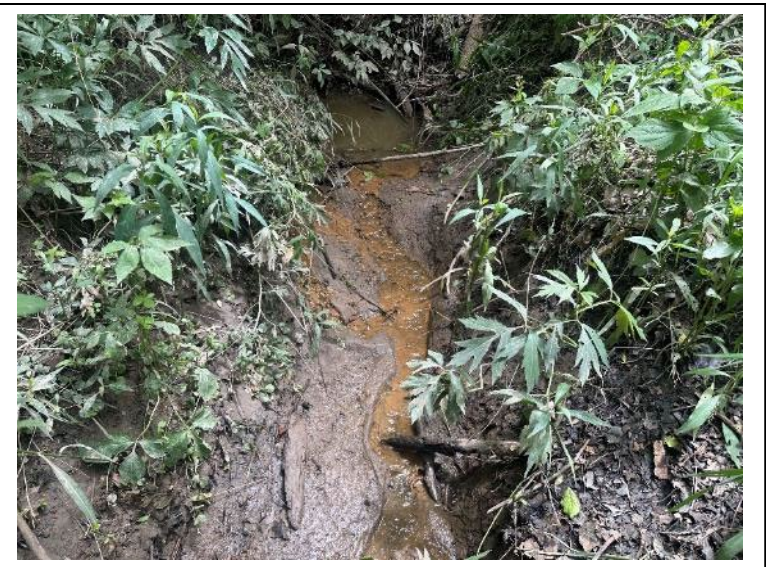
Photo 10

Area where the gully meets Lick Creek.

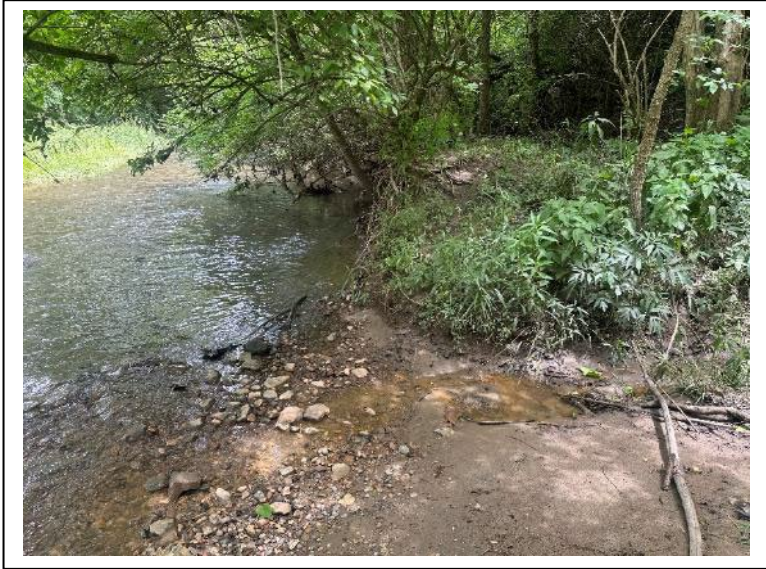
Photo 11

Area where the gully meets Lick Creek with exposed waste.

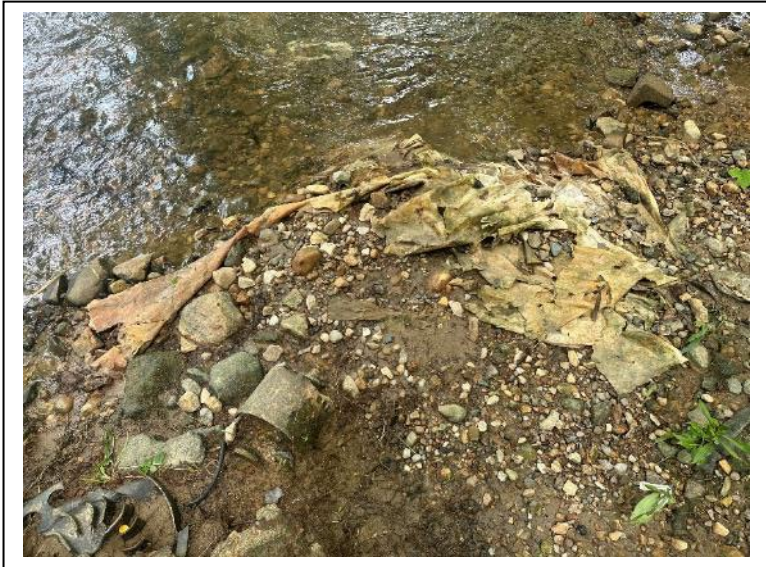
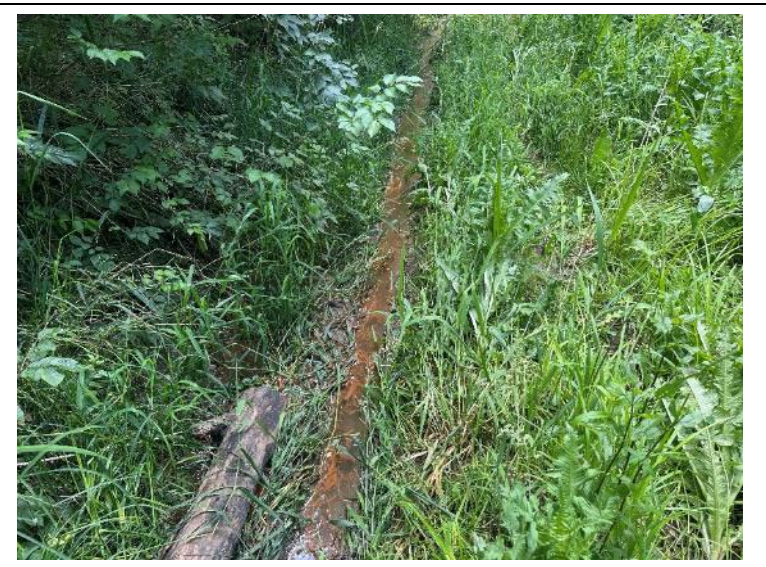
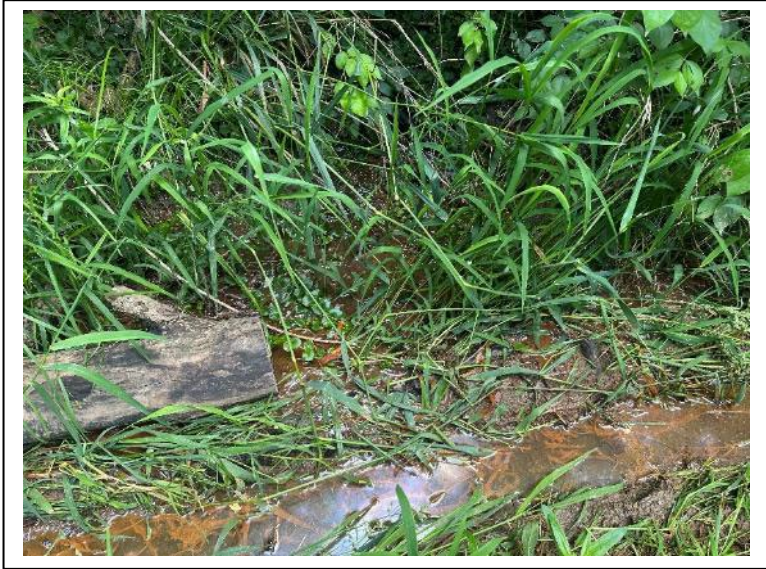
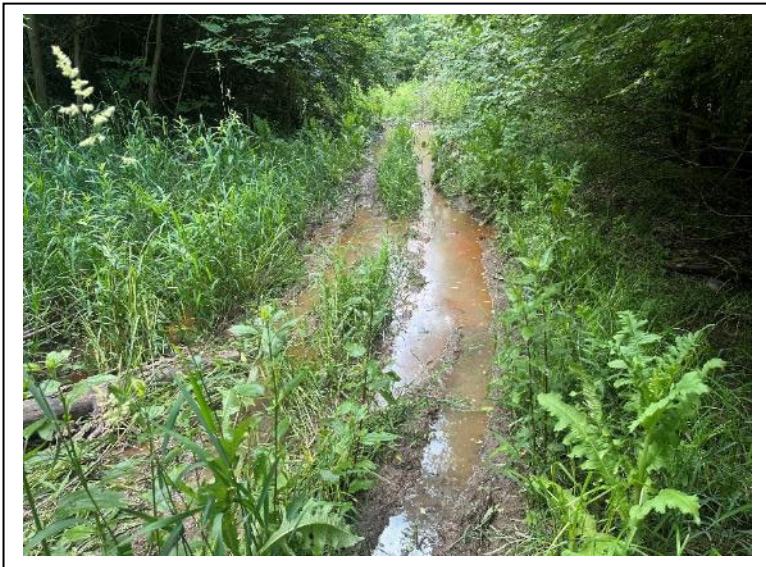
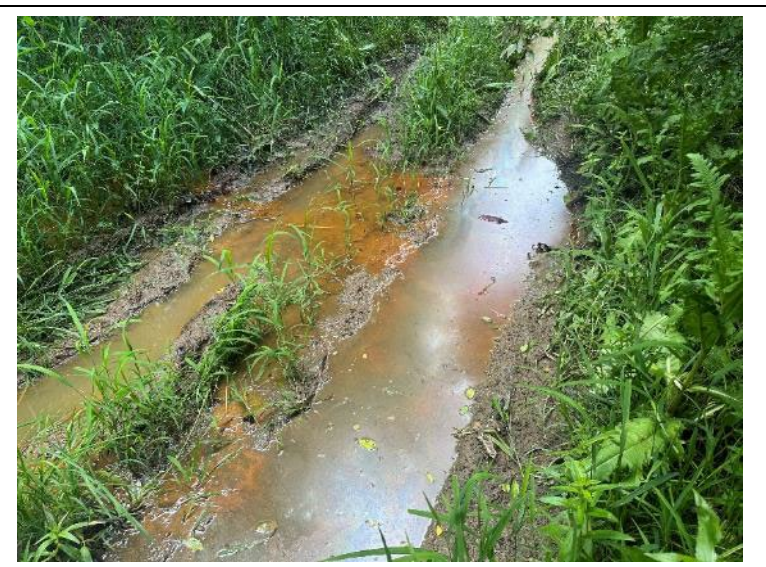
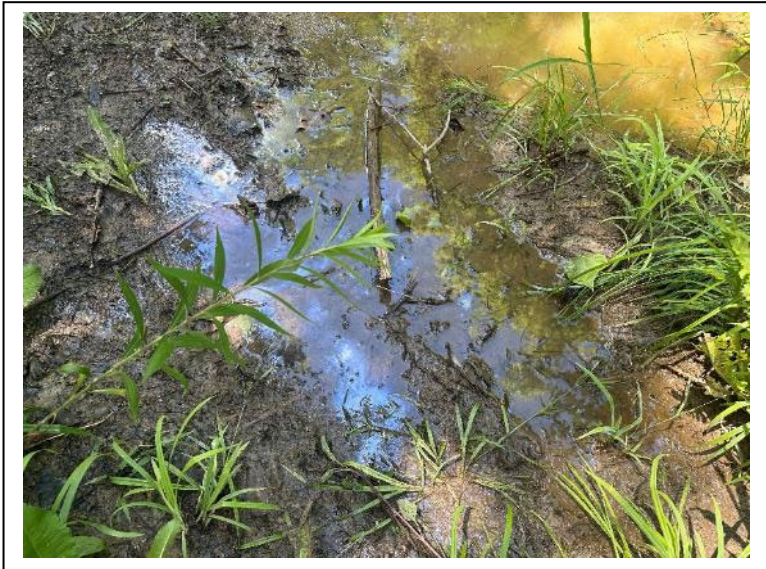
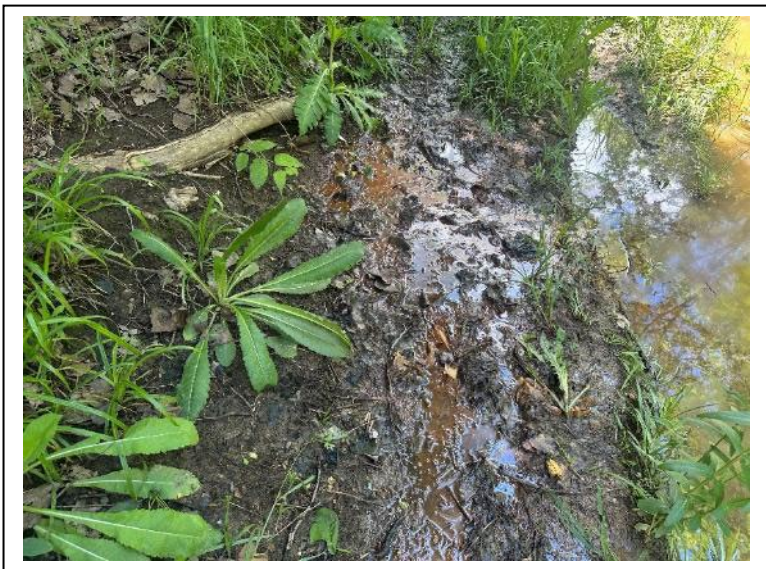
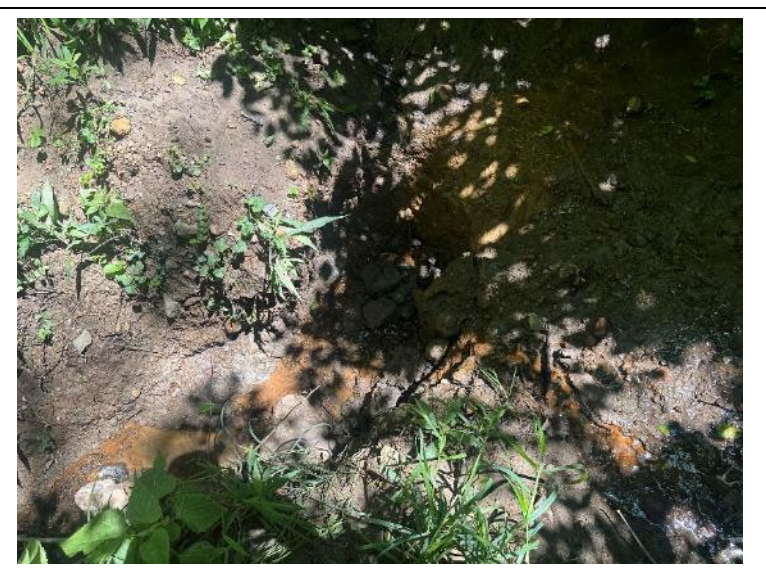
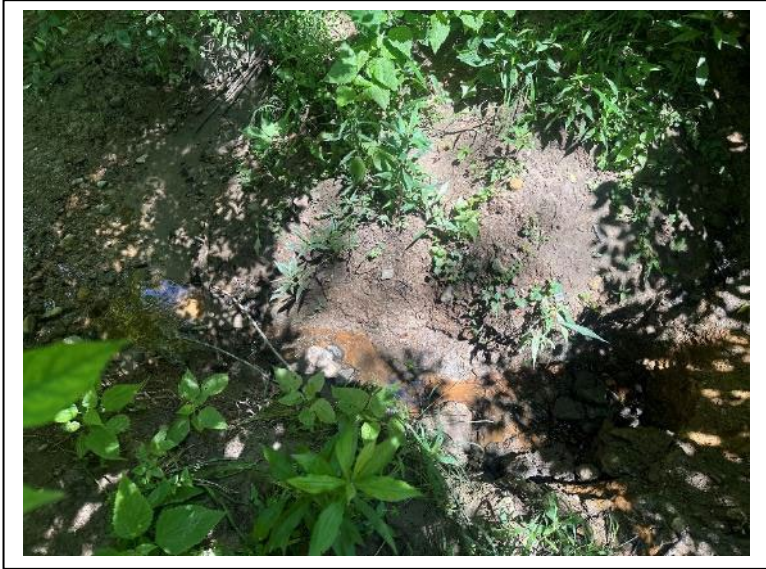
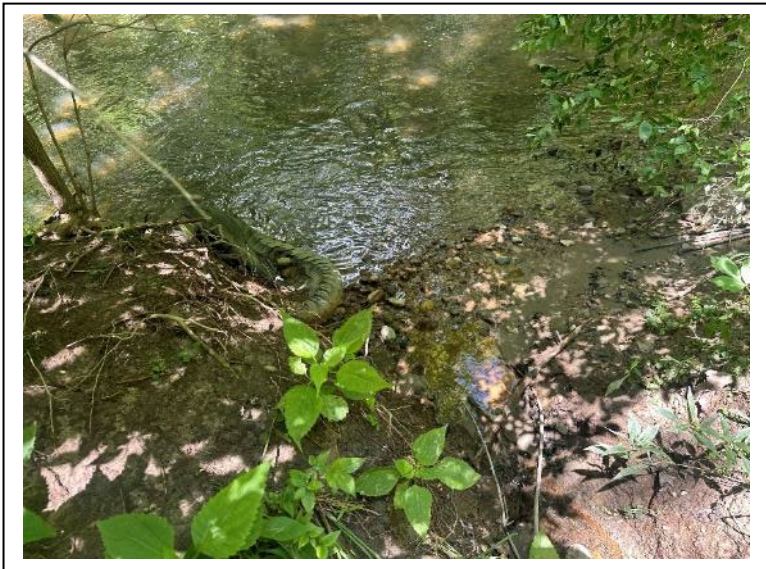
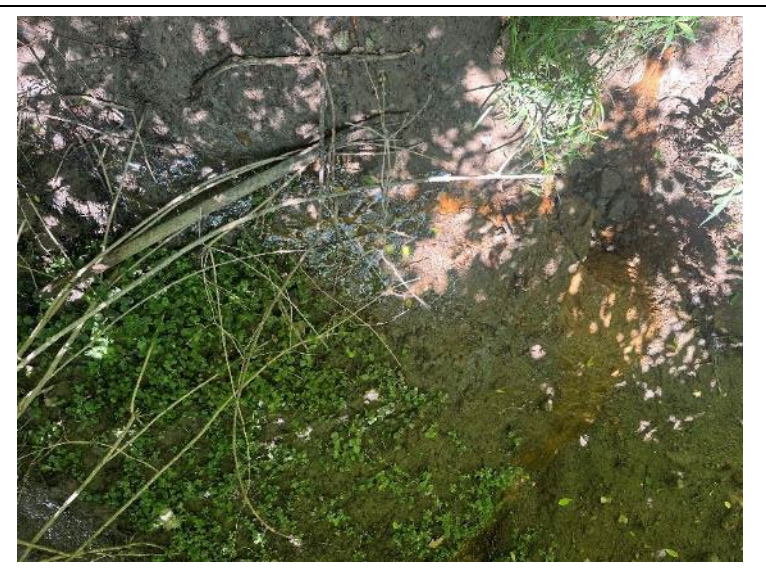
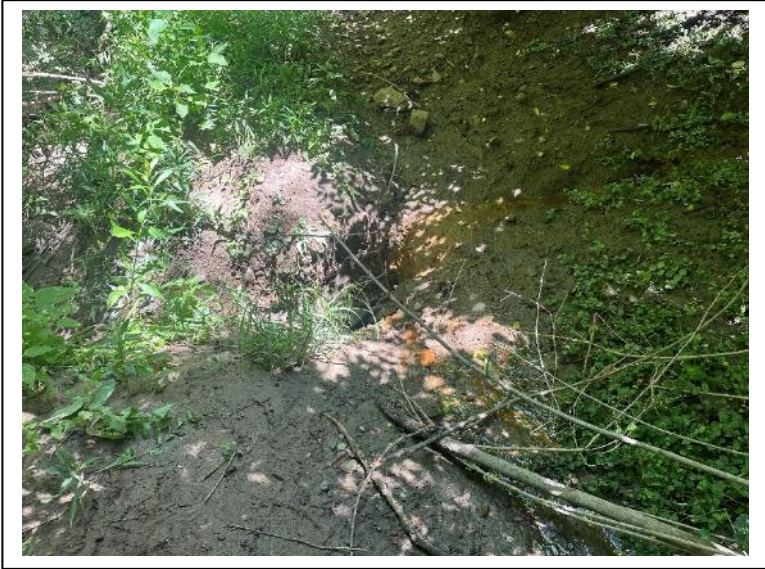
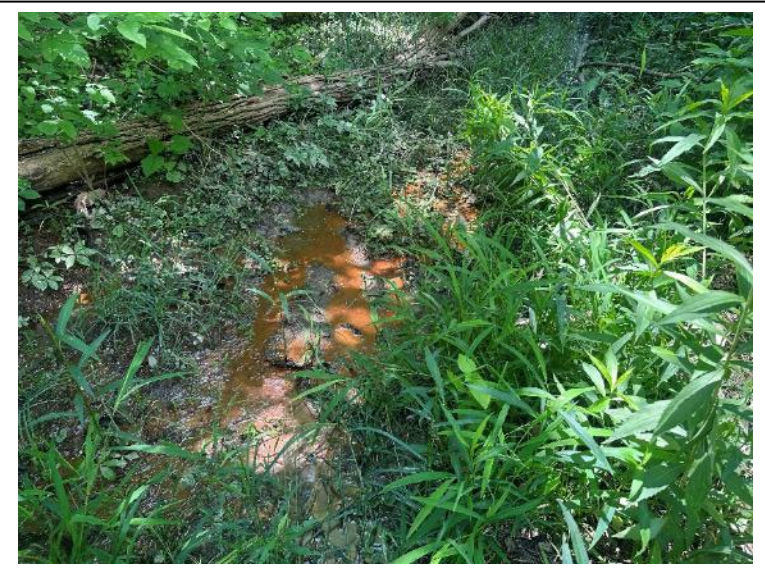
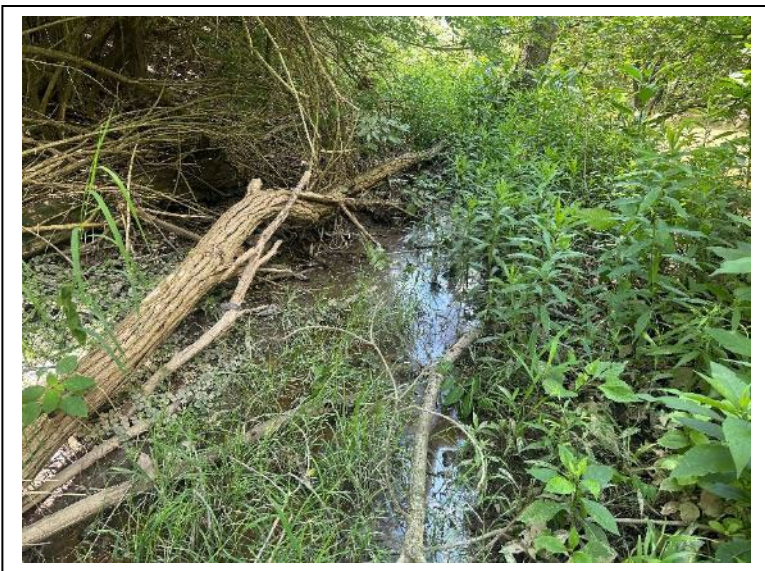
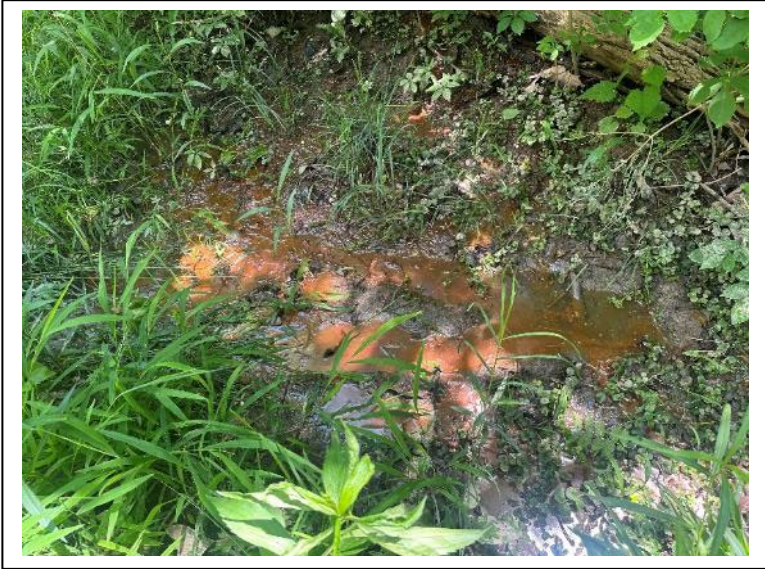
The inspection walkthrough continued west along the creek bank. IDEM staff observed water ponding on the landfill along the bank. IDEM staff observed many leachate seeps along the creek bank while walking to the western access road to the creek (*see attached photo log – photos 12-25 and attached map – leachate seep 2-4*).

Leachate seep on the northwestern waste boundary.
See attached map – Leachate Seep 2

Leachate seep on the northwestern waste boundary.
See attached map – Leachate Seep 3

Leachate seep on the northwestern waste boundary near the northwest access road.

Leachate seep on the northwestern waste boundary near the northwest access road.
See attached map – Leachate Seep 4

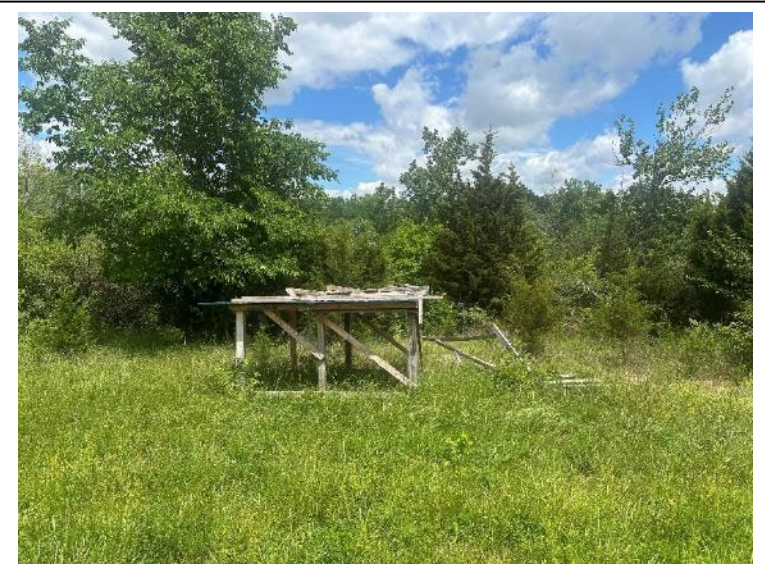
Photo 26

IDEM staff walked back up the northwest access road to the creek to continue the inspection of the landfill cap. IDEM staff observed a wooden structure on the landfill cap near the northern corner of the cap (*see attached photo log – photo 26*). IDEM staff advised Mr. Coffman that the structure needs to be removed from the landfill cap and disposed of properly.

Wooden structure on the landfill cap.

- Remove wooden structure off the landfill cap and properly dispose of it.
- Repair the grassed waterway to promote positive drainage off the landfill cap.
- Regrade the cleared access path to promote positive drainage and prevent ponding of water.
- Submit a plan to IDEM’s Antique Landfill Coordinator that describes how the leachate seeps will be repaired.
- Continue to work with IDEM’s Antique Landfill Coordinator until completion of the project.

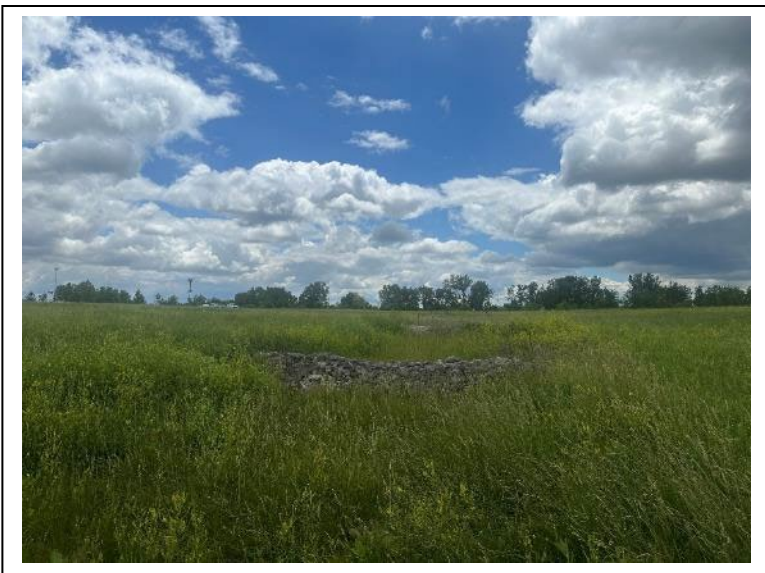
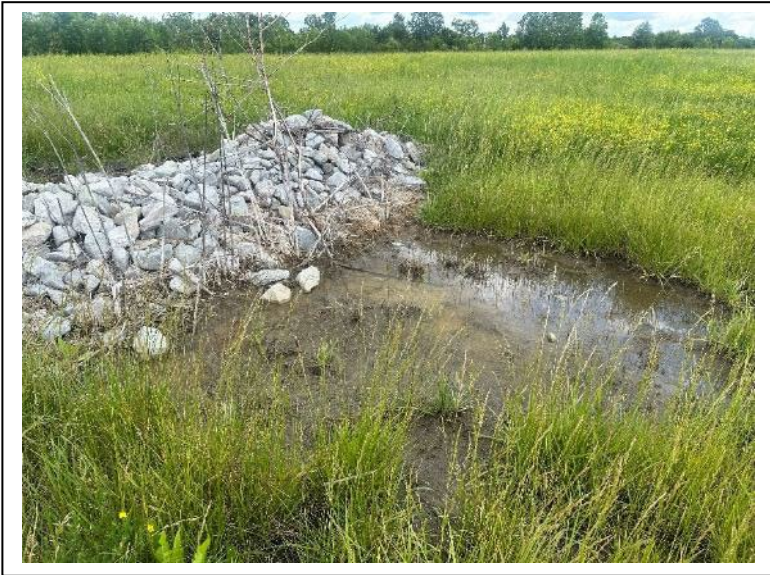
IDEM staff then viewed the grassed waterway with riprap dams, added to slow the movement of surface water drainage on the landfill cap (*see attached photo log – photo 27*). At the time of the inspection, there was water collecting within the grassed waterway (*see attached photo log – photo 28*). Ponded water on the landfill creates opportunity for surface water to infiltrate the landfill cap and increases the likelihood of leachate. IDEM staff recommends correcting the ponded water area and adjacent riprap dam to allow water flow through the rip-rap dam and promote positive drainage off the cap. Repairs may require regrading and/or reconstruction of the riprap dam.

Grassed waterway with riprap dams.

Ponded water within the grassed waterway with riprap dams.

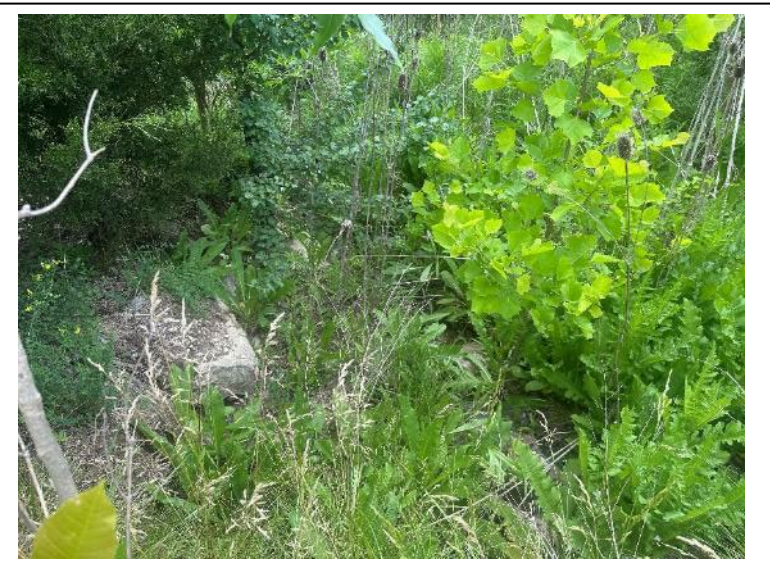
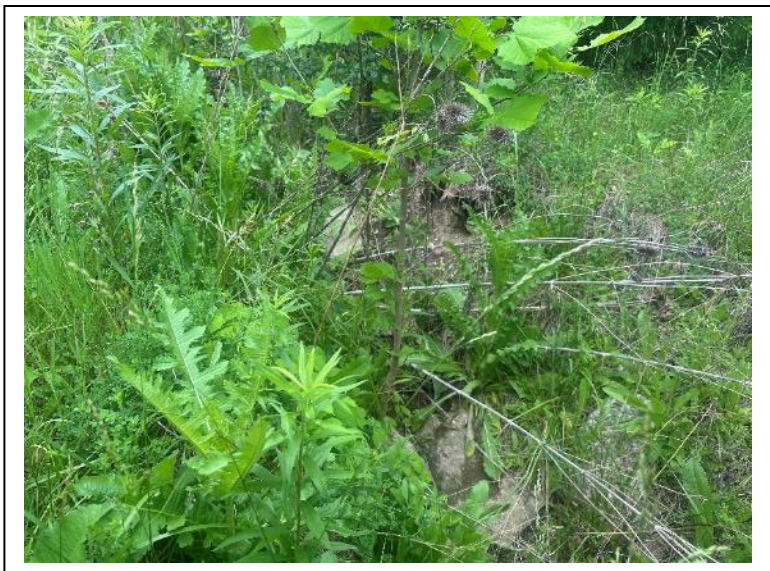
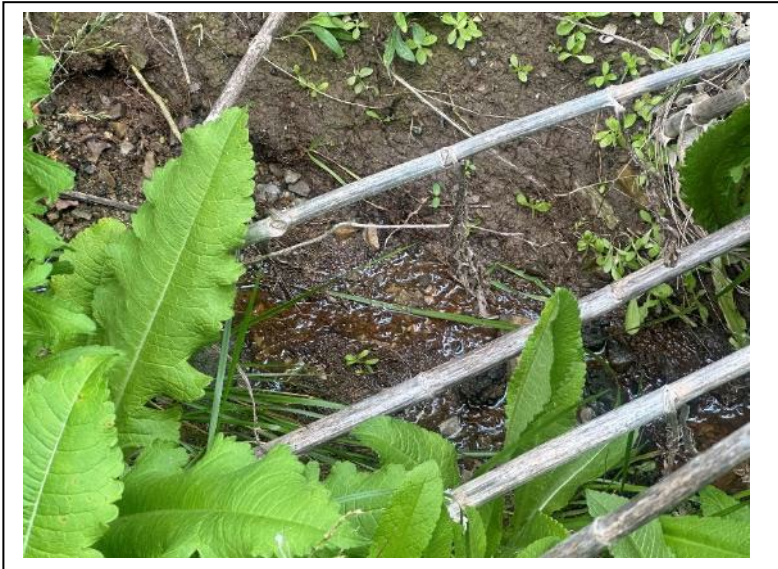
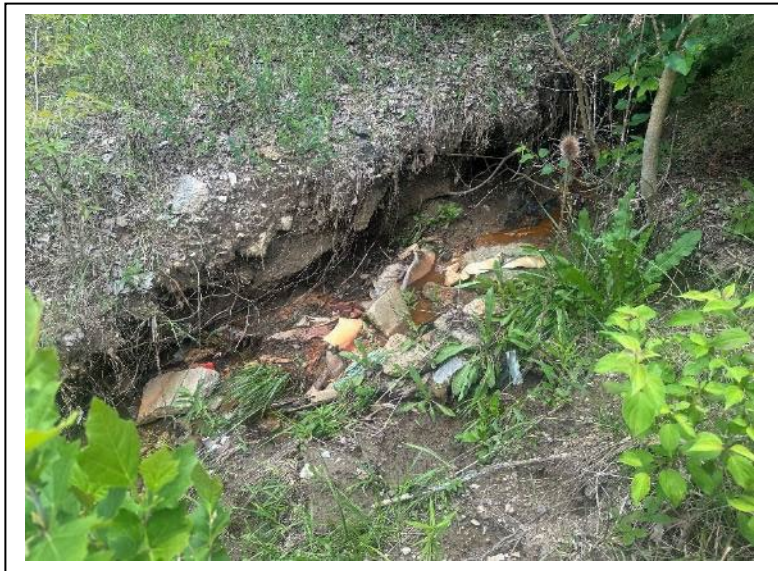
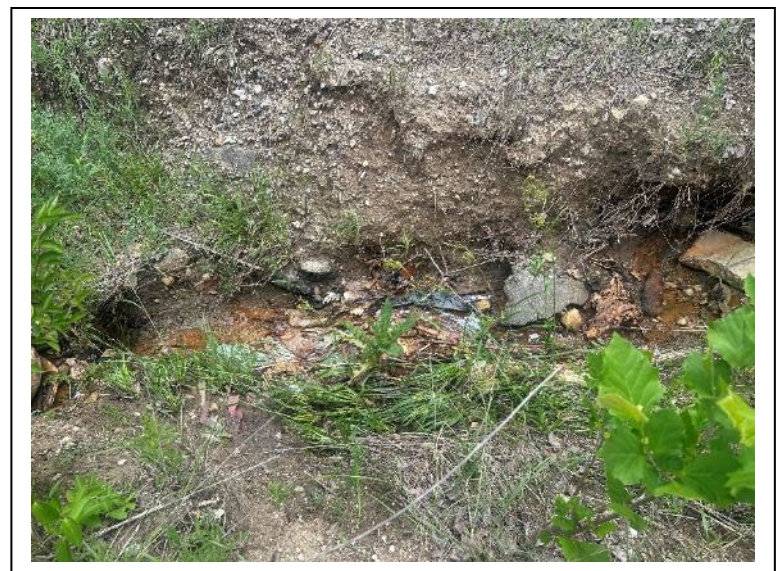
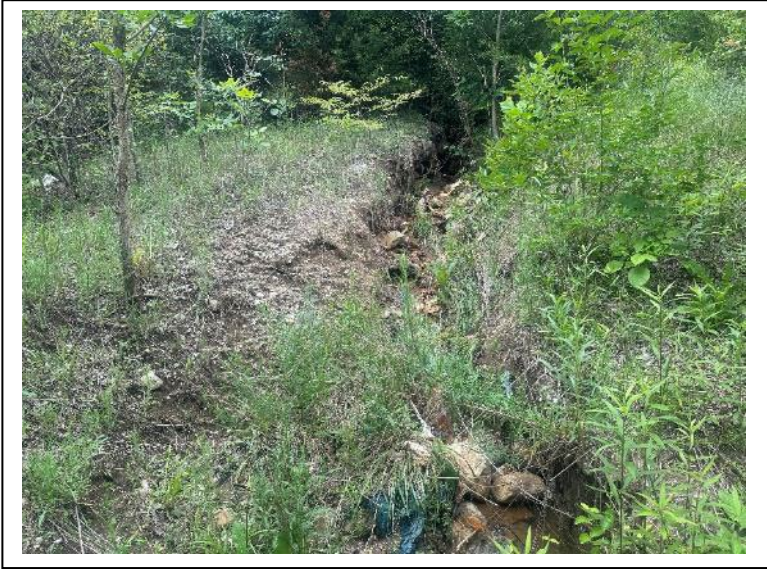
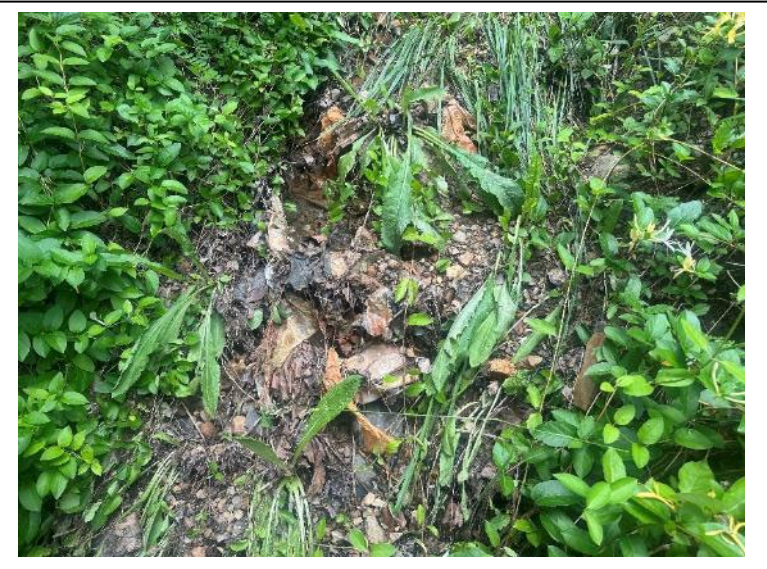
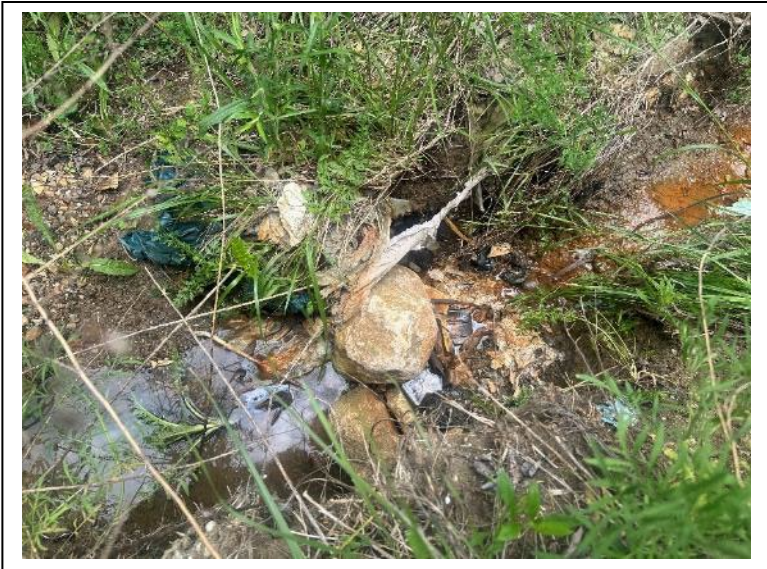
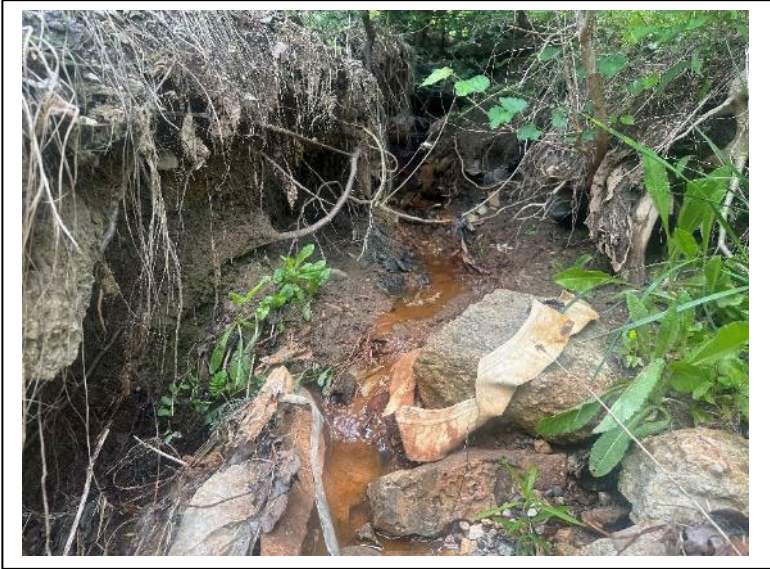
IDEM staff then viewed the outlet of the grassed waterway on the northeast waste boundary line. At the time of the inspection, IDEM staff observed a large gully with leachate and exposed waste (*see attached photo log – photos 29-37 and attached map – leachate seep 5*).

Erosion gully at the outlet of the grassed waterway.

Leachate within the erosion gully at the outlet of the grassed waterway.

Leachate and exposed waste within the erosion gully at the outlet of the grassed waterway.

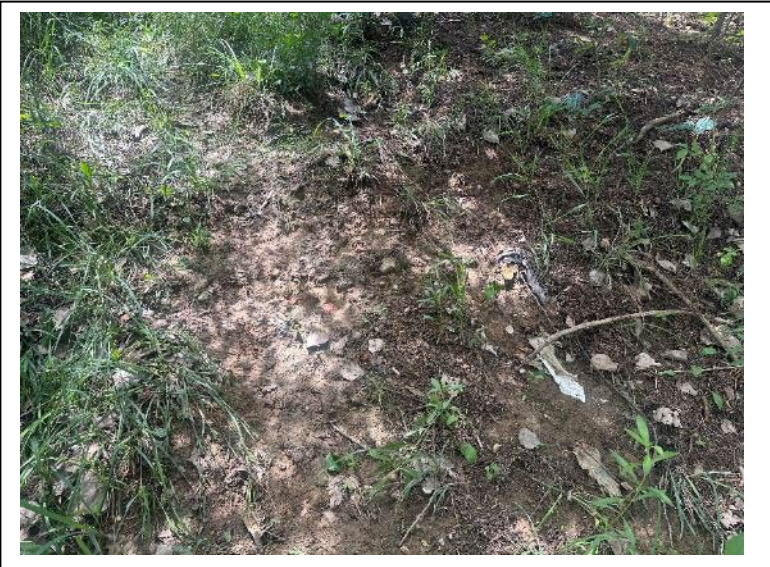
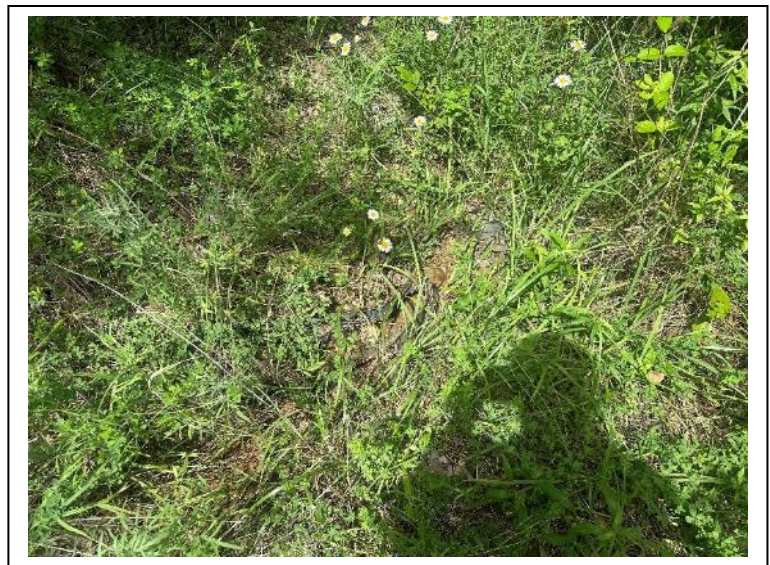
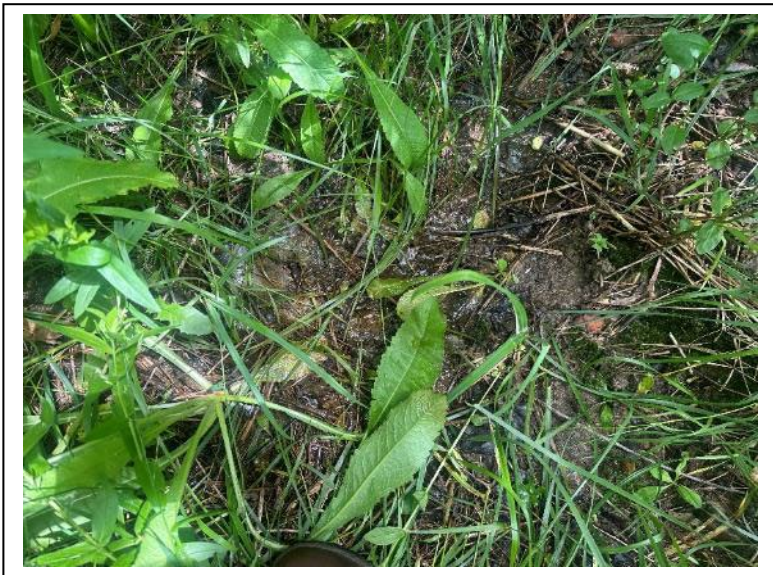
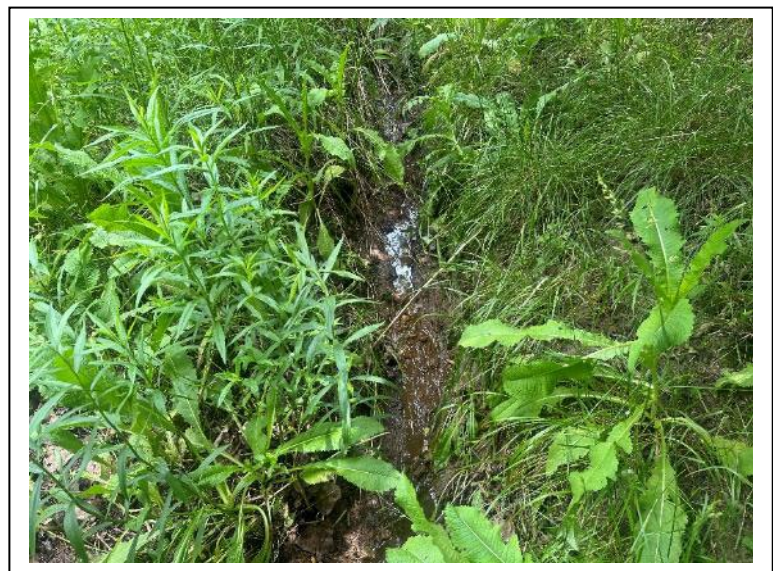
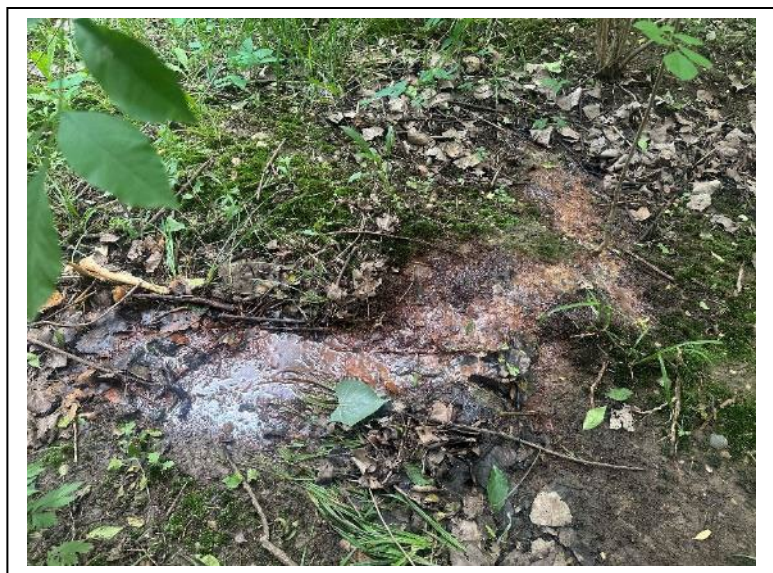
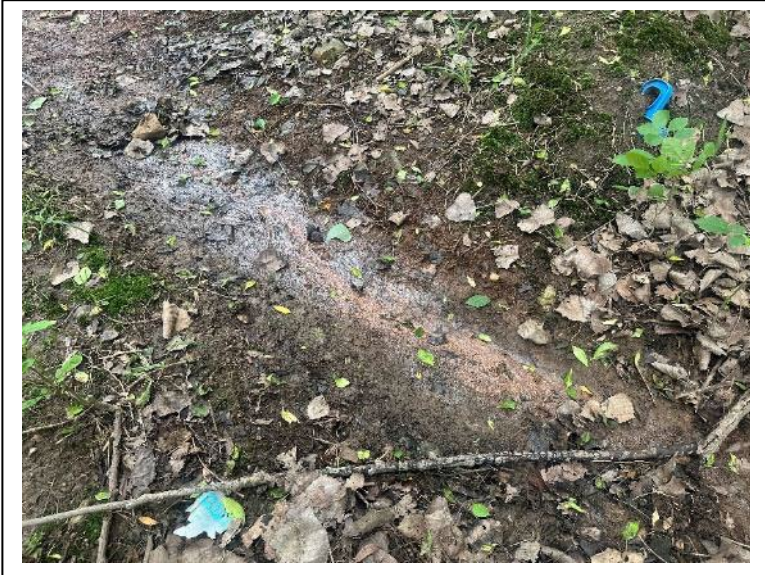
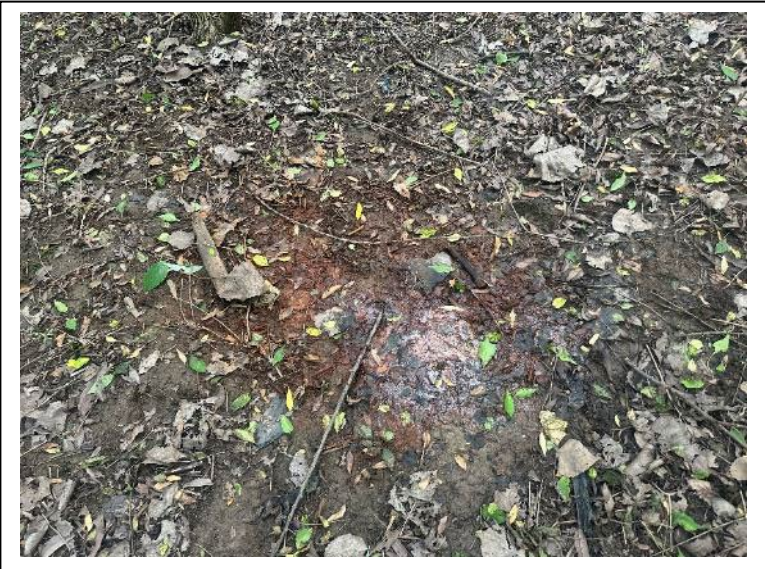
The walkthrough continued southeast along the waste boundary line. IDEM staff observed more exposed waste and leachate along the southeast waste boundary (*see attached photo log – photos 38-44 and attached map – leachate seep 6*). At this point, IDEM staff crossed the property boundary line into the parcel owned by Moorehouse Body Shop, Inc.

Exposed waste on the northeast side of the landfill.

Leachate seep on the northeast side of the landfill.
See attached map – Leachate Seep 6.

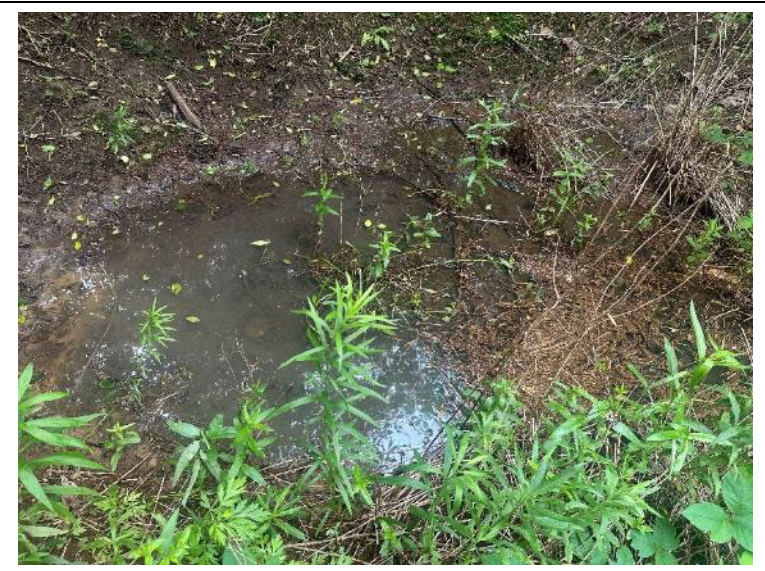
Photo 45

The walkthrough of the Moorehouse Body Shop, Inc. property began at the northeast waste boundary line. IDEM staff observed a grassed path cleared of vegetation along the property boundary. Along the path, IDEM staff noted areas with ponded water (*see attached photo log – photo 45*). IDEM staff recommends regrading areas of ponded water to promote positive drainage off the landfill cap. At the time of the inspection, IDEM staff observed a leachate seep along the access path on the Moorehouse Property (*see attached photo log – photo 46 and attached map – leachate seep 7*).

Ponded water on the cleared access path.

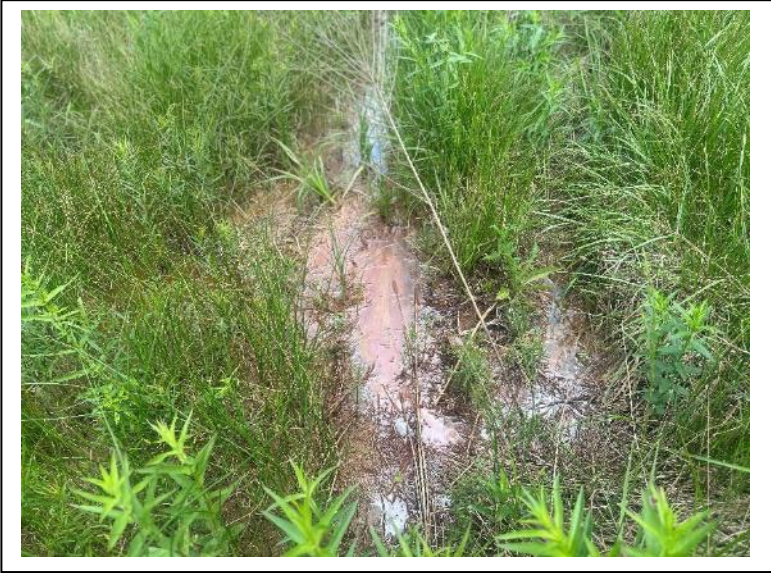
Photo 46

Leachate seep on the southeast corner of the landfill.
See attached map – Leachate Seep 7.

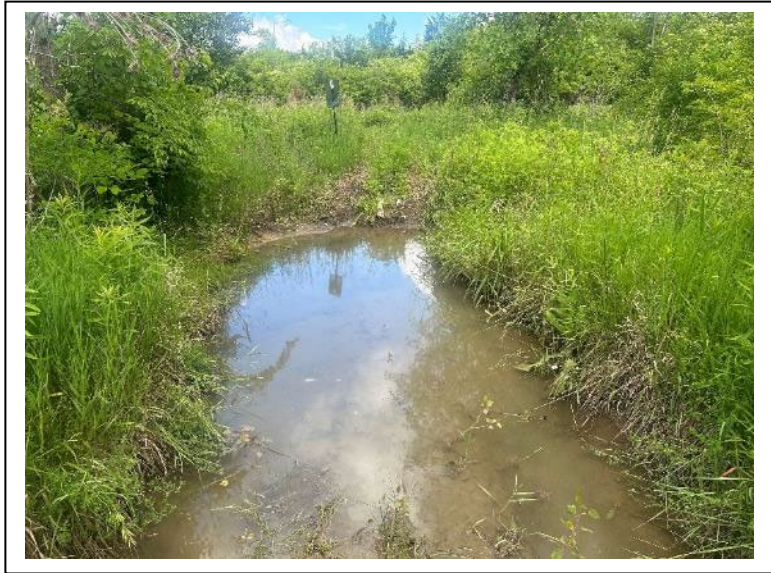
Photo 47

IDEM staff then viewed the area that Mr. Moorhouse stated trespassers often enter the property at on the northeast corner of the property. At the time of the inspection, IDEM staff observed ponded water and vehicle ruts from off road vehicles (*see attached photo log – photo 47*).
