INDIANA DEPARTMENT OF ENVIRONMENTAL MANAGEMENT

Re: **Inspection Summary Letter**
Emerson Avenue Landfill
SW ID: 49-02
Beech Grove, Marion County

Name of registration or Tempo (RM): Emerson Avenue Landfill (AI ID: 24985)	Location: 2700 South Emerson Avenue, Beech Grove, Indiana	Type of Inspection: Compliance Assistance
County: Marion County	Permit #: SW ID: 49-02	Permit Expires: Closed

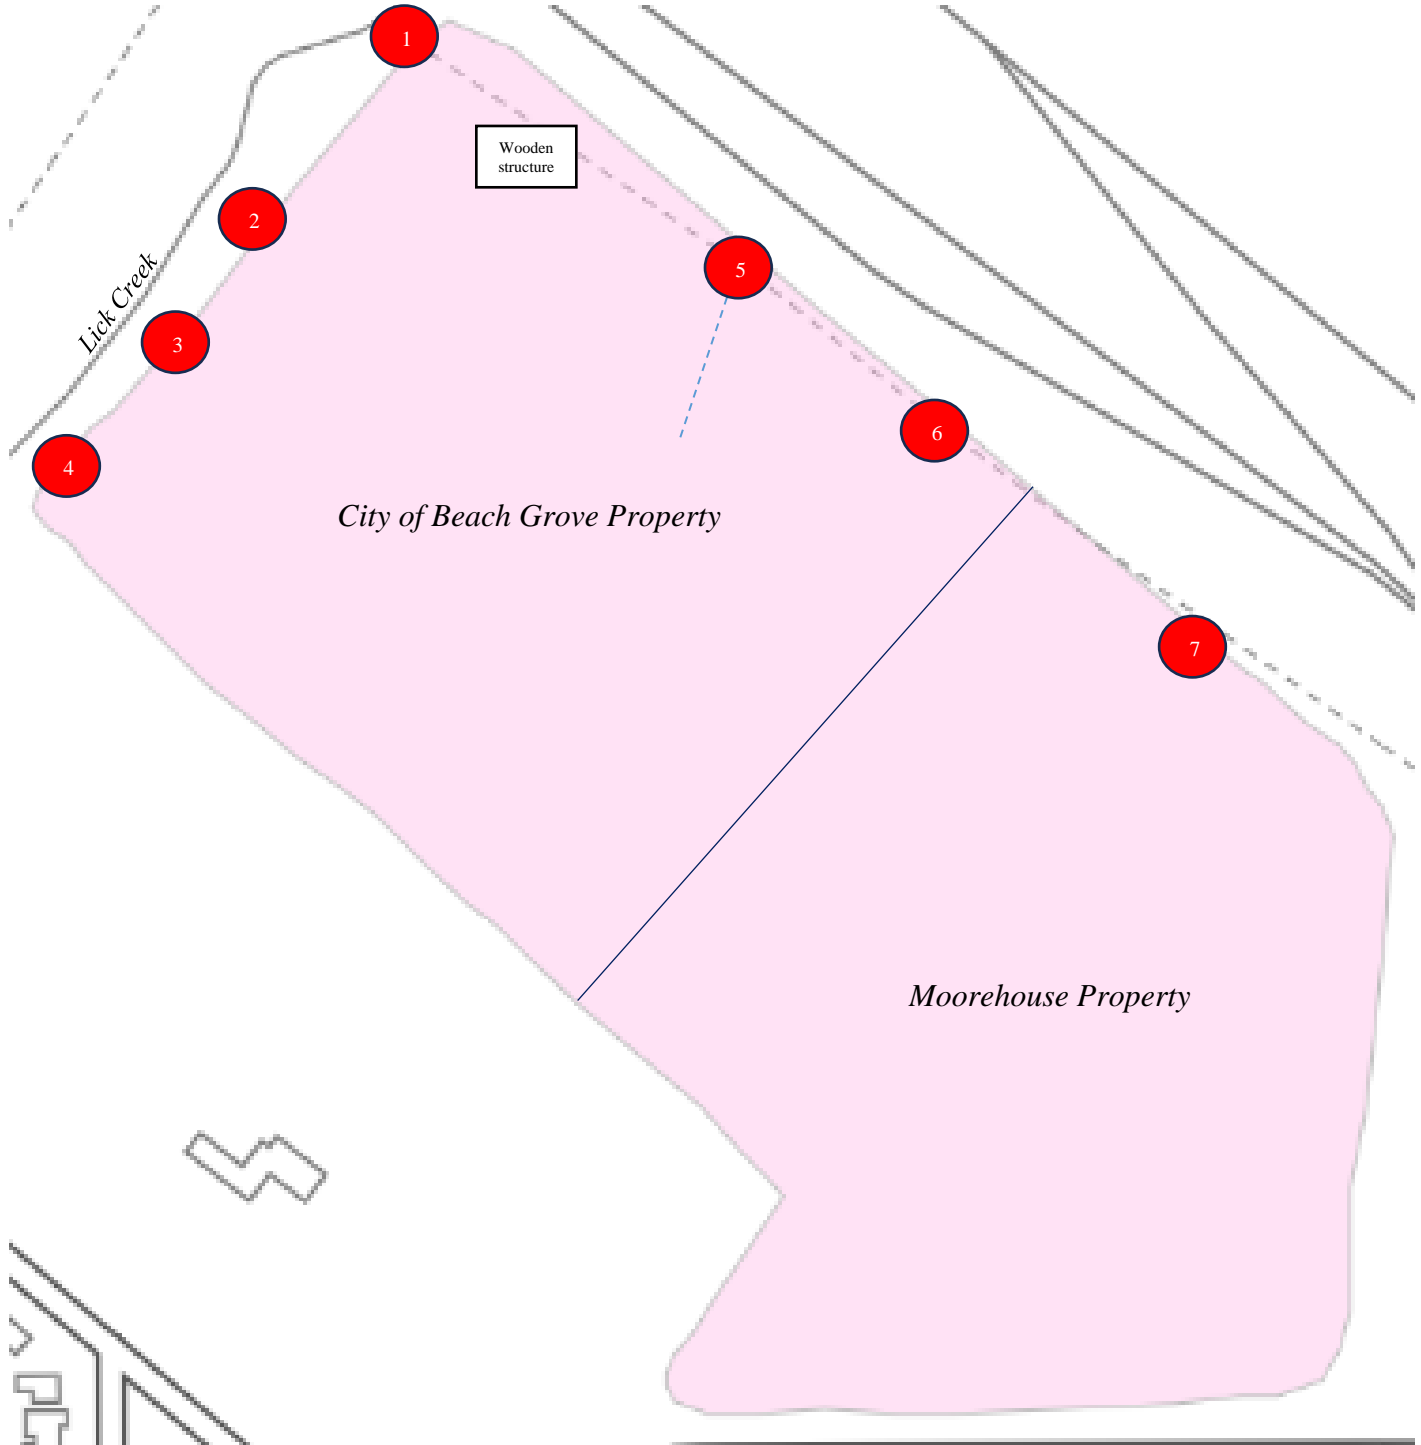
INDEX	
	Approximate Property Boundary
	Leachate Seep
	Grassed Waterway
