AGRICULTURE AND SOLID WASTE COMPLIANCE

State Form 47272 (R3/12-08)
INDIANA DEPARTMENT OF ENVIRONMENTAL MANAGEMENT

File:	County: Henry	Report: Construction		
<u>Name of Inspector:</u> Mike Sonnefeld		<u>Date of Inspection:</u> June 25, 2024	<u>Time In:</u> 9:30 am	<u>Time Out:</u> 10:30 pm
<u>Name of Facility:</u> Hayes LF			<u>Permit:</u> 33-01	
<u>Mailing Address:</u> 3450 S Spiceland Rd New Castle, IN 47362		<u>Location:</u> same

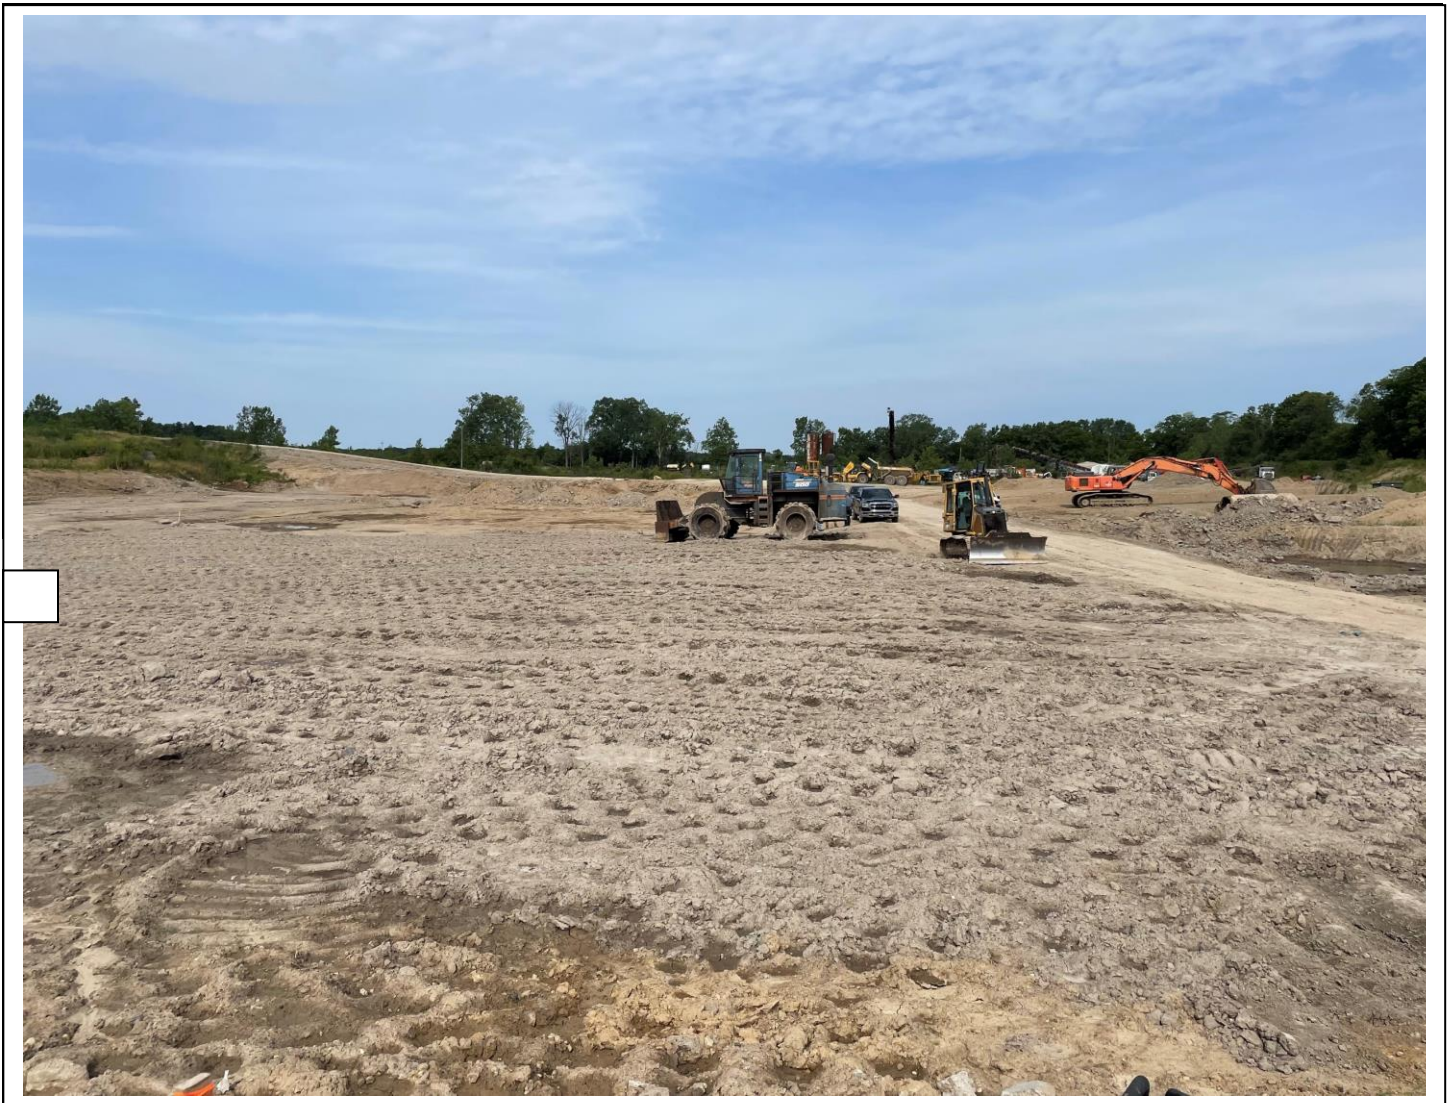
Number	1
	Description	Standing at the NE corner of the cell looking W at the cell area. Excavation completed. Looking at the surface of the compacted clay.
	Photographer	Mike Sonnefeld
	Facility Name	Hayes LF Cell 3W
	Photo Date	June 25, 2024
	Others

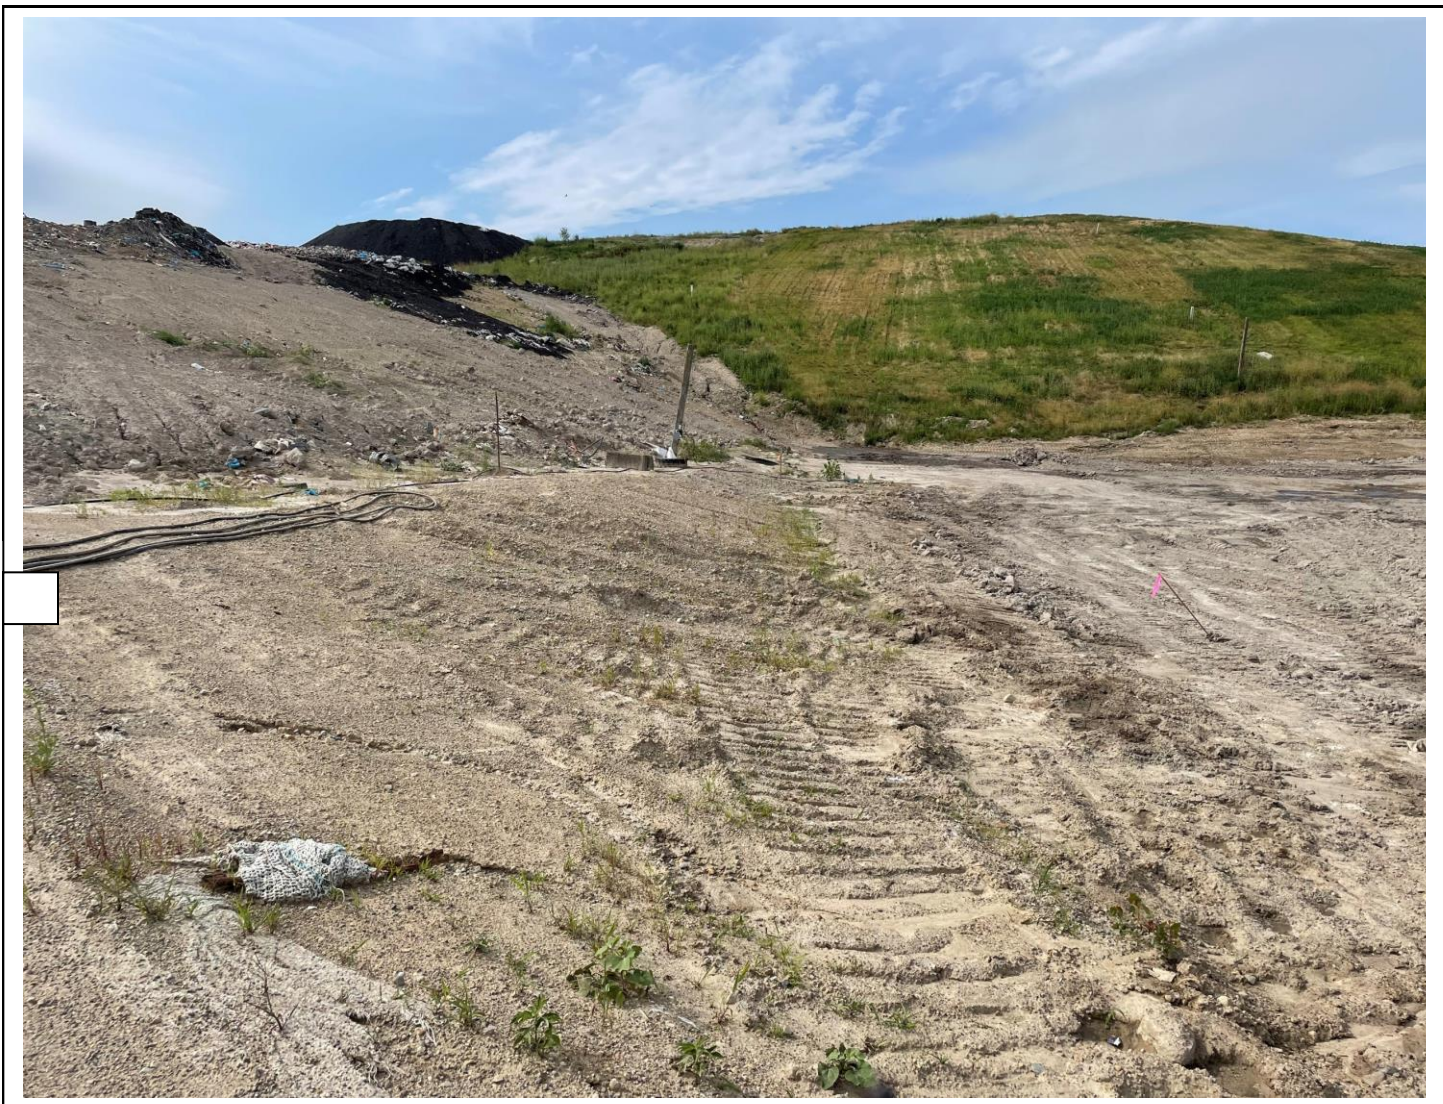
Number	2
	Description	Standing at the NE corner of the cell looking S along the west edge of Cell 3E.
	Photographer	Mike Sonnefeld
	Facility Name	Hayes LF Cell 3W
	Photo Date	June 25, 2024
	Others

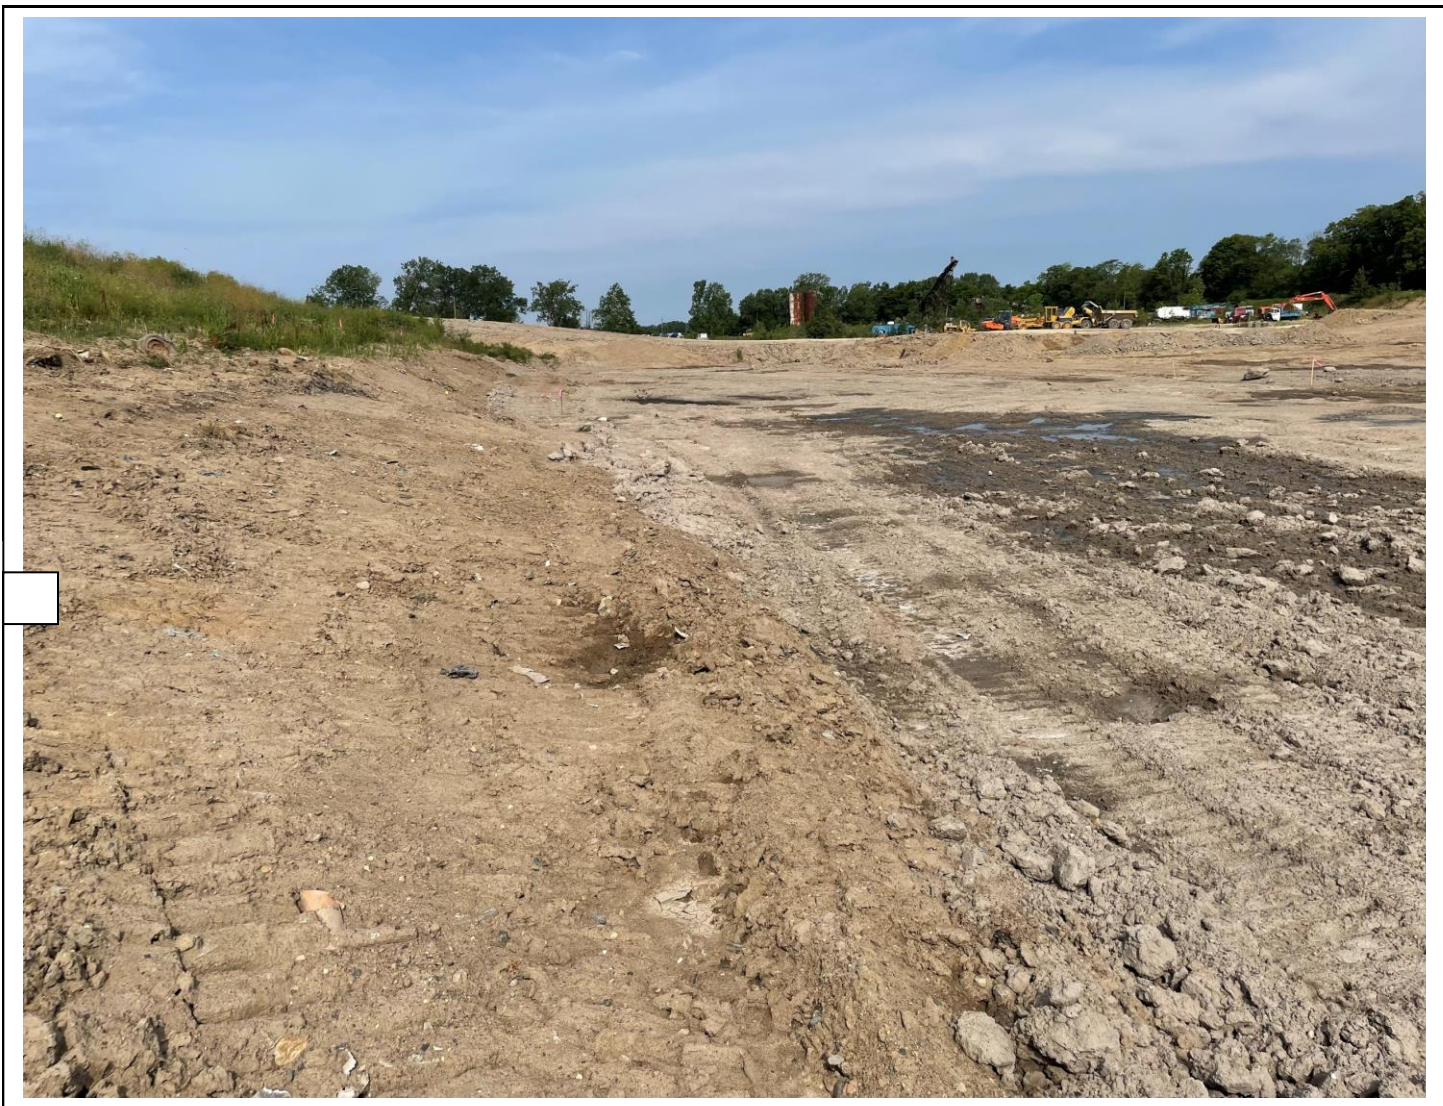
<div style="border: 1px solid black; width: 30px; height: 30px; margin-bottom: 5px;"></div>	Number	3
	Description	Standing at the SE corner of the cell looking W along the north edge of Cell 2.
	Photographer	Mike Sonnefeld
	Facility Name	Hayes LF Cell 3W
	Photo Date	June 25, 2024
	Others

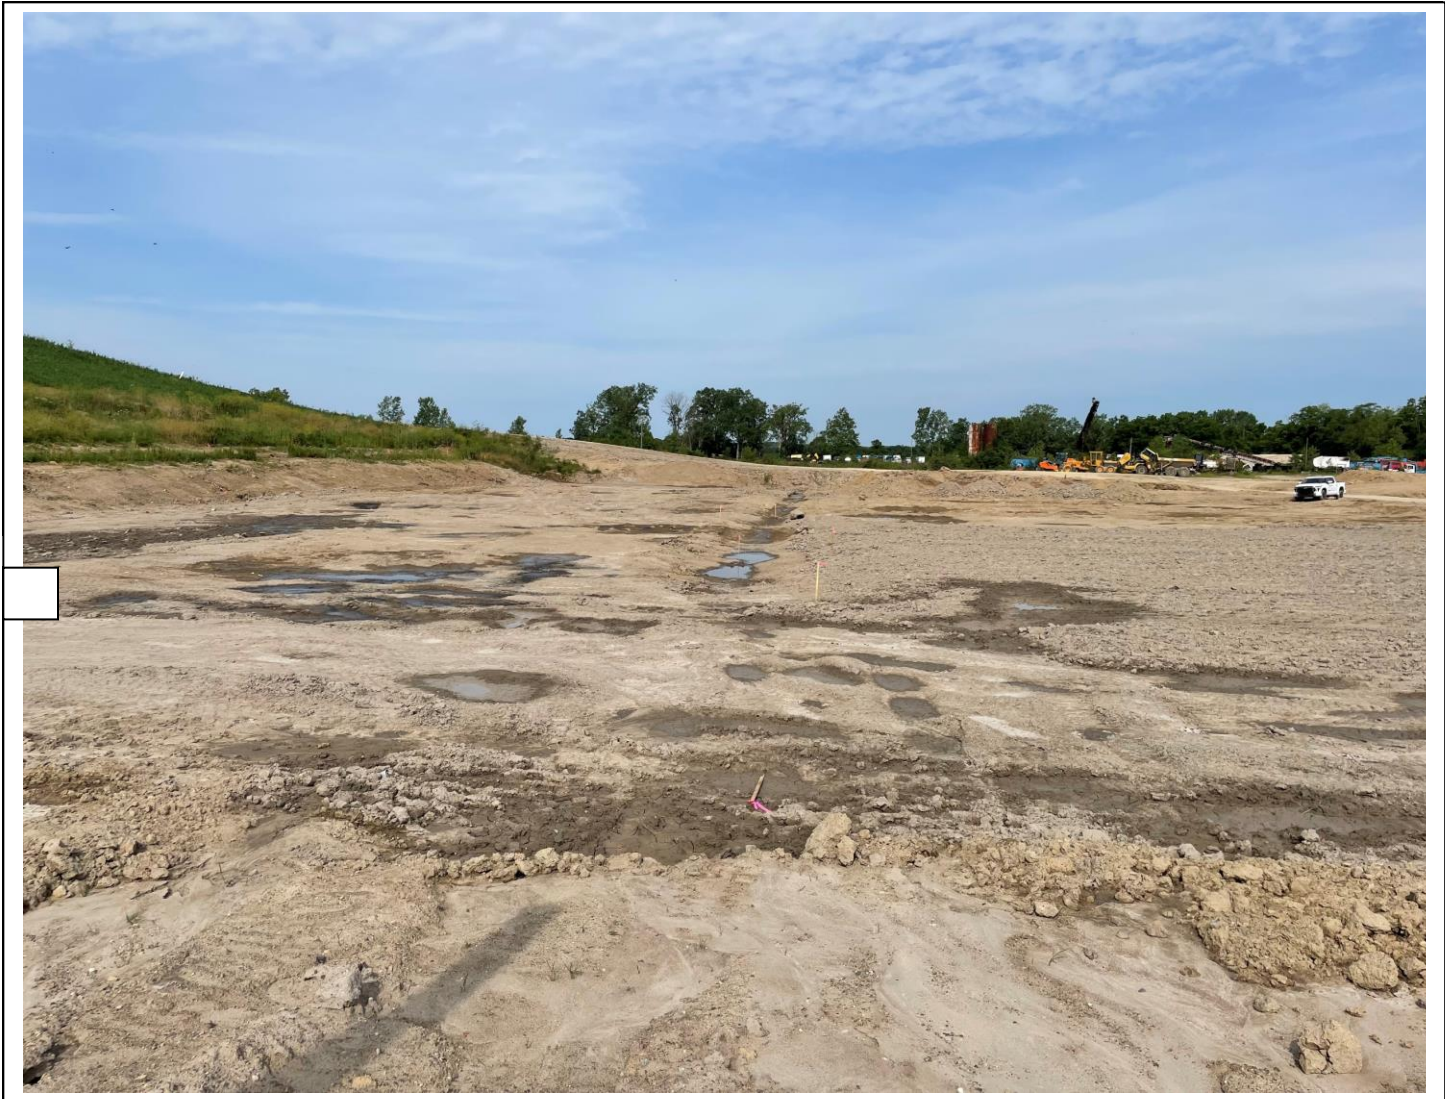
Number	4
	Description	Standing at the center of the cell, east edge, looking west at the leachate flow line; from east to west, through the cell.
	Photographer	Mike Sonnefeld
	Facility Name	Hayes LF Cell 3W
	Photo Date	June 25, 2024
	Others

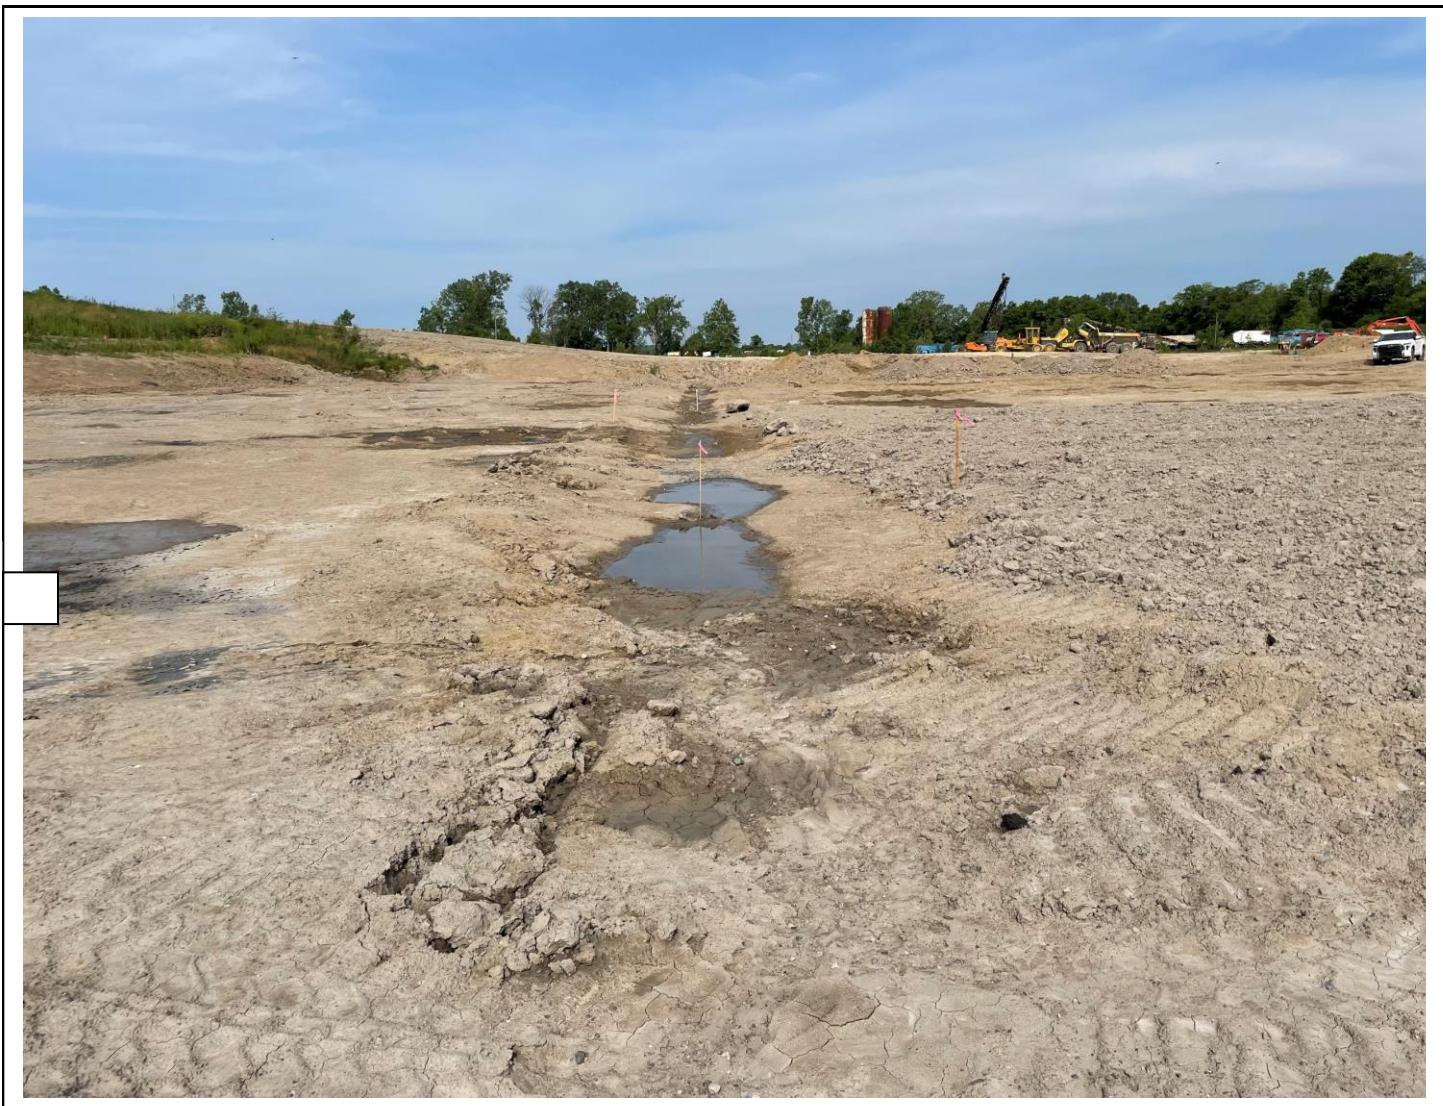
Number	5
	Description	Standing in the center of the leachate flow line looking west.
	Photographer	Mike Sonnefeld
	Facility Name	Hayes LF Cell 3W
	Photo Date	June 25, 2024
	Others

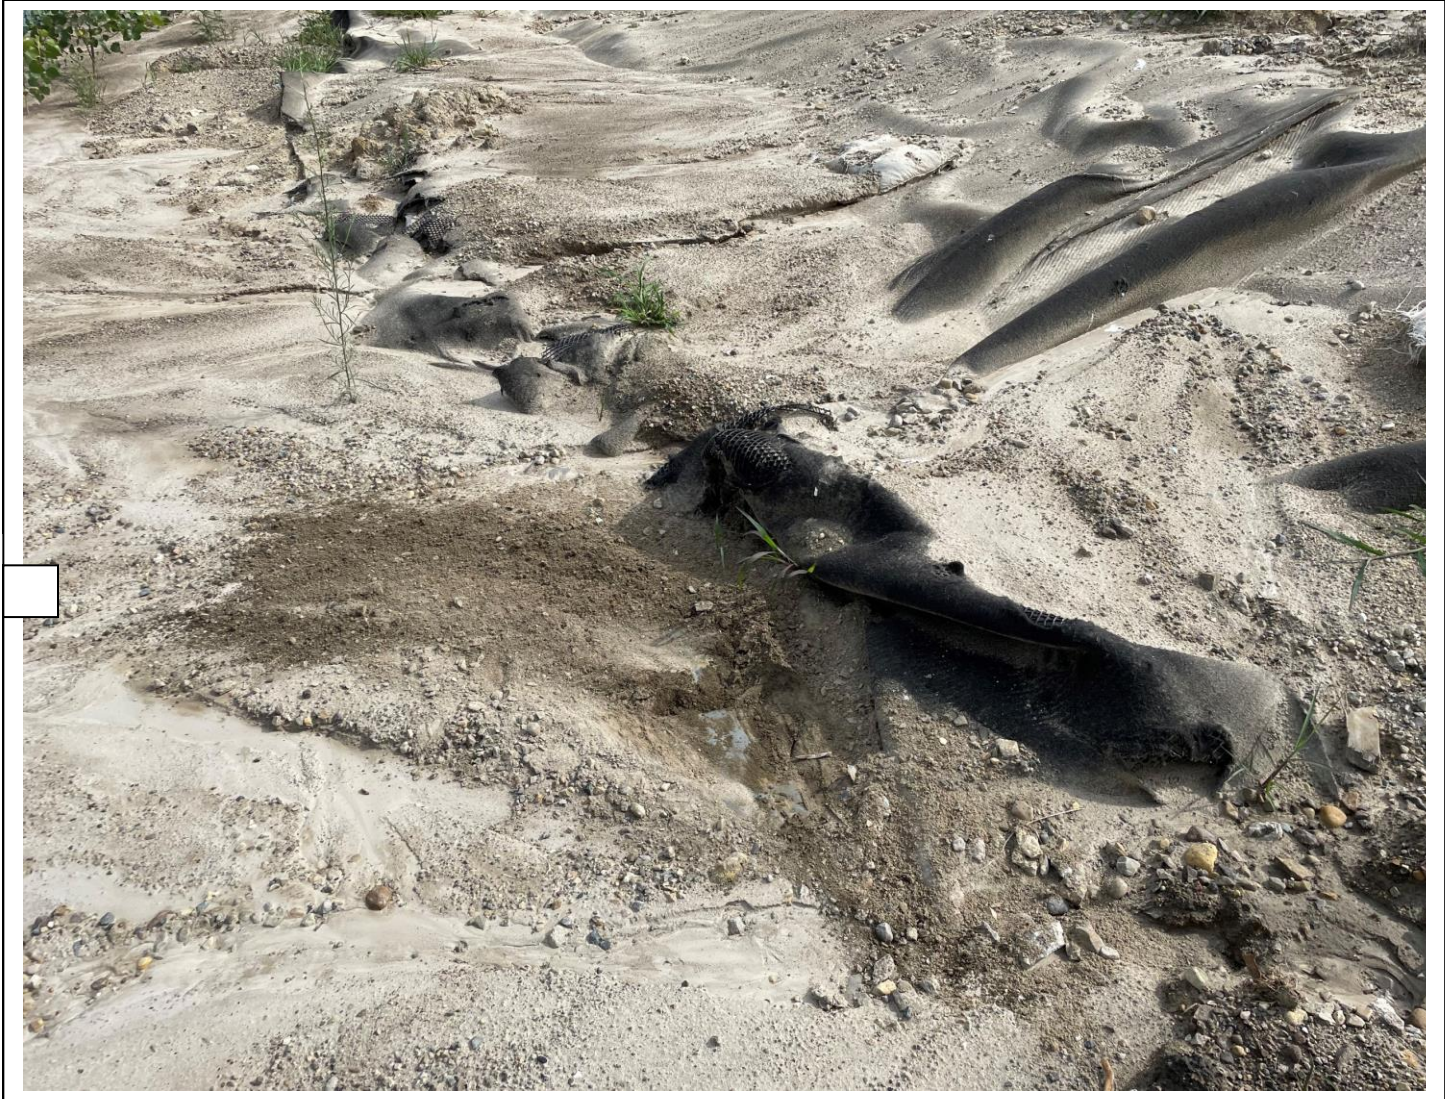
Soil and geosynthetic liners have been exposed along a small area of Cell 3E.

Number	6
	Description	Cell 3E geosynthetics exposed at Cell 3E west edge.
	Photographer	Mike Sonnefeld
	Facility Name	Hayes LF Cell 3W
	Photo Date	June 25, 2024
	Others
