**CONFINED FEEDING OPERATION
Construction Inspection Report**
INDIANA DEPARTMENT OF
ENVIRONMENTAL MANAGEMENT

Inspector's Name:	Mike Sonnefeld
Others Present	
Date:	Friday, June 28, 2024
Time In:	10:45 AM
Time Out:	11:45 AM
Inspection Type	Construction

Facility Information	
Facility Name	Donald Willmann
Facility Location	3407 S CR 850 E Portland, IN 47371 Jay County
Facility Mailing Information	Same Address as Facility
Facility Contact During Inspection	Donald Willmann 419 852 9258 michael.willmann@yahoo.com
Owners Contact During Inspection	Same as Facility Contact
Construction Contact	DM Service & Repair

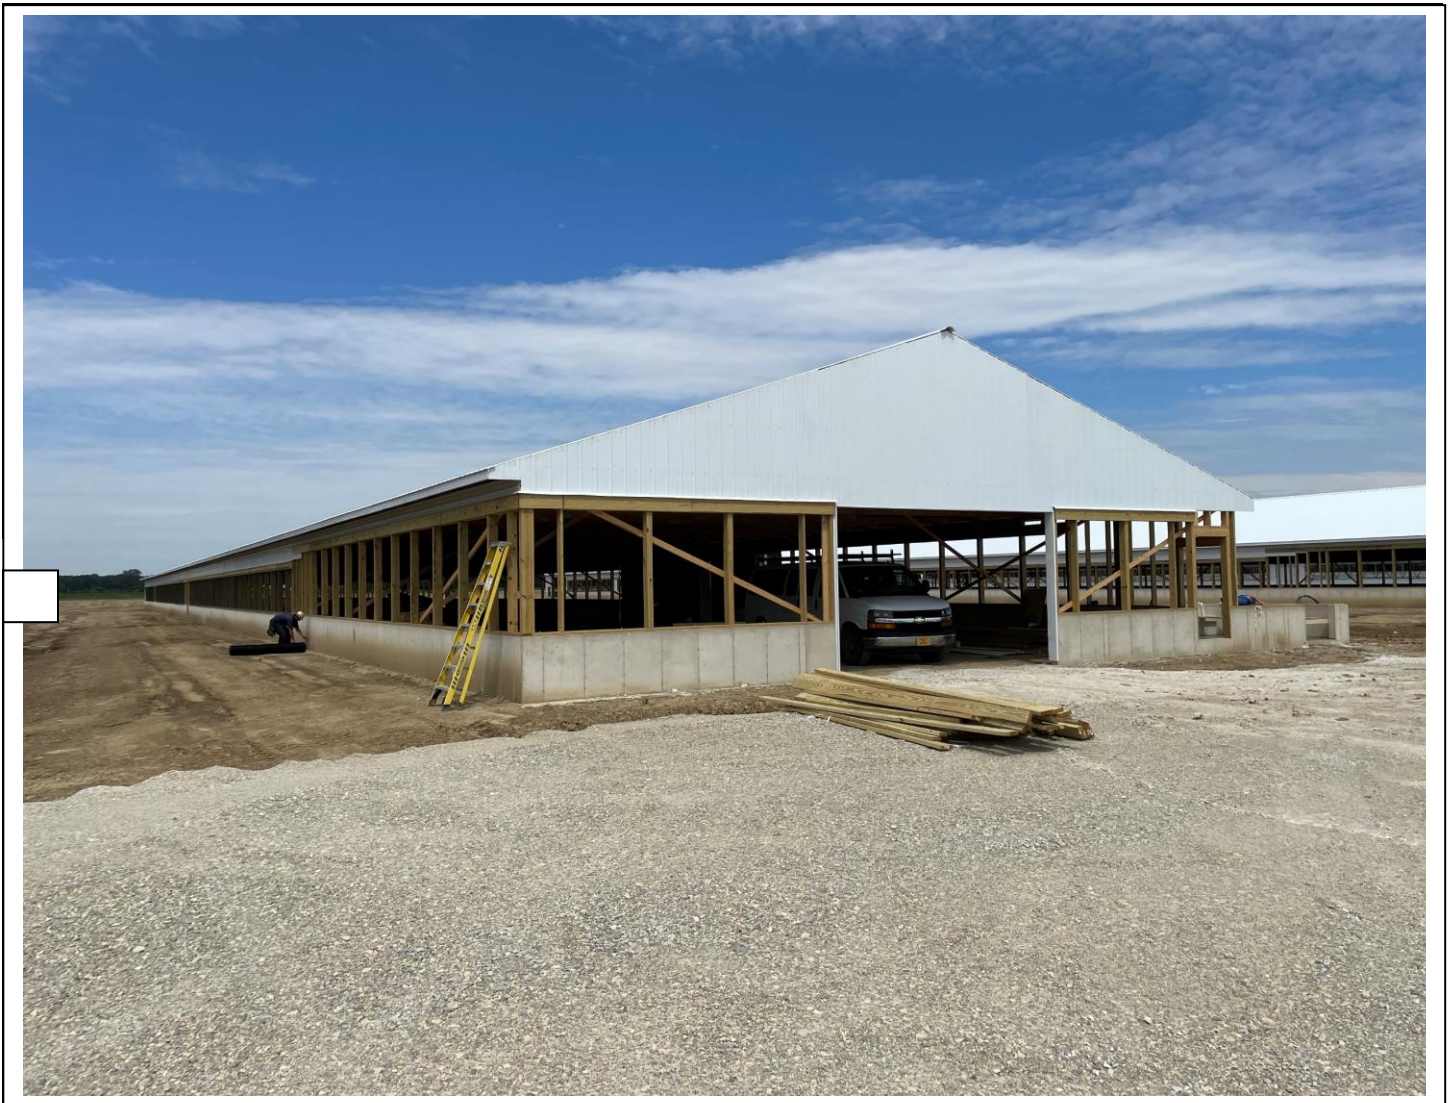
Number	1
Description	Looking west at the east end of barn P2.
Photographer	Mike Sonnefeld
Facility Name	Donald Willmann
Photo Date	June 28, 2024

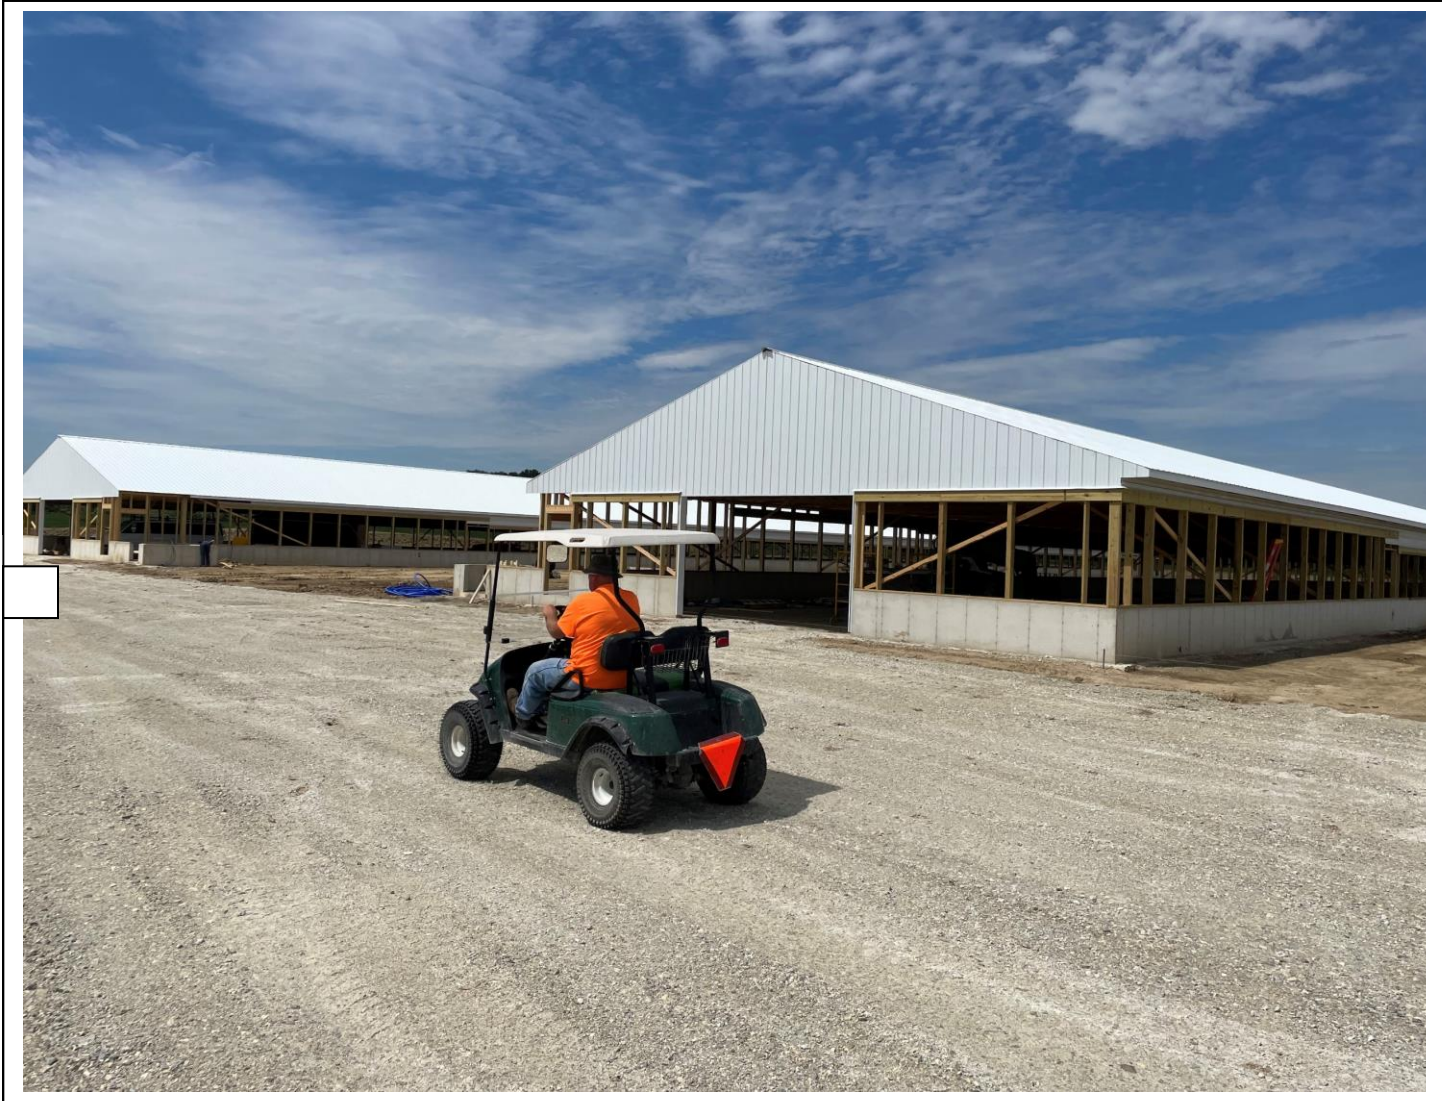
Number	2
Description	Looking west at the east end of barn P1.
Photographer	Mike Sonnefeld
Facility Name	Donald Willmann
Photo Date	June 28, 2024

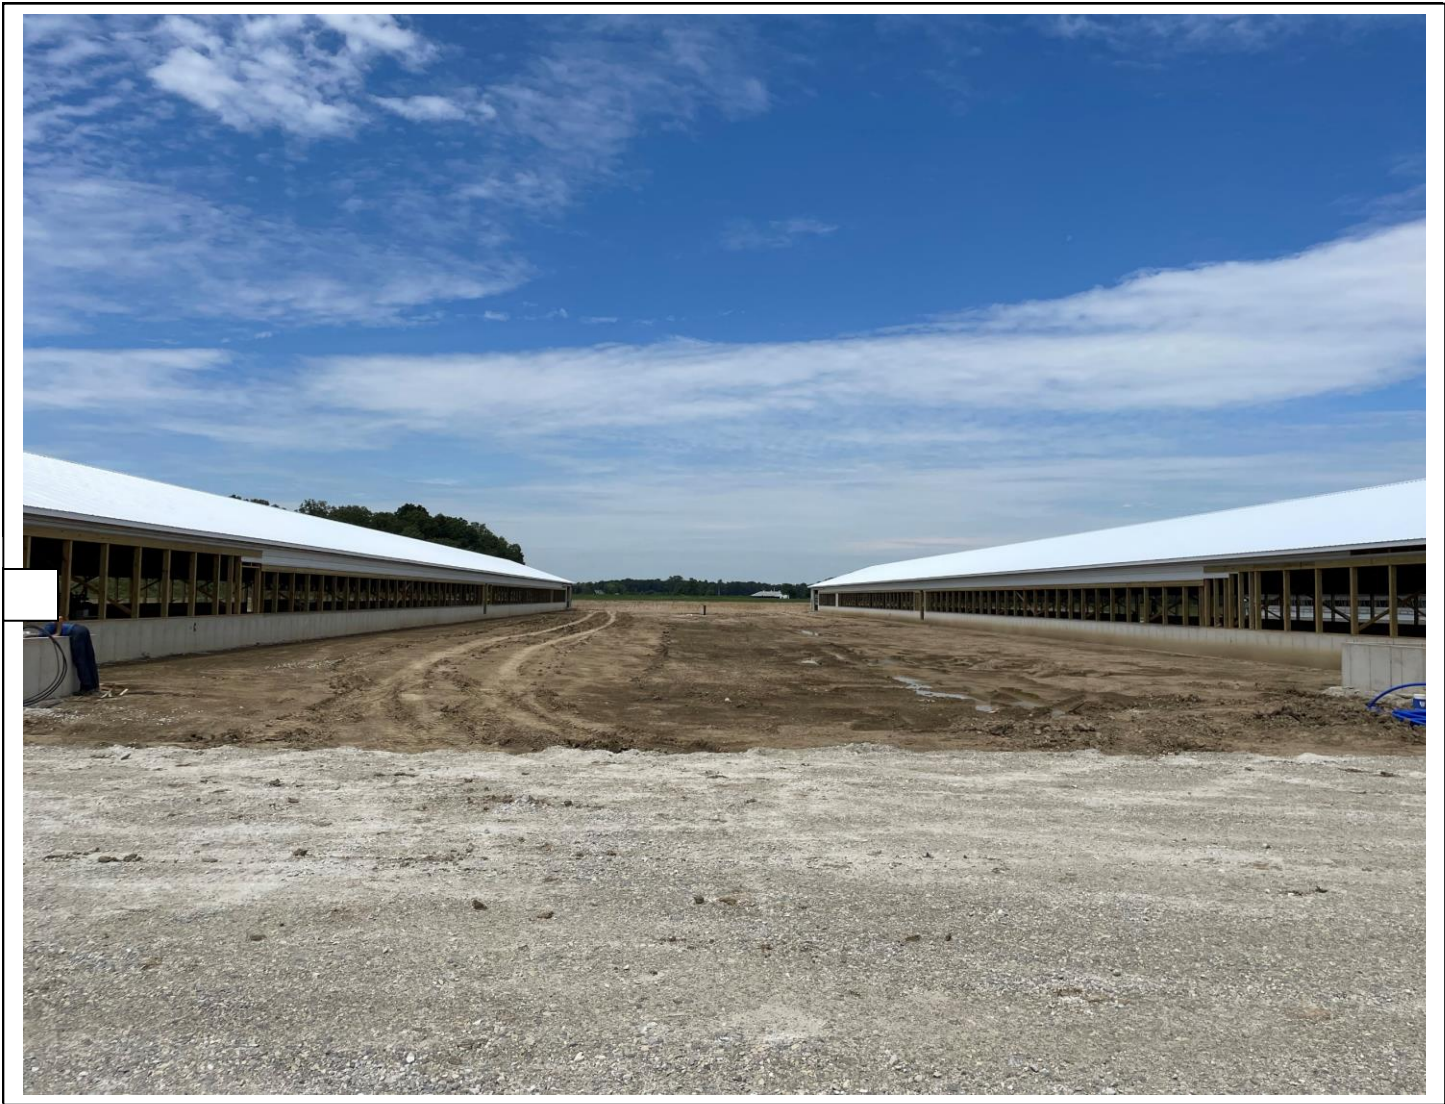
Number	1
Description	Open space between barns P1 and P2; looking west.
Photographer	Mike Sonnefeld
Facility Name	Donald Willmann
Photo Date	June 28, 2024

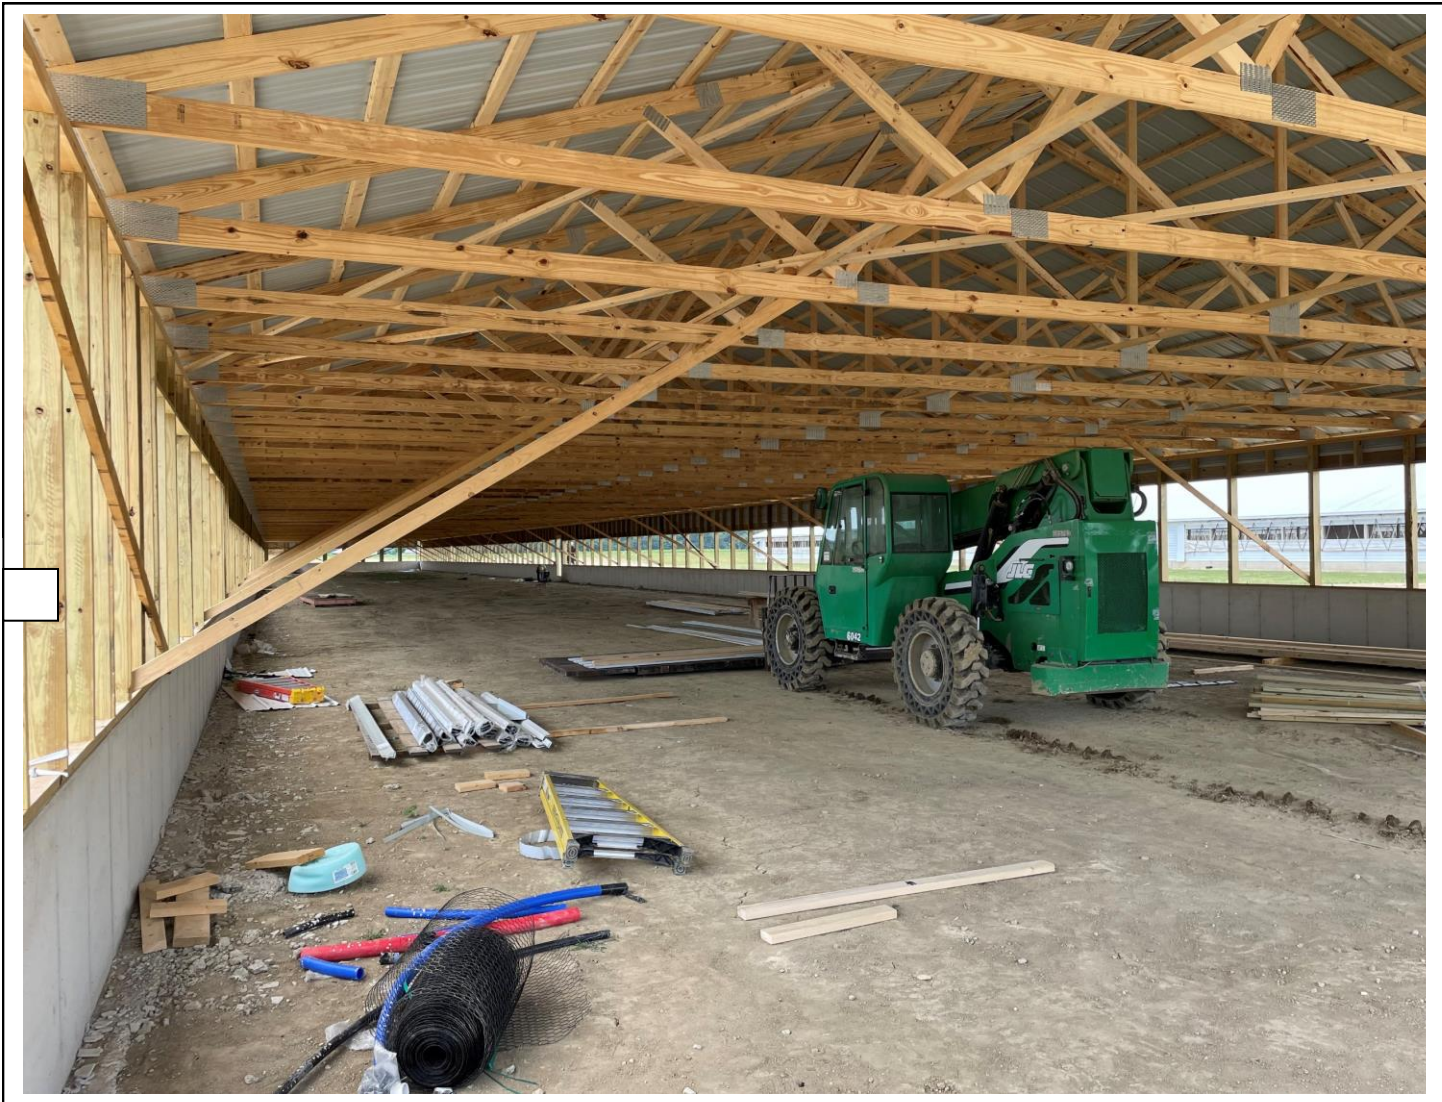
Number	2
Description	Interior of barns; typical P1 and P2.
Photographer	Mike Sonnefeld
Facility Name	Donald Willmann
Photo Date	June 28, 2024
