**CONFINED FEEDING OPERATION
Construction Inspection Report**
INDIANA DEPARTMENT OF
ENVIRONMENTAL MANAGEMENT

Facility Name	River Valley
Facility Location	6555 N Dubois Road NE Dubois, IN 47527 Dubois County
Facility Mailing Information	PO Box 157 Dubois, IN 47527
Facility Contact During Inspection	Mark Eisenhut 812 678 3131 marke@wabashvalleyproduce.com
Owners Contact During Inspection	Same as Facility Contact
Construction Contact	Knepp Construction

NPDES Permit Number	
CFO Approval	188

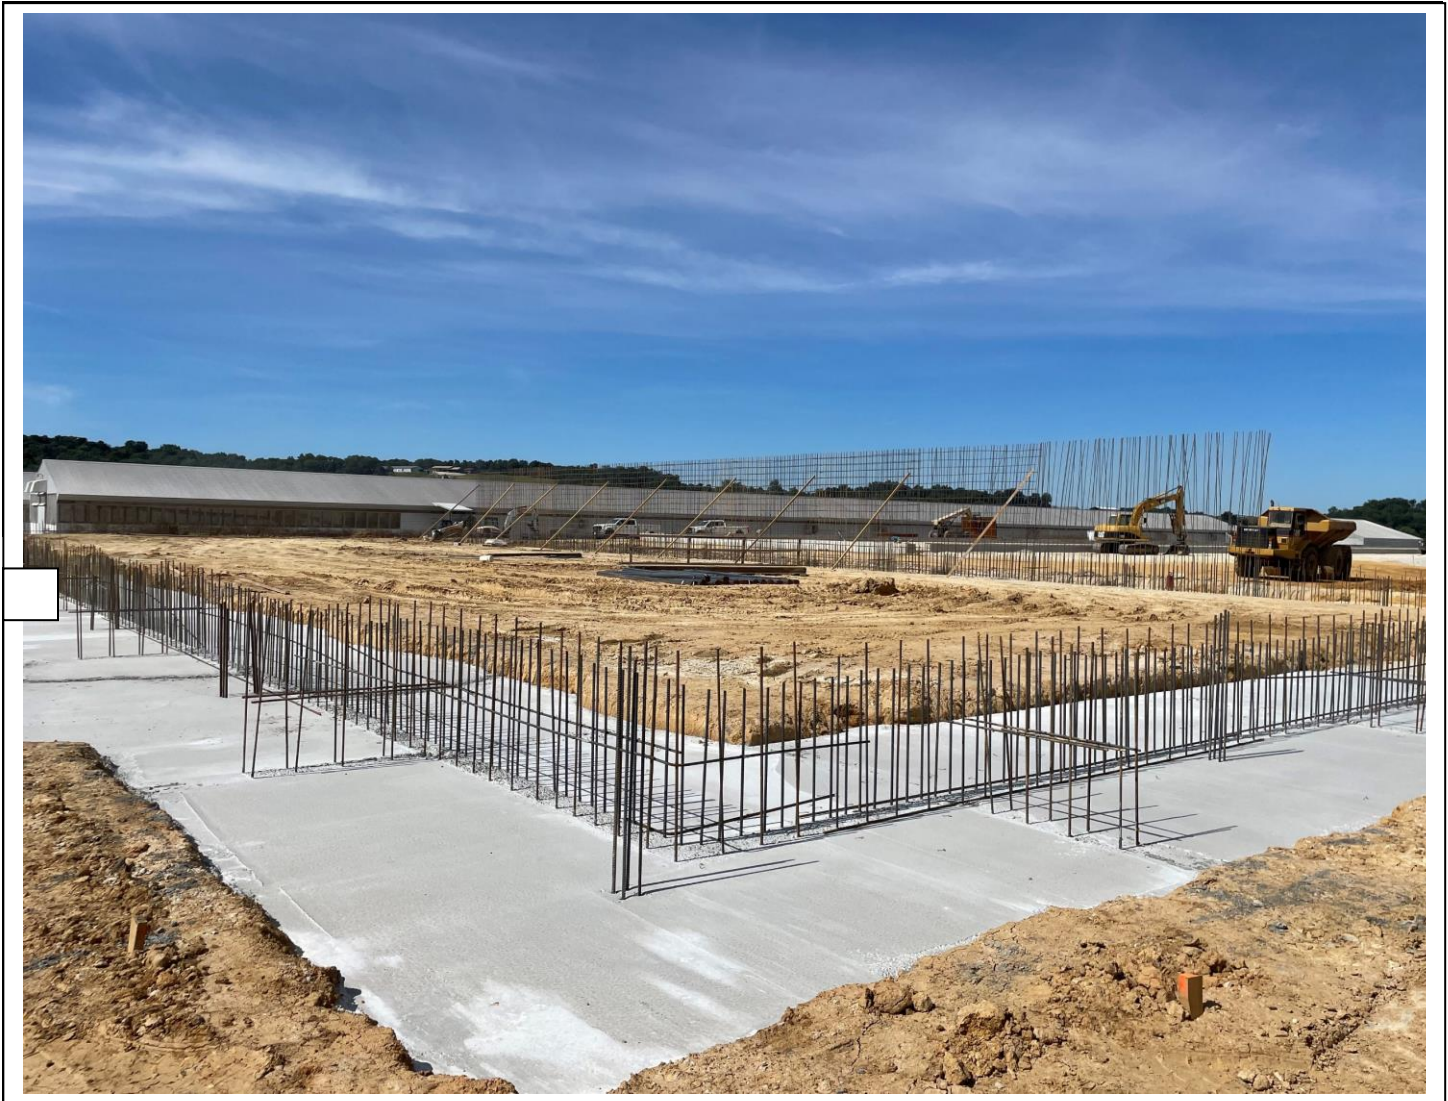
Number	1
Description	Standing at the north east corner of P2, manure storage, looking south west at footings/foundations and wall reinforcing steel.
Photographer	Mike Sonnefeld
Facility Name	River Valley
Photo Date	July 2, 2024

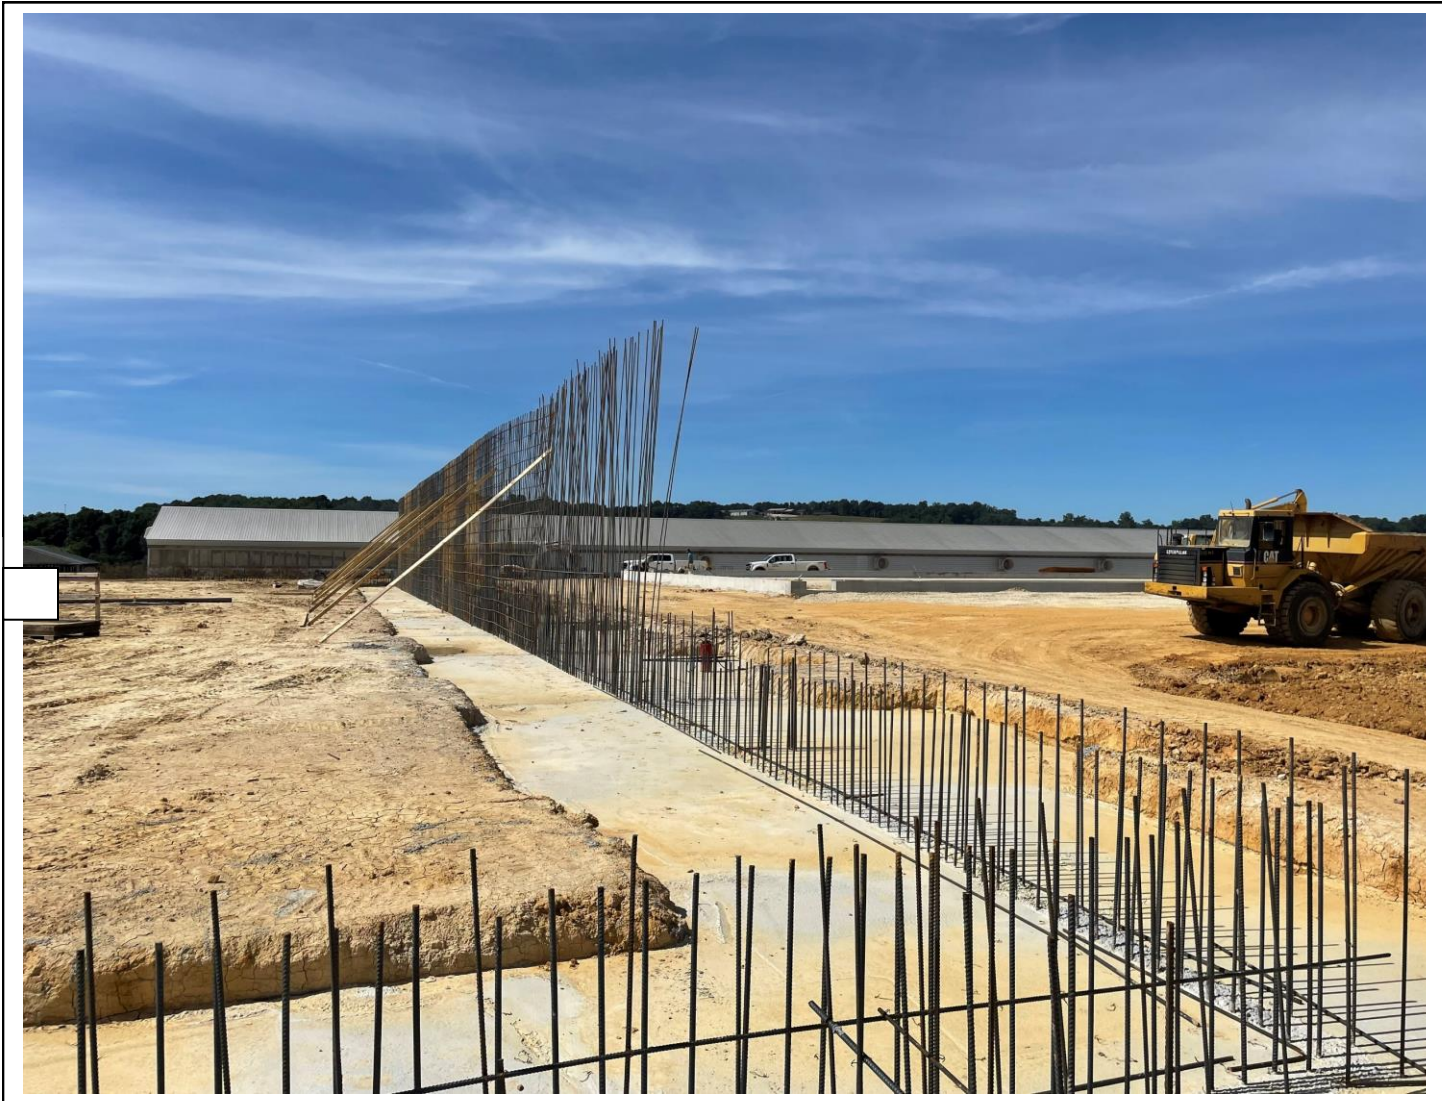
Number	2
Description	Standing at the north west corner of P2, manure storage, looking south at footings/foundations and wall reinforcing steel.
Photographer	Mike Sonnefeld
Facility Name	River Valley
Photo Date	July 2, 2024

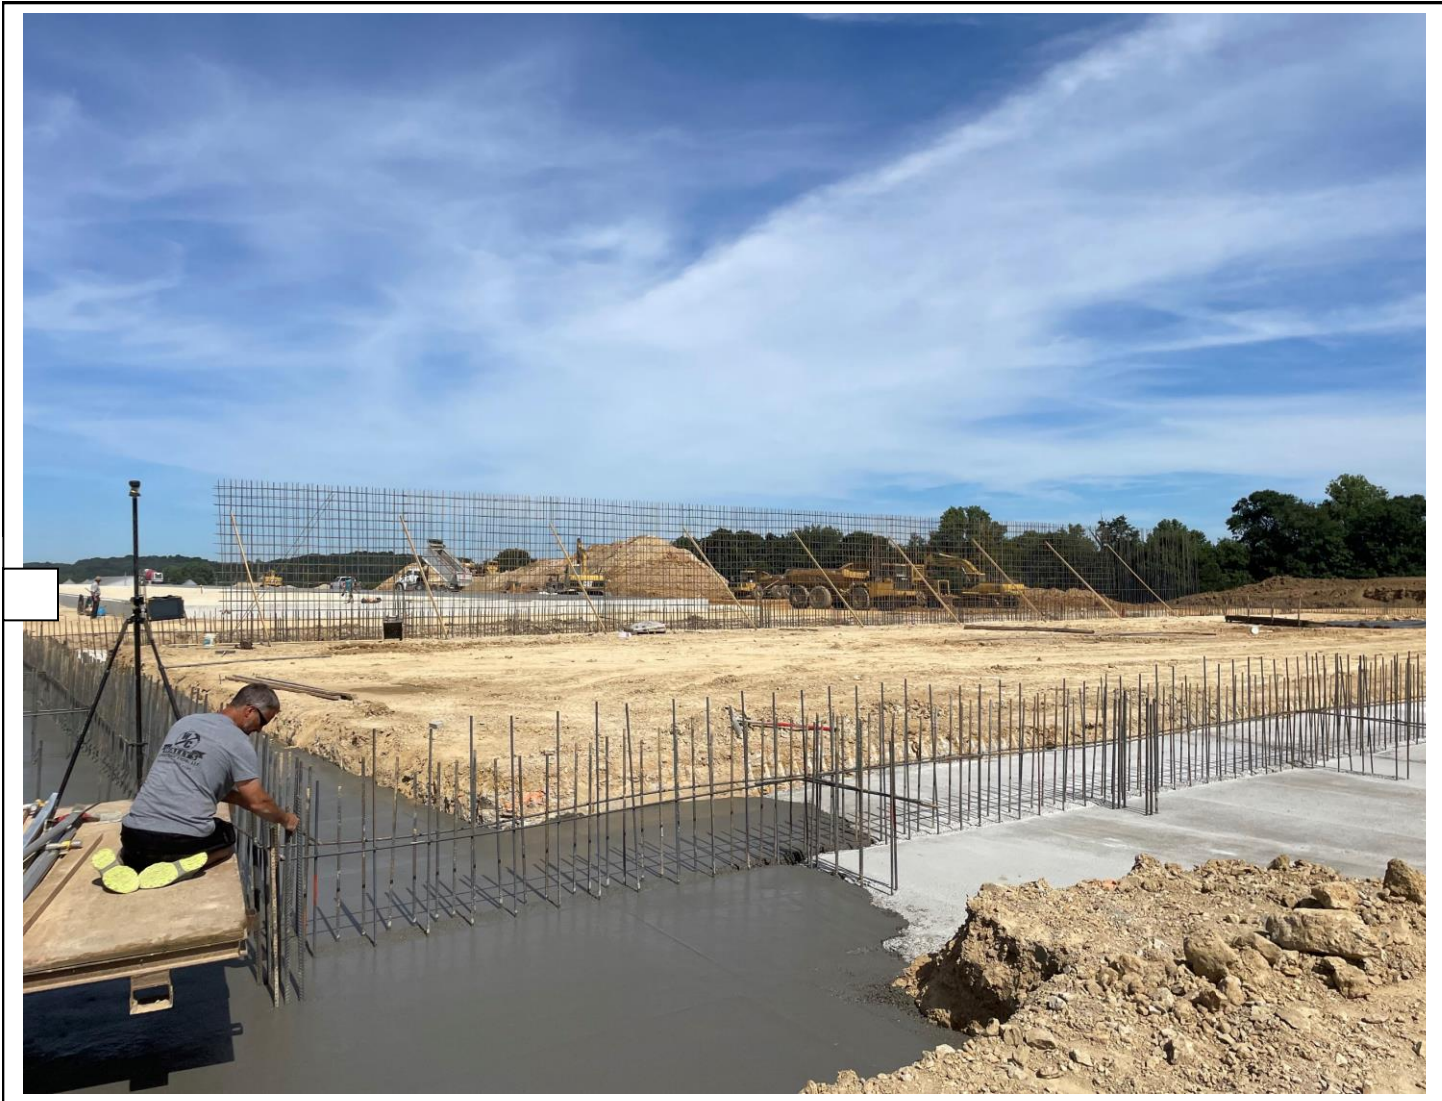
Number	3
Description	Standing at the south east corner of P2, manure storage, looking west at just placed footings/foundations concrete and wall reinforcing steel.
Photographer	Mike Sonnefeld
Facility Name	River Valley
Photo Date	July 2, 2024

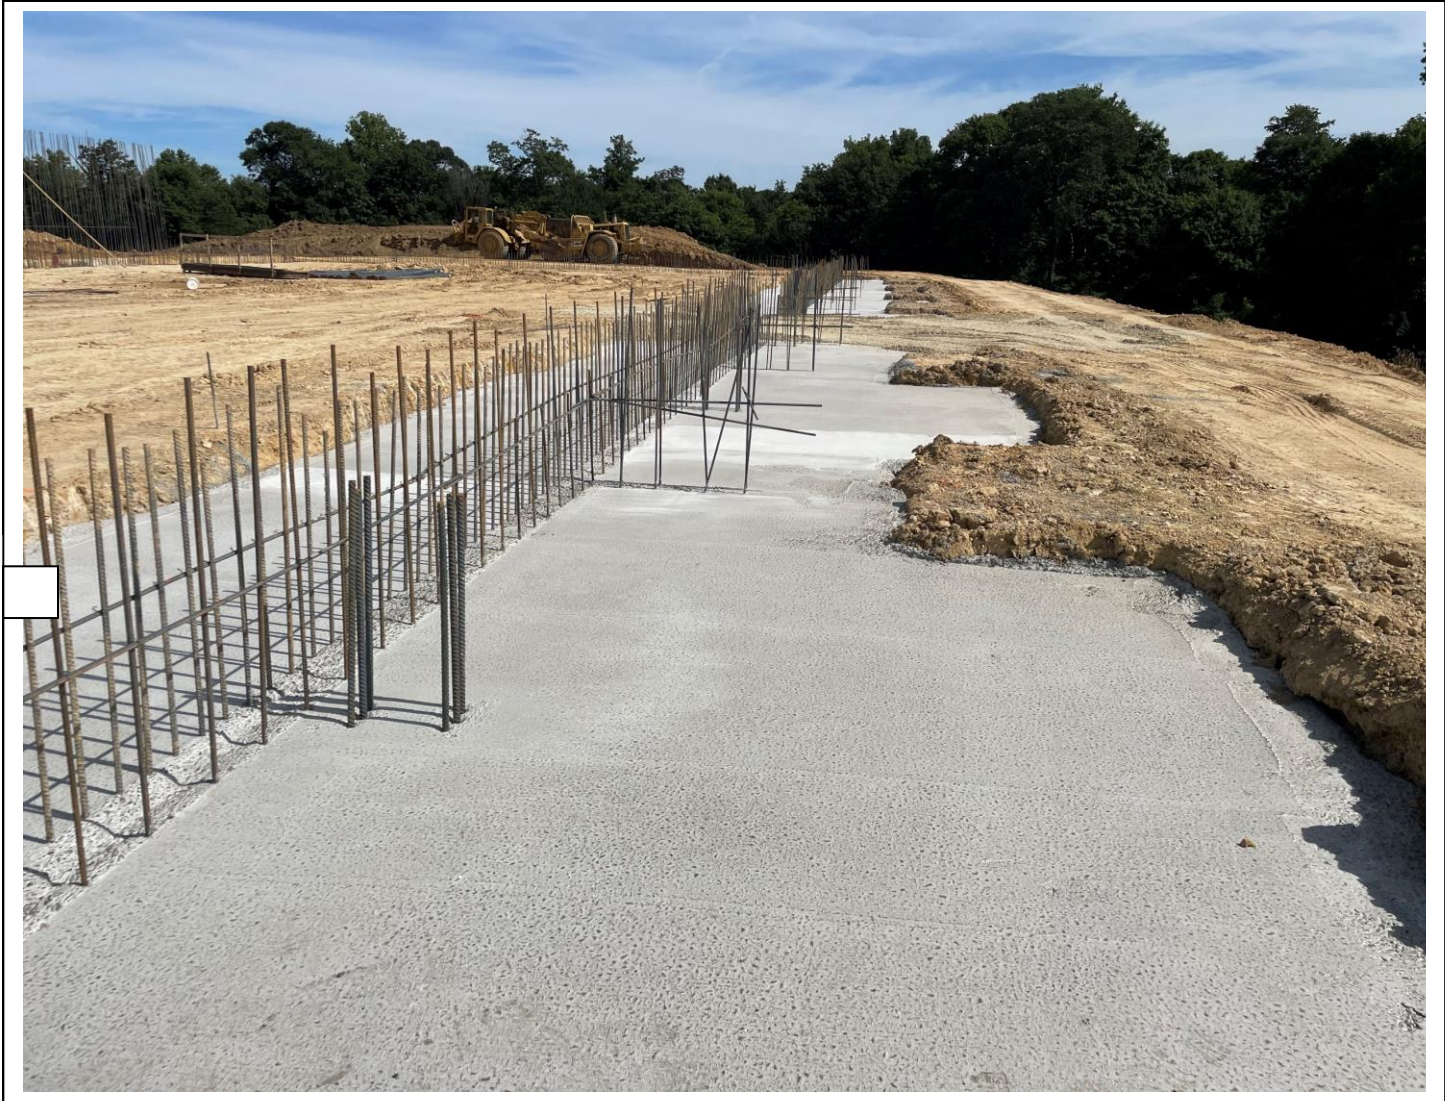
Number	4
Description	Standing at the south east corner of P2, manure storage, looking north at footings/foundations and wall reinforcing steel.
Photographer	Mike Sonnefeld
Facility Name	River Valley
Photo Date	July 2, 2024

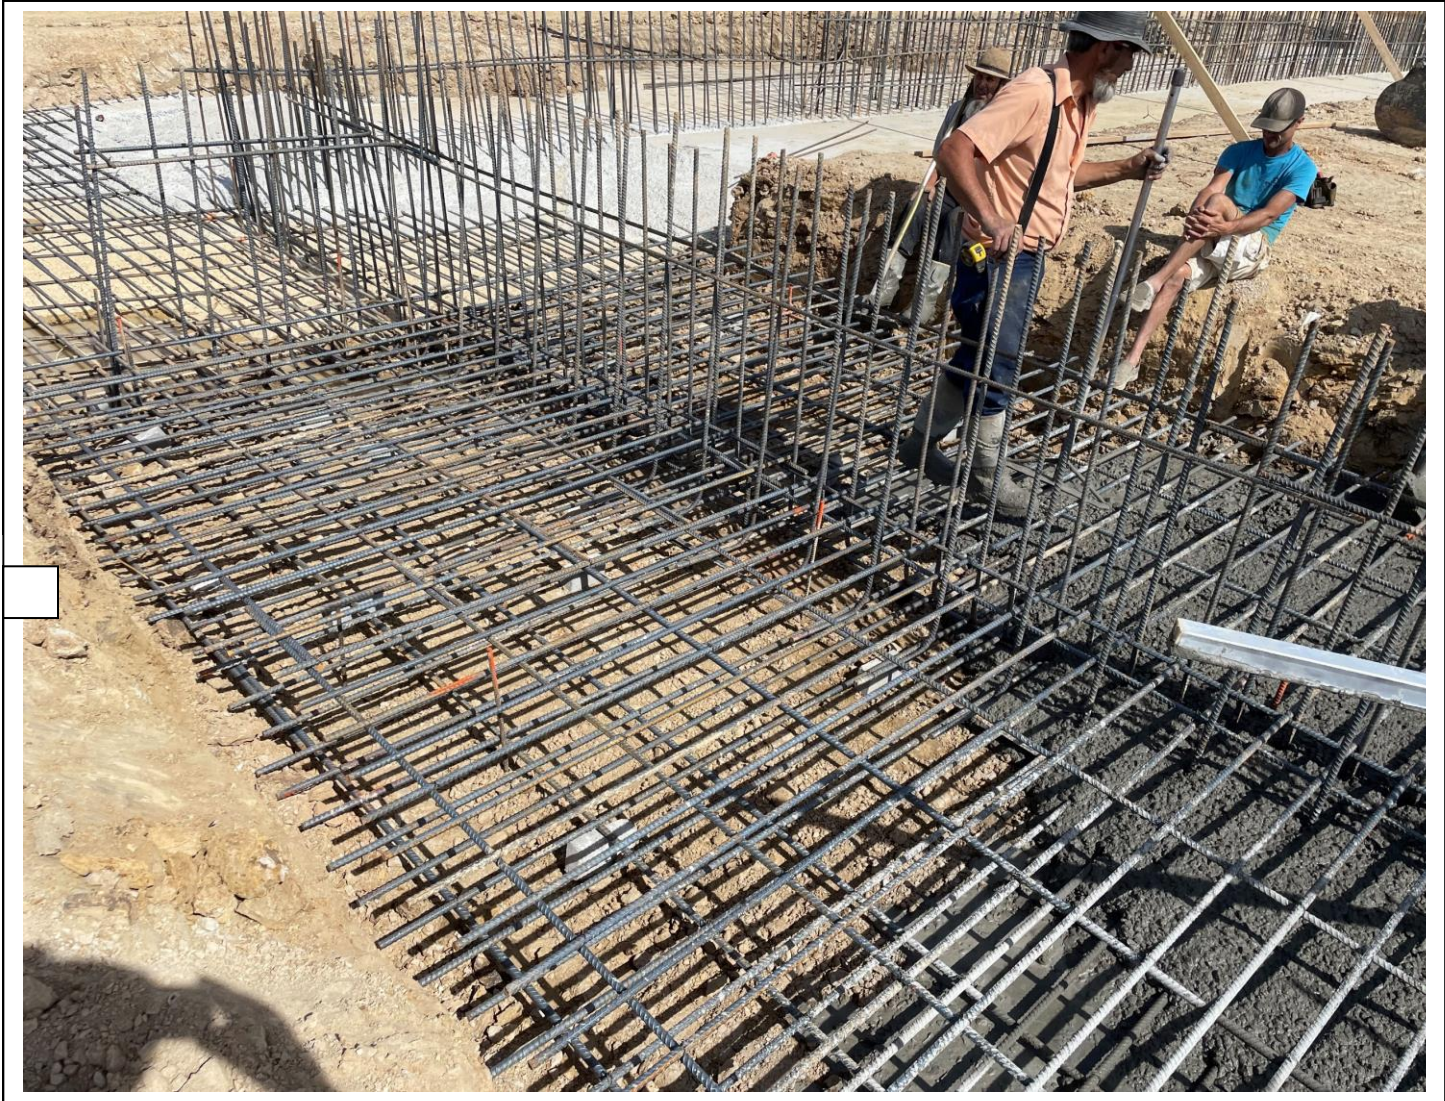
Number	5
Description	P2 wall footing with reinforcing steel.
Photographer	Mike Sonnefeld
Facility Name	River Valley
Photo Date	July 2, 2024

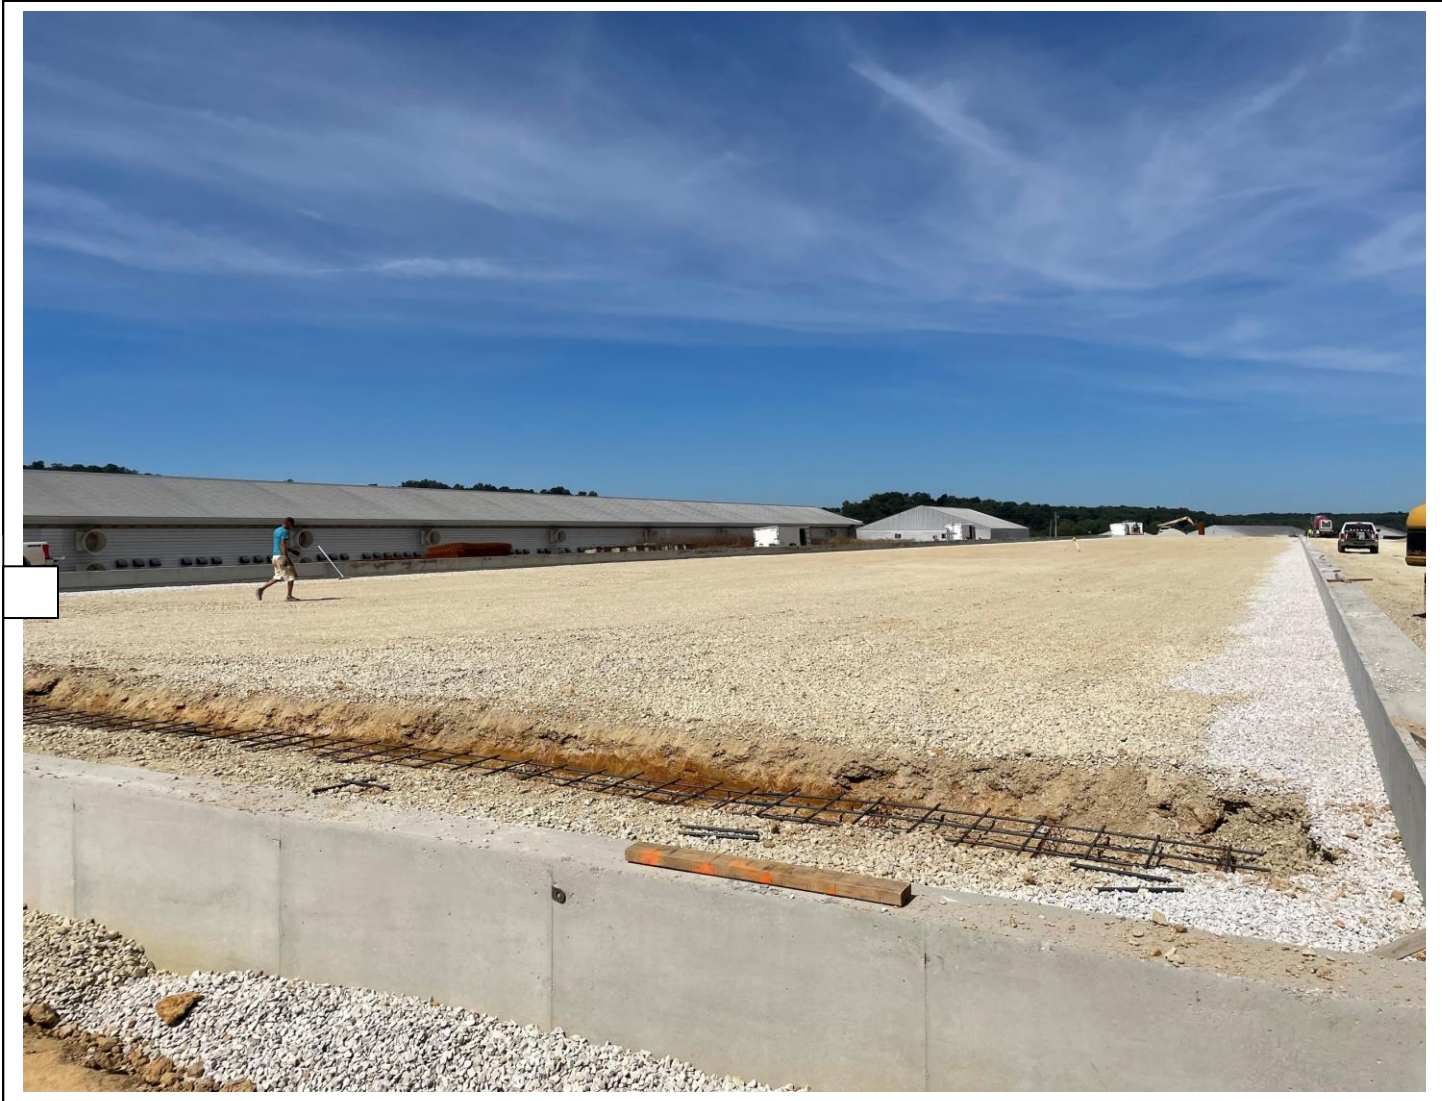
Number	6
Description	East end of P1 layer barn looking west at wall and aggregate base for concrete slab.
Photographer	Mike Sonnefeld
Facility Name	River Valley
Photo Date	July 2, 2024
