**Re:** Response to IDEM Comments

**Former Classic Cleaners**

RE: Sub-Slab Depressurization System

**Operation Maintenance and Monitoring Plan**

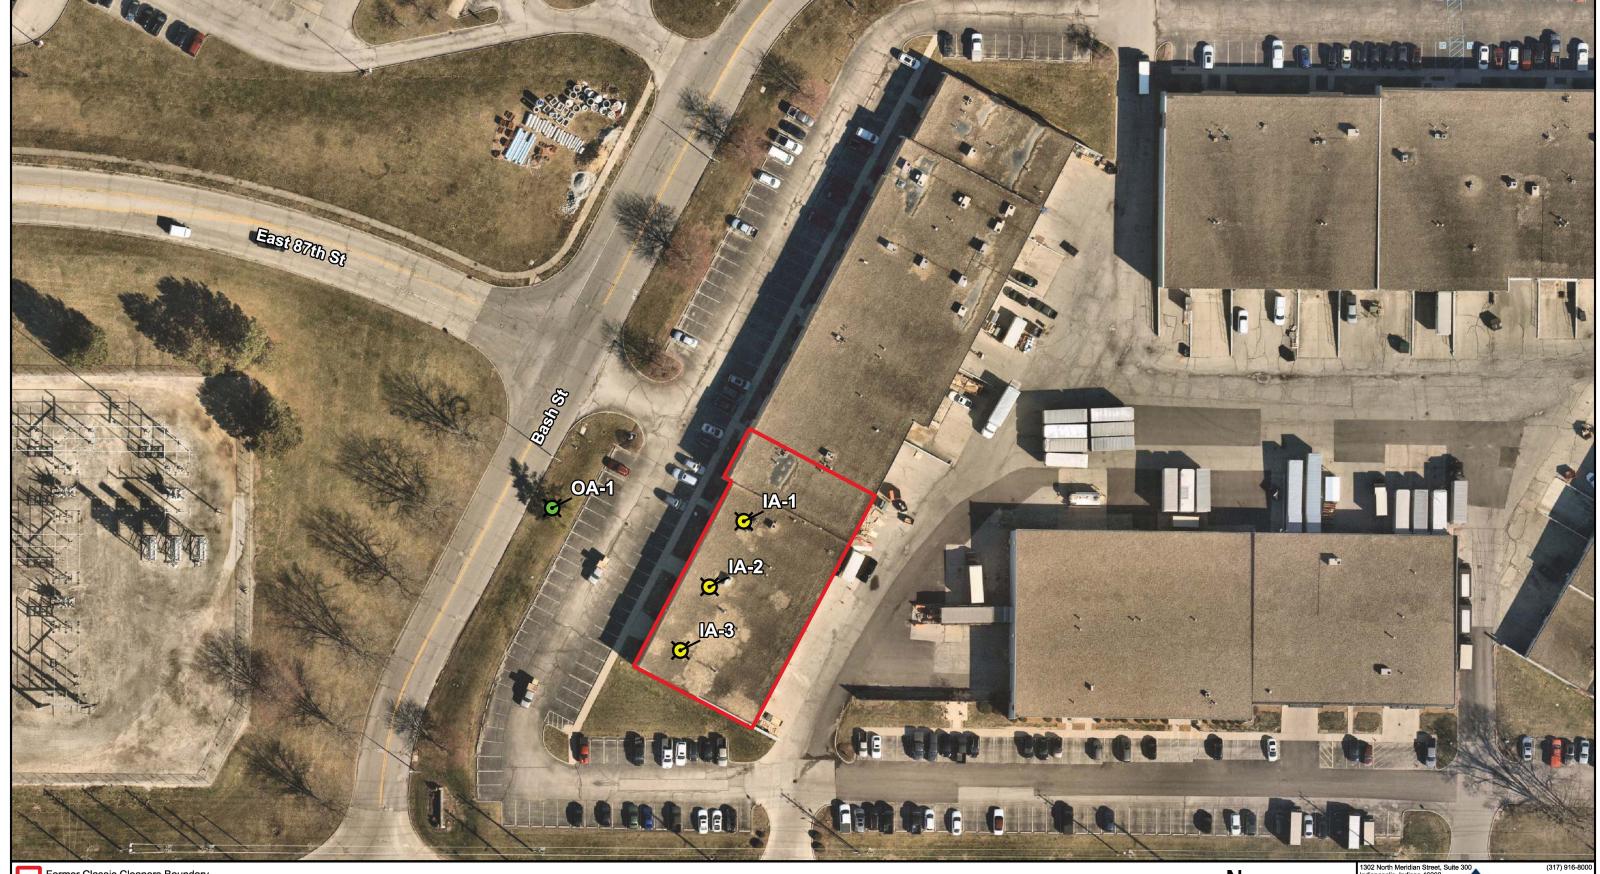
**Figure 1:** Site Plan

Indoor Air Sample

Outdoor Air Sample

### Site Plan

Prior to completing the next sampling event, the SSDS system should be shut down for an approximate 30-day equilibration period. During the sampling events, three (3) IA samples (plus one duplicate IA sample) will be collected and analyzed for VOCs using United States Environmental Protection Agency (U.S. EPA) Method TO-15. IA sampling procedures are provided in **Attachment D**. A pre-sampling walkthrough and building occupant interview to document building characteristics and potential indoor air contaminant sources will be completed before each IA sampling event. A copy of the building survey checklist is provided in **Attachment E**. The sample locations are based on the historical sampling IA locations used by SESCO Group in August 2019, March 2020, February 2022, and October 2022. The locations of the three IA samples (IA-1, IA-2, and IA-3) are depicted on **Figure 1**.

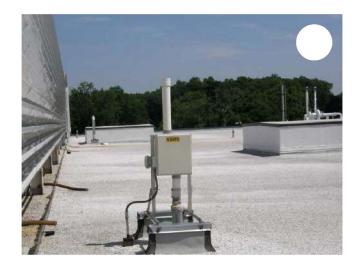
### **OBAR GBR 76UD**

- \* Our modular design means the blower and manifold assembly can be removed and replaced as a unit. This makes
- repairs cost effective and easy and allows contractors to upgrade systems simply by swapping assemblies.
- \* The GBR series is based on a bypass blower designed to handle combustible materials.
- \* The housing is not required to be air tight so you can add gauges and alarms without compromising the system.
- \* Built in condensate bypass.
- \* Variable speed controller included.
- \* Quick disconnect electrical harness.
- \* All UL listed components including UL listed enclosure for outside use.
- \* Wall fastening lugs included.
- \* GBR series roof and wall mounts available to quickly configure the blowers for your installation while providing a

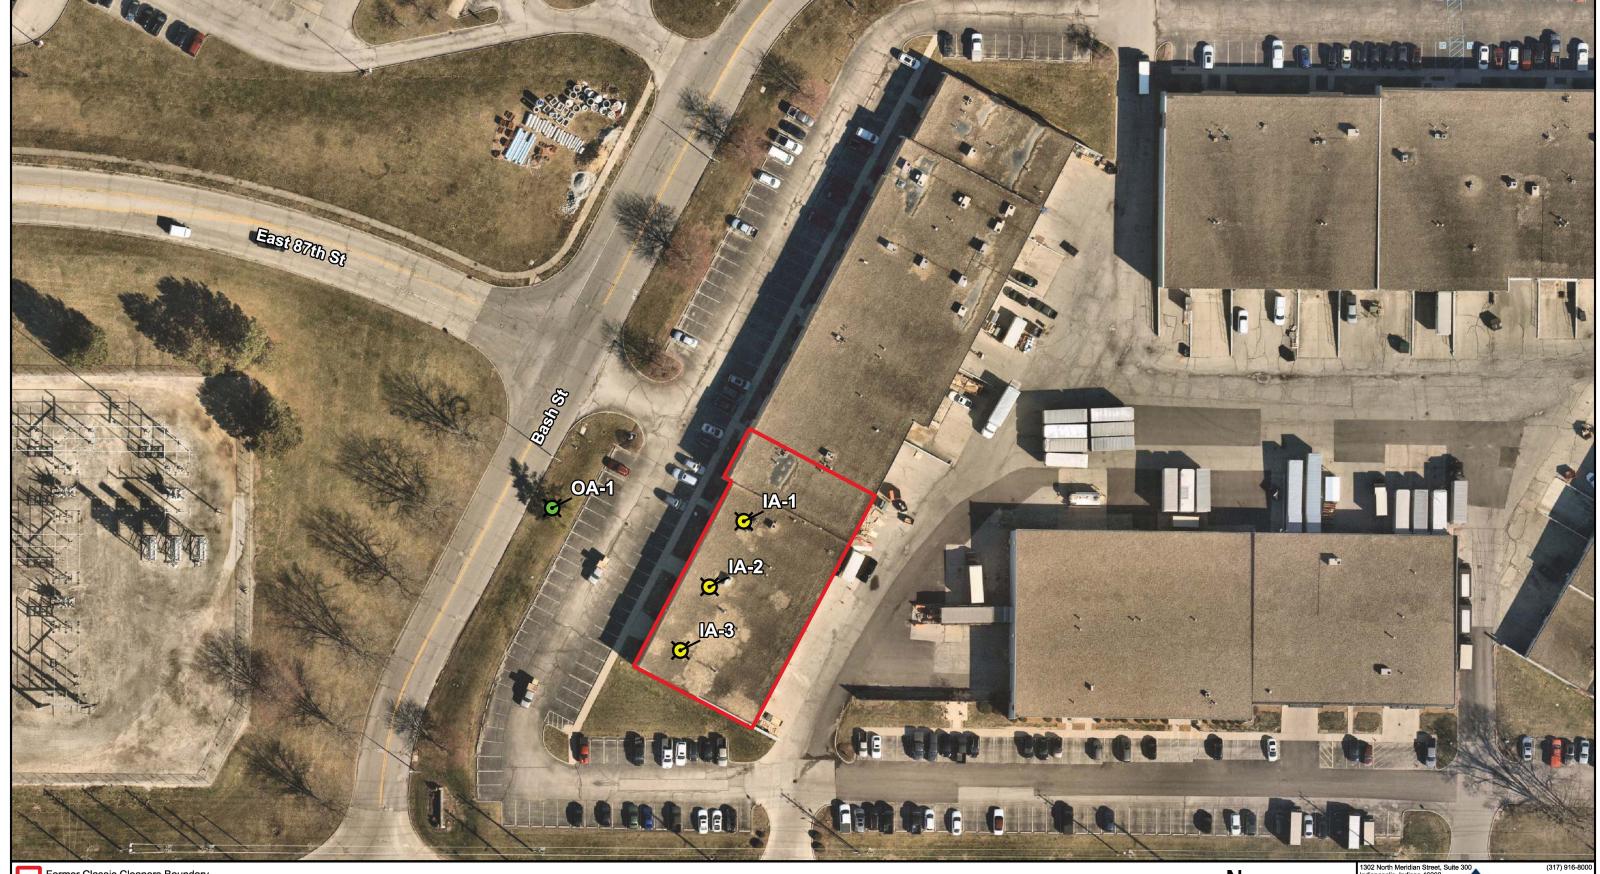
**Figure 1**: Site Plan

Indoor Air Sample

The three (3) IA samples and appropriate quality control/quality assurance (QA/QC) sample were collected from the Site building over an eight (8)-hour period. One duplicate sample (DUP-1-20240412) was collected from location IA-3. All samples were collected in six (6)-liter stainless steel canisters equipped with a laboratory-supplied regulator. Samples were delivered to EnvisionAir and analyzed for VOCs via U.S. EPA
