**Douglas Road Landfill Superfund Site  
Operations and Maintenance (O&M) Report  
1st Quarter 2024  
Mishawaka, Indiana  
Patriot Project No. 22-0034-01E**

**Prepared By**  
Patriot Engineering and Environmental, Inc.  
6150 East 75<sup>th</sup> Street  
Indianapolis, Indiana 46250

May 23, 2024

**FIRST QUARTER 2024  
OPERATION AND MAINTENANCE REPORT  
DOUGLAS ROAD LANDFILL SUPERFUND SITE  
MISHAWAKA, INDIANA  
PATRIOT PROJECT NO. 22-0034-01E**

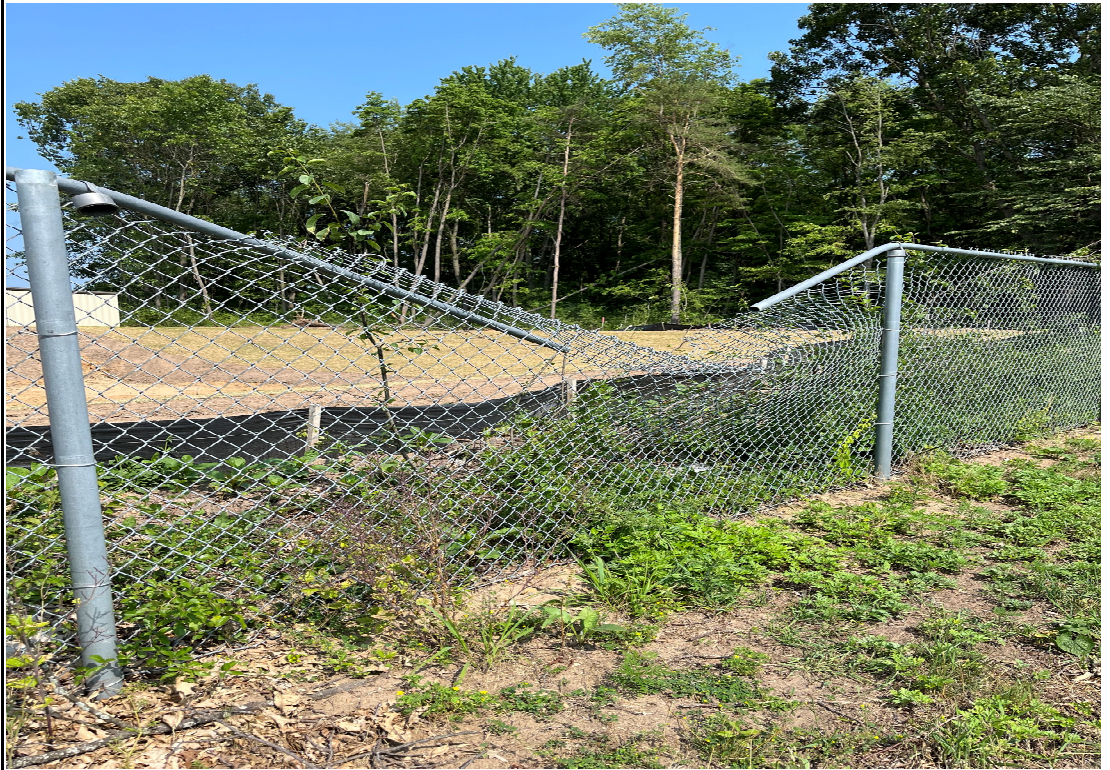
**Photo #1**

View of damaged fence on western property boundary.

Patriot performed repairs of a portion of perimeter fencing on the west side of the Site which had been damaged by off-Site construction activities on the adjacent property. A photo log documenting the fence repair activities is included in Attachment B.

*Previously documented damaged/felling fence on west property boundary was repaired during visit.*

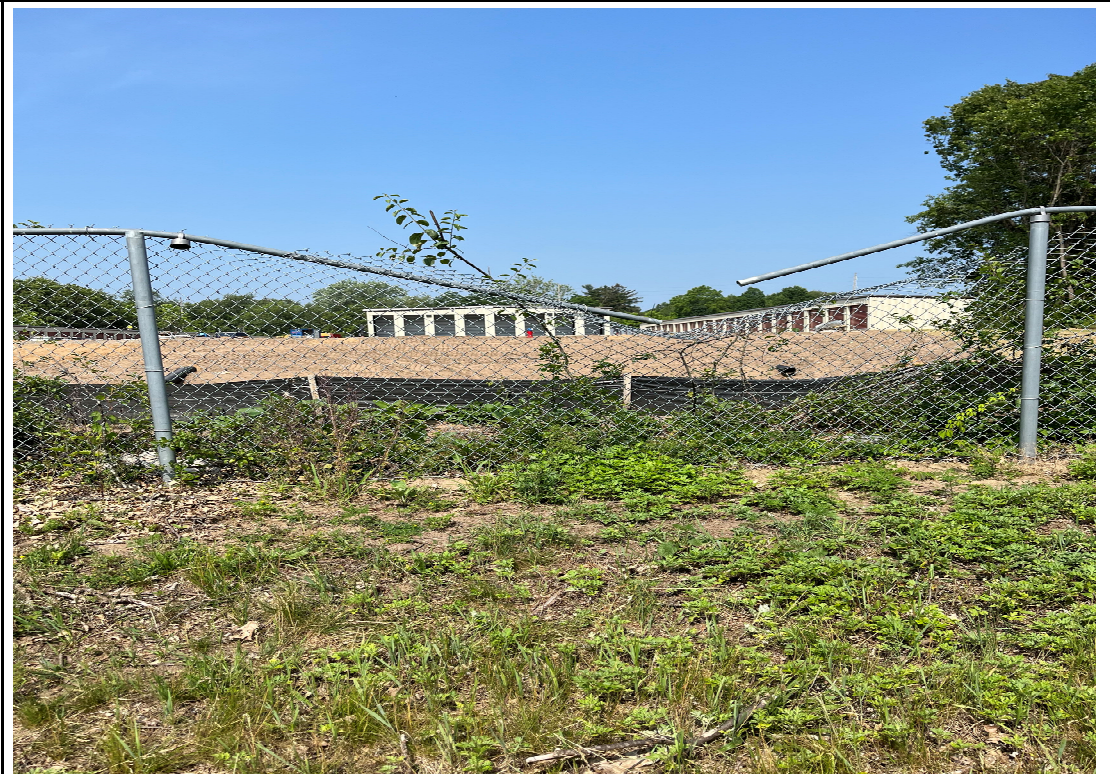
**Photo #2**

View of damaged fence on western property boundary.

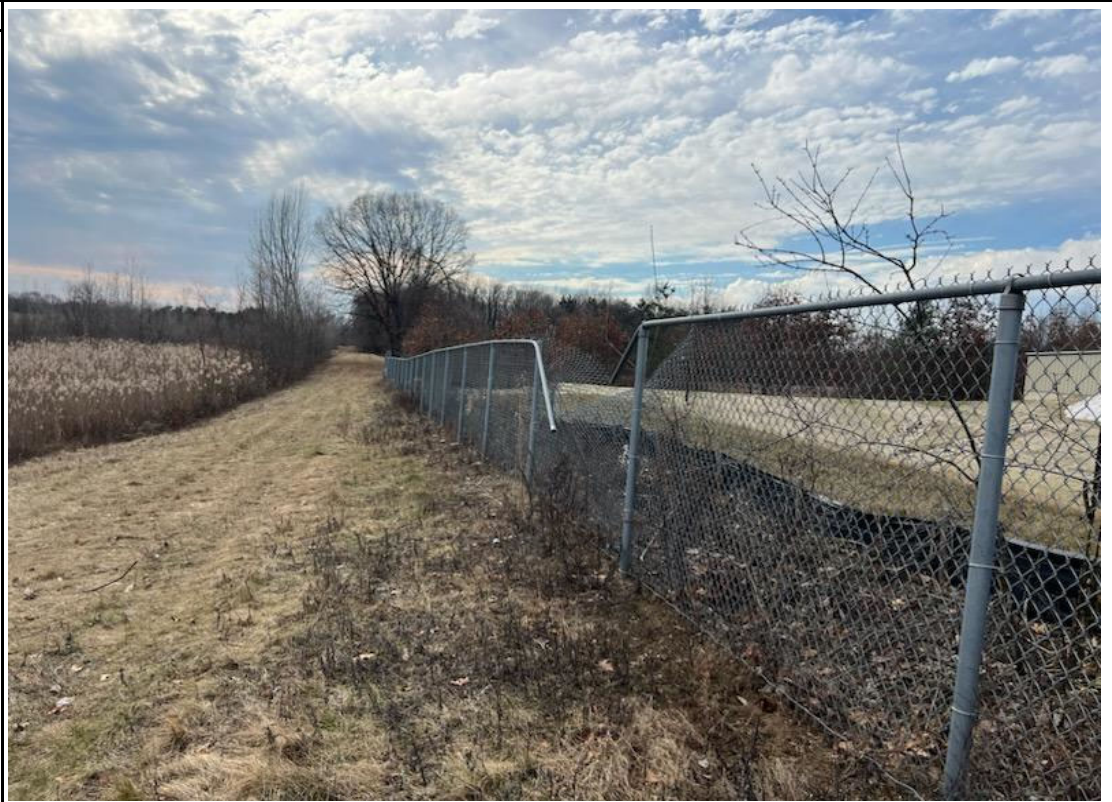
**Photo #3**

View of damaged fence on western property boundary.

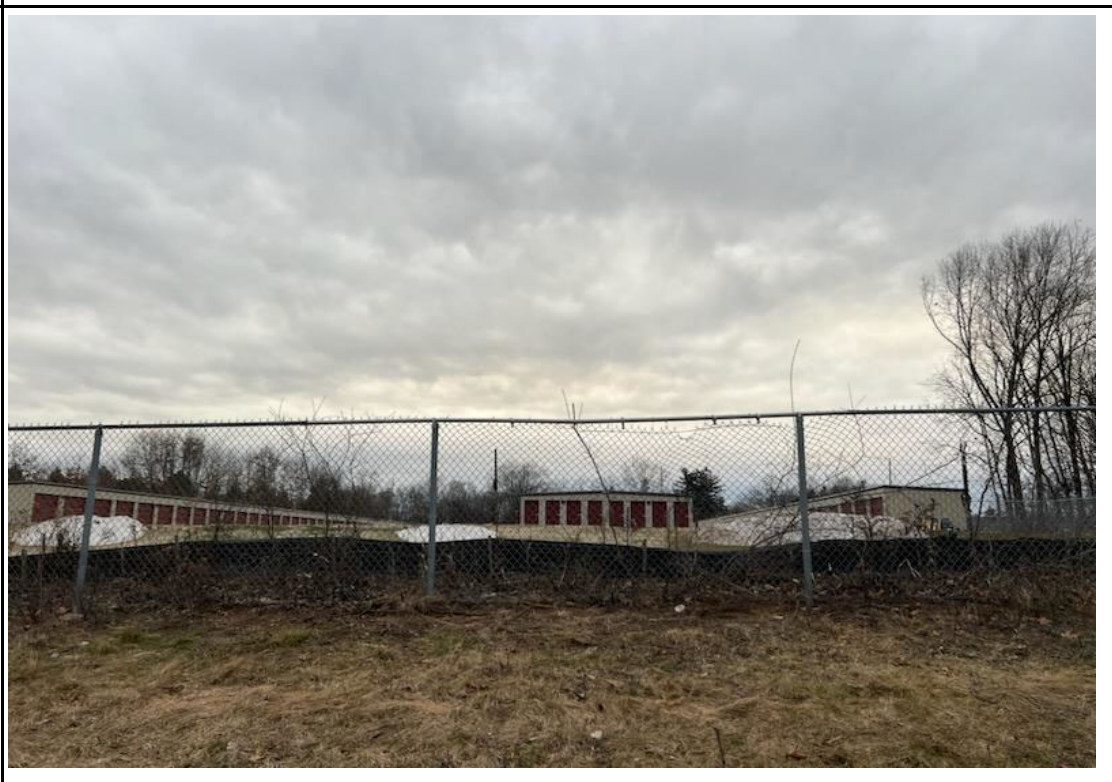
**Photo #4**

View of fence after Patriot performed repairs.
