Re: **Inspection Summary Letter**  
Hoosier Park, LLC.  
Farm ID # 6309  
Anderson, Madison County

**CFO**  
**INSPECTION REPORT**  
 INDIANA DEPARTMENT OF  
 ENVIRONMENTAL MANAGEMENT

Inspection Type: CFO- Follow-up

Facility Name: Hoosier Park, LLC. Harrah's Hoosier Park Racing & Casino

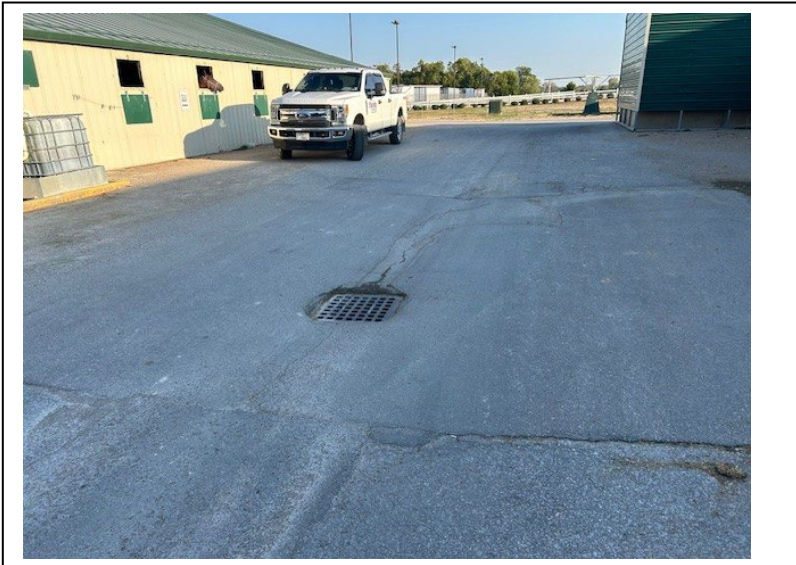
This photo displays there is no wash water entering the stormwater drain.

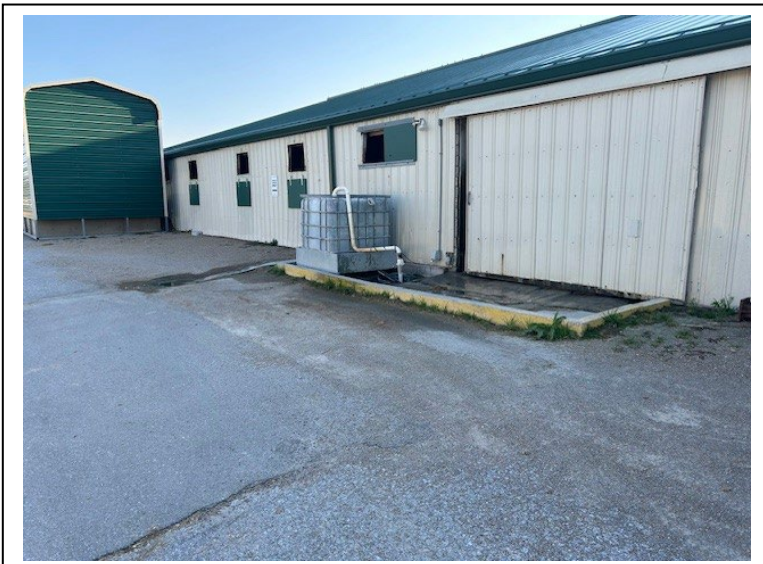
This photo displays the wash station. A temporary flap has been added to help direct water on the back side of the container.

Once on-site, I met with Andrew Paxton, backside manager. After a brief overview, a site tour was conducted. We looked at both wash stations. Previously, these wash stations had evidence of wash water/process wastewater migrating out of the bounds of their permitted structures. Mr. Paxton and I discussed the increased frequency of pumping and temporary changes that they have tried implementing. More permanent solutions may be required to ensure the wash water does not come out of the containment system. These solutions are going to be discussed with their consultant on Friday, September

20th. Once a plan has been developed, modifications will be submitted to IDEM's CFO/CAFO permitting section for their review. Please continue to manage these structures as required to prevent any unpermitted discharge.

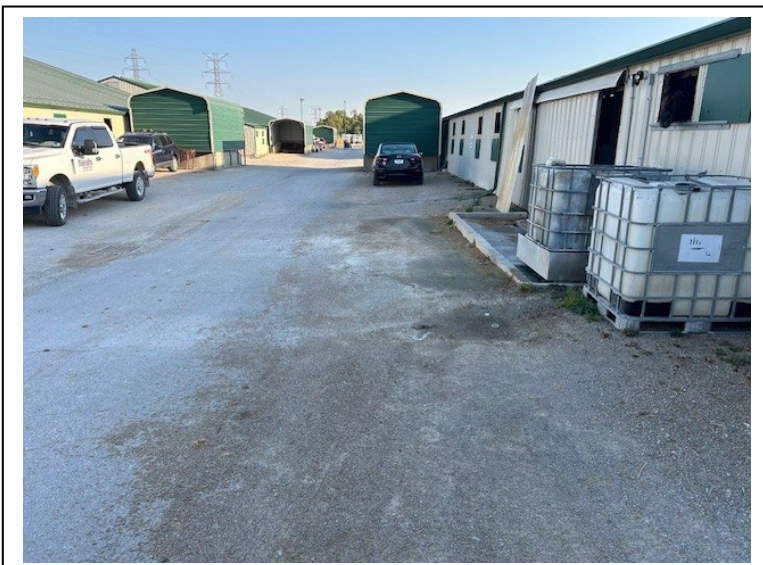
This photo displays the second wash station. No wash water is entering the storm drain. A temporary flap has been added to help direct water on the back side of the container.
