**RE: Vapor Residential Sampling & Mitigation Report
Former Harman-Becker Automotive Systems, Inc.
1201 South Ohio Street
Martinsville, Morgan County, Indiana
State Cleanup Site #1996-06-183
SESCO Project No. 3872**

Figure 2 – Residential Indoor Air, Crawl Space & Ambient Air Analytical Results Map

Figure 3 – Residential Sub-Slab Analytical Results Map

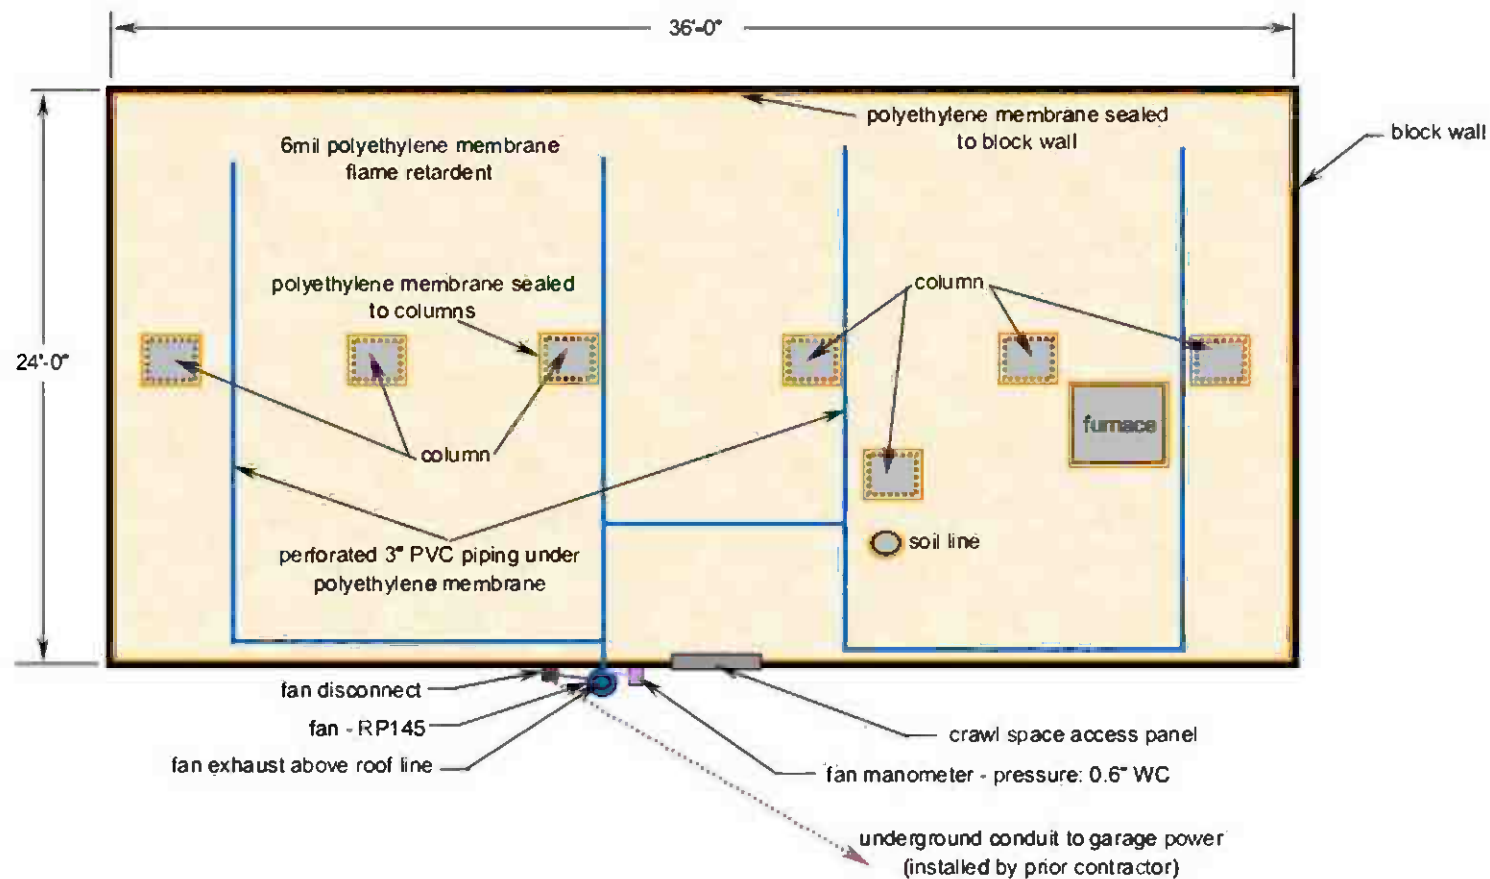
520 Basca Drive Sub-Membrane Depressurization System Schematics

On March 17, 2010, SESCO personnel collected one (1) indoor air sample from the Rhine residence, which is a one-story structure with a crawl space. The residence currently has a vapor mitigation system that was installed by Keramida, Inc. (Keramida) on February 18, 2009. All VOCs were below the IDEM 30-Year Chronic Residential Indoor Air Action Levels, with the exception of PCE, at 3.2 ug/m³. SESCO upgraded the vapor mitigation system at the residence on June 25, 2010. The *Sub-Membrane Depressurization System* schematics are provided in **Appendix E**. SESCO will collect additional indoor air samples during the 2010 winter season and continue to inspect the vapor mitigation system, on a semi-annual basis, to ensure it is functioning properly.

- Due to the vapor concentrations of PCE in the indoor air (3.2 ug/m³) at 520 Basca Drive, SESCO upgraded the vapor mitigation system at the residence on June 25, 2010. Confirmation samples will be collected to ensure the system is functioning properly.
