FURTHER SITE INVESTIGATION REPORT

**Former Harman-Becker Automotive Systems, Inc.
1201 South Ohio Street
Martinsville, Indiana 46151**

State Cleanup Site #1996-06-183

Issued: July 8, 2011

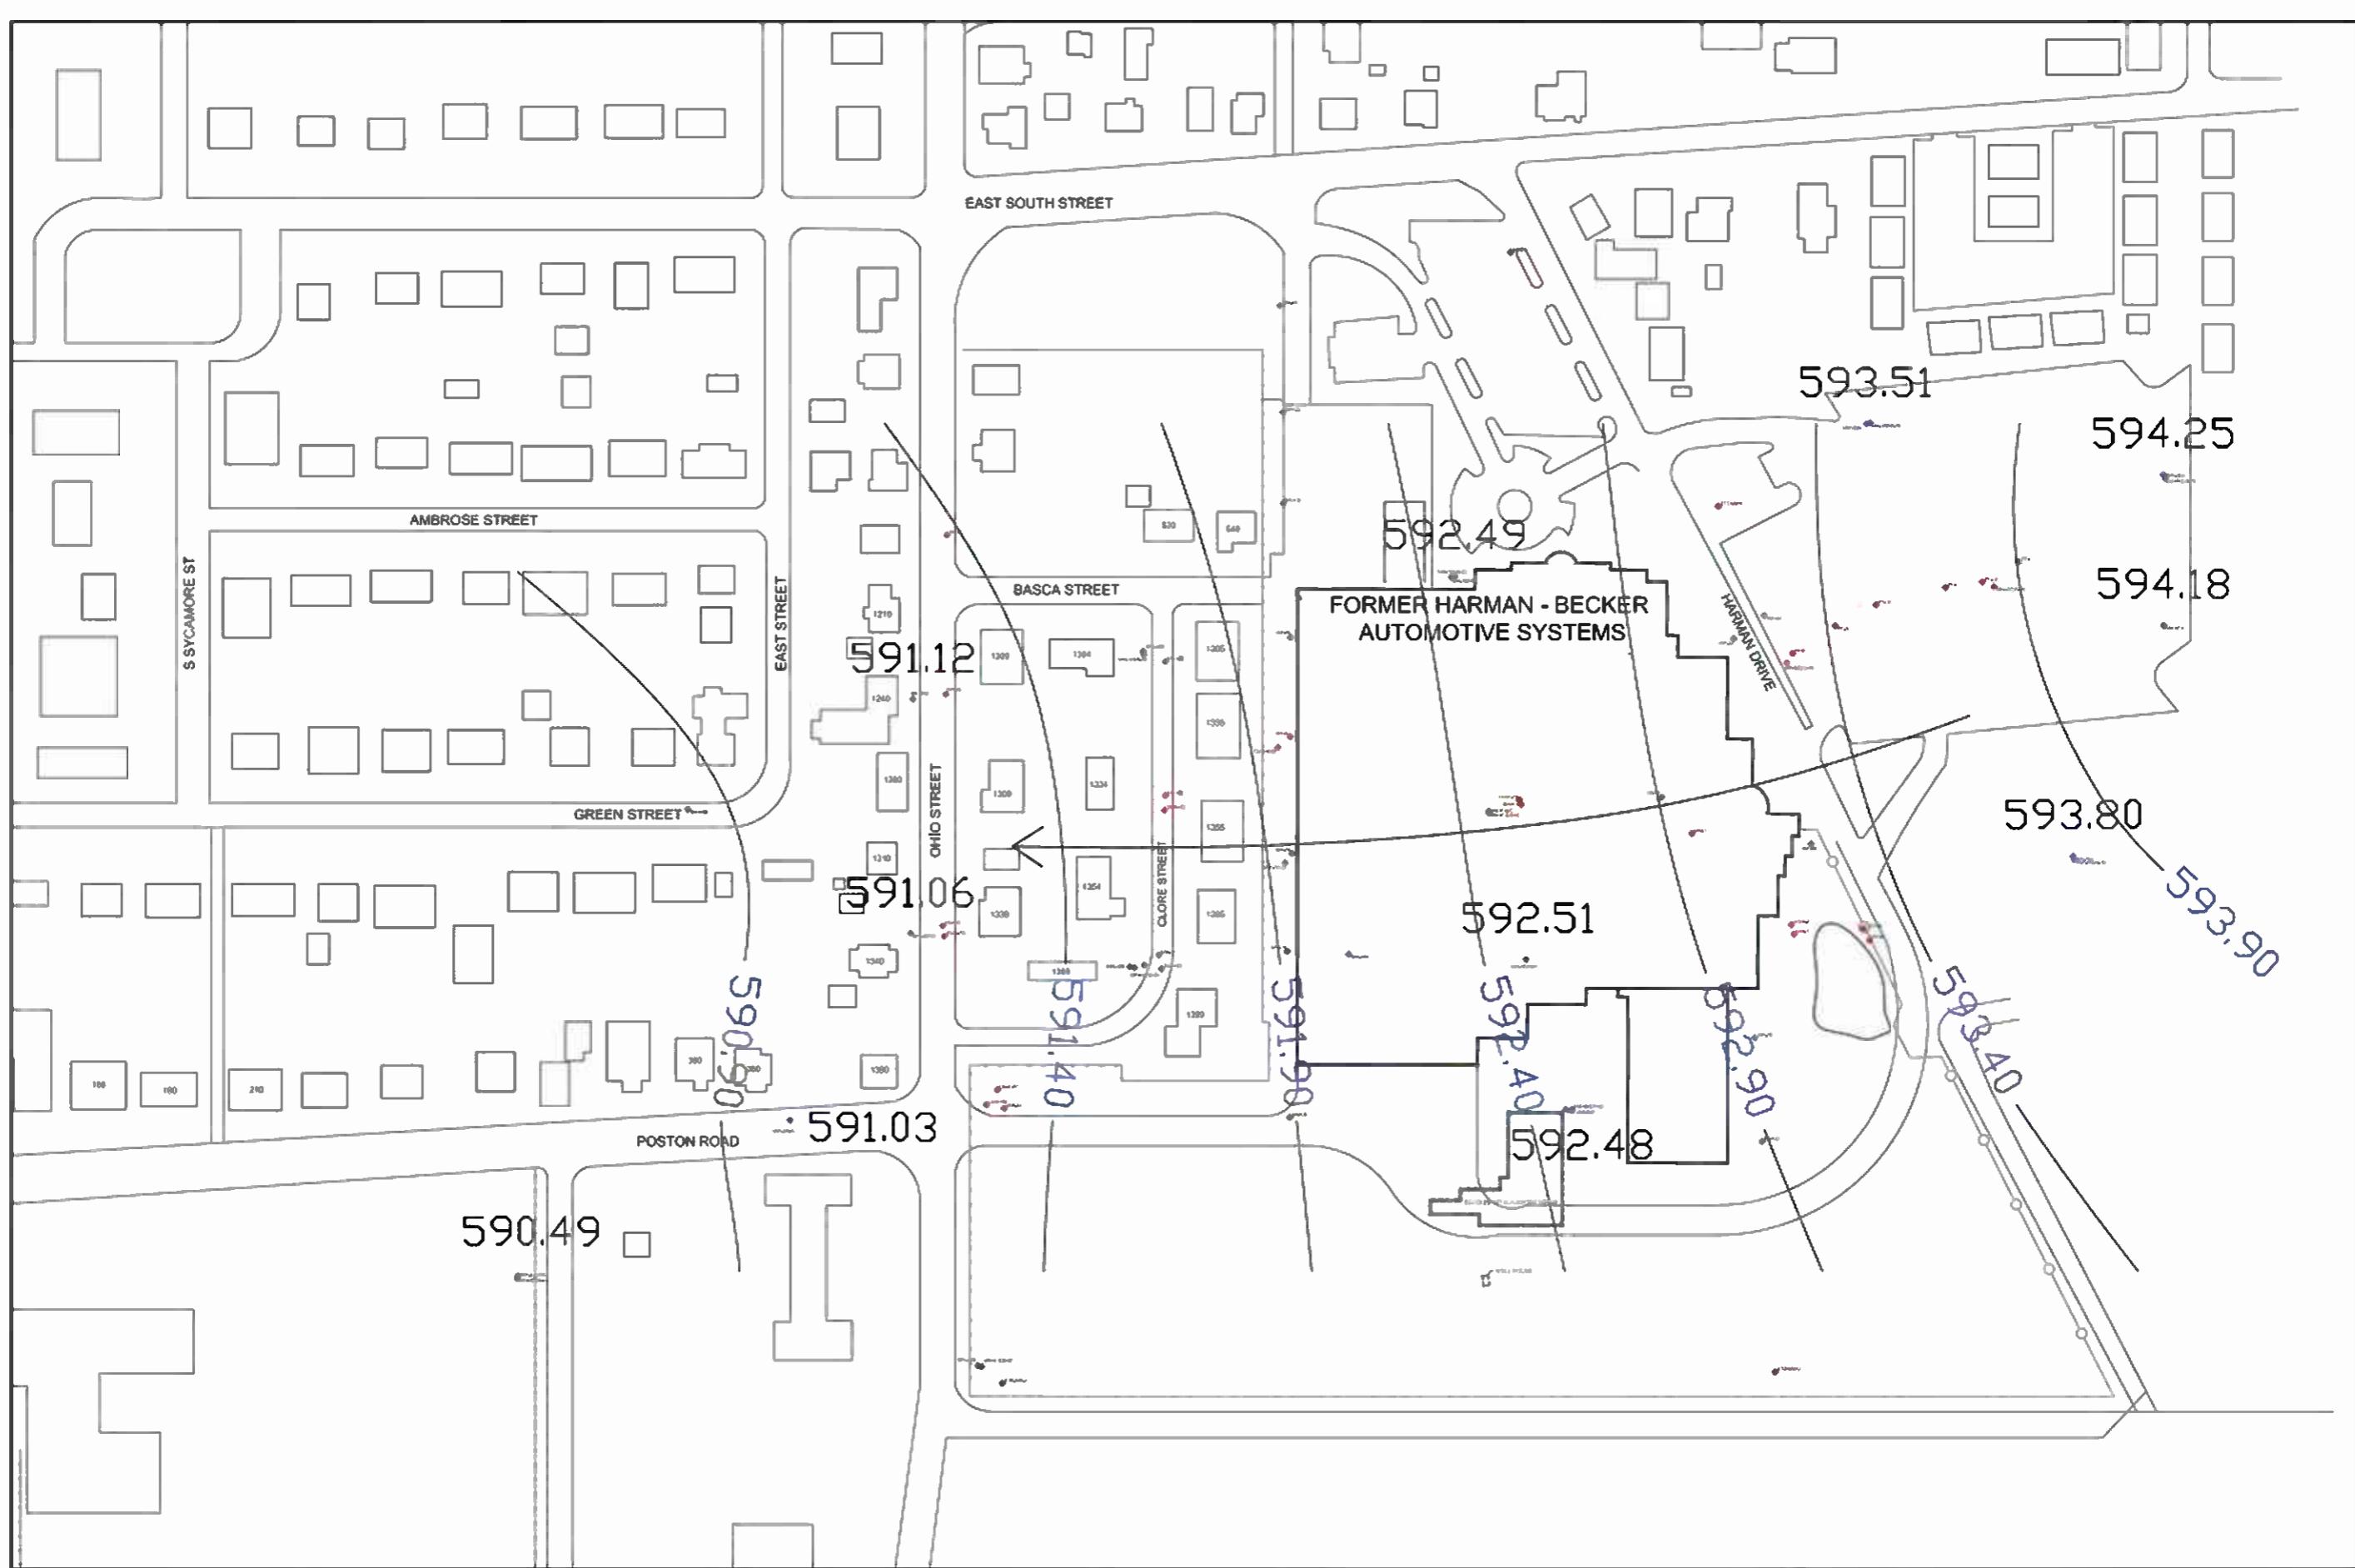
FIGURE # 5A

Site-specific hydraulic gradient information was obtained from groundwater monitoring wells installed using hollow-stemmed augers or rota-sonic technology. Monitoring wells screened across the water table indicate groundwater flow is to the southwest in the unconfined surficial sand and gravel aquifer. Cumulative groundwater elevation data are summarized in Table 1. Water table elevation maps are included as Figure 5A-5C.

Figure 5A – Water Table Elevation Map (March 15, 2010)

The static water levels of the monitoring wells were measured to the nearest 0.01-foot with a properly decontaminated static water level indicator, prior to sampling. The well caps were removed approximately 30 minutes prior to gauging the static water levels to allow the static pressure heads to reach equilibrium. Groundwater elevation data obtained from the monitoring well network is summarized in Table 1. The groundwater elevation data were used to construct the water table elevation maps provided as Figures 5A – 5C. Groundwater elevation data collected on March 15, 2010, May 18, 2010, and November 2, 2010, indicate the horizontal hydraulic gradient is primarily to the southwest in the surficial sand and gravel aquifer.
