UNITED STATES ENVIRONMENTAL PROTECTION AGENCY  
REGION 5  
77 WEST JACKSON BOULEVARD  
CHICAGO, IL 60604-3590

Re: Notice of Violation  
RCRA Compliance Evaluation Inspection – Warsaw Chemical Co. Inc.  
EPA I.D. No.: IND 005 430 244

The purpose of the inspection was to conduct an un-announced Follow-Up Inspection (FUI) at the Warsaw Chemical Co. Inc. (Warsaw), located at 390 Argonne Road, Warsaw, Indiana. The FUI was to examine Warsaw's management of its Resource Conservation and Recovery Act (RCRA) regulated waste, by the U.S. Environmental Protection Agency, after entering into an agreement, a Complaint and Compliance Order, with EPA on September 28, 2007, based on violations found during a June 8, 2006 inspection.

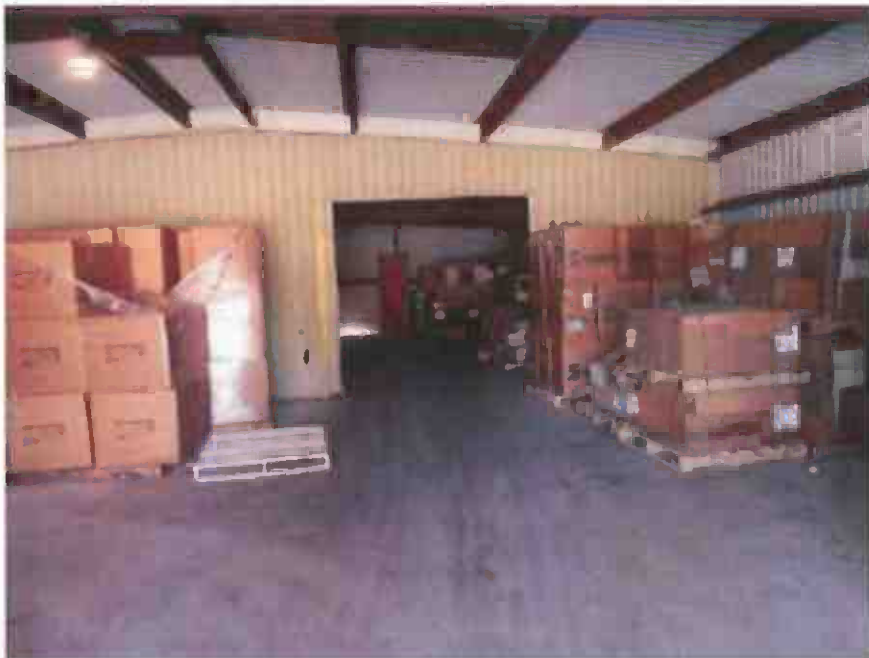
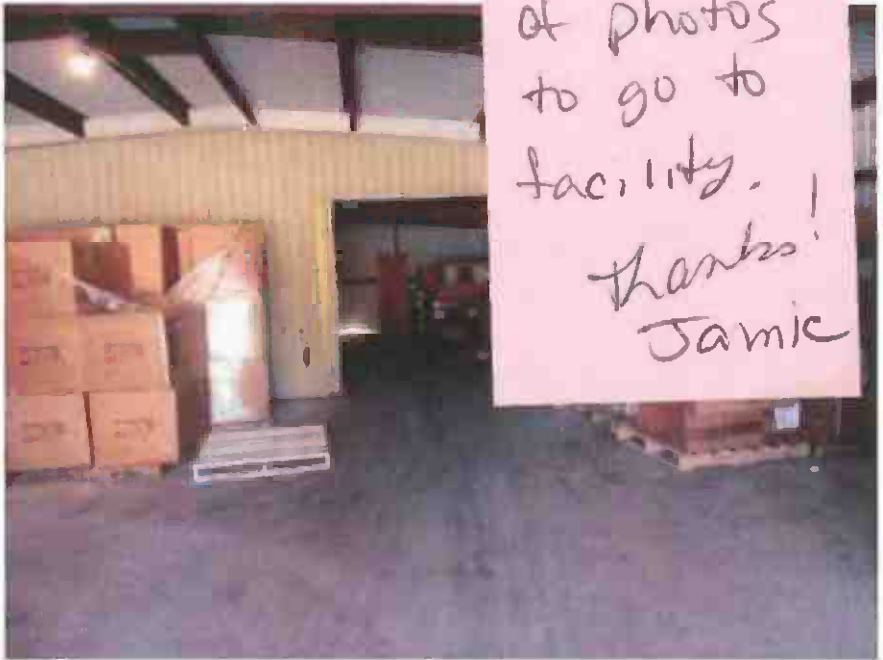
Old Bulk Plant. Raw packaging, boxes and raw material storage.

Mr. Shull escorted us on the physical inspection, which began in the Old Bulk Plant. Warsaw was only storing raw packaging, boxes and raw materials inside of this building at the time of the inspection. In the past, they used to store hazardous waste inside. *See*, photograph 1.

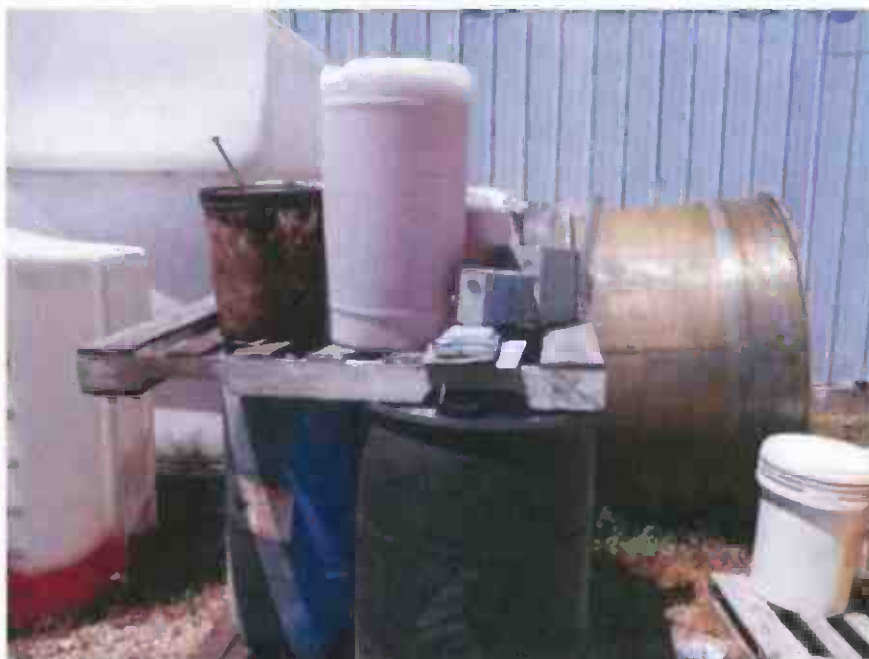
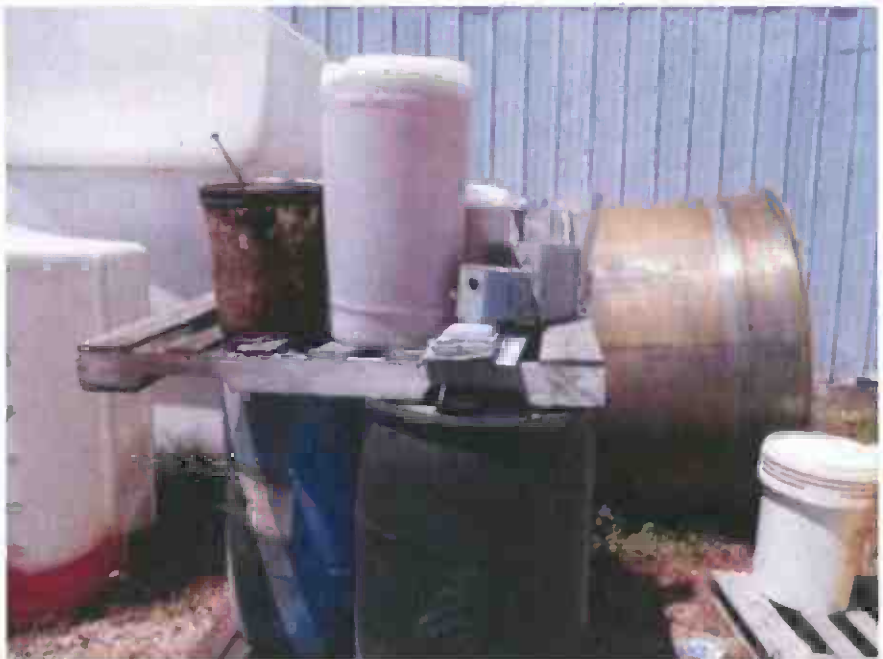
**Disk Number** 1  
**Photo Number** 2  
**Photo Filename** DSCN0292.jpg  
**Date/Time** 6/4/2012  
12:49:02 PM  
**Photographer** Jamie Paulin

Outside area, located to the East of the Old Bulk Plant. Warsaw was not aware of what this material actually was.

At the time of the inspection, Warsaw was storing unidentified material in several containers; approximately three 55-gallon containers, one 20-gallon container, and three or four 5-gallon containers. These containers were located in an outside area, positioned to the East of the Old Bulk Plant. Warsaw was not aware of what material was actually being stored in each container.

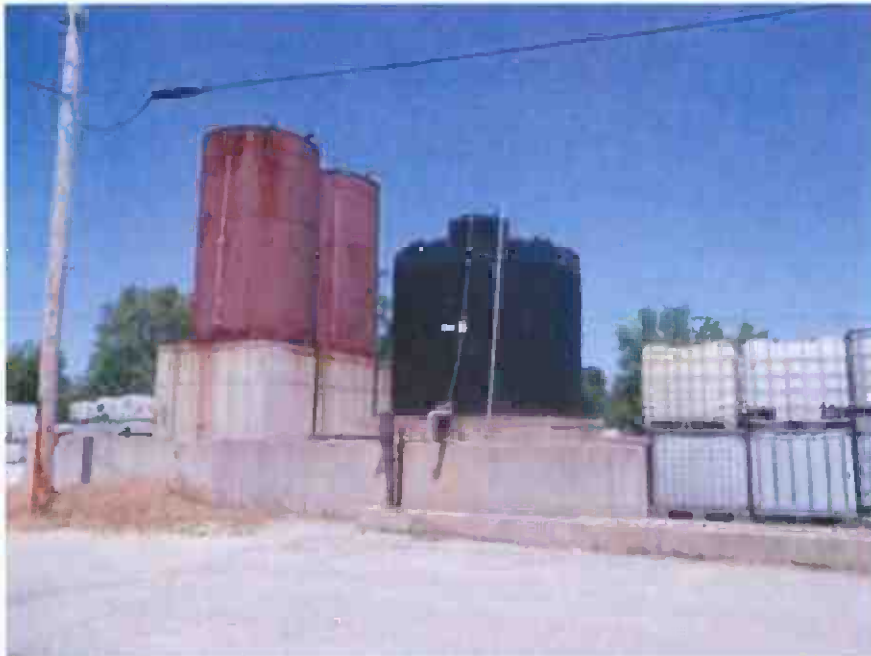
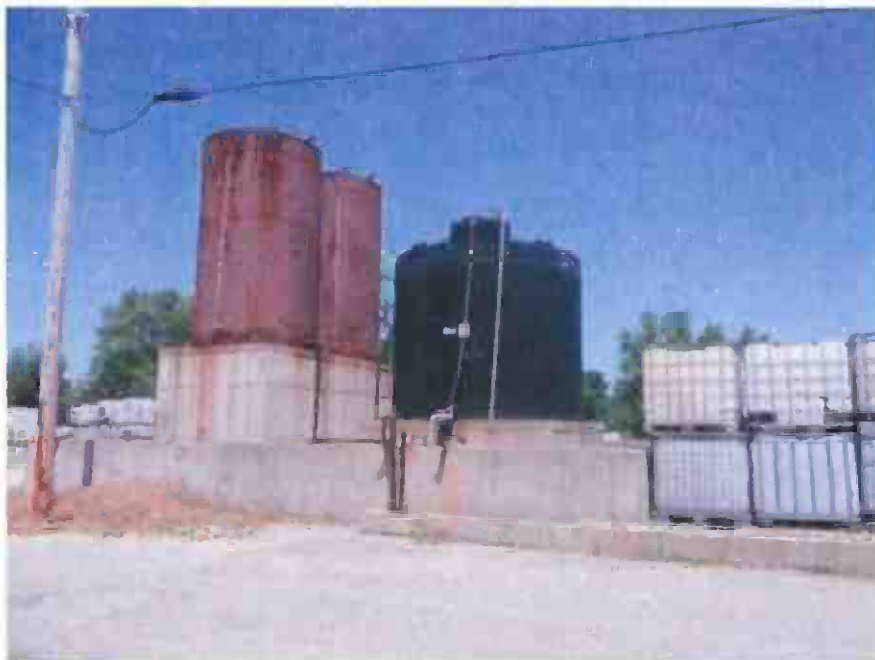
Black 7000 gallon tank (EB Tank). The tank was storing ethylene glycol monobutyl ether as a raw material. Two tall rust tanks were no longer in use. Material was being stored for use in the process.

On the North side of the facility yard, Warsaw was storing ethylene glycol monobutyl ether (EB), as a raw material in a black 7000 gallon tank. Two tall rusty tanks were positioned next to this EB tank; however, Mr. Shull explained that those two tanks were empty and not in-use. *See*, photograph 3.

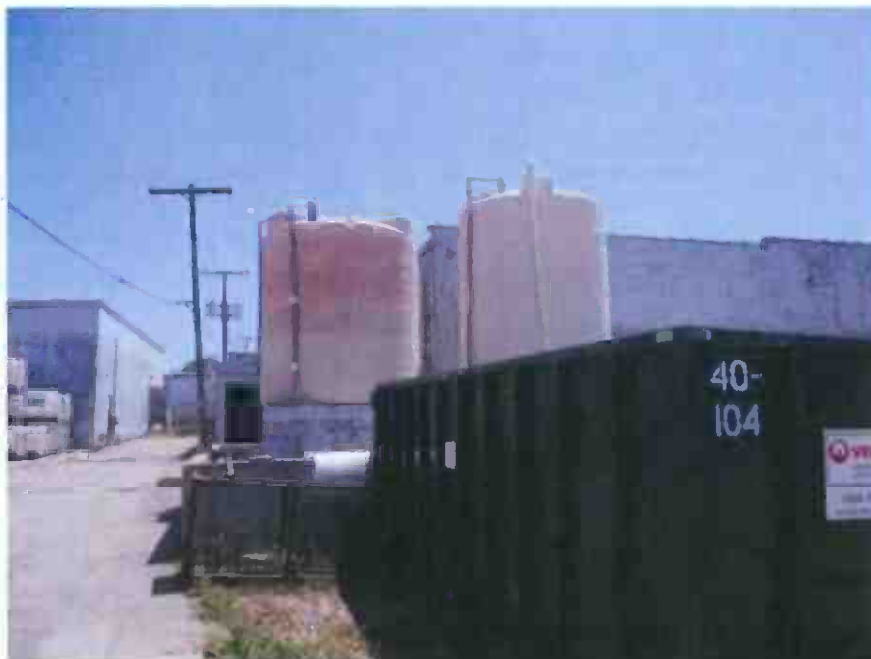
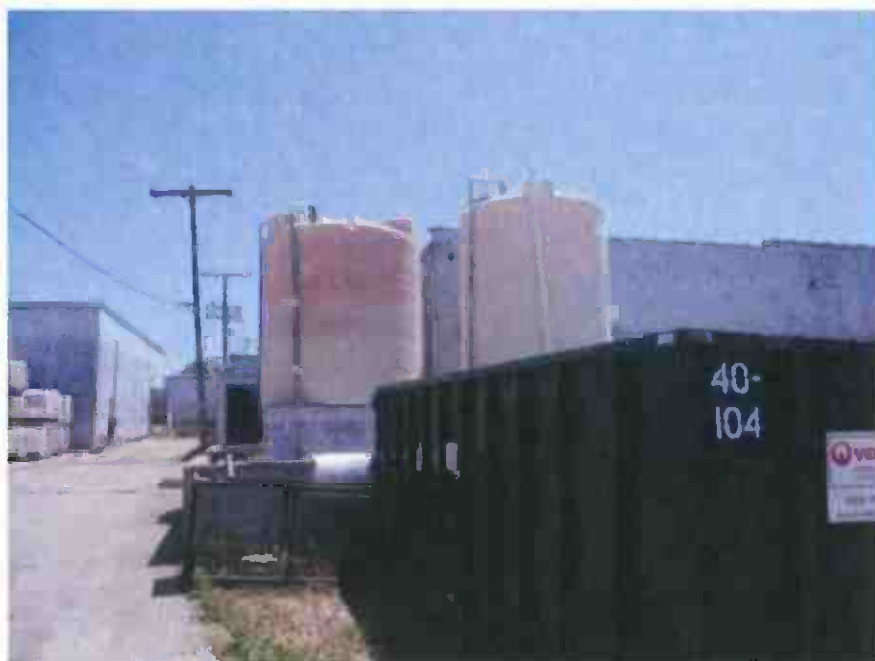
**Disk Number** 1  
**Photo Number** 4  
**Photo Filename** DSCN0294.jpg  
**Date/Time** 6/4/2012  
12:52:04 PM  
**Photographer** Jamie Paulin

Two tall white, 6000 gallon tanks were storing Hydrochloric Acid, on the right, and Phosphoric Acid, on the left. All materials were being stored for use in the process or in the WWTU.

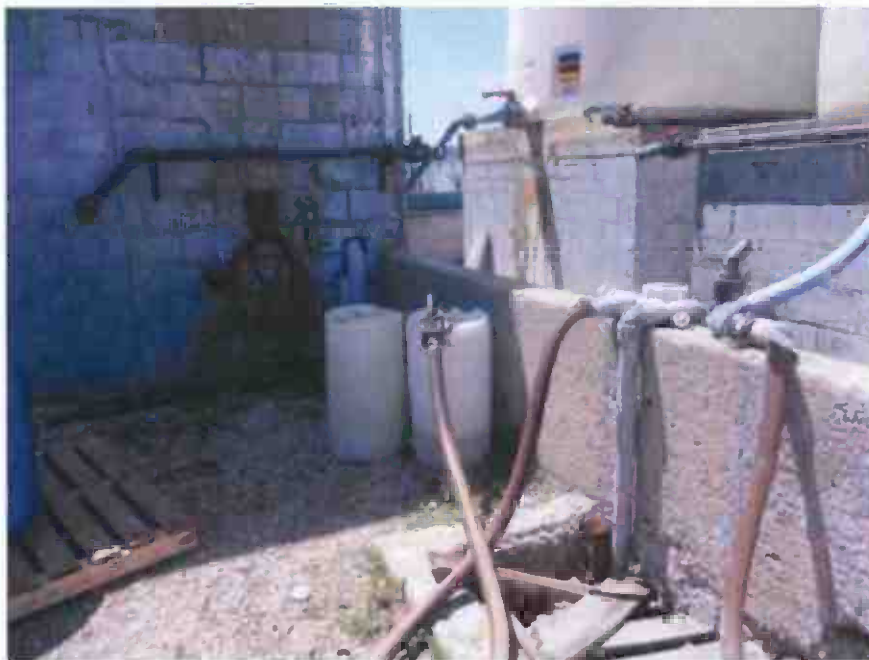
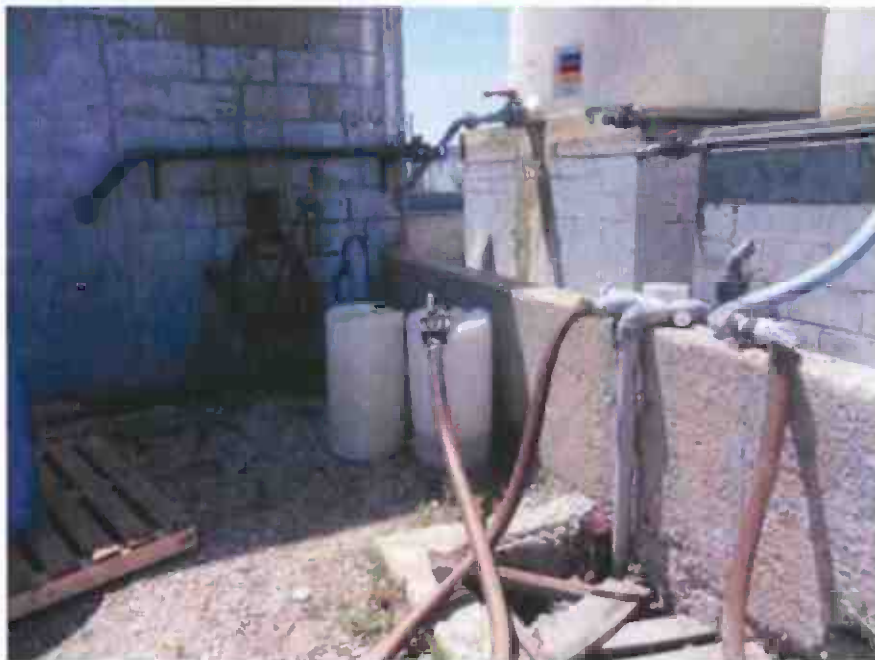
Acid collection from the tanks. The pipes and the hoses connect from the tanks to the process inside of the building. The collected acid is put back into the WWTU.

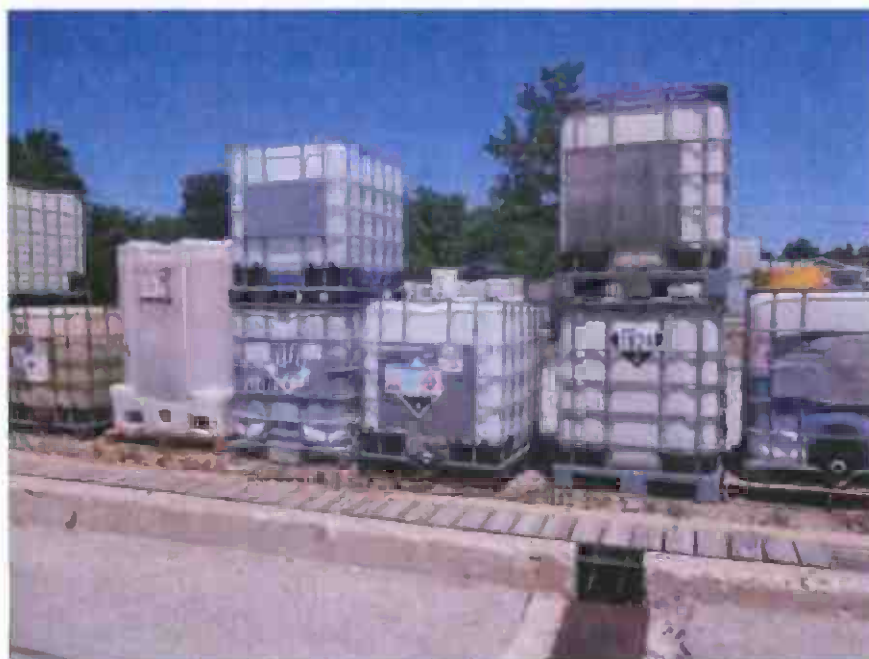
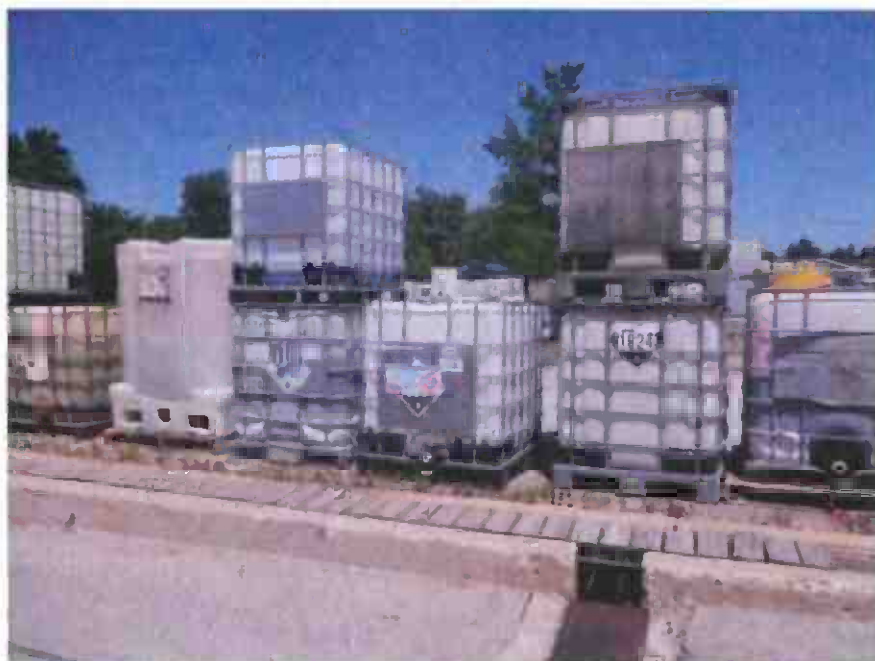
**Disk Number** 1  
**Photo Number** 6  
**Photo Filename** DSCN0296.jpg  
**Date/Time** 6/4/2012  
12:56:26 PM  
**Photographer** Jamie Paulin

Storage of rinse water, antifreeze, Lime Solve, methanol and other types of raw materials in totes, outside on the North side of yard.

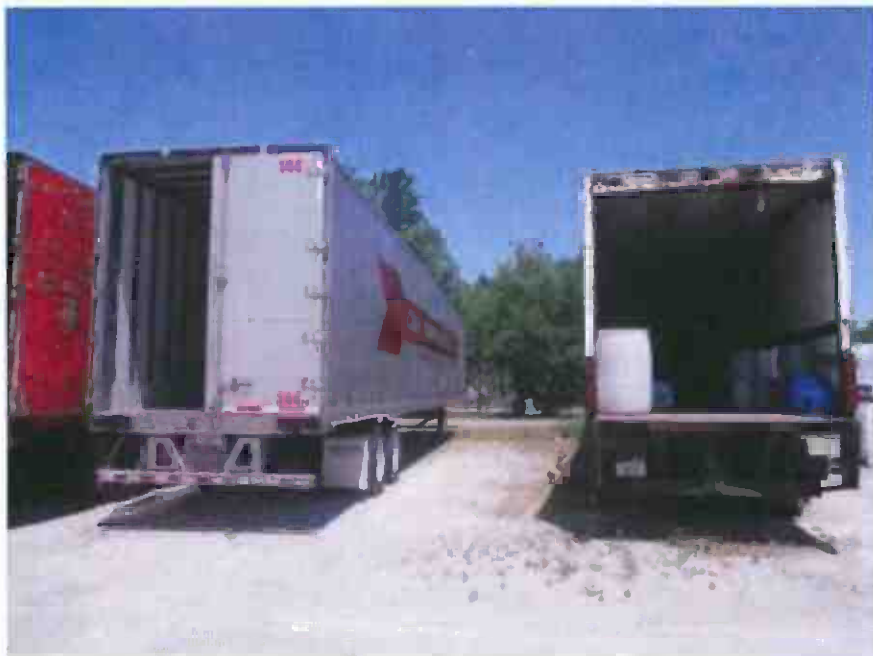
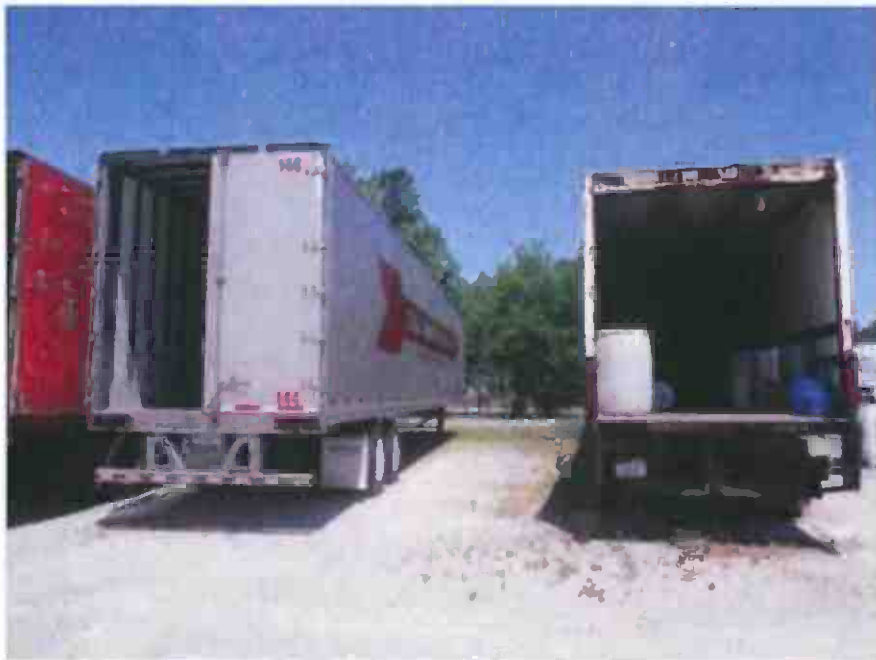
Open trailers were being stored in the yard. Empty 55-gallon containers were being stored in the trailer on the right and raw materials were being stored in the trailer on the left.

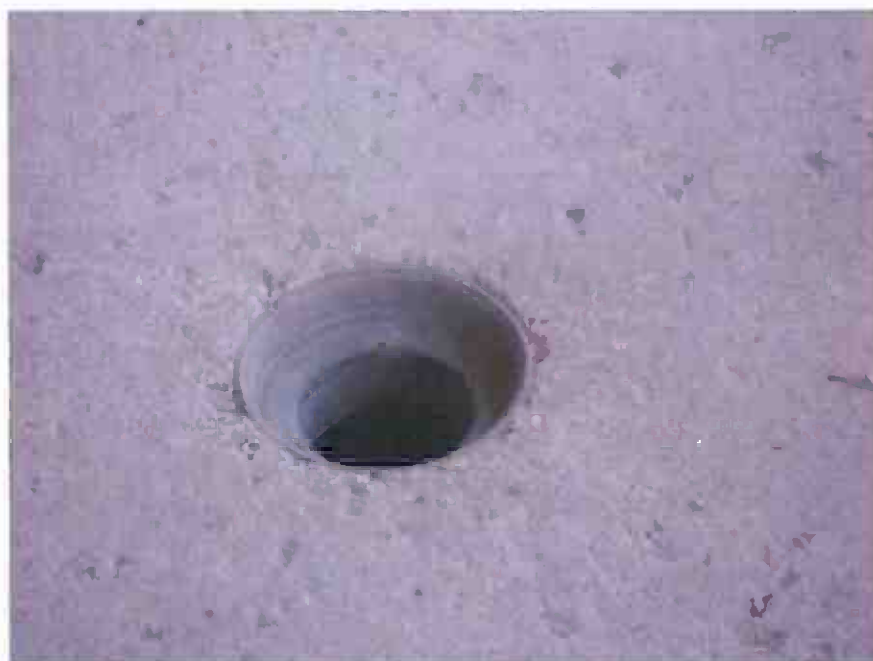
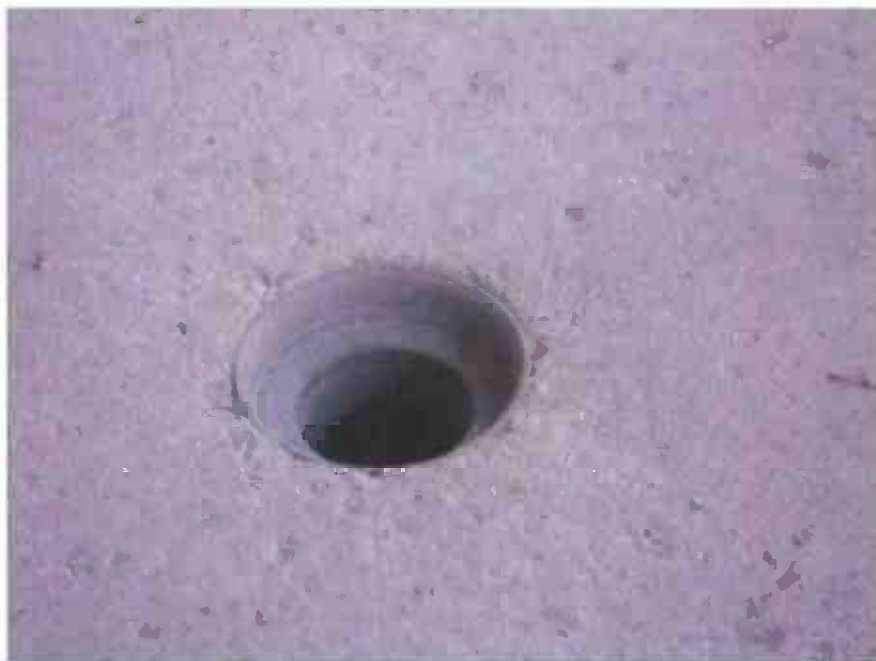
**Disk Number** 1  
**Photo Number** 8  
**Photo Filename** DSCN0298.jpg  
**Date/Time** 6/5/2012  
1:06:42 PM  
**Photographer** Jamie Paulin

Open drain located at the truck off-loading area. The drain leads to a sump, inside of the Bulk Plant, on the West side of the facility.

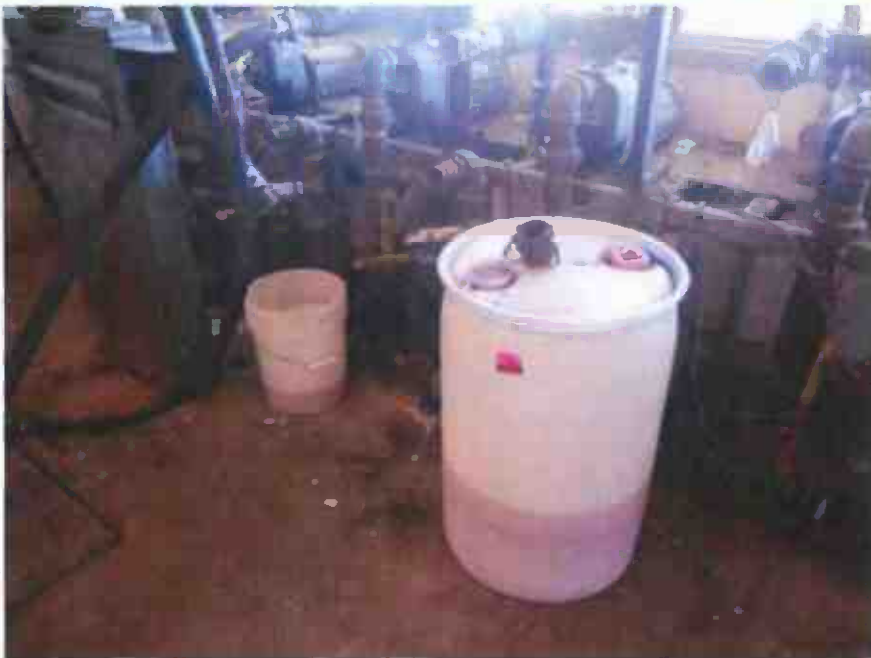
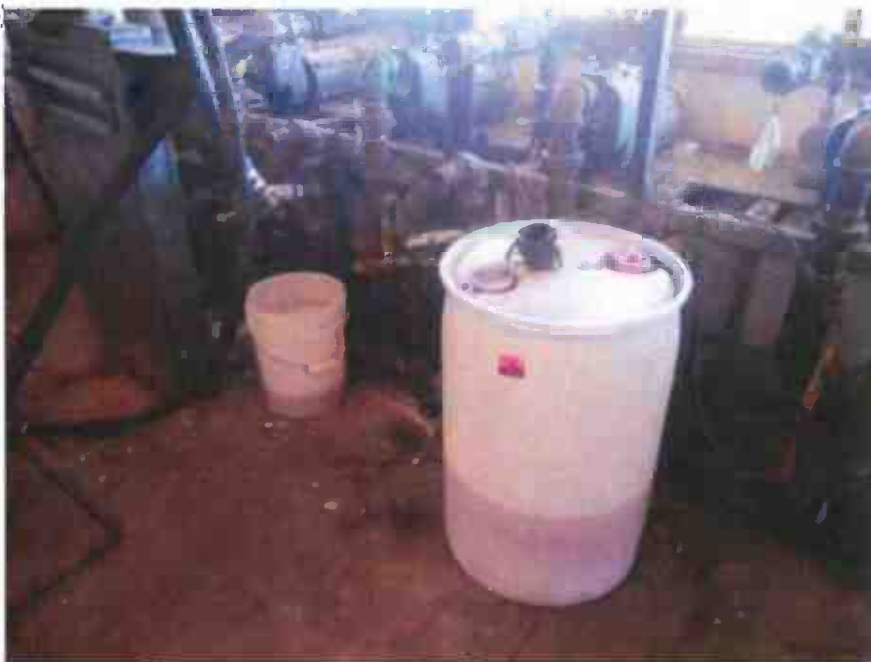
Open 5-gallon bucket of flammable paint-like material. The bucket did not contain any type of label. An open 55-gallon container was being stored next to the bucket with no label.

- At the time of the inspection, several containers located in four of Warsaw's satellite accumulation areas (SAAs), and one container located in an SAA near the hazardous waste storage area inside of the new Bulk Plant were not marked with either the words, "Hazardous Waste," or with other words identifying the contents of the containers.

- Finally, several of the containers located in these SAA locations contained hazardous waste, yet were not closed, but were open when waste was not being added to, or removed, from the containers.

- I stated that Warsaw should manage their small containers better. I explained that they need to keep all containers closed, when not adding or removing waste, and that they should label the containers with either the words, "Hazardous Waste," or with words identifying the contents.
- I also recommended that Warsaw properly store and label the universal waste, the used fluorescent light bulbs. I stated that used fluorescent light bulb containers need to be closed and properly labeled. Lastly, I explained that Warsaw also needs to be able to associate a date of accumulation with the used lamps.

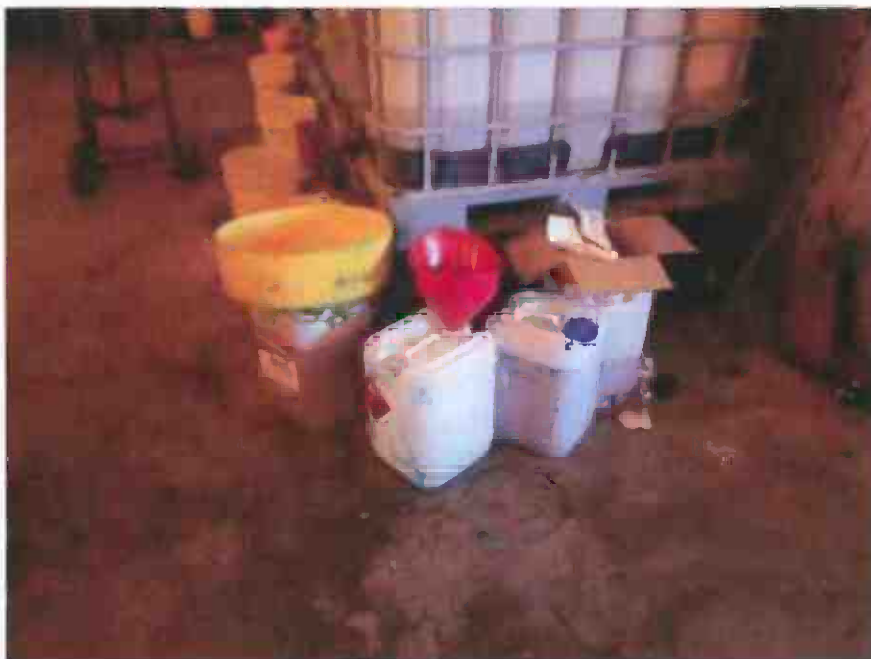
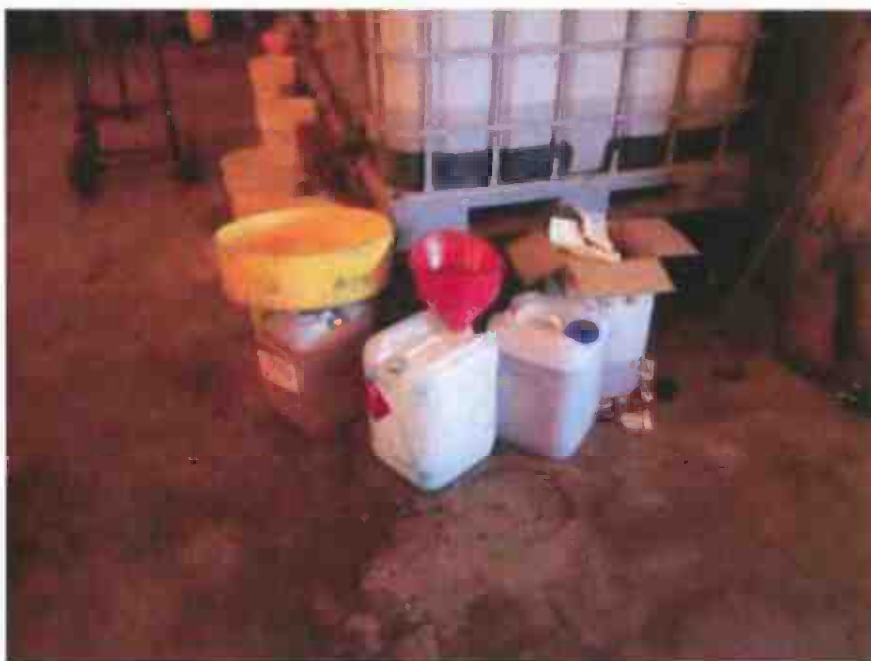
**Disk Number** 1  
**Photo Number** 10  
**Photo Filename** DSCN0300.jpg  
**Date/Time** 6/5/2012  
1:10:58 PM  
**Photographer** Jamie Paulin

Bulk Plant. Several containers were being stored around the totes. Some of the containers were open. Car wash methanol, heptane and hexane were being stored inside of the container.

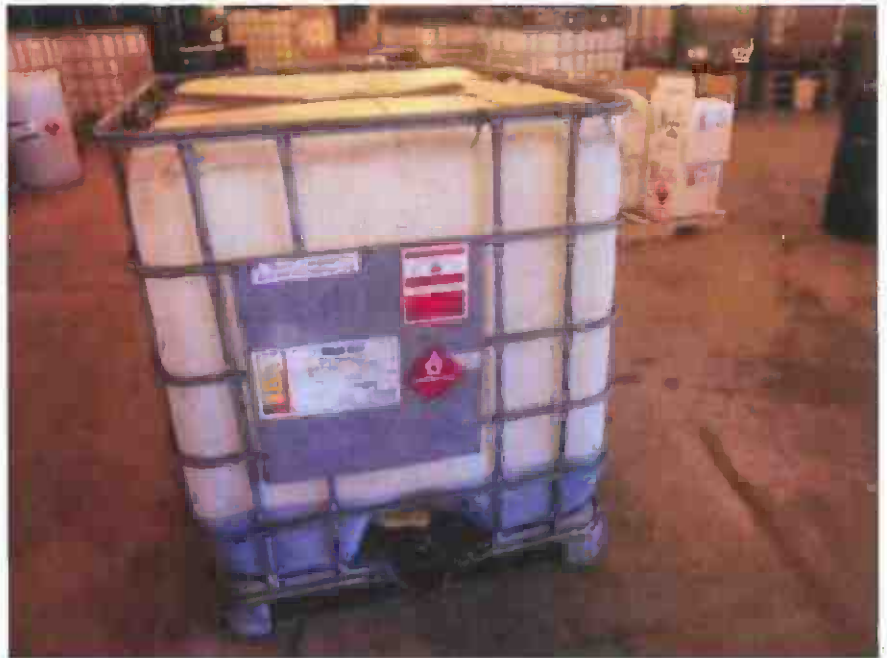
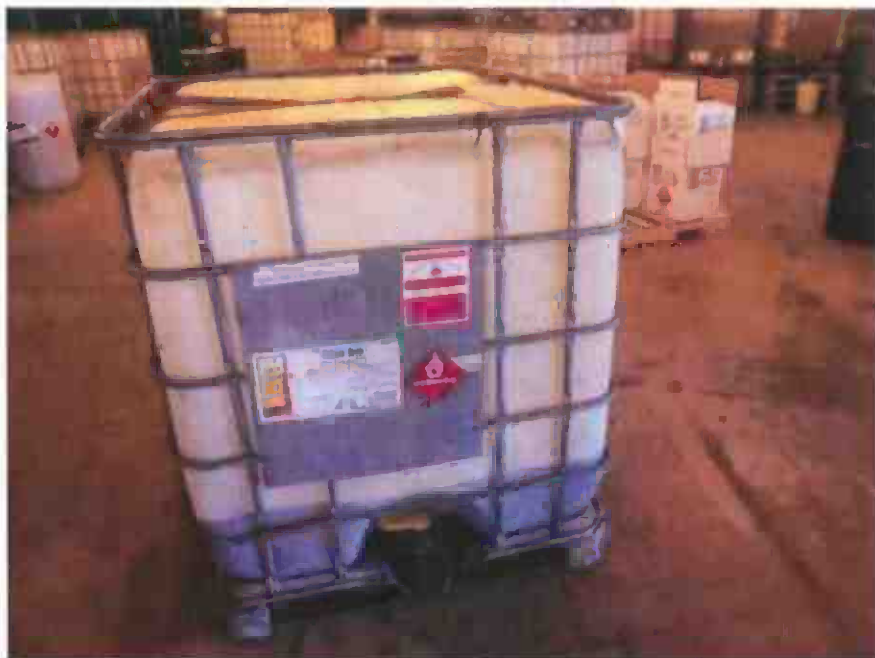
One tote of Blue Ice, which is used as a tire dressing.

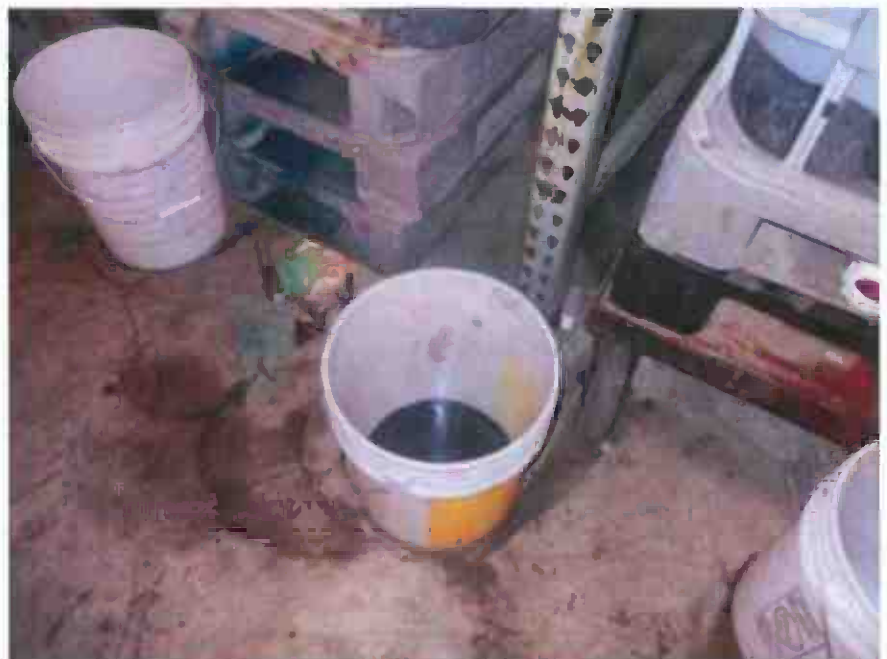
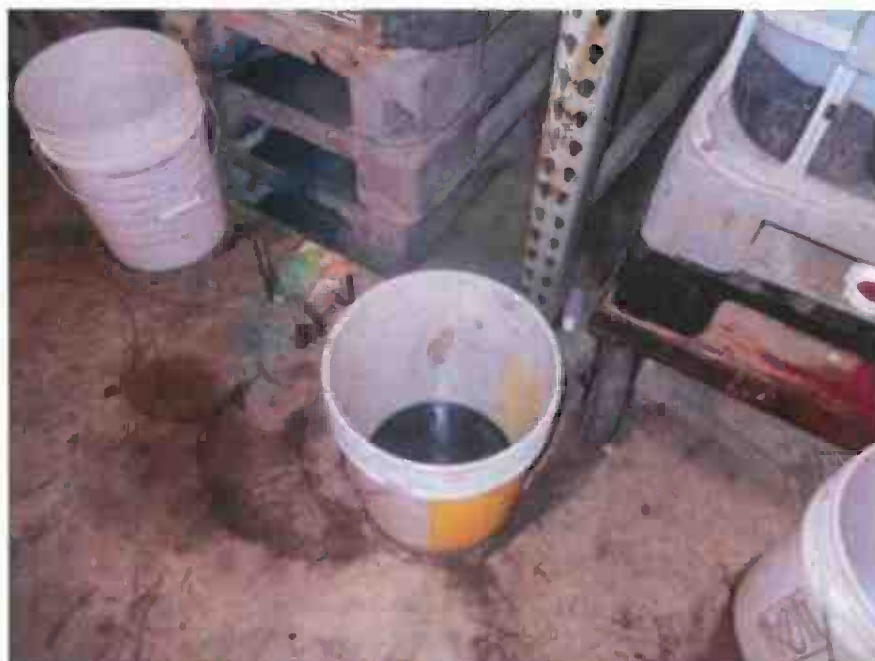
**Disk Number** 1  
**Photo Number** 12  
**Photo Filename** DSCN0302.jpg  
**Date/Time** 6/5/2012  
1:15:52 PM  
**Photographer** Jamie Paulin

IPA pre-mix. An open 5-gallon bucket on the East side of the Bulk Plant was storing a flammable IPA pre-mix.

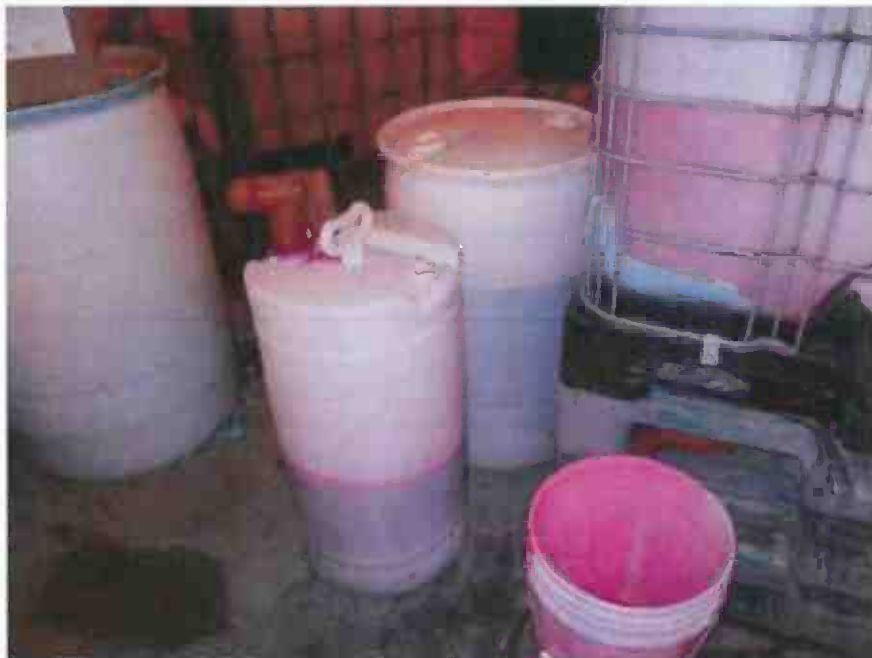
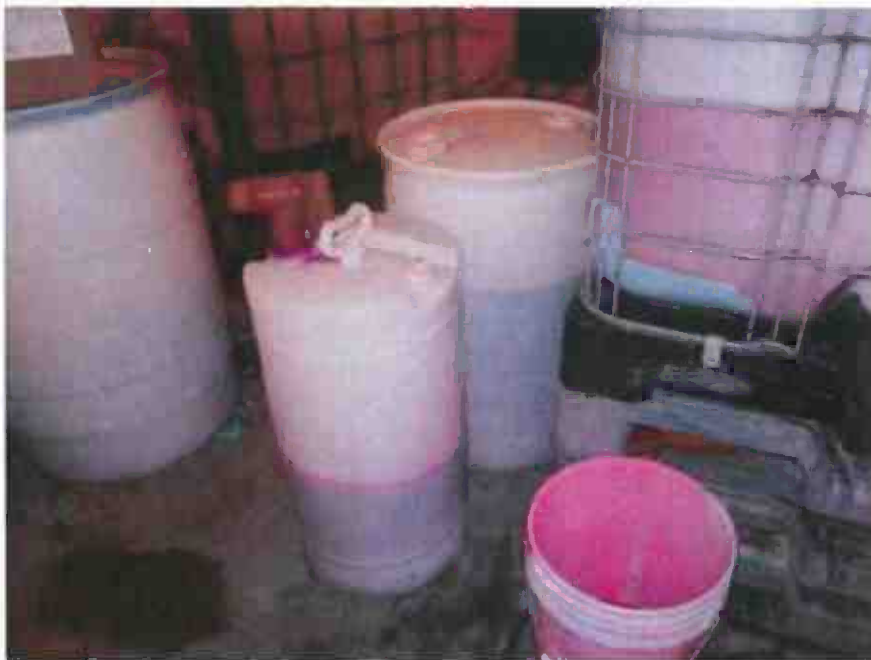
An open 5-gallon bucket was storing a pink material. The container did not have a label.

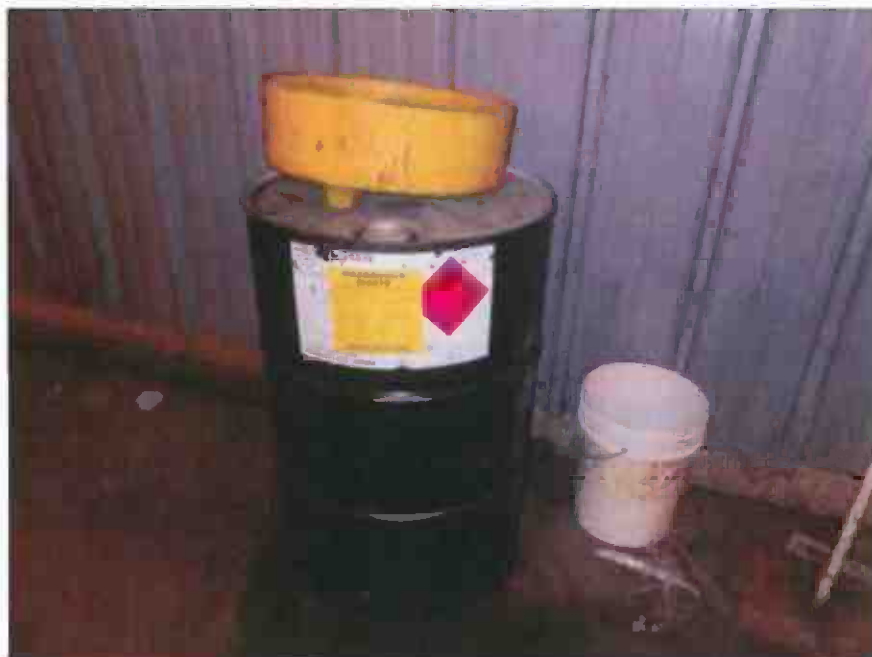
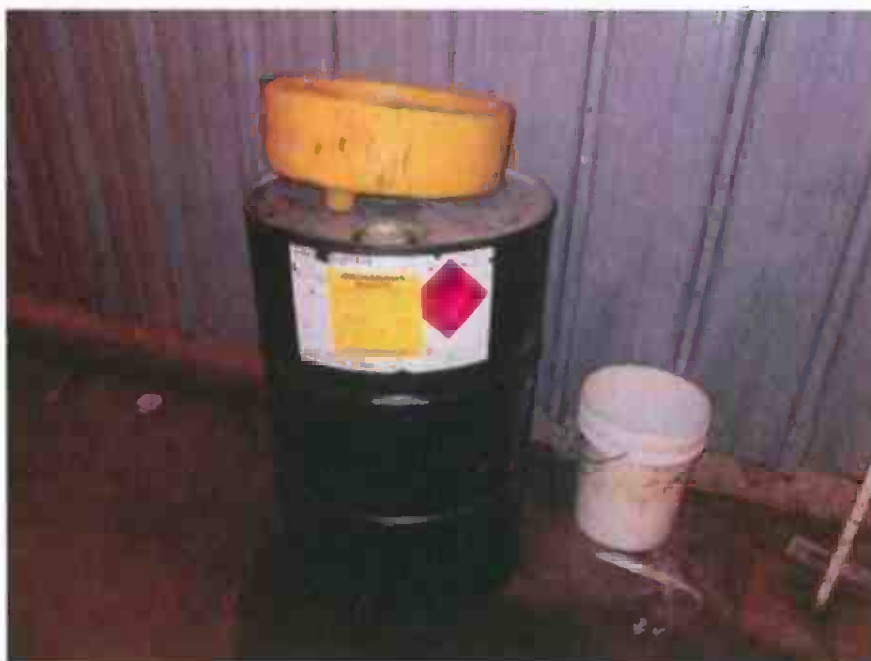
**Disk Number** 1  
**Photo Number** 14  
**Photo Filename** DSCN0304.jpg  
**Date/Time** 6/5/2012  
1:22:38 PM  
**Photographer** Jamie Paulin

I then inspected the hazardous waste storage area. One 55-gallon container of hazardous waste was being stored in the hazardous waste storage area, at the time of the inspection. The date on the container was, 2/19/12. An open 5-gallon bucket, storing D001 hazardous waste, was positioned by the 55-gallon container. The bucket did not have a label containing the words, "Hazardous Waste," or containing any words identifying the contents of the bucket. *See*, photographs 14 and 15.

One 55-gallon container of hazardous waste was being stored in the hazardous waste storage area, located in the Bulk Plant. The date on the container was, 2/19/12.

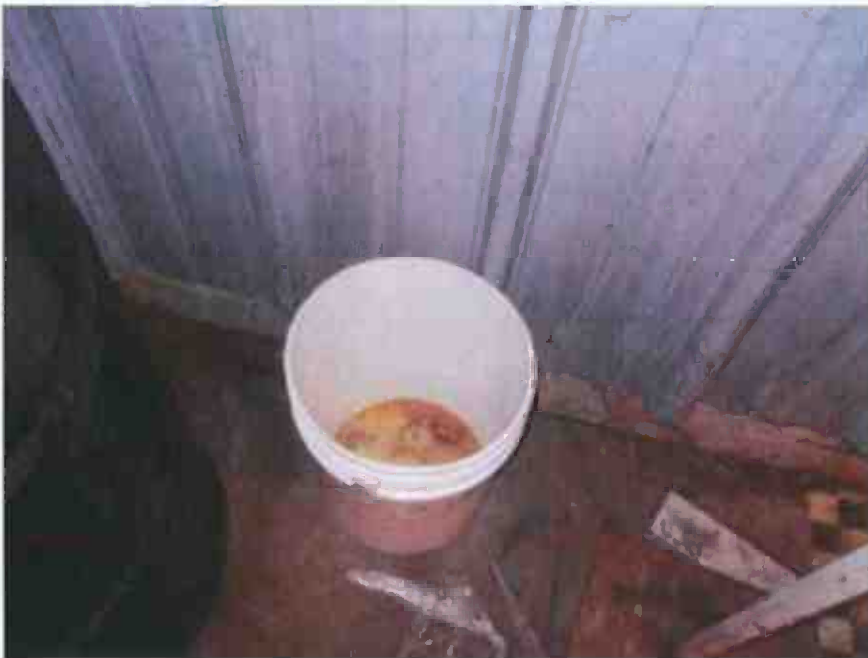
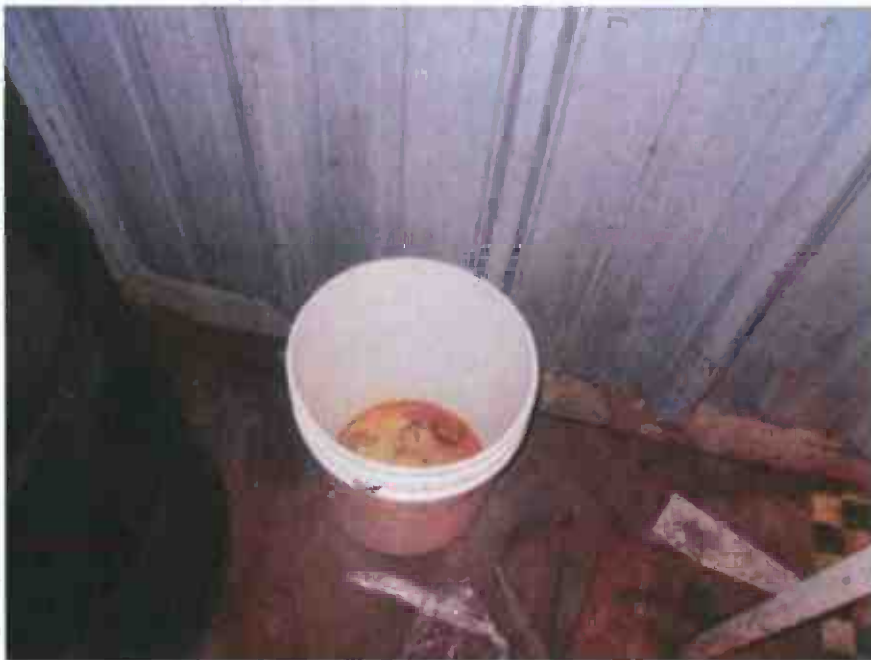
An open 5-gallon bucket, storing D001 material, was positioned by the 55-gallon container. The bucket did not have a label.

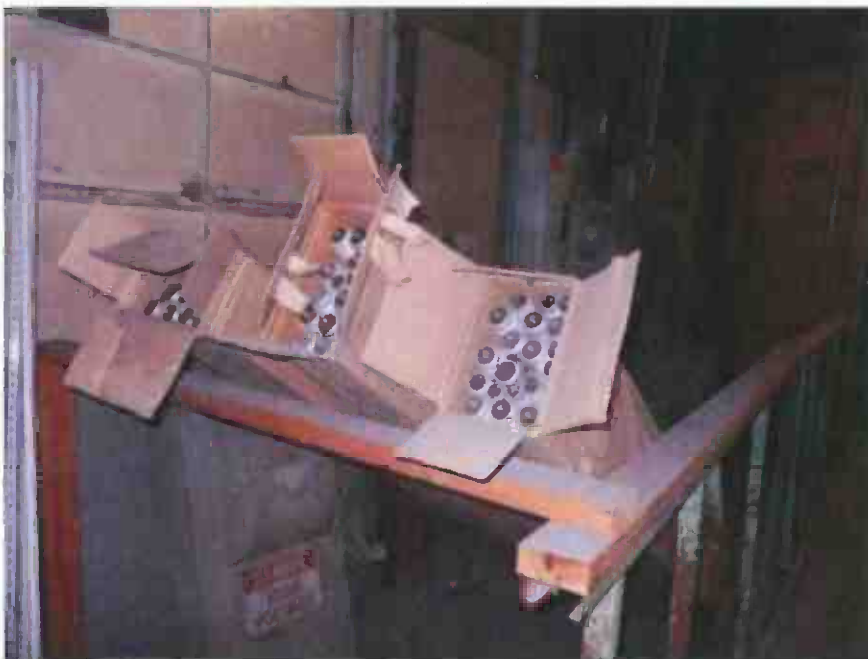
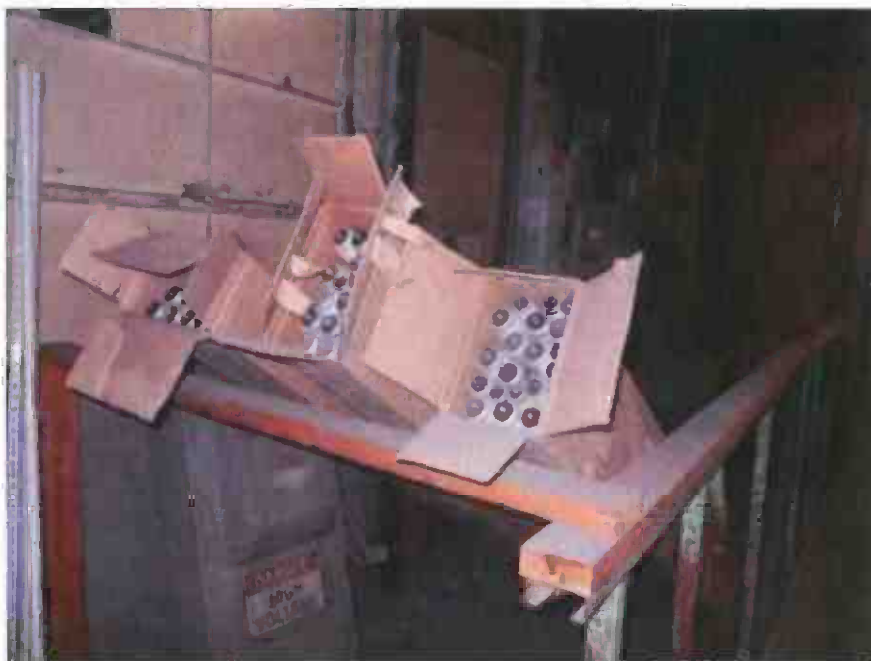
**Disk Number** 1  
**Photo Number** 16  
**Photo Filename** DSCN0306.jpg  
**Date/Time** 6/5/2012  
1:46:10 PM  
**Photographer** Jamie Paulin

At the time of the inspection, Warsaw was storing used fluorescent light bulbs in three open containers, which did not contain the proper required labeling.

At the time of the inspection, Warsaw was storing used fluorescent light bulbs inside of three containers that did not include an accumulation date. Warsaw did not have another way to demonstrate the length of time that the universal had been accumulated from the date it became a waste.

Used fluorescent light bulb storage. The boxes were open and there was no proper labeling and no date of accumulation associated with the used lamps.

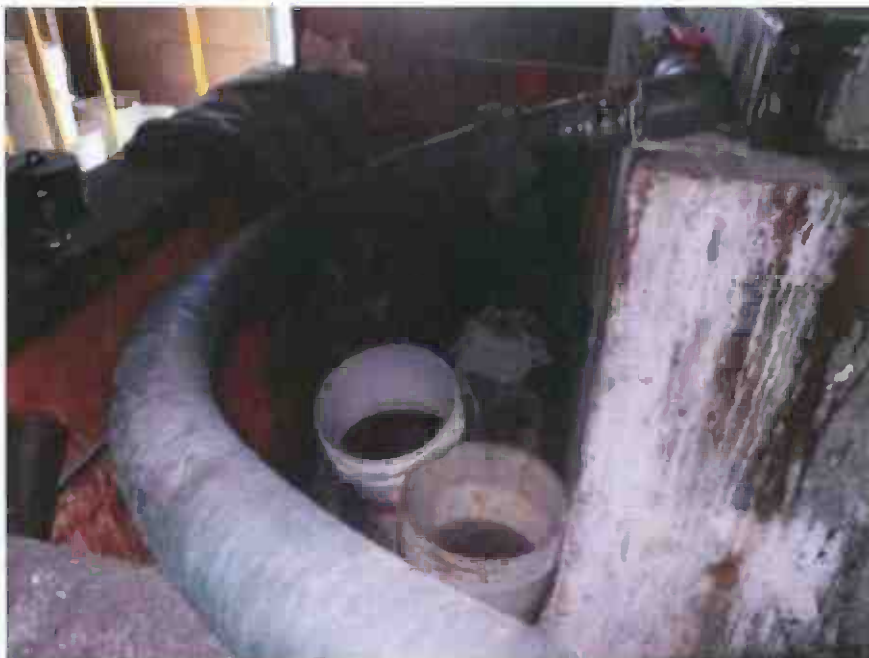
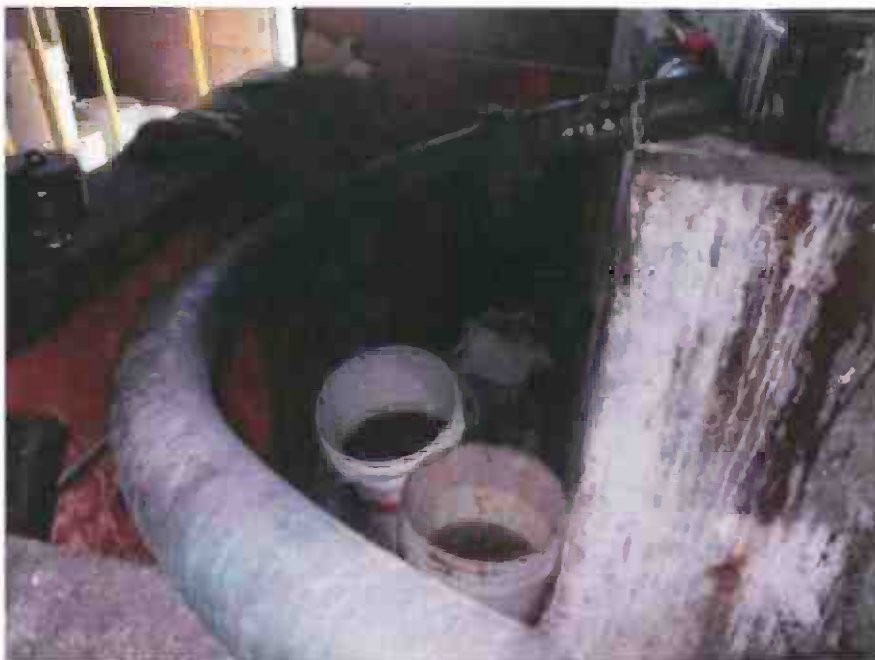
- In addition, several 5-gallon buckets, located in the containment areas of the storage and staging tanks, were not marked with either the words, "Hazardous Waste," or with other words identifying the contents of the containers.

We then proceeded to the Tank Storage and Staging Area of raw materials. The tank storage area was labeled as, "Hazardous Material." However, several open buckets containing material were being stored within the secondary containment area of this storage area. The buckets did not contain any type of labeling to identify the contents. *See*, photographs 17, 18 and 19.

Open buckets were being stored in the containment areas of the storage and staging areas. The buckets did not contain any type of labeling to identify the contents.
