UNITED STATES ENVIRONMENTAL PROTECTION AGENCY  
REGION 5  
77 WEST JACKSON BOULEVARD  
CHICAGO, IL 60604-3590

Re: Notice of Violation  
RCRA Compliance Evaluation Inspection – Warsaw Chemical Co. Inc.  
EPA I.D. No.: IND 005 430 244

The purpose of the inspection was to conduct an un-announced Follow-Up Inspection (FUI) at the Warsaw Chemical Co. Inc. (Warsaw), located at 390 Argonne Road, Warsaw, Indiana. The FUI was to examine Warsaw's management of its Resource Conservation and Recovery Act (RCRA) regulated waste, by the U.S. Environmental Protection Agency, after entering into an agreement, a Complaint and Compliance Order, with EPA on September 28, 2007, based on violations found during a June 8, 2006 inspection.

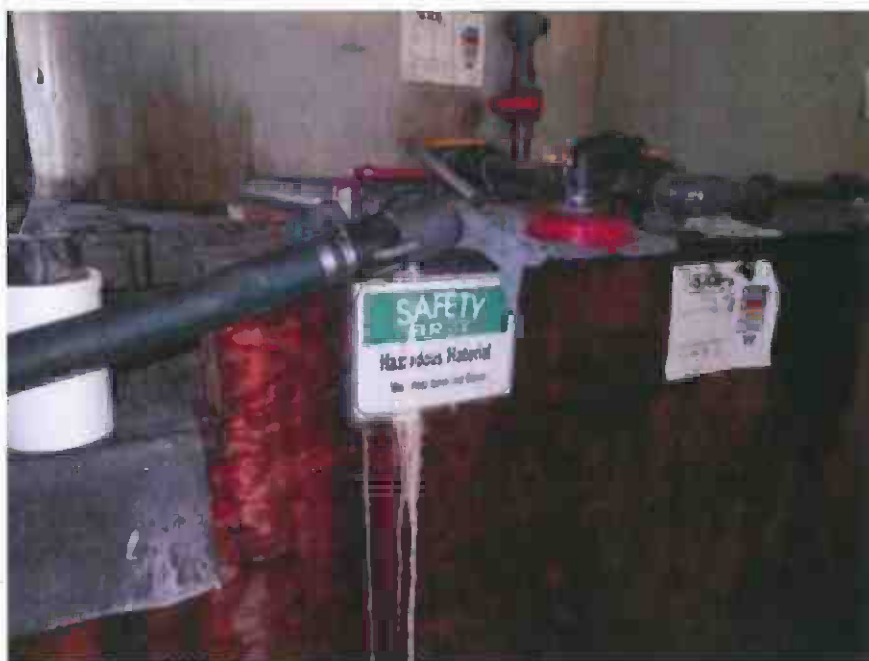
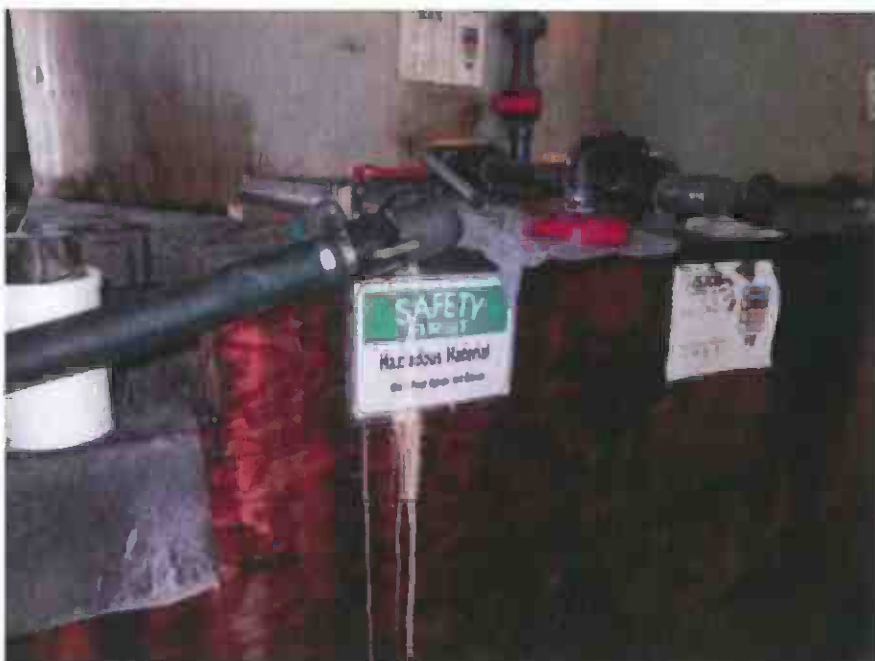
**Disk Number** 1  
**Photo Number** 18  
**Photo Filename** DSCN0308.jpg  
**Date/Time** 6/5/2012  
1:50:10 PM  
**Photographer** Jamie Paulin

We then proceeded to the Tank Storage and Staging Area of raw materials. The tank storage area was labeled as, "Hazardous Material." However, several open buckets containing material were being stored within the secondary containment area of this storage area. The buckets did not contain any type of labeling to identify the contents. *See*, photographs 17, 18 and 19.

The product tank storage area was labeled as, "Hazardous Material." The open 5-gallon buckets were being stored inside of this wooden wall - the secondary containment area.

- I stated that Warsaw should manage their small containers better. I explained that they need to keep all containers closed, when not adding or removing waste, and that they should label the containers with either the words, "Hazardous Waste," or with words identifying the contents.
- I also recommended that Warsaw properly store and label the universal waste, the used fluorescent light bulbs. I stated that used fluorescent light bulb containers need to be closed and properly labeled. Lastly, I explained that Warsaw also needs to be able to associate a date of accumulation with the used lamps.

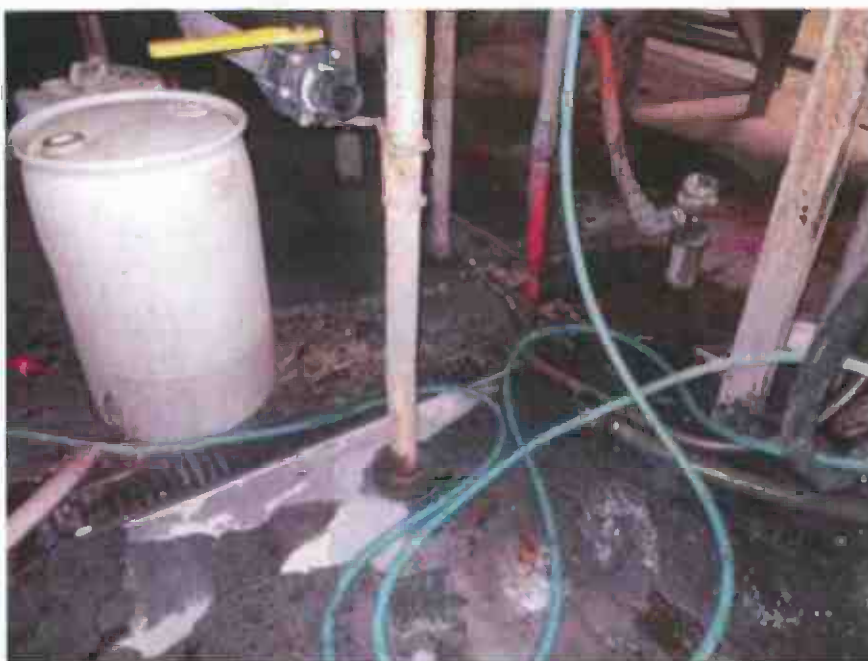
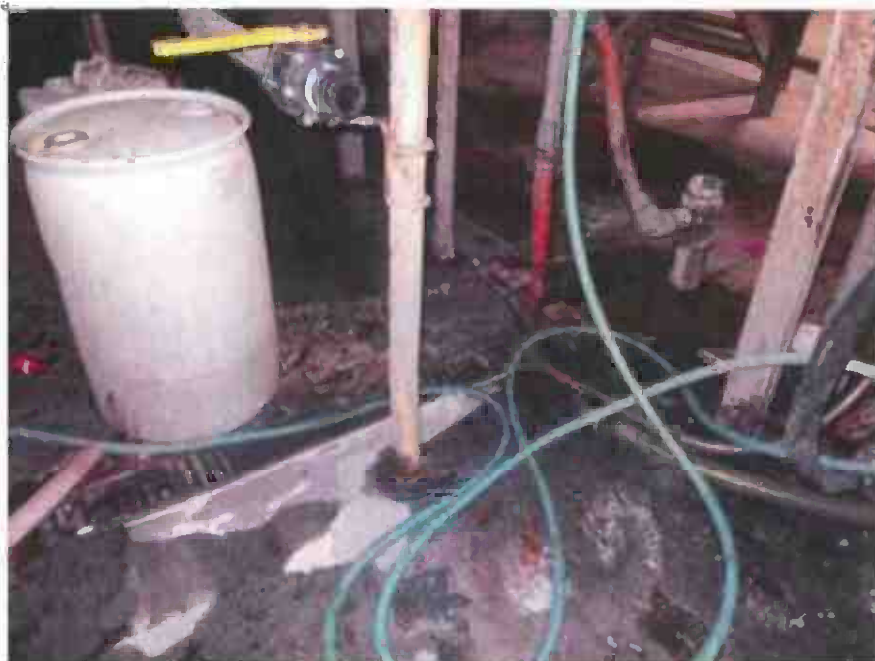
**Disk Number** 1  
**Photo Number** 20  
**Photo Filename** DSCN0310.jpg  
**Date/Time** 6/5/2012  
2:04:54 PM  
**Photographer** Jamie Paulin

At the time of the inspection, hazardous constituents were being stored on the floor underneath the waste water treatment unit. The floor was corroded in the vicinity of a grated pit, showing that the material that was located on the floor was causing significant damage to the floor and to the pit.

Lastly, I inspected the WWTU. The WWTU was elevated on a platform and the floor located under the unit was corroded. Several hoses and pipes were in disarray and were difficult to follow. Mr. Mike Marion, WWTU Supervisor, explained to us that Warsaw has a POTW permit to discharge. They treat waste water in the small tanks, adding caustic to adjust the pH. A sump is used to pump the water from the tanks to the discharge pipe. The solids collected from the WWTU are non-hazardous and are shipped to Action Environmental. Mr. Marion also stated that Warsaw was planning on renovating the floor of the WWTU at some point in the near future. *See*, photographs 20 through 22.

Floor located under the WWTU. The floor was corroded and hoses and pipes were difficult to follow.

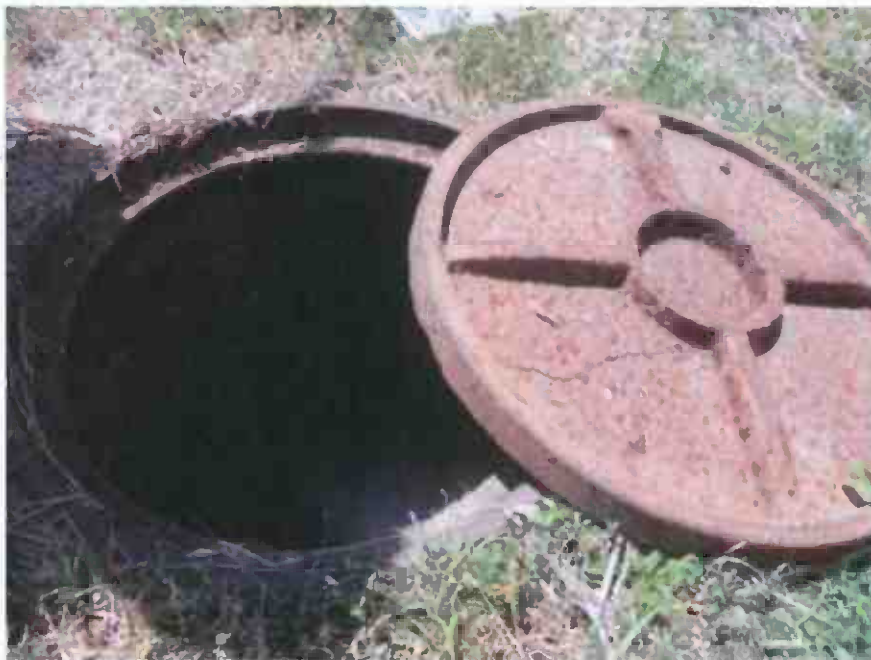
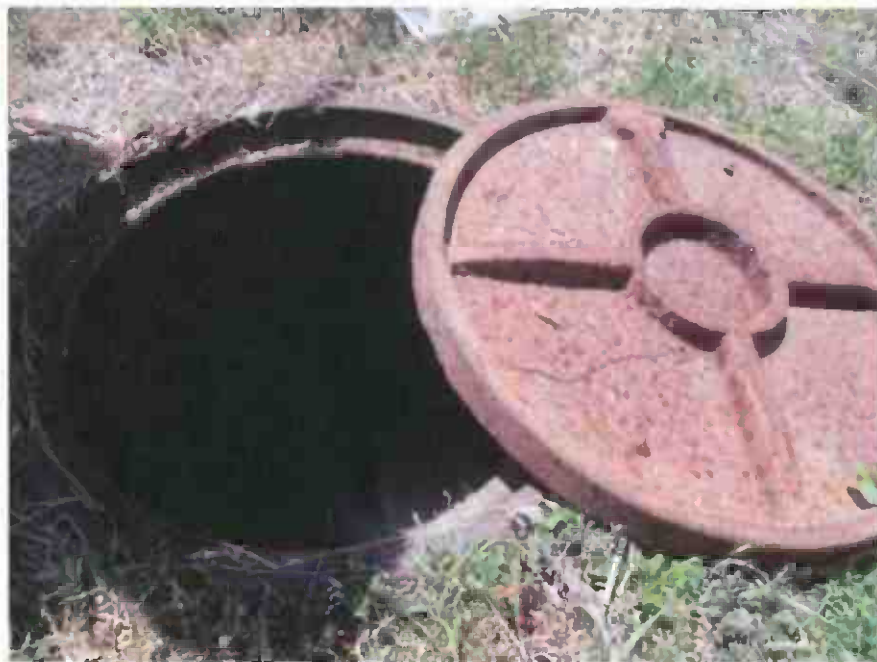
WWTU discharge pipe. Located outside the facility on the East side.

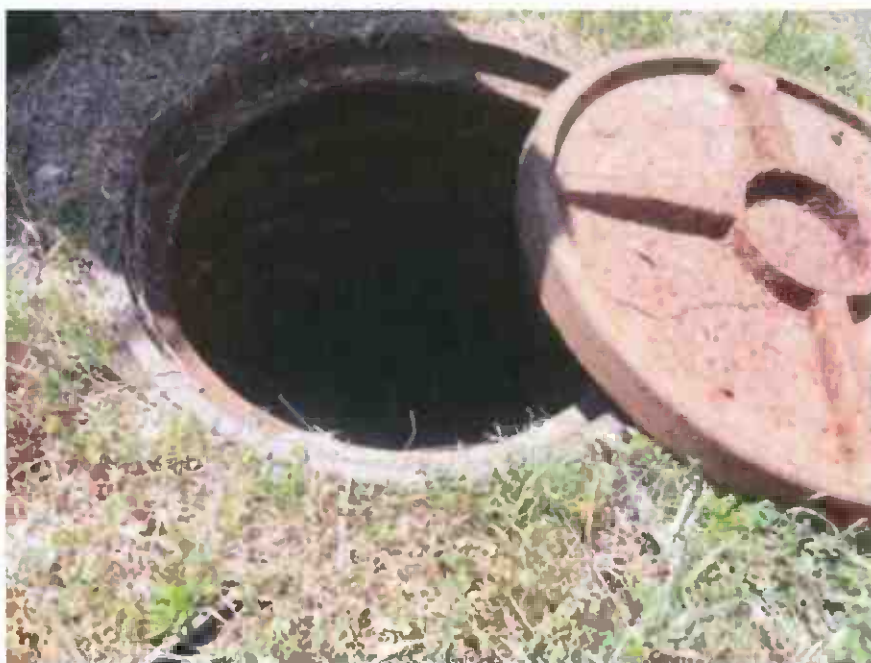
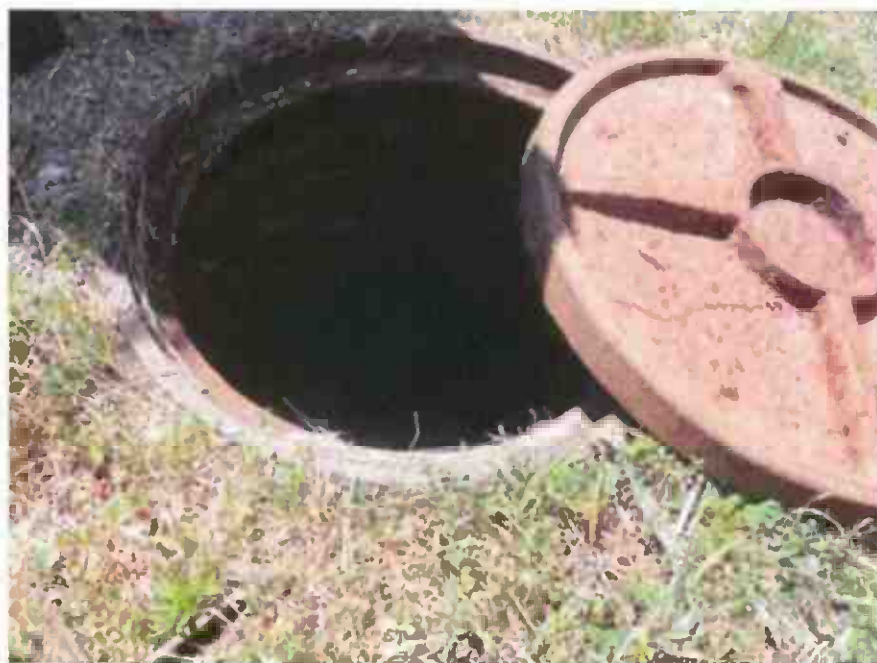
**Disk Number** 1  
**Photo Number** 22  
**Photo Filename** DSCN0312.jpg  
**Date/Time** 6/5/2012  
2:07:38 PM  
**Photographer** Jamie Paulin

WWTU discharge pipe. Located outside the facility on the East side.
