Re: Violation Letter

Pilkington North America Inc.

Type of Inspection: Compliance Evaluation Inspection

# INDUSTRIAL/HAZARDOUS WASTE INSPECTION REPORT

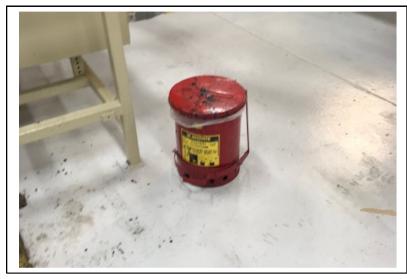
Twelve total 5.3-gallon contamined PPE waste (D001,D035) containers were not properly labeled with the words "Hazardous Waste" located in Cells 1-10, CIVIC, and Clip Line.

Number	1
Description	One 5.3-gallon satellite container of contaminated (D001, D035) waste without the proper words "Hazardous Waste" located in Cell 5.
Photographer	Celeste Marroni
Facility Name	Pilkington North America Inc.
Photo Date	6/25/2019
Others	Brittny Bellows

Mark all satellite hazardous waste containers with the words "Hazardous Waste" or other words that identify the contents.

Within thirty (30) days, submit to this office photos of the satellite containers with the properly labeled words "Hazardous Waste".

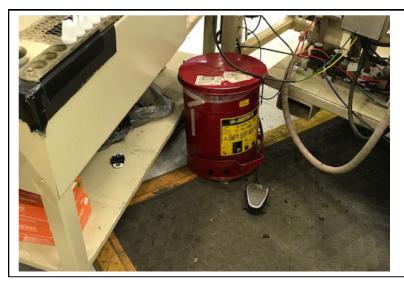
Number	2
Description	One 5.3-gallon satellite container of contaminated (D001, D035) waste without the proper words "Hazardous Waste" located in Cells 1-10.
Photographer	Celeste Marroni
Facility Name	Pilkington North America Inc.
Photo Date	6/25/2019
Others	Brittny Bellows
	·

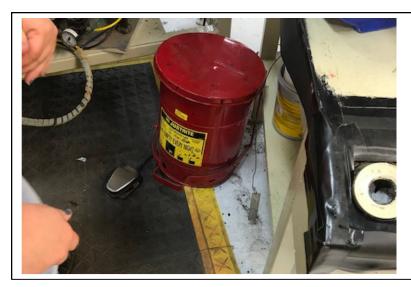
Number	3
Description	One 5.3-gallon satellite container of contaminated (D001, D035) waste without the proper words "Hazardous Waste" located in Cells 1-10.
Photographer	Celeste Marroni
Facility Name	Pilkington North America Inc.
Photo Date	6/25/2019
Others	Brittny Bellows
