Project Name: Bacon Prairie Ditch WMP

Plan Type: Watershed Management Plan

Sponsor: Tipton County SWCD

Watershed Management Plan
Bacon Prairie Ditch Watershed

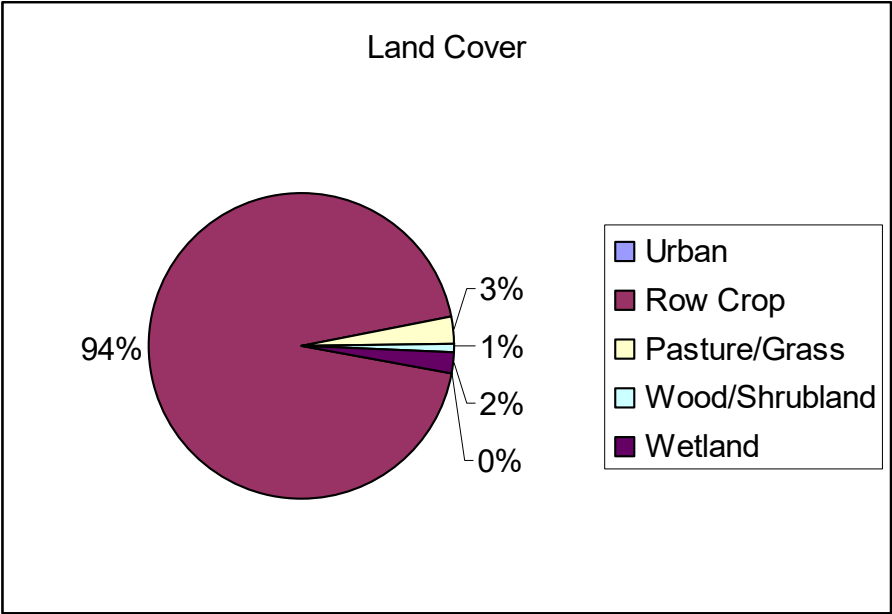
The graphics below depict the major land-cover forms and their distribution, as mapped in the watershed.

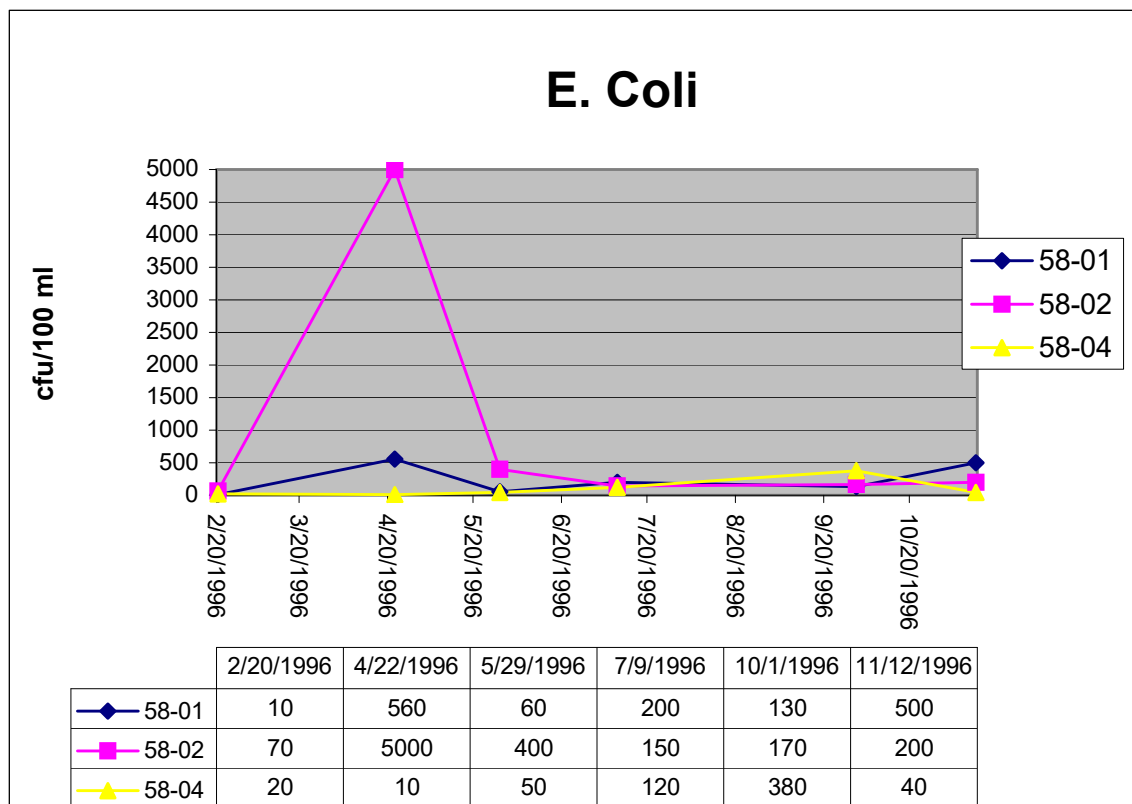
The graphic below depicts levels of E. coli bacteria collected by the study at the sample points listed above in the Cicero Creek basin.
