Baugo Creek Watershed Management

Plan—I Baugo Creek/Wisler Ditch Sub-watershed

St. Joseph and Elkhart Counties, Indiana

Final Revised Draft

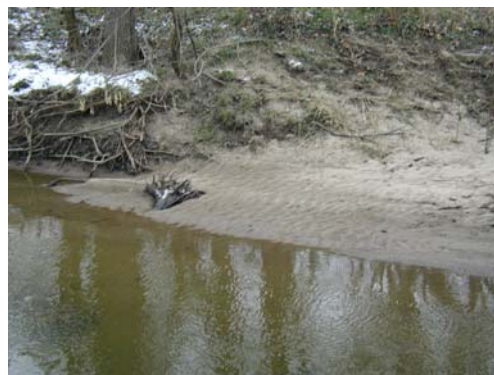
Soils in the northern portion of the Watershed characteristically have higher potential for erosion and sloughing. Evidence of erosion is present even in locations surrounded by forested land.

In addition, in some areas the banks have steep slopes, which further reduces the stability of the overall waterway.

Erosion of banks associated with natural meander of Baugo Creek

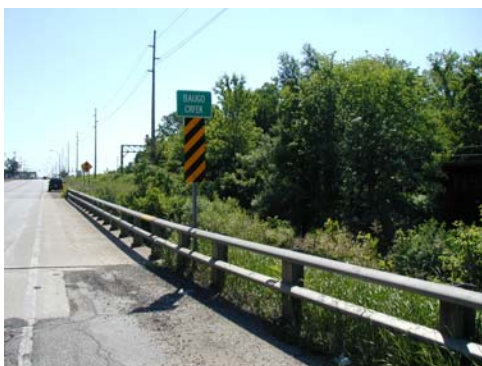
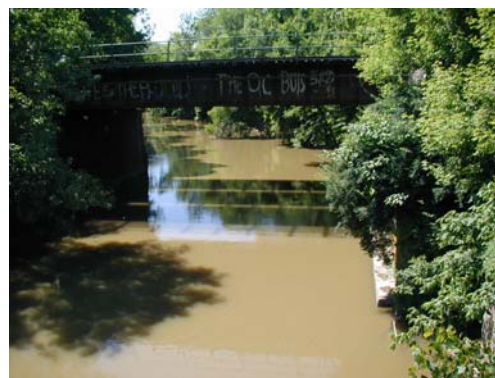
One of the leading concerns citizens expressed about the Watershed was sediment coming through the system depositing and causing flow restrictions or depositing at the discharge of Baugo Creek into the St. Joseph River.

Baugo Creek at the Lincolnway East Bridge after a 2.5-inch rain

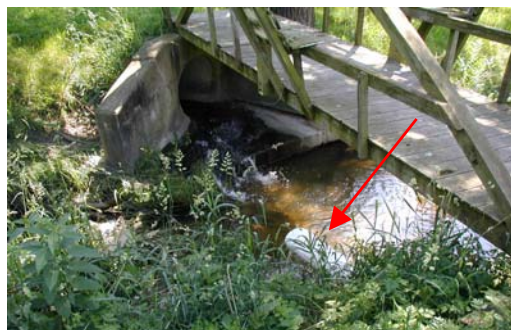
- Illicit discharges. The Town of Wakarusa has identified 99 tiles or pipes that enter the Werntz Ditch which discharges to the Wisler Ditch. A one-time sampling identified 24 sites over the *E. coli* standard. In all 45 tiles were discharging at the time of the Wakarusa study ranging in *E. coli* levels of <1 to 14,100 colonies per 100 ml. Source of the pipes and continual discharges have not been identified to date.

Discharge pipe with unknown source to Werntz Ditch

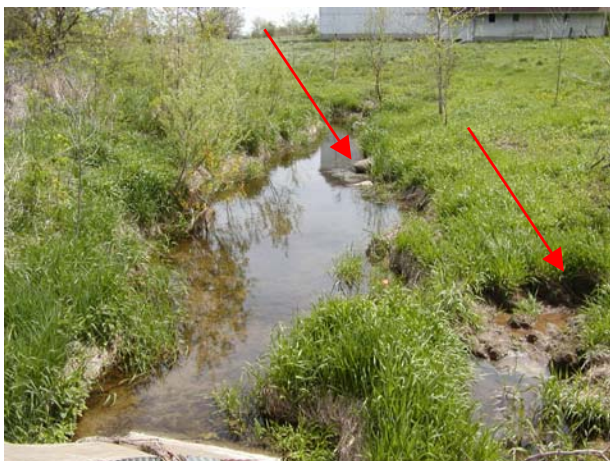
- Identification of other illicit discharges in the Baugo-Wisler Ditch Watershed. 14 of 34 sites within the sub-watershed inventory had tiles noted. Once again it is important to note that the observations were made at stream-crossings and may not represent all discharges to the neighboring waterbodies.

Tile from sheep pasture area

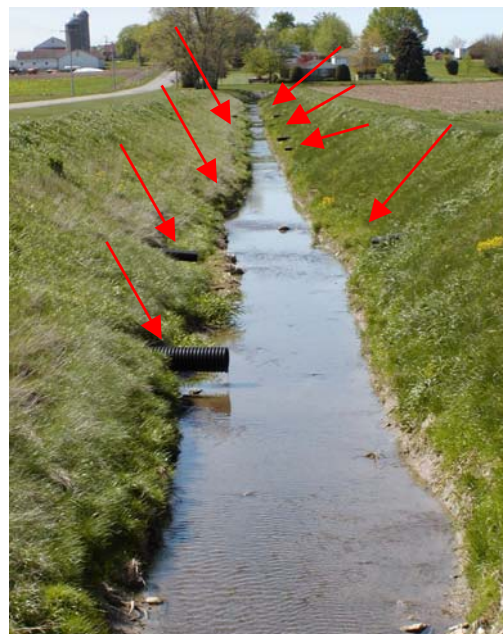
Field tiling along newly constructed ditch

Historically, soil types and landuse dictate where some tiling may be installed specifically for lowering seasonal high water tables or discharges from sump-drains associated with building footing drains. Tiling in itself does not result in elevated levels of *E. coli*. However, it may serve as a conduit in areas where manure is applied or connections are made to onsite wastewater systems. Further water quality analysis, may link potential sources of *E. coli* with some of these discharges.

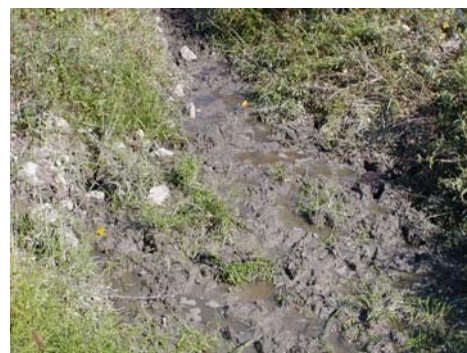
- Livestock access to the neighboring waterway, discharge of livestock operations wastes or livestock fenced to top of banks. There was at least one large livestock operation observed on the west side of Wakarusa where livestock had access to the waterway. Several smaller operations in the overall watershed were also observed. Three other operations observed had livestock fenced to the top of the bank, with no filter strips or buffers to control runoff.

Livestock prints in ditch going through pasture

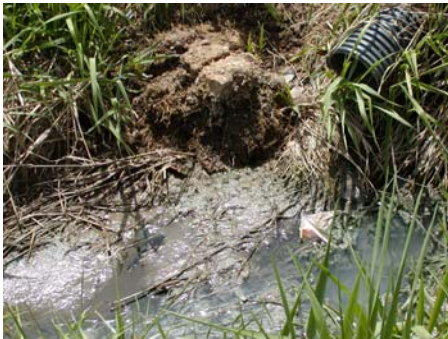
Discharge pipe from barnyard area

Additionally, tiling in at least three locations in the sub-watershed were discharging material other than groundwater.

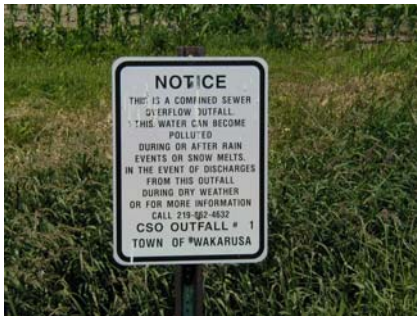
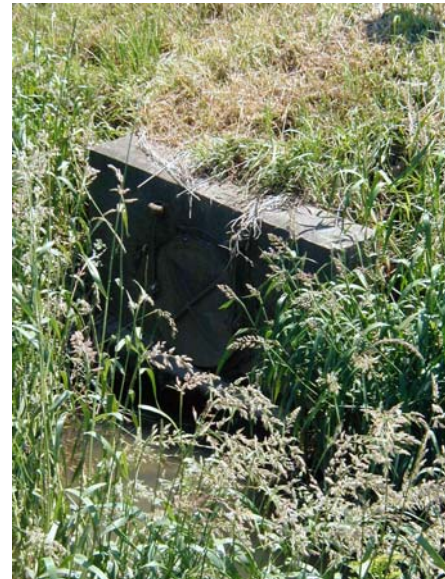
COMBINED SEWER OVERFLOW

- Combined Sewer Overflows. The Town of Wakarusa has six combined sewer overflows that discharge to Werntz Ditch eventually discharging to the Wisler Ditch. Only one consistently discharges, and the Town has currently submitted its Long Term Control Plan (June 2004) to the Indiana Department of Environmental Management.

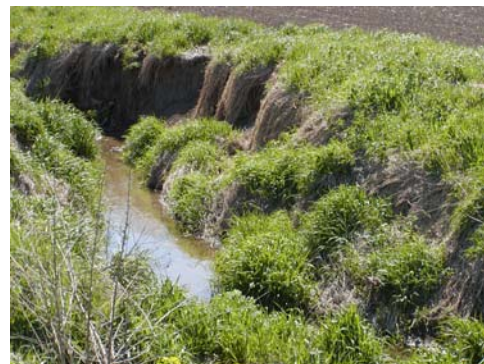
- Bank erosion and lack of stream buffers. Erosion was observed at seventeen stream-crossing sites evaluated in the Wisler Ditch portion of the Watershed. Erosion in a portion of the watershed is a function of steep banks and soils in some portion of this watershed. As a result complete elimination of erosion may not be possible. Stabilization and decreased deterioration through buffering may reduce increased breakdown of banks, since actual rehabilitation or restoration is difficult.

Sloughing banks

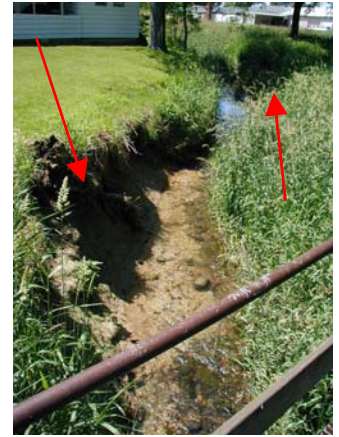
Patches of erosion in the watershed as small as this picture are seen throughout the watershed and contribute a cumulative amount of sediment.

Erosion and bank sloughing
along Wernitz Ditch

$$15 \text{ ft.} \times 2 \text{ ft.} \times 0.5 \text{ ft.} \times .04 = \mathbf{0.6 \text{ tons of sediment}}$$
