Project Name: Conns Creek WMP

Plan Type: Watershed Management Plan

Conns Creek Watershed Management Plan

**Prepared for Conns
Creek Watershed
June, 2003**

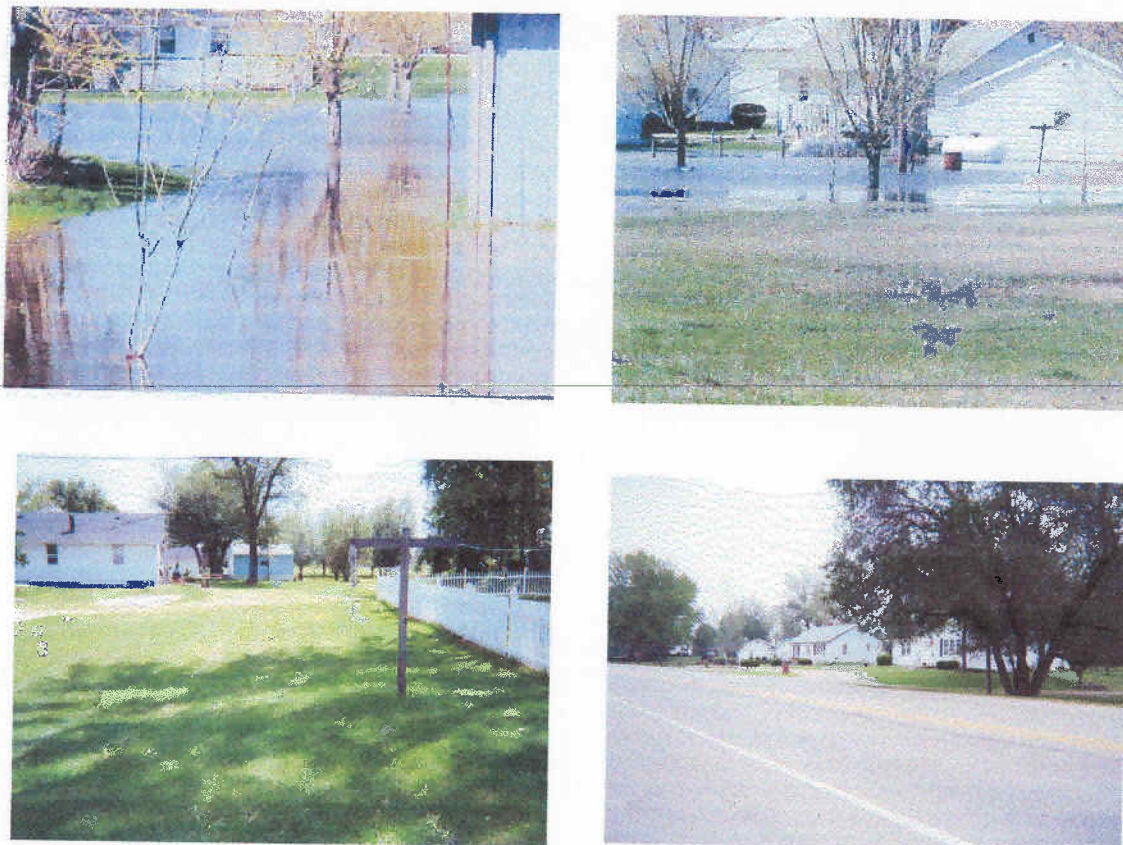
Homer residents accomplished their own mini project during this time frame. During the spring of 2002, the watershed area along with the entire two-county area was inundated with twenty inches of rain. The town of Homer relied on an antiquated tile system to remove storm water and septic system drainage to Mud Creek. Homeowners were specifically invited by letter and general postings to attend a public meeting with the steering committee to discuss their situation. Homer residents knew it was important to drain the flood water to reduce property damage. Working together as private citizens, the homeowners were able to finance and replace damaged/plugged tiles throughout the town and remove standing water for individual property owners. It was discovered that the septic systems were tied into these drainage tiles, allowing the effluent to directly enter Mud Creek. **Figure 4.** illustrates the extent of the standing water problem in Homer and the resulting change in the landscape following the repairs.

Figure 4. Before and after pictures of Homer, Indiana, cooperative drain repair project.

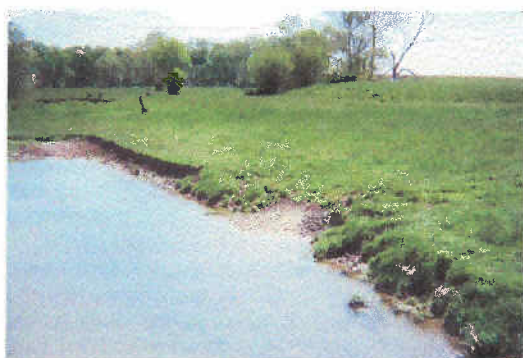
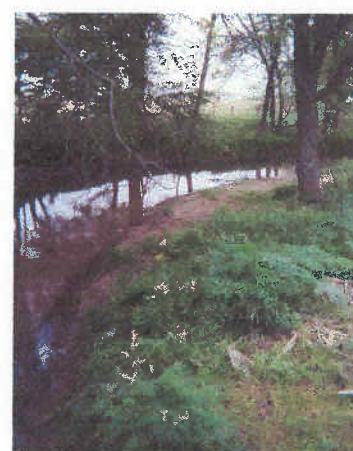
Figure 9.

Livestock access for watering along the stream is one of the sources of erosion of stream banks in livestock pasturing areas. As the livestock enter the stream, their access is generally down the slope and directly into the water. These bank sections tend to be less steep in slope, but are subject to repeated erosion by livestock in the adjacent pasture. Fencing to restrict livestock access, along with stabilizing the banks by reseeding, would improve the stream bank stability in a wider area. The pasturing of livestock along the stream is minimal and localized. There is one active location and one inactive location where livestock have access to the stream. However, as evidenced in **Figure 9.**, the evidence of bank erosion is especially prevalent in these areas.

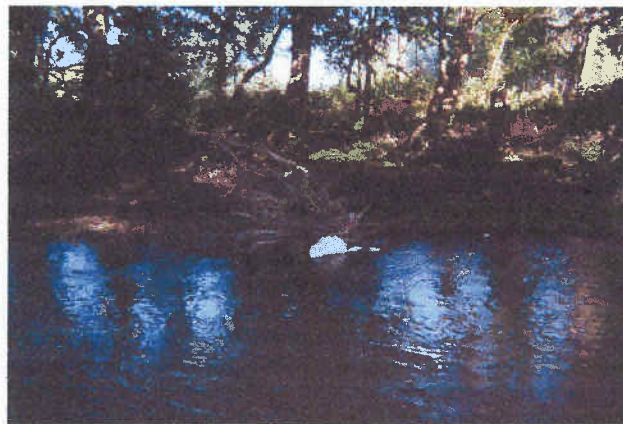
Figure 12.

As a trash problem, the practice of dropping the old bridge directly into the stream has been addressed under the streambank erosion and sedimentation section. However, these concrete pieces are wastes, but could be used for stabilization of stream banks in the area around the bridges. Trash was also inventoried as in **Figure 12.** along Conns Creek between Middletown and Waldron. This trash was estimated at being at least ten to fifteen years old. There is no evidence of new trash being added.

These remaining concrete pieces that restrict the flow of water underneath the bridge contribute to the sediment problem in the stream. The county has been approached about relocating the pieces to the stream bank on three bridges in the watershed. These concrete pieces would help conserve the integrity of the bank and prevent further erosion around the bridge area.

Because of the estimated age of the trash observed in the stream, dumping is not still occurring in the area. Removal of the existing trash is the only issue that needs to be resolved in this area. There are two major trash sites that need to be cleaned up.
