Project Name: Big Pine Creek

Plan Type: Watershed Management Plan

Big Pine Creek and Mud Pine Creek Watershed Management Plan

HUC 0512010803 and 0512010804

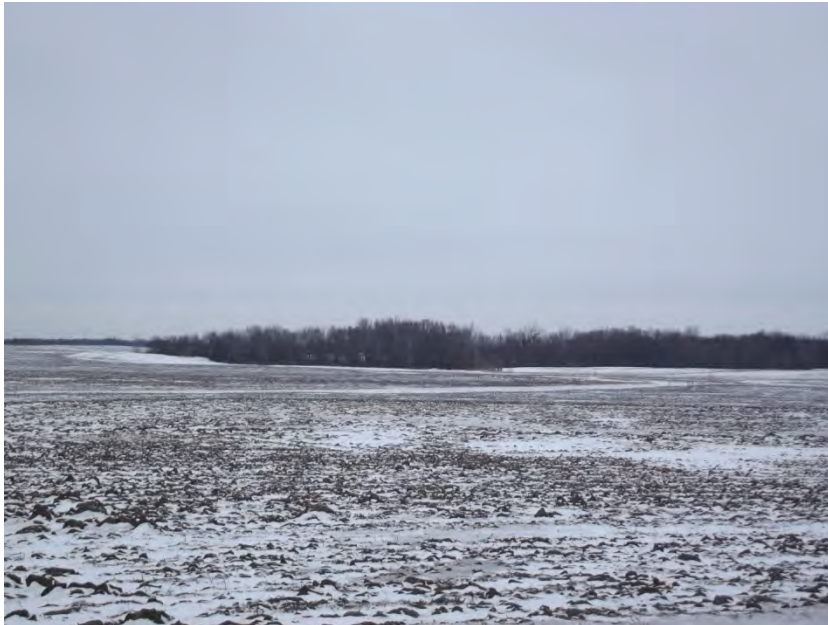
Typical tillage in the watershed.

The amount of tilled fields observed during the windshield survey in spring 2014 aligns with the 2013 cropland data for Benton County (10% no-till corn and 65% no-till beans) and Warren County (6% no-till corn and 50% no-till beans). However, in the fall of 2013 many tilled bean fields were observed, which is evident in the soil-covered snow in fields and on ditch banks (see photo below). Fencerows in this open and slightly sloping watershed are critical for providing habitat and reducing wind erosion. The few remaining fencerows may be threatened if center pivot irrigation becomes more intense in the watershed. With 7% of the watershed in forest land cover and only 2% in wetlands several natural filters are missing and the watershed experiences a lot of flashiness in water volume and velocity.

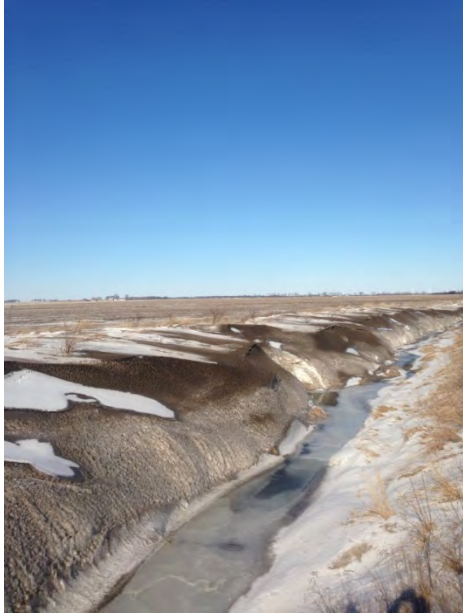
The result of wind erosion on a tilled field in the watershed; proof that windbreaks and cover crops are a needed conservation practice.

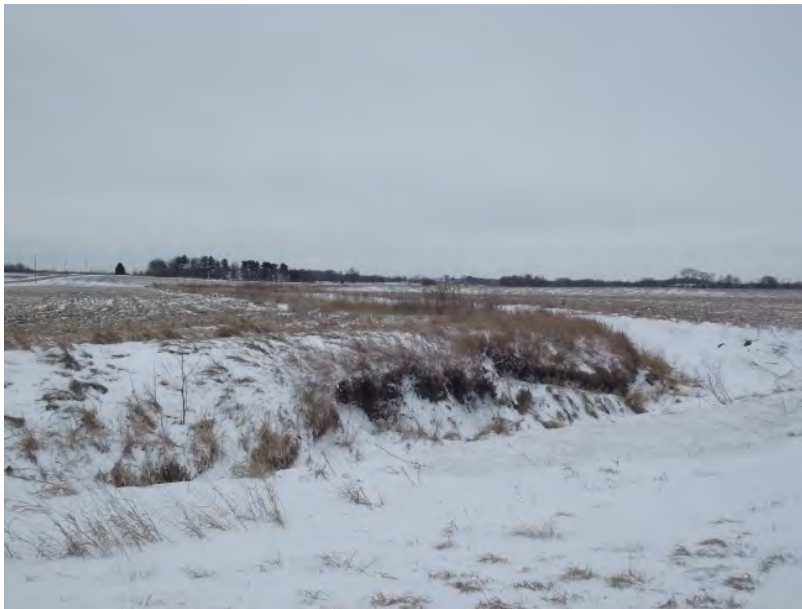
Typical bank failure as a result of water flashiness.
