Project Name: Deep River - Portage Burns Waterway WMP

Plan Type: Watershed Management Plan

Deep River-Portage Burns Waterway Watershed Plan

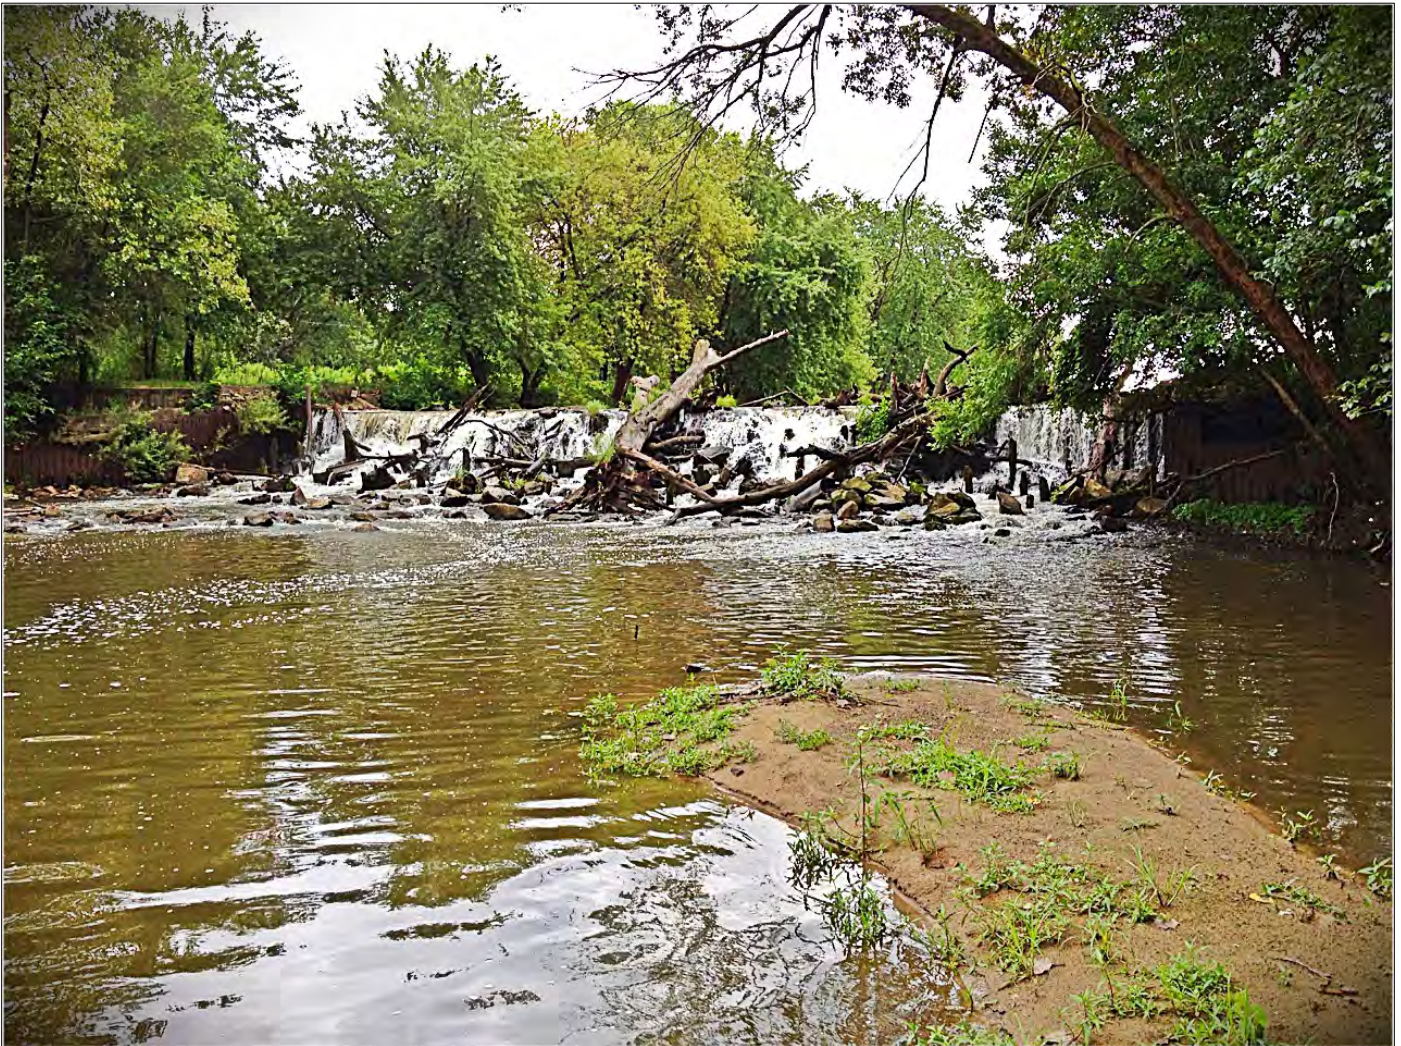
Figure 24 Deep River Dam

Another dam of particular interest in the watershed is the Deep River Dam (State ID # 45-1). It is located in Lake Station approximately 1/3 mile downstream from where Deep River joins the West Branch of the Little Calumet River (Figure 25) and is shown in Figure 24. The dam structure consists of a sheet pile wall crossing the channel with remnants of a rock-filled wooden crib structure. Crushed rock has been placed immediately downstream of the sheet pile wall in an effort to stabilize the channel and prevent erosion. The dam impounds approximately 10 feet of hydraulic head during normal river stage conditions. According to the Deep River Flood Risk Management Plan (Section 2.7.14), the dam controls the normal water level of Deep River up to 37th Avenue, a distance of nearly 6 miles. Due to the deteriorated physical nature of the dam, if a complete failure were to occur, it would likely be due to washout at the abutment ends or seep through the sheet pile wall.
