Duck Creek Watershed Management Plan

Final Report

February 2008

Williams Creek Consulting, Inc.
Babeca Building
919 North East Street
Indianapolis, IN 46202
(317) 423-0690

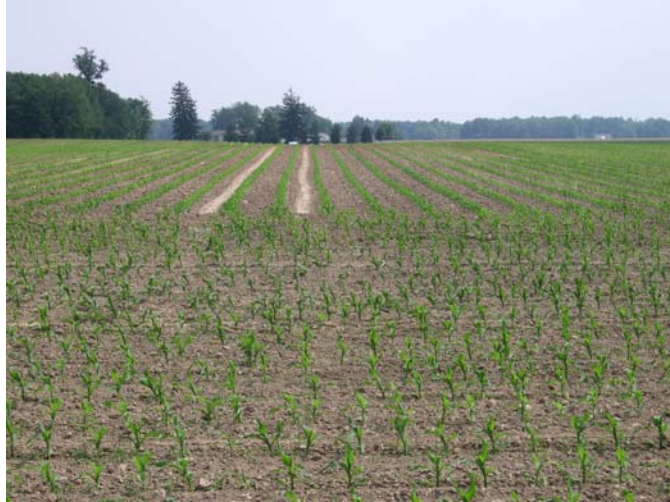
Figure 26. Conventional Tillage

Figures 23 through 25 show till trends in each of the three Duck Creek Watershed counties for 2004 (*Indiana State Department of Agriculture Division of Soil Conservation*). The windshield survey conducted as part of preparing this watershed management plan concurs in general with the 2004 tillage transect data. Example photos of different tillage practices are shown on **Figures 26 through 28**.

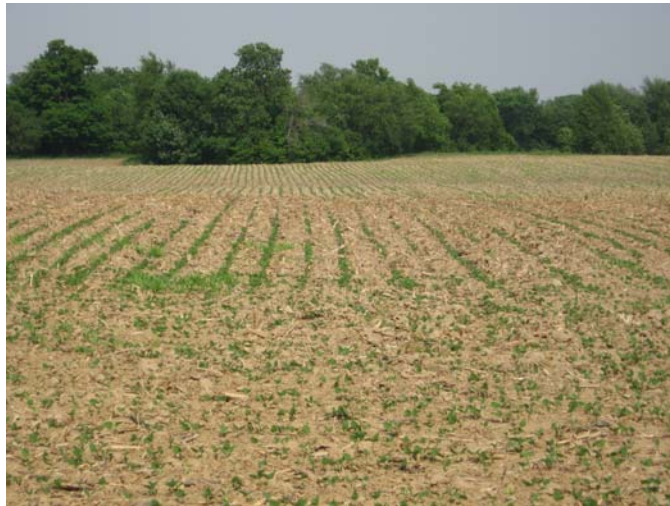
Figure 27. Mulch Tillage

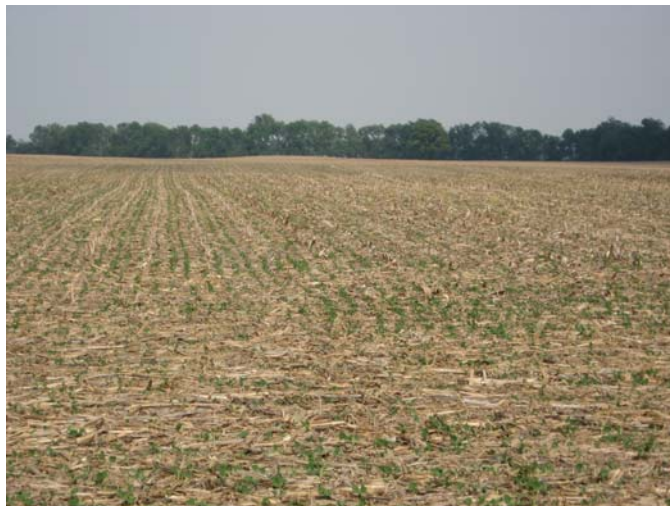
Figure 28. No-Till

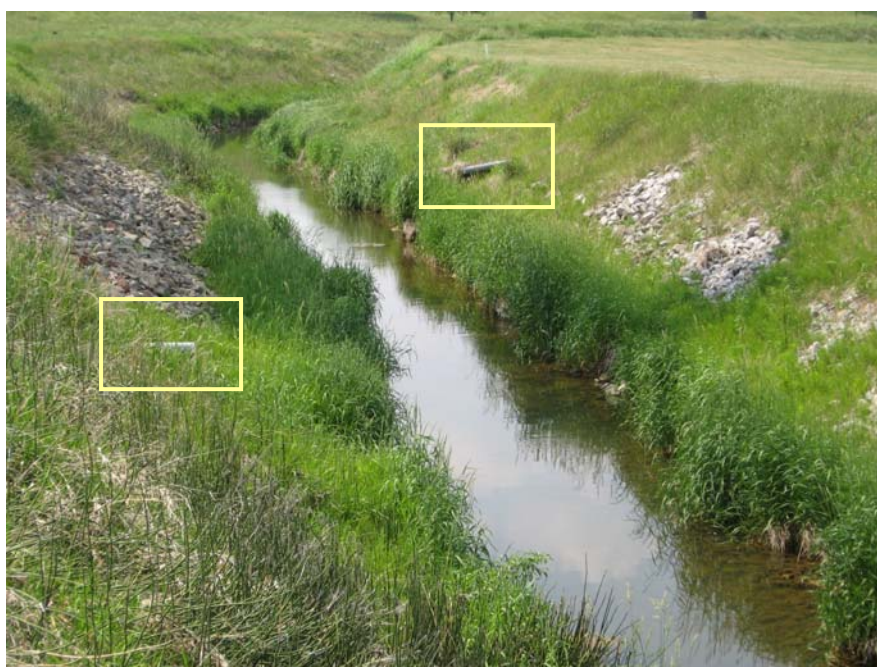
Figure 29. Tile Drains in the Duck Creek Watershed

Tile drains have been determined to affect water quality in many parts of Indiana. Newer tile drains usually consist of perforated, flexible tubes, while older tile drains are commonly clay tile. Information on the number and location of tile drain systems in Indiana is not available, but agricultural experts expect that nearly all poorly drained farmland contain tile drain systems (Schnoebelen et al., in press). Based on the majority of poorly drained soils and the heavy emphasis on agriculture in the Duck Creek Watershed, it can be assumed that most of the land in the watershed outside of Elwood is artificially drained. Tile drains short circuit infiltration into the soil and bypass riparian buffers, therefore transporting nutrient laden water directly to nearby ditches or streams. Tile drains can be particularly problematic to water quality if rainfall occurs shortly after the application of fertilizers or manure. Studies are being conducted that may link the hypoxic zone or “dead zone” in the Gulf of Mexico to high nitrogen loads from agricultural drainage in the Midwest to the Mississippi River. Numerous studies, including a Purdue University study, *Interpreting Nitrate Concentration in Tile Drainage Water*, have found high nitrogen concentrations in tile drains, and determined that agricultural fertilizers, manure application, conventional tillage, crop rotation, and the spacing of the tile drains all influence the amount of nitrogen entering tile drains (Bongen *et. al.*). **Figure 29** displays two tile drains outletting into a drain in the Duck Creek Watershed.

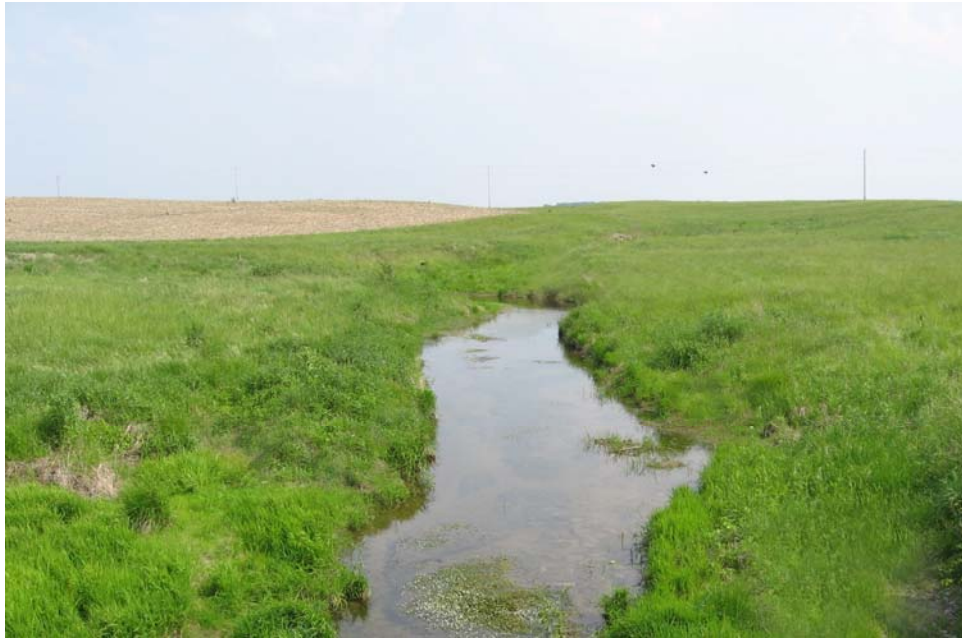
Figure 44. Adequate Grassed Buffer

Buffers are, according to The U.S. Department of Agriculture, Natural Resource Conservation Service's *Conservation Practice Standard, Filter Strip, 393A*, grassed or forested areas that extend 20 feet from either side of a stream. Buffers can also be located along ditches, roads, and contours within a field, and are an extremely effective way of slowing runoff down and filtering out potentially harmful substances such as sediment, nutrients, animal waste, and chemicals from fertilizers, pesticides, herbicides, etc. They are especially important when located along conventionally tilled fields or fields to which manure has been applied because they filter out some of the sediment, nutrients, and pathogens associated with those practices. A lack of adequate buffers has been observed in certain areas in the watershed, especially along the headwater streams of the watershed. These areas are identified in **Figure 39**. The three subwatersheds; Polywog Creek (W4), Little Duck Creek (W5), and Todd Ditch (W6); with highest percentages of inadequate buffers are the same three watersheds that have the most acres of conventionally tilled fields and Polywog Creek (W4) and Little Duck Creek (W5) also have the highest pollutant loads for TSS. These subwatersheds are the headwater reaches of the larger Duck Creek Watershed. **Table 33** shows the percent of inadequate buffers by subwatershed and **Figures 44 and 45** show examples of adequate grassed and forested buffers.

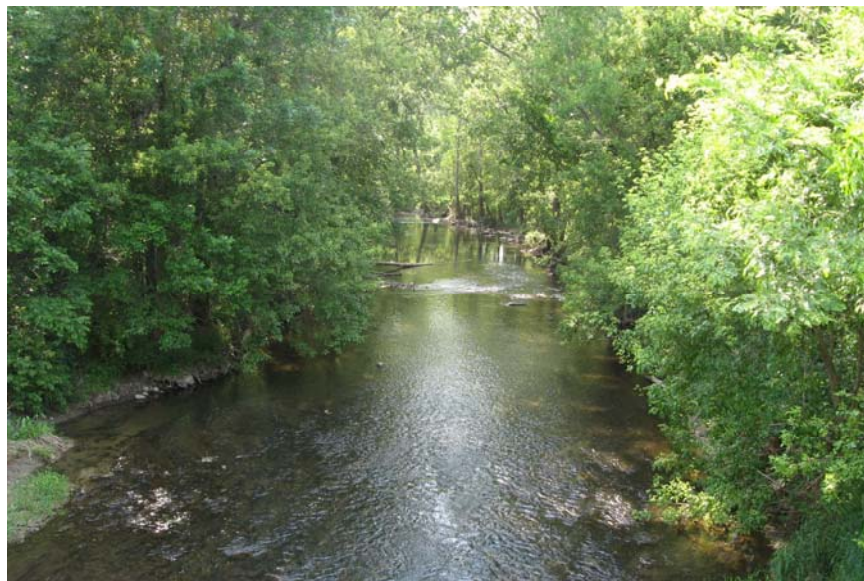
Figure 45. Adequate Forested Buffer

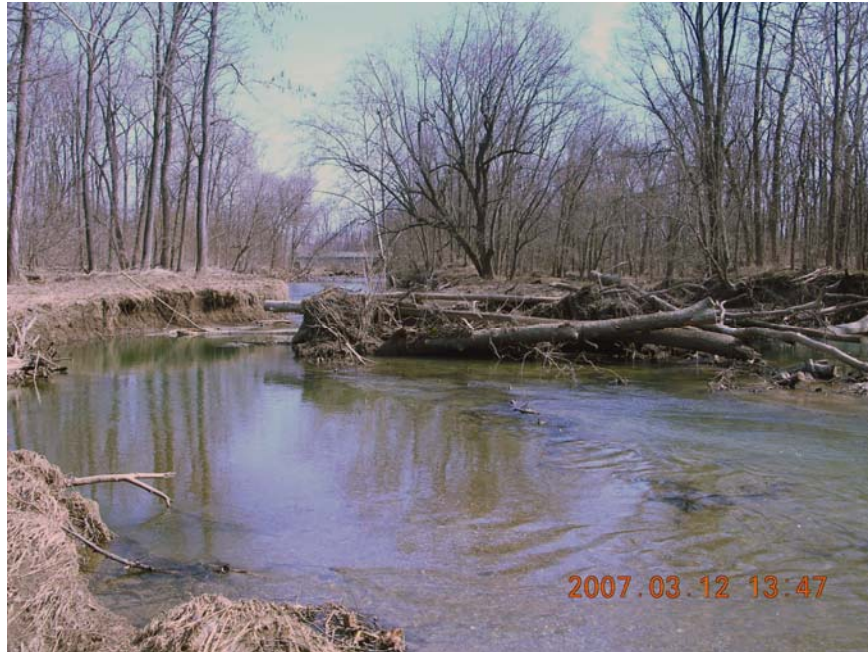
Figure 46. Log Jam and Erosion on SR 213 in the Long Branch Watershed (W1)

Stream bank erosion is occurring in several areas throughout the watershed. The erosion is more severe in the southern portion of the Lamberson Ditch Watershed along both Duck Creek and Lamberson Ditch, where large log jams are located. Typical areas of stream bank erosion range from 40 to 200 feet in length and 8 to 30 feet in height. (See **Figure 37** for location of known log jams.) **Figure 46** shows streambank erosion caused by a log jam in the Long Branch watershed (W1). **Figure 47** shows a less severe case of streambank erosion in the Lamberson Ditch watershed (W3).

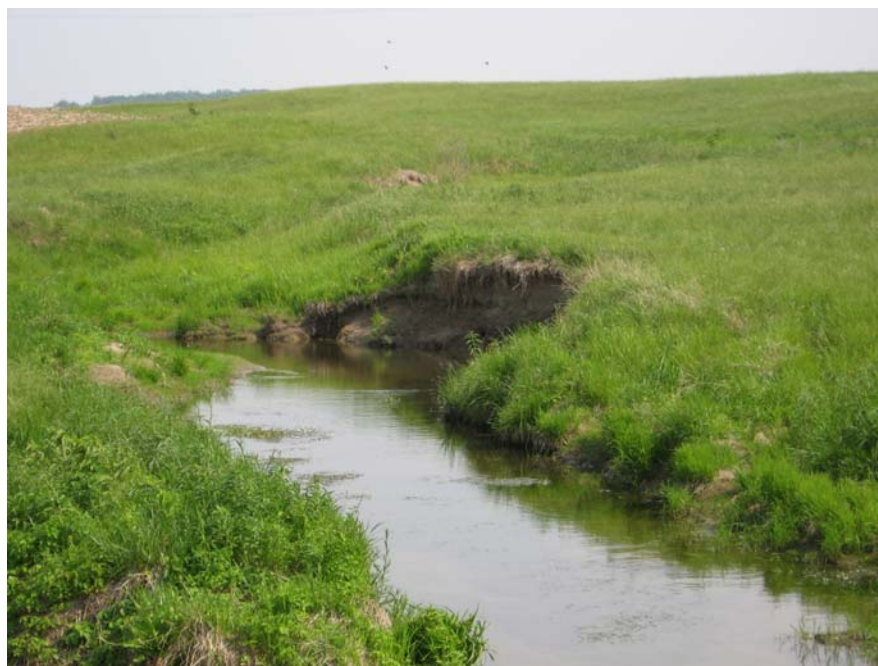
Figure 47. Streambank Erosion on Lamberson Ditch

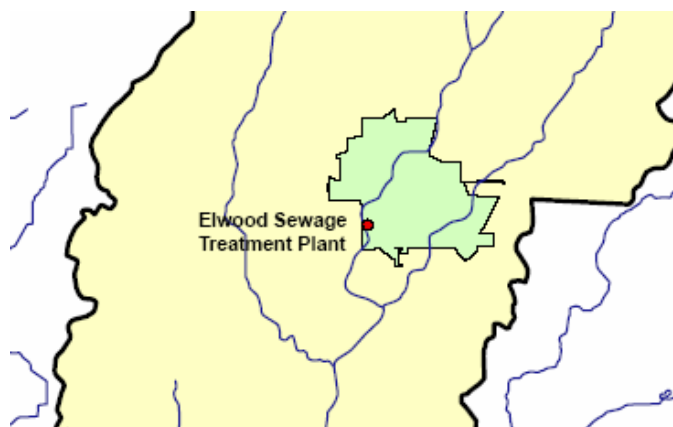
Figure 48. Elwood Municipal Sewage Treatment Plant (●) Location

The Elwood Sewage Treatment Plant (**Figure 48**) is permitted to discharge up to 3.22 million gallons per day (MGD). The *E. coli* load associated with this discharge amount was estimated in the Draft TMDL Report to be 1.52E+10 count/day (**Table 34**). This treatment plant violated the *E. coli* daily maximum effluent limit in 2001 and consequently signed an Agreed Order with IDEM (IDEM, 2005). The IDEM definition of an agreed order; Agreed Order - By statute, the Respondent has a 60-day settlement period after receiving a Notice of Violation in which to enter into an Agreed Order with IDEM. Agreed Orders contain steps the Respondent must take to comply with the law. In most cases, Agreed Orders include a fine for past violations and stipulated penalties for failure to complete future compliance steps. Agreed Orders will not necessarily require a Respondent to admit that a violation of law occurred. Fines may be lessened if the Respondent can demonstrate that mitigating circumstances existed.

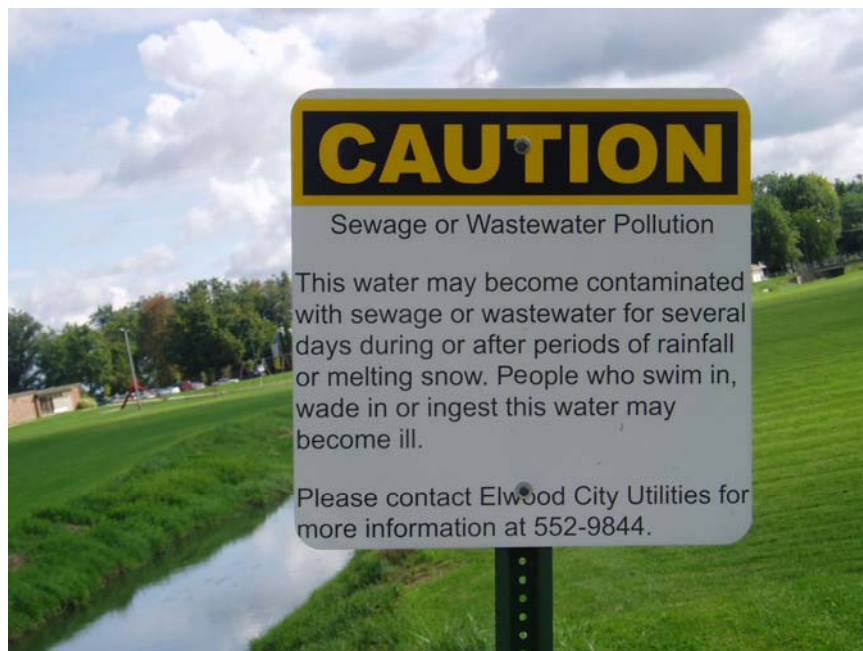
Figure 50. Sign for CSO Outfall in the Little Duck Creek Watershed (W5)

According to the 2005 IDEM TMDL for *E. coli* Report, there are 14 CSO outfalls in Elwood (**Figure 49**). A CSO is a single pipe that conveys both wastewater (domestic, commercial, and industrial) and storm water to a sewage treatment plant. A combined sewer overflow is the discharge from this system at a point before the water gets to the sewage treatment plant. Overflows usually occur during or after large storm events, when the volume of flow overloads the sewage treatment plant causing it to divert the flow directly (untreated) into the receiving water (Frankenberger, 2002). All of the samples collected under storm flow conditions as part of the TMDL study were in excess of the state standard for *E. coli*, indicating *E. coli* is correlated to storm runoff and/or CSO discharges. The *E. coli* load from the Elwood CSO Community was estimated in the TMDL Draft Report to be 2.22E+12 count/day (**Table 35**). **Figure 50** shows a sign located a CSO discharge site in the Little Duck Creek.

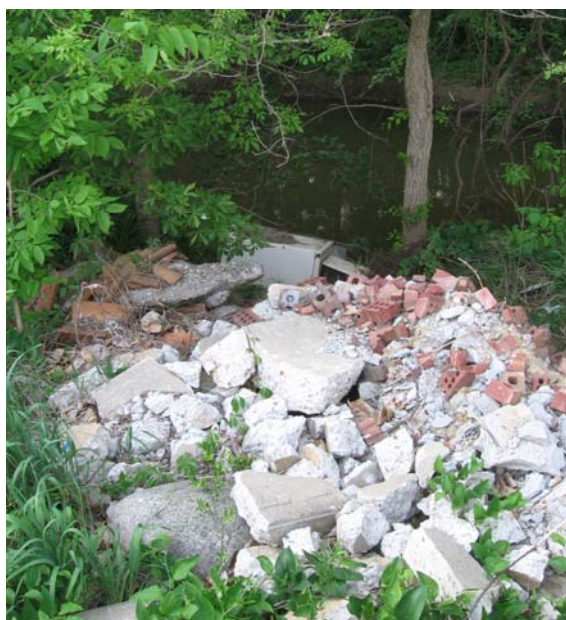
Figure 52. Dumping Site on Henry Gunn Road

Although dumping waste in waterways may not have a direct impact on water quality, it could be harmful to the stream and its habitat. Therefore, dumping waste locations have been noted and identified, but are not considered a source of the priority pollutants in this plan. Locations of dumping sites are shown on **Figure 38**, and **Figure 52** shows a dumping site in the Lamberson Ditch watershed (W3)

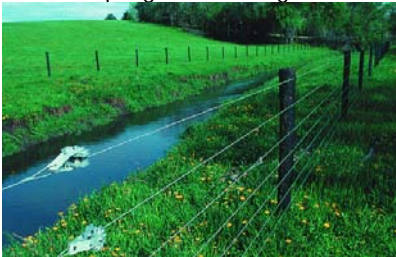
Livestock Exclusion Fencing	<p>Fencing can be installed along streams and ditches to keep livestock away from the waterways. This prevents the livestock from trampling and eroding the streambanks or from depositing waste in or near the streams.</p>

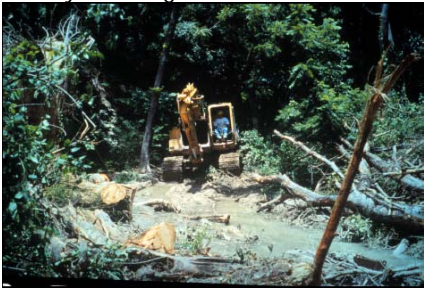
Stream Obstruction Removal	<p>Removal of unwanted or hazardous structures, vegetation, debris, or other material restores the natural flow of a waterway, usually reducing in stream erosion.</p>

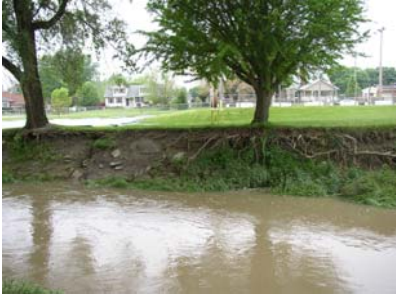
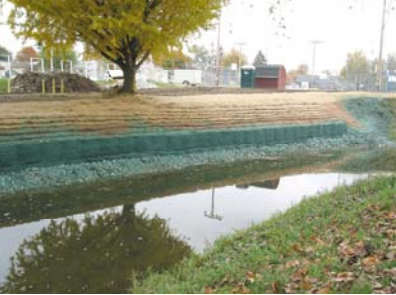
<p>USDA Natural Resource Conservation Service</p>
Streambank Stabilization	<p>Regrading or vegetating an unstable streambank reduces erosion and therefore sedimentation and may provide wildlife habitat. Any undertaking on a regulated drain or the drain easement will require permit approval from and meet the standards and specifications as published by the county surveyors' office. Other state and federal permits may be required.</p> <div style="display: flex; justify-content: space-around;">

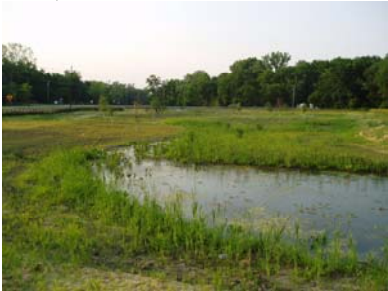
Wetland Restoration	<p>Wetlands slow water down allowing sediment, nutrients, and other contaminants to settle out. They also act as biological filters, provide wildlife habitat, reduce the risk and damage of flooding by providing overflow storage during storm events, and recharge groundwater. Wetlands have been found beneficial in reducing nutrient and <i>E. coli</i> concentrations to flowing streams (DeBusk, 1999). A study by the University of California found that wetlands reduced <i>E. coli</i> loads by an average of 73% (Atwill et al. 2007).</p>
