**Project Name:** Hogan Creek WMP

**Plan Type:** Watershed Management Plan

**Sponsor:** Dearborn County SWCD

# Hogan Creek Watershed Management Plan

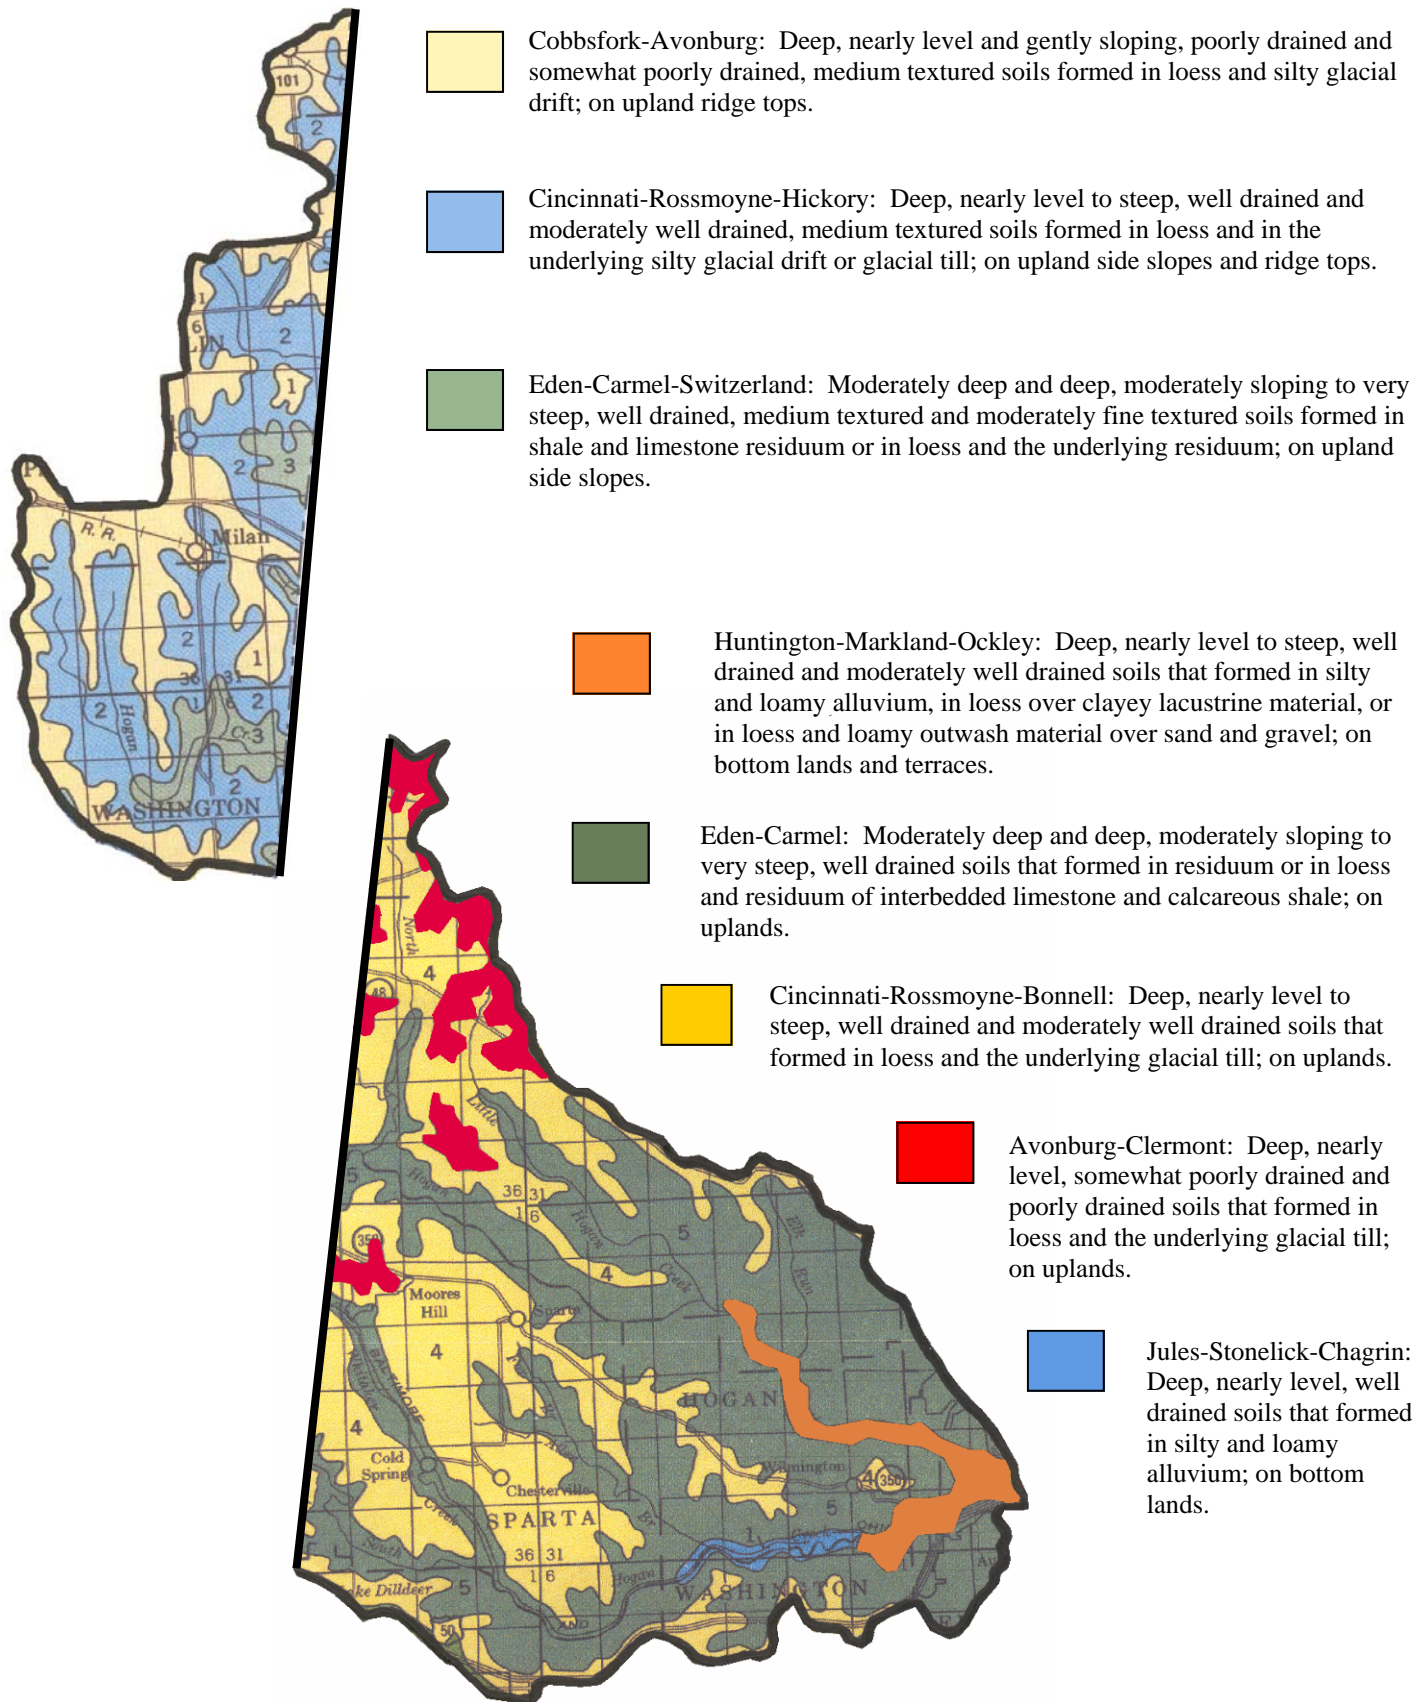
### Figure 2: Hogan Creek Watershed Soil Associations

Five soil associations in Dearborn County cover the watershed area. See Figure 2.

- Jules-Stonelick-Chargin: These soils are deep and well-drained. They are typically located on the bottom lands adjacent to streams. Although soils are generally used for cropland, flooding is a severe threat to these areas.<sup>14</sup>

- Huntington-Markland-Ockley: Huntington, Markland and Ockley soils are deep and well-drained. Huntington soils are on the lower lying areas adjacent to the Ohio River. Markland are on high terraces along major tributaries of the Ohio River. Ockley soils can be found on outwash terraces. These soils are suitable for crops, pasture, residential, and urban areas but flooding is a major hazard in the lower areas, while erosion is a problem in the hard-sloping terraces.<sup>15</sup>

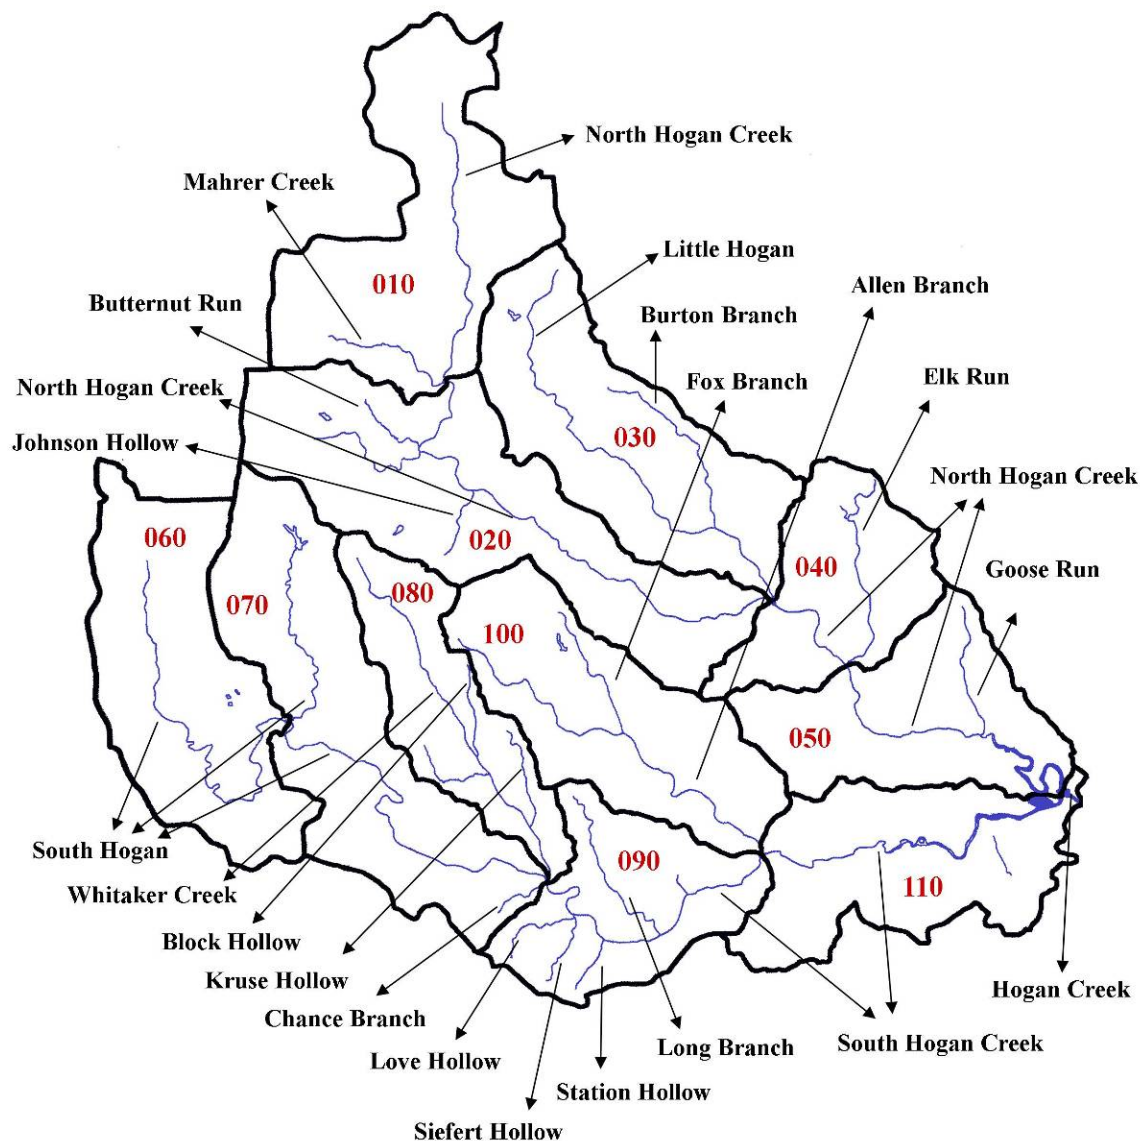
**Figure 3: Hogan Creek Watershed Hydrology**

subwatersheds. The subwatersheds include: North Hogan-Mahrer Creek (05090203040010), Butternut Run (05090203040020), Little Hogan Creek (05090203040030), North Hogan – Elk Run (05090203040040), North Hogan – Wilmington (05090203040050), South Hogan Creek Headwaters (05090203040060), South Hogan – Milan Tributary (05090203040070), Whitaker Creek (05090203040080), South Hogan – Dillsboro Station (05090203040090), Allen Branch (05090203040100), and South Hogan – Cochran (05090203040110). See Figure 3.

According to the Natural Resources Commission, Hogan Creek is a navigable waterway beginning at the Ohio River for 0.4 miles. North Hogan extends for another 4.9 miles and South Hogan extends for another 5.0 miles.<sup>20</sup>

There are two dams located in the Hogan Creek Watershed. One is located in the Dillsboro Station subwatershed, 05090203040090, at the headwaters of the Long Branch tributary. The second dam is located in the Allen Branch subwatershed, 05090203040100, in the middle of the Fox Branch tributary.<sup>21</sup>

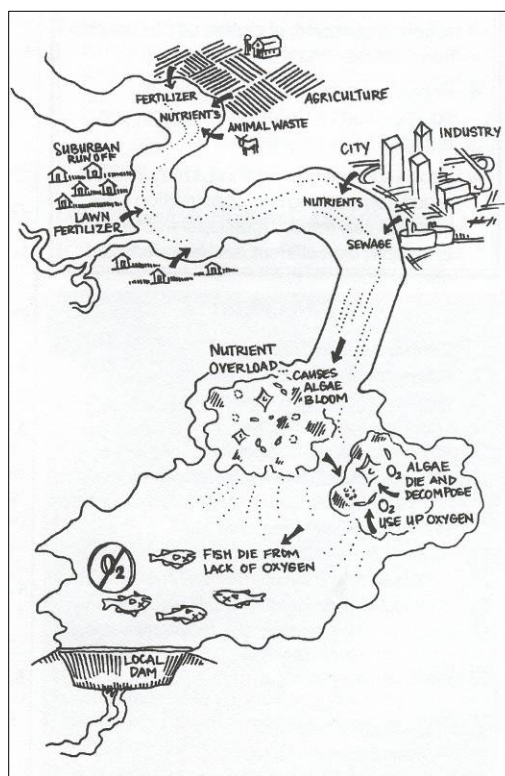
Figure 7: Process of Eutrophication

Nitrogen and phosphorus are very similar. They are both much needed nutrients which assist in plant growth, and when given too much, eutrophication can occur. There is, however, one major

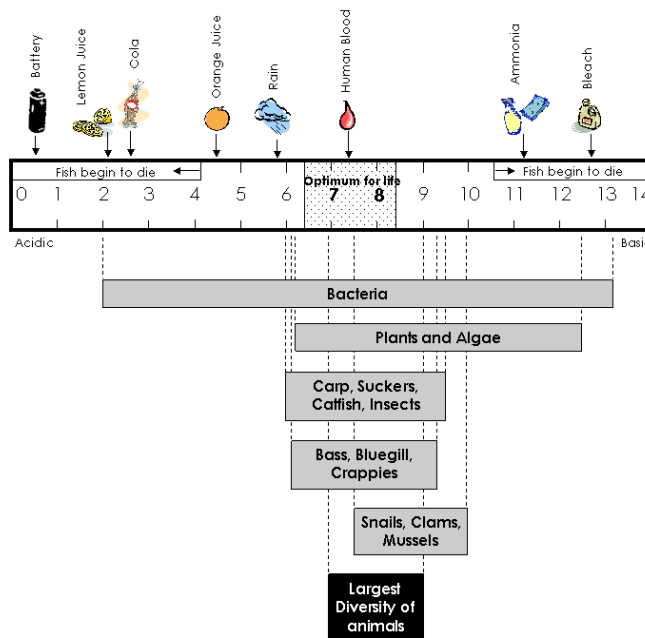
**Figure 8: Optimal pH Levels for Aquatic Organisms**

In addition, waterbodies with frequent algae blooms may have a pH range of 9 or higher because algae are removing carbon dioxide during photosynthesis.<sup>44</sup> As previously stated, raising the pH level above 8.2 puts unnecessary stress on aquatic organisms and could cause that organism to perish.

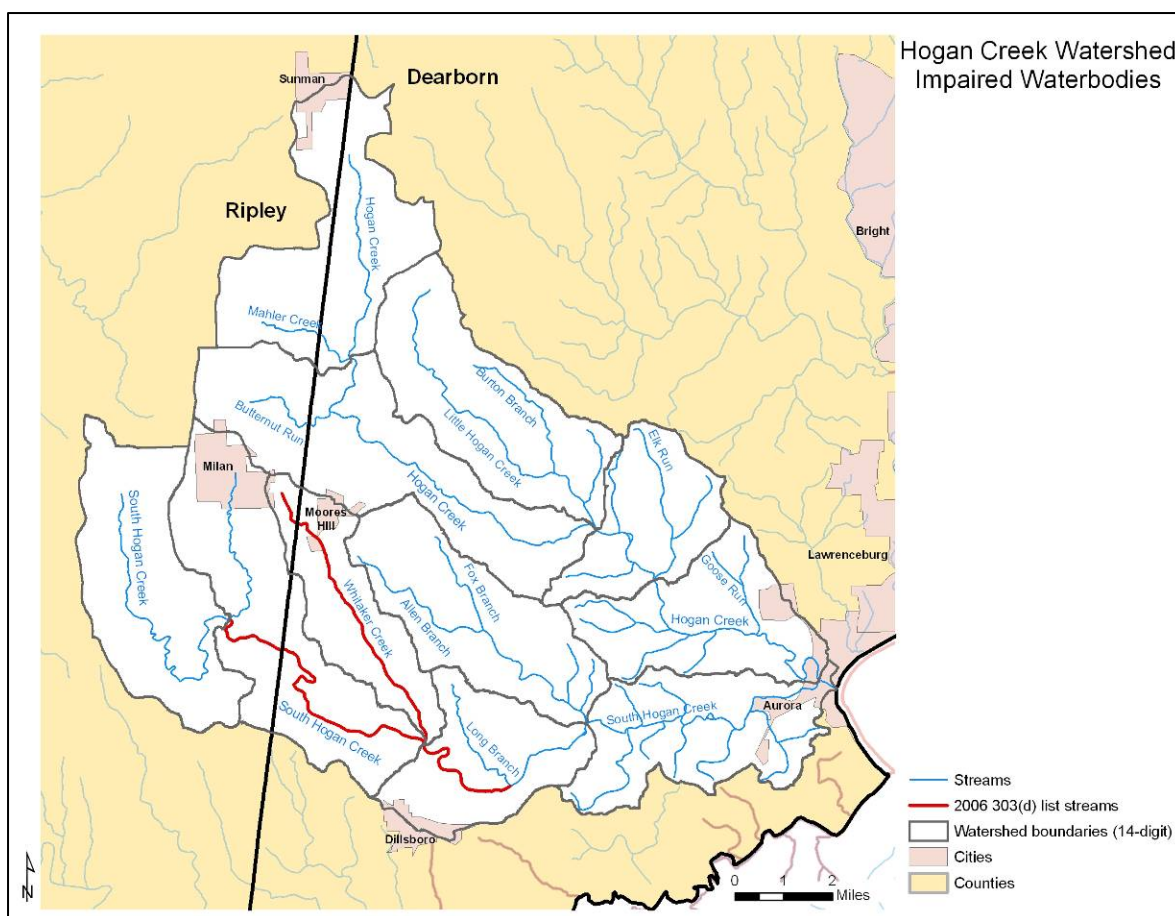
Figure 9: 303 (d) Impaired Waterbodies

- **Impaired Biotic Community:** An Impaired Biotic Community (IBC) means that a waterbody's aquatic life differs from the expectation of water that was unaffected by human activity. Measuring aquatic life is an excellent way to measure overall stream health, more accurate than by chemically testing for pollutants alone. Because of this, the presence of an IBC means that the waterbody is not healthy.<sup>56</sup>
- **E. Coli:** E. coli is a bacteria found in human and animal waste. Certain strains can lead to infection (symptoms are severe diarrhea and stomach cramping) and even kidney failure and death in some cases. One source of infection is contact with contaminated water.<sup>57</sup>

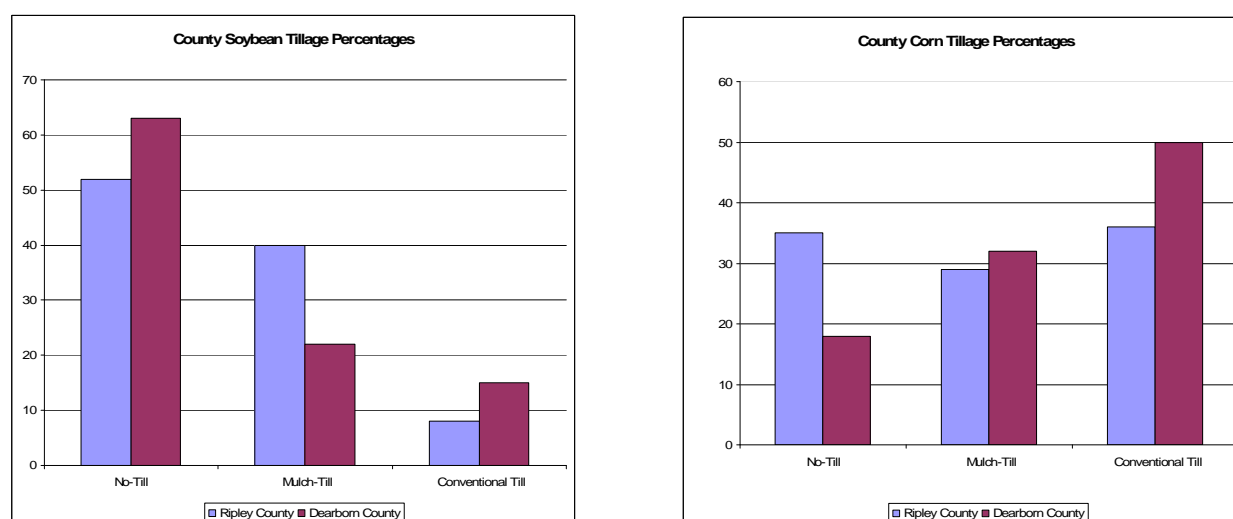
**Figure 11: County Tillage Comparison**

When looking at the watershed as a whole, it is estimated that 27 percent of the corn planted within the watershed is no-till, 30 percent is mulch-till, and the remaining 43 percent is conventional tillage. Likewise, soybeans are estimated to have a 57 percent no-till rating, 32 percent mulch-till rating, and 11 percent conventional tillage rating.

Because conservation tillage efforts are being made with soybeans, the watershed group will focus conservation efforts with landowners planting corn.

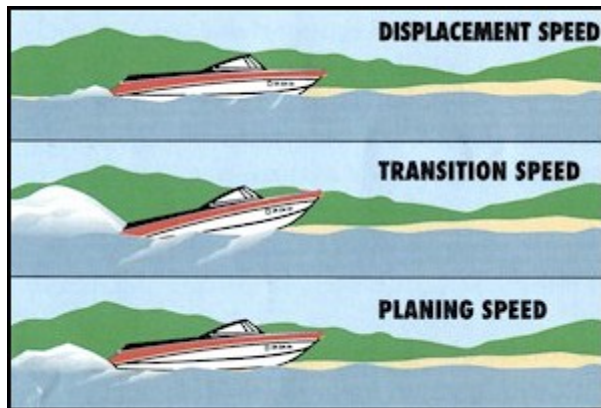
**Figure 12: Watercraft Speed**

Speed of the water craft is also a significant factor in boating wakes. Waves that have an estimated height of 12.5 cm do not typically cause damage to the banks. These wakes are generally created by boats operating at speeds less than 10km/hr. A wave that is 25 cm high is five times more destructive than a 12.5 cm wave; 62.5 cm high waves are thirty times more destructive.<sup>62</sup>

larger boats that do not plane can generate waves that can easily reach heights of 62.5 cm or more.<sup>63</sup>

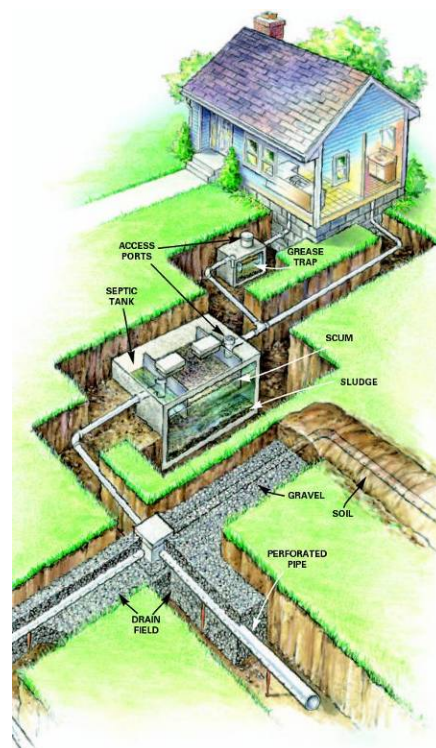
**Figure 13: Septic System Illustration**

Septic systems cannot dispose of all the material that enters the system. Solids that are not broken down by bacteria begin to accumulate in the septic tank and eventually need to be removed. The most common reason for system failure is not having these solids removed on a regular basis<sup>70</sup>. When the holding tank is not pumped out frequently enough, the solids can enter the pipes leading to and from the tank. This can cause sewage to back up into the house or cause the drainage system to fail as the pipes and soil become congested. These problems are often costly to fix, pose a danger to public

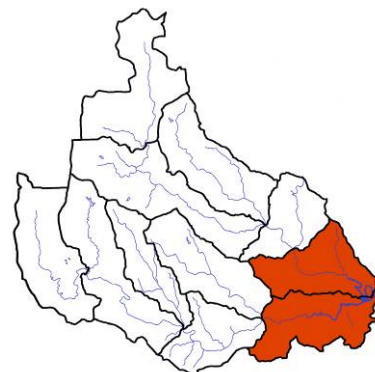
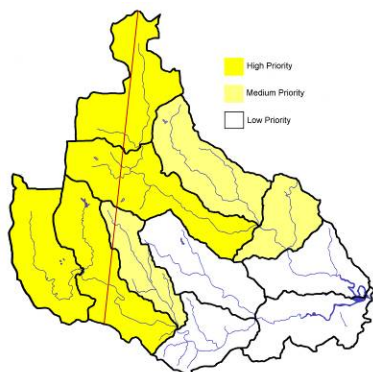
#### 7.1.1 – Riparian Buffers and Boat Wakes

While the committee believes streams throughout the Hogan Creek Watershed are sufficiently buffered, they expressed greatest concern for the areas in subwatersheds 110 and 050 highlighted in the map to the right. This area is greatly influenced by boat wakes from local bass tournaments and leisure and has the highest probability of causing sedimentation. Although it may be difficult to establish buffers in this area due to flooding, the group would like to develop a plan for flood-resistant trees, plants and grasses to plant in this area.

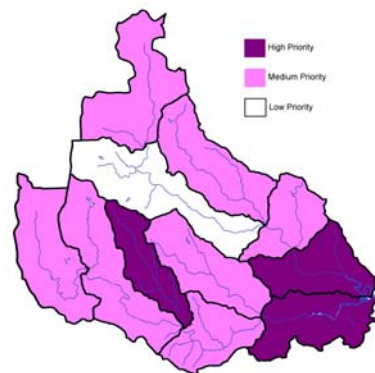
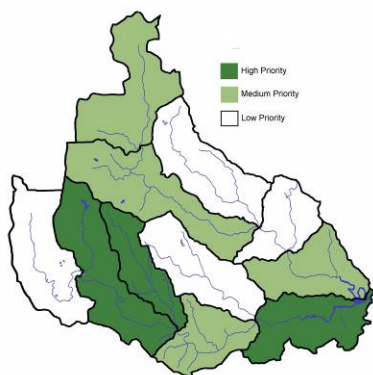
The committee analyzed IDNR 2004 Tillage Transect data and prioritized the subwatersheds by percentage of row crop. Subwatersheds which have a land use of row crops greater than 15% were given a “high priority” rating; subwatersheds which have a land use of row crops between 10% and 15% were given a “medium priority” rating; and subwatersheds with a land use of row crops lower than 10% received a “low priority” rating. The map to the left shows each subwatershed’s rating in color.

The committee prioritized this source by pasture percentage and livestock access in each subwatershed. Subwatersheds with pasture greater than 40% were ranked with a high score of 3; 35-40% was given a 2; and less than 35 % is given a 1. Subwatersheds with livestock access greater than 40% were given a score of 3; those with 10-40% were given a 2; and less than 10% were given a 1. Scores were combined to find critical areas. High priority had a combined score of 5 or more, medium had a combined score of 3 or 4 and low had a combined score of 2.

Because of its close proximity to Cincinnati, the committee anticipates a boost in population in the Hogan Creek watershed. According to STAT Indiana, statisticians confirm this idea. Ripley County is expected to increase in population by 7.7% from 1990 to 2010 while Dearborn County will see an 18.7% increase in population (12<sup>th</sup> largest increase in Indiana) by 2010. The committee prioritized this source by current construction projects going on in the watershed and areas that have already seen a significant rise in population such as Milan, Moores Hill and Aurora. Refer to the map at the left for a detailed illustration of prioritized areas.

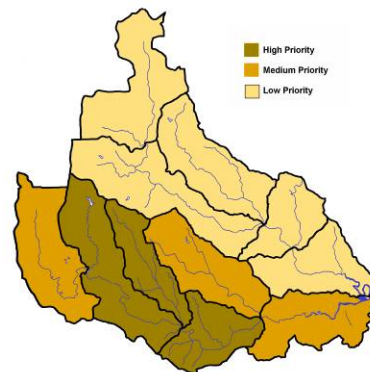
### 7.2.1 – Septic Systems

After speaking with Dearborn and Ripley County Health Department representatives, it is apparent that the most severe problem with septic systems comes from the South Hogan Creek Watershed. The committee chose to put emphasis on the three subwatersheds listed on the 303(d) list for *E.coli* as a high priority with the South Hogan Creek Watershed as a medium priority area. While the South Hogan subwatersheds are most critical, the committee feels the whole watershed should be investigated. Refer to the map at the right for a detailed illustration.

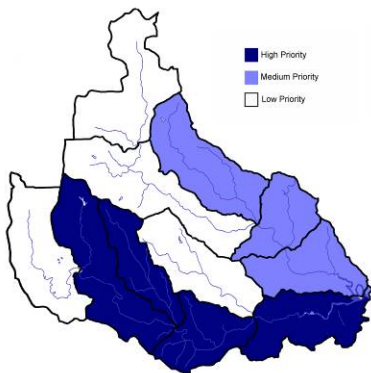
### 7.2.2 – Livestock Access

Because it is difficult to pinpoint where livestock has access to the creek, the committee prioritized this source by the results of the windshield survey. Subwatersheds which consisted of 40% or higher of livestock access were given a “high priority” ranking; subwatersheds which have between 10% and 40% were given a “medium priority” ranking; and those subwatersheds with less than 10% livestock access were given a “low priority” ranking. Additionally, the committee has given a high priority to the subwatersheds that have waterbodies that are listed on the 303(d) list for *E.Coli*. Refer to the map on the left for a detailed illustration.

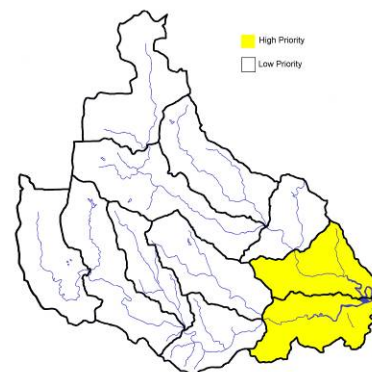
### 7.2.3 – Combined Sewer Overflows

Because the City of Aurora is the only town in the watershed with a combined sewer overflow problem, the subwatersheds closest to Aurora are recommended as the critical areas. Although the areas affected by combined sewer overflows in the subwatersheds may be minimal, the committee continued with the theme of selecting subwatersheds opposed to specific areas within the subwatershed.

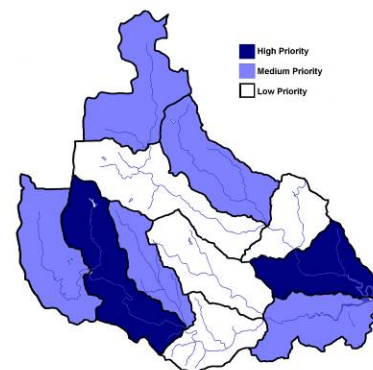
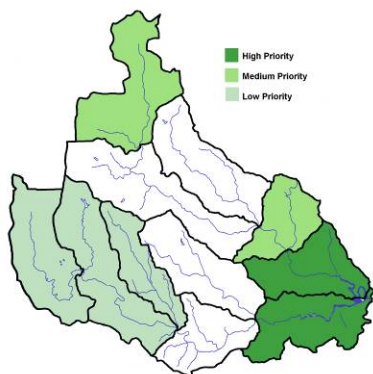
#### 7.3.1 – Impervious Areas

The committee determined the critical areas of impervious surfaces by analyzing Table 18 on page 35. The committee determined the subwatersheds with the highest acreage of impervious surface should be high priority. Subwatershed with more than 100 acres of impervious surface would be given a medium priority and those containing less than 100 acres would be considered a low priority.

While the committee has performed windshield and land surveys, it is often difficult to determine areas where pesticide runoff is occurring without testing the nearby waterbody. Since testing for pesticides is not a parameter tested by the project, the committee based their critical area for agricultural hazardous chemicals by riparian buffers. Those areas not adequately buffered were given a high priority (050 and 110). Areas that are moderately buffered were given medium priority (040 and 010). Areas that are moderate/high buffered were given a low priority (060, 070, and 080).

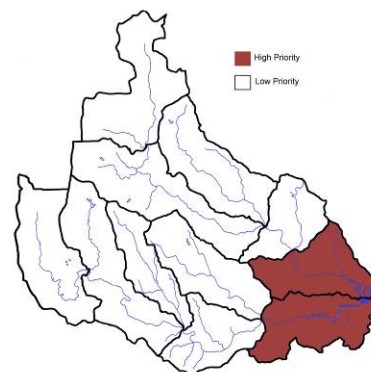
According to the Natural Resources Commission, Hogan Creek is a navigable waterway beginning at the Ohio River for 0.4 miles. North Hogan extends for another 4.9 miles and South Hogan extends for another 5.0 miles.<sup>80</sup> Since subwatersheds 110 and 050 are the only subwatersheds which have marinas or can be traveled by motorized boats, the committee believes these two subwatersheds should have a “high priority” ranking while the rest of the watershed should have a “low priority” ranking. Refer to the map on the right for a detailed illustration.

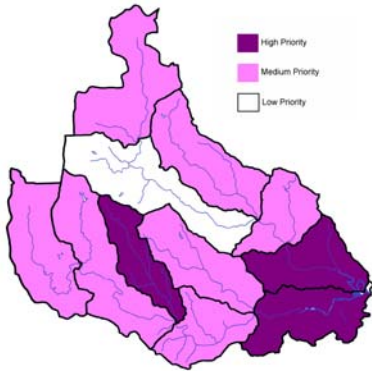
### 7.4.1 – Livestock Access

The committee prioritized this source by pasture percentage and livestock access in each subwatershed. Subwatersheds with pasture greater than 40% were ranked with a high score of 3; 35-40% was given a 2; and less than 35 % is given a 1. Subwatersheds with livestock access greater than 40% were given a score of 3; those with 10-40% were given a 2; and less than 10% were given a 1. Scores were combined to find critical areas. High priority had a combined score of 5 or more, medium had a combined score of 3 or 4 and low had a combined score of 2.

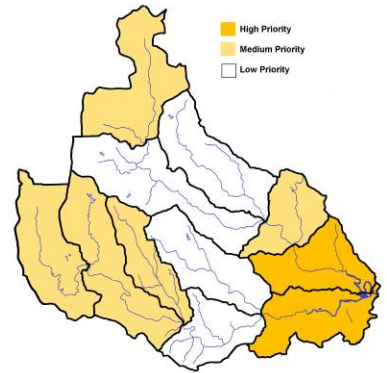
### 7.4.2 – Agricultural Lands

While the committee has performed windshield and land surveys, it is often difficult to determine areas where fertilizer runoff is occurring. Because test results for nitrogen and phosphorus show minimal concentrations, the committee based their critical area for excess nutrients by riparian buffers. Those areas not adequately buffered were given a high priority (050 and 110). Areas that are moderately buffered were given medium priority (040 and 010). Areas that are moderate/high buffered were given a low priority (060, 070, and 080).
