# Indian Kentucky Watershed

August 15, 2014

## Watershed Management Plan

*Jefferson, Ripley, & Switzerland Counties, Indiana*

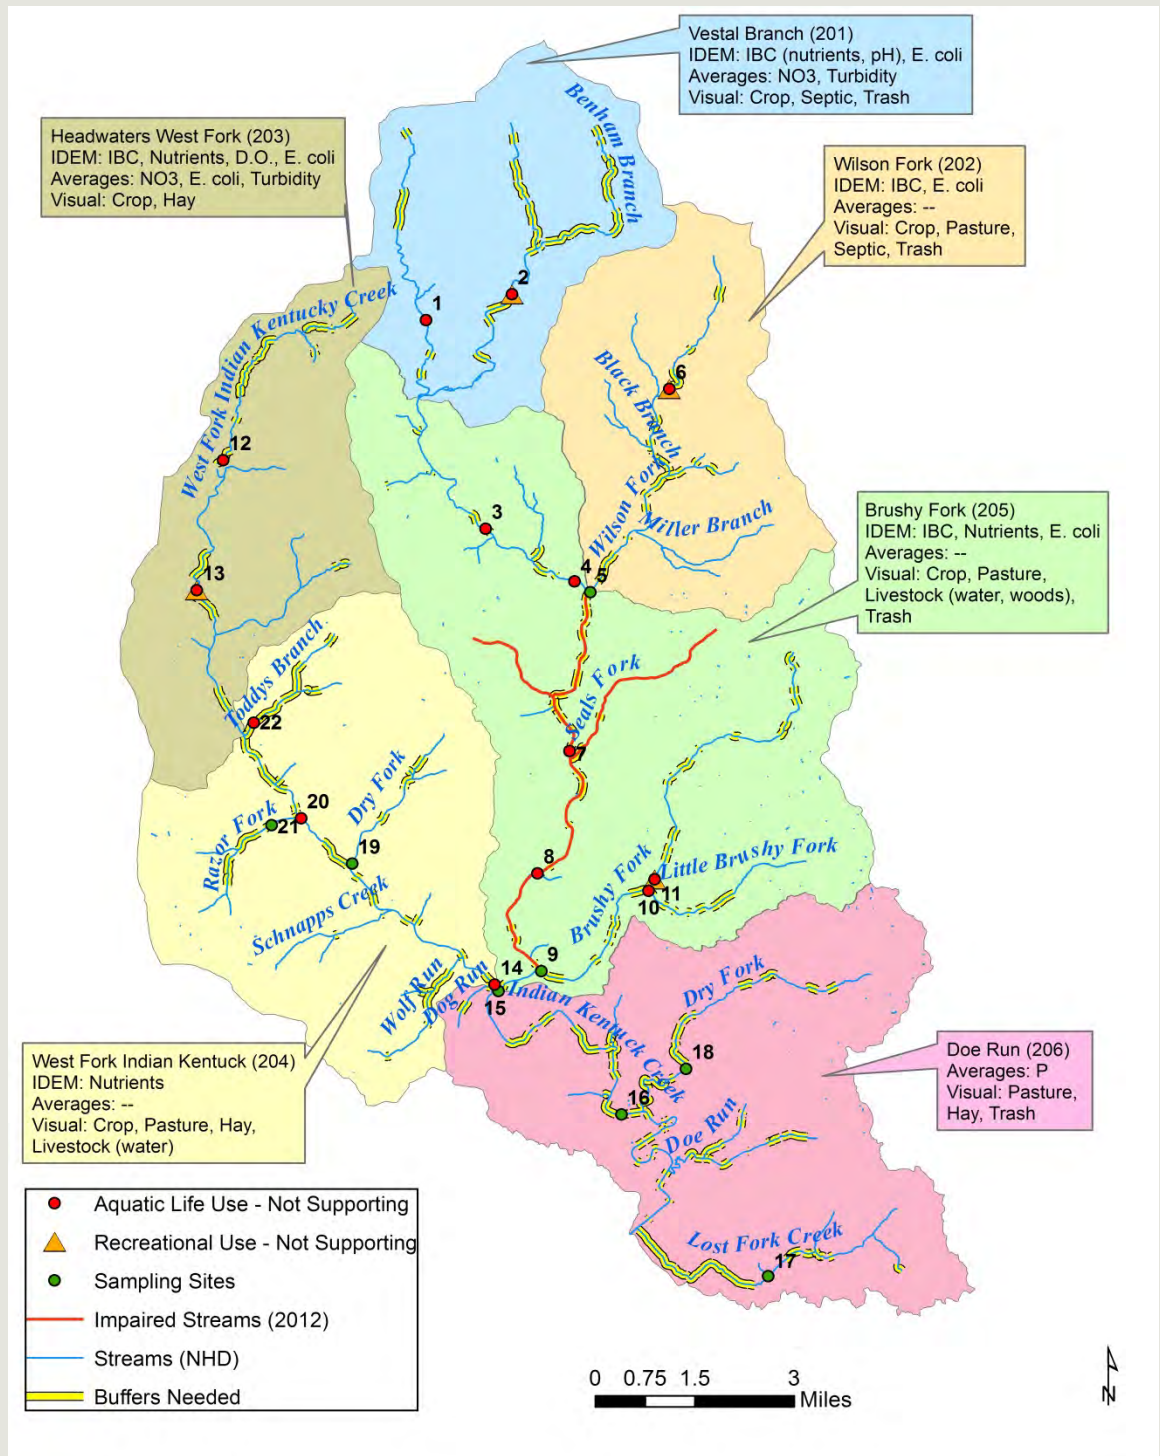
**Figure 110: Pollution Parameters Identified in the Subunits of Indian Kentucky Watershed**

The map in figure 110 shows sub-units of the Indian Kentucky Watershed area, IDEM water quality testing data and visual assessments that exceeded standards set by the IKW Steering Committee.
