Project Name: South Laughery Creek WMP

South Laughery Creek

Watershed Management Plan

June 2006

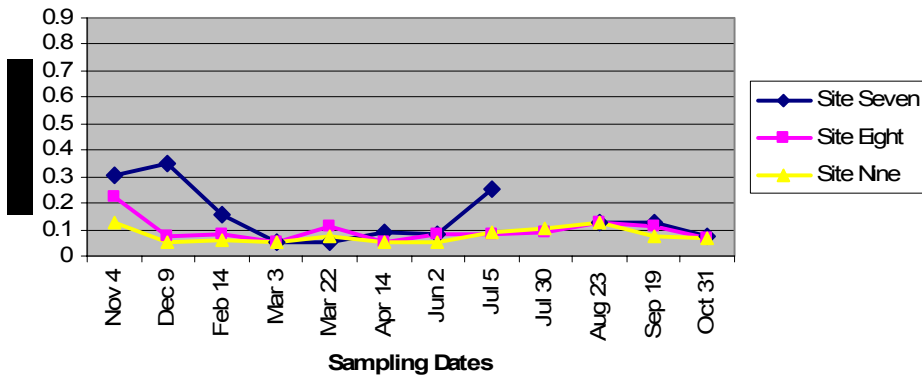
When transported into aquatic systems, phosphorous increases aquatic plant growth such as algae and weeds. When phosphorus levels are too high, excess plant and algal growth creates water quality problems. Plants begin to die and decompose, depleting the dissolved oxygen supply in the water. This can ultimately lead to fish kills in some circumstances. Phosphorus is also released from decomposing plants back into the water continuing the cycle. The reaction of the aquatic system to an overloading of nutrients is known as eutrophication. (Figures 26-30 illustrate Total Phosphorus numbers for the one year sampling period.*)

Phosphorus Testing Results – Several spikes were observed above the 0.3mg/L targeted level for phosphorus. These spiking events may correspond with nutrient application on agricultural land or septic system inputs.

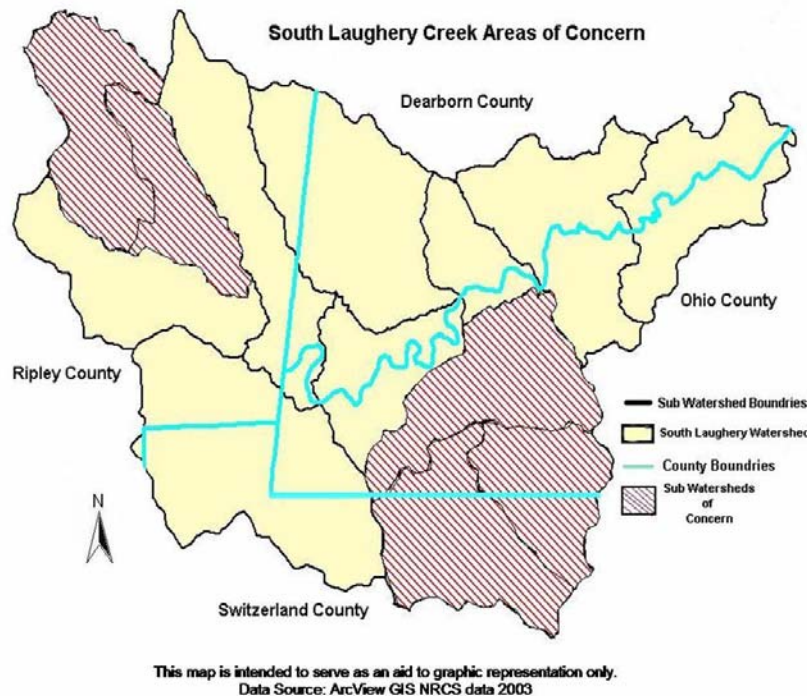
Figure 32 South Laughery Creek Watershed Areas of Concern

There was unanimous agreement by the Steering Committee that test Site Five (0803 South Laughery Lower sub watershed), Site Six (0802 Willow Creek sub watershed) and Site Seven (0801 South Fork Headwaters sub watershed) indicated a high priority of concern. Site Five is the area listed on the 303d impaired waterbodies list for *E. coli*. Site Six and Site Seven are upstream from Site Five and there is some concern that Site Six and Site Seven are contributing to lower water quality at Site Five. These three sites often exceeded the standard level for *E. coli* of 235/CFU's/100mL for total body contact. (Figure 32 shows the areas of concern.)

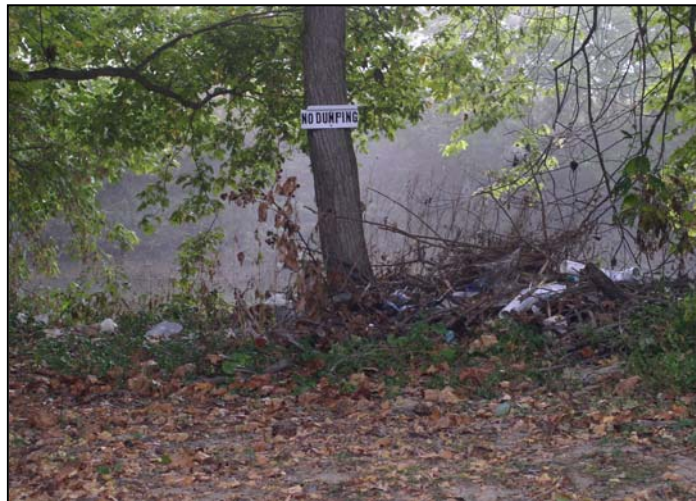
Figure 38 No dumping sign at trash site

During several drive-by activities conducted throughout the inventory process the presence or absence of trash was noted. Whether the trash was near a waterbody or just within the watershed boundary, eventually, all trash leads to a body of water. Trash can be introduced into watersheds by passing motorists, travelers, landowners and flooding events. Trash seems to be the greatest problem in Dearborn County. Cole Lane, which was the site of a clean-up effort, is heavily used as an easy access route to reach neighboring counties. Once trash reaches a waterbody it may float along the surface or sink to the bottom. Trash interferes with habitats, decreases navigations, and takes decades to decompose, therefore impacting wildlife for many years. Certain pollutants can cause irreparable harm to the landscape. In addition to trash impacting water quality, trash can also affect the stream's aesthetic properties. (See Figures 38 and 39.)

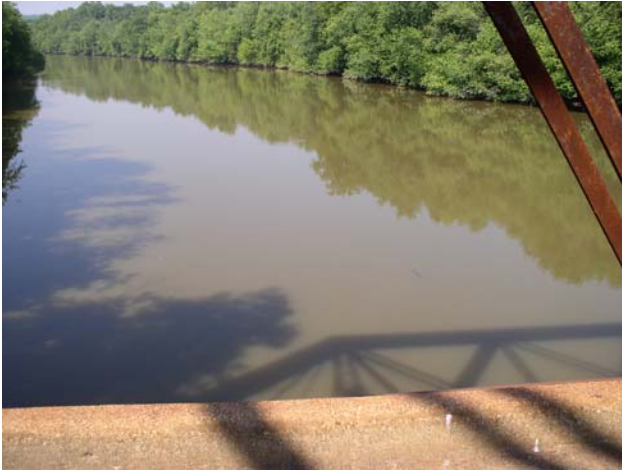
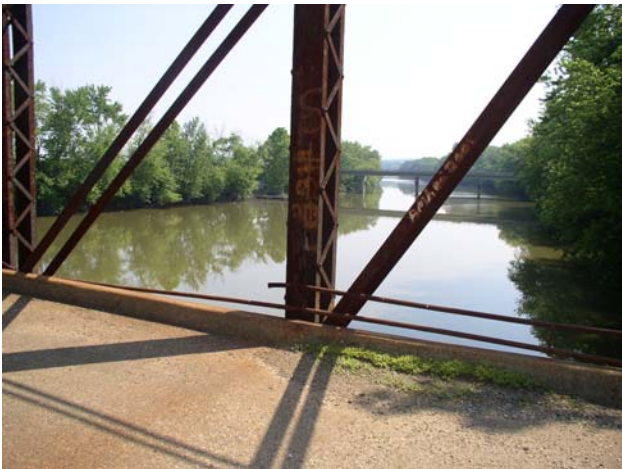
Site One

Kinnet Subwatershed – The testing was performed on the creek directly near the Old Iron Bridge on 56 by French before discharging into the Ohio River in Randolph Township.

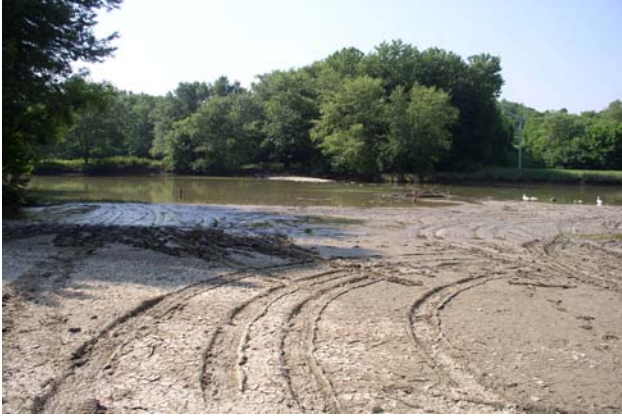
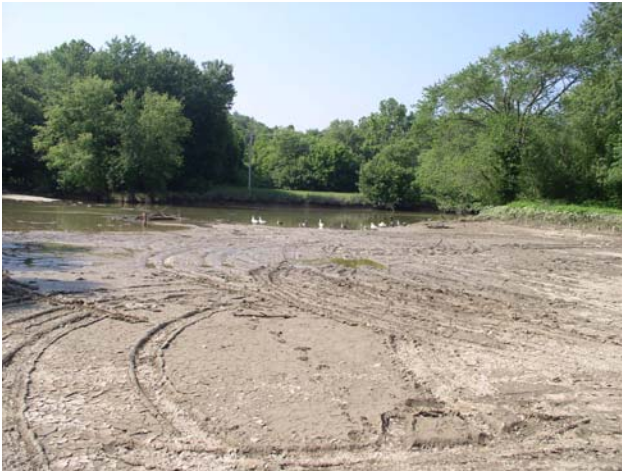
Site Two

Goodpasture Subwatershed – The testing was performed on the creek directly at the Hartford Ford on Cole Lane in Washington Township.

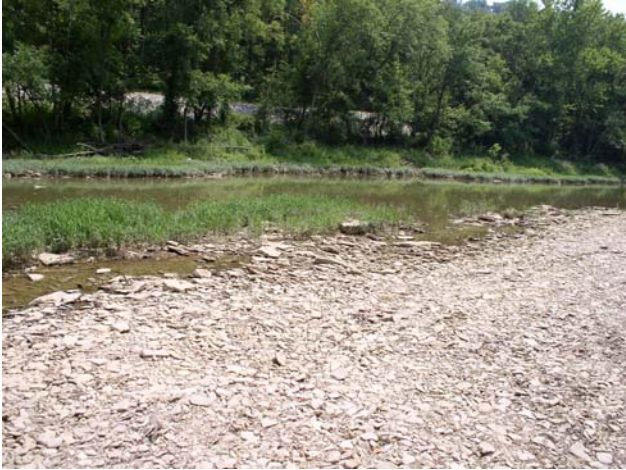
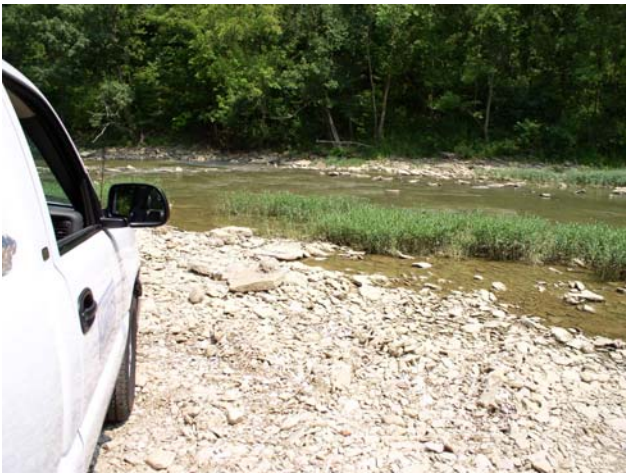
Site Three

Mud Lick Subwatershed – Testing was performed directly on Laughery Creek via Laughery Creek Road in Clay Township

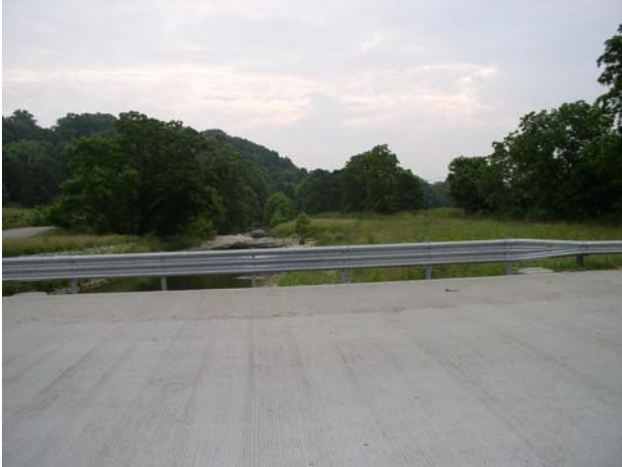
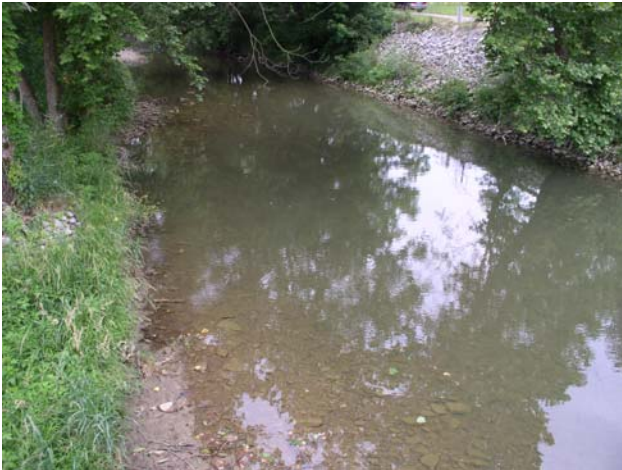
Site Four

Hayes Branch Subwatershed – Testing was performed down from where all tributaries (Boyd Branch, Hayes Branch, Peter Creek, and Bob Branch) meet before entering Laughery Creek. Access is from Roberts Road in Clay Township.

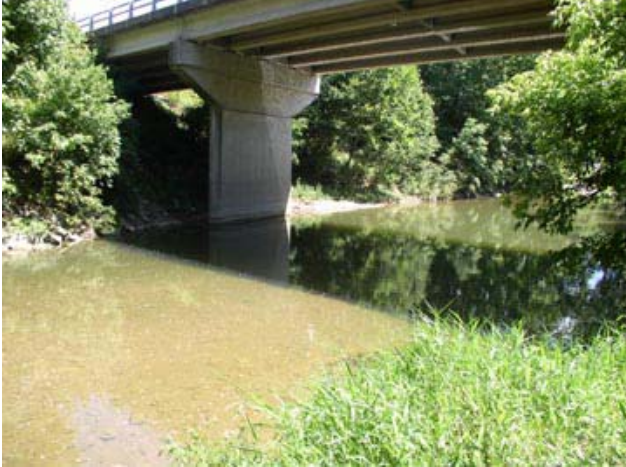
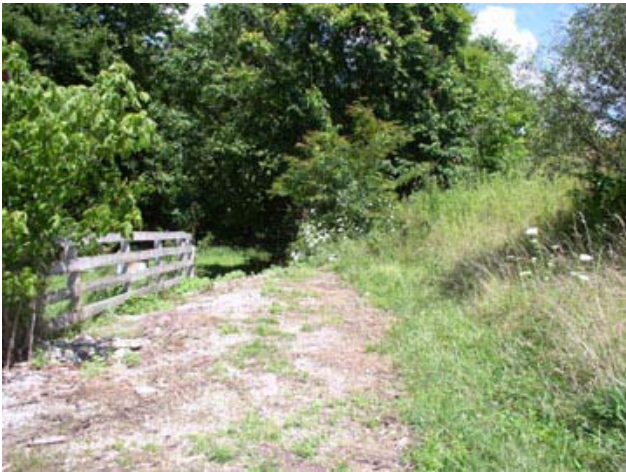
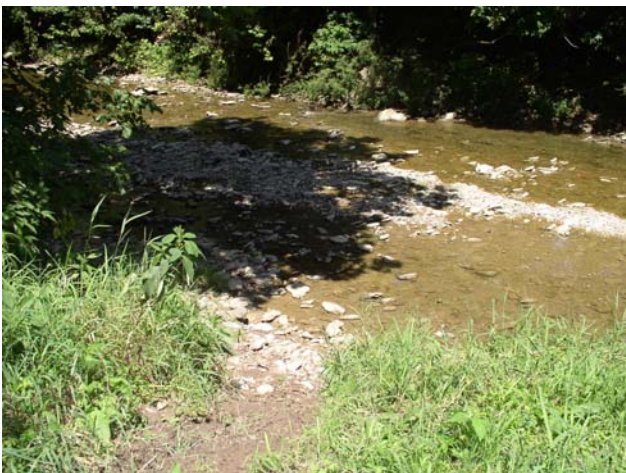
Site Five

South Fork Lower Subwatershed – Testing was performed down from where all tributaries (South Fork, Dry Branch, and Mud Lick Creek) converge before entering Laughery Creek in Union Township.

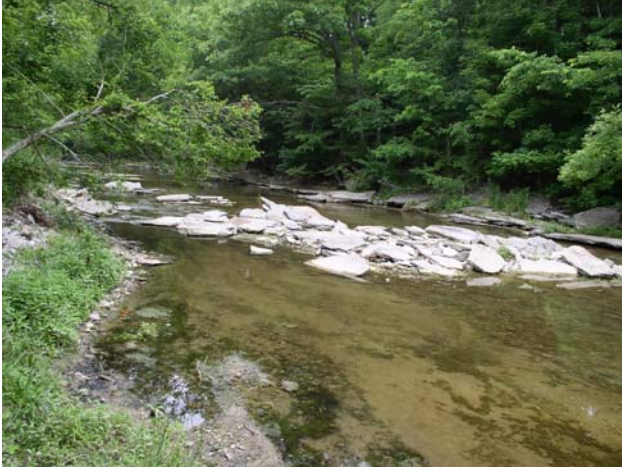
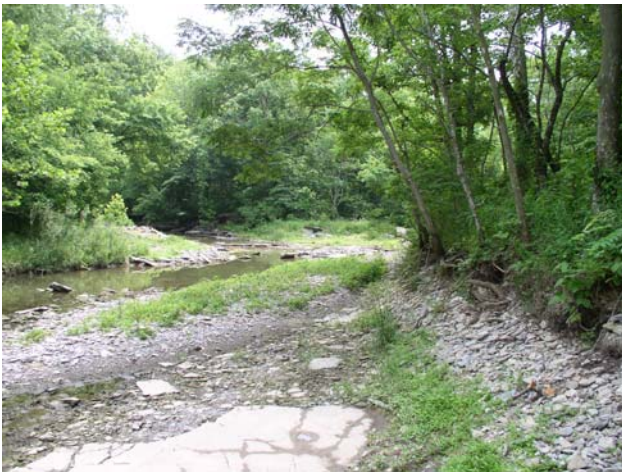
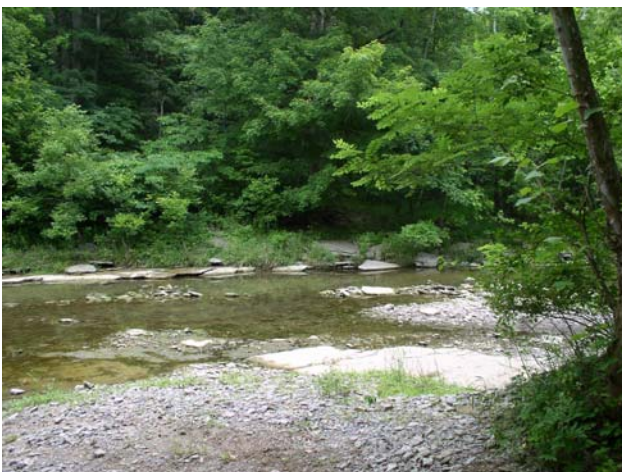
Site Six

Willow Creek Subwatershed – Testing was performed down from where all tributaries (Willow Creek and Murray Branch) converge before entering Laughery Creek in Cass Township.

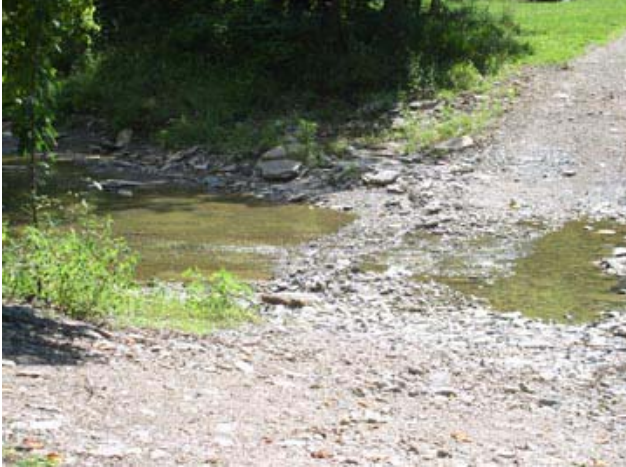
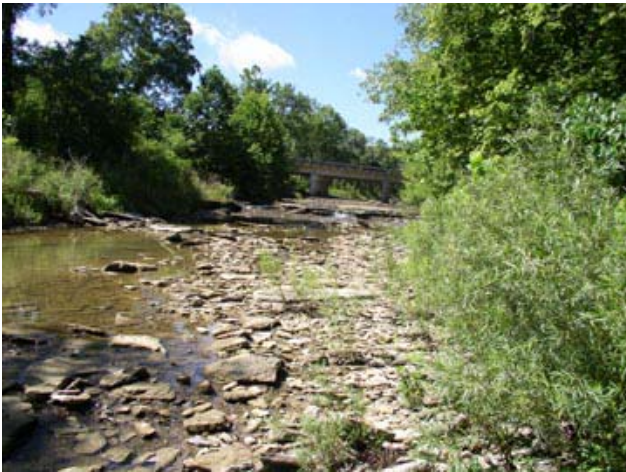
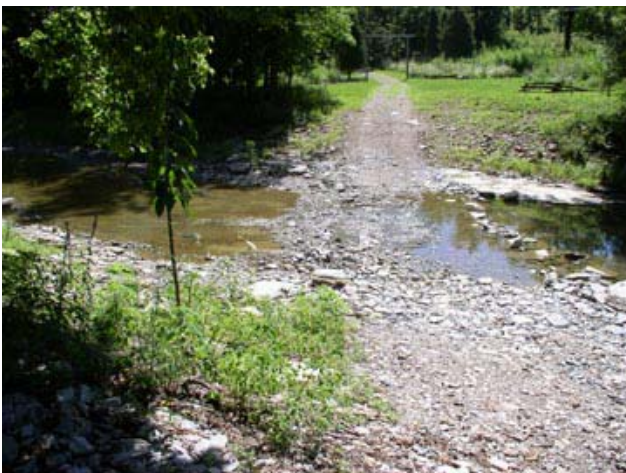
Site Seven

South Fork Headwaters Subwatershed – Testing was performed down from where all tributaries (Sugar Branch, Elk Creek, and South Fork) converge before entering Laughery Creek in Pike Township.

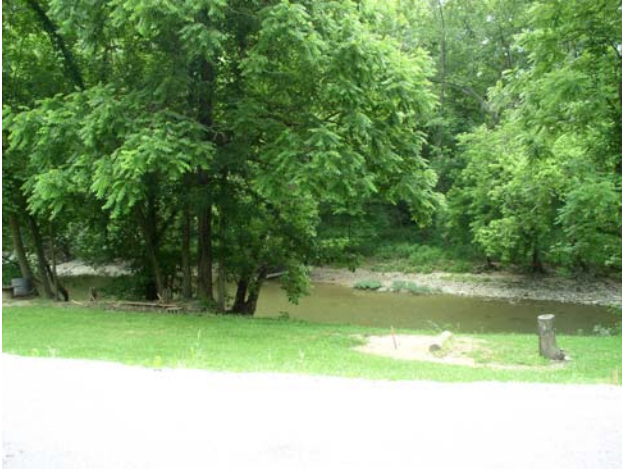
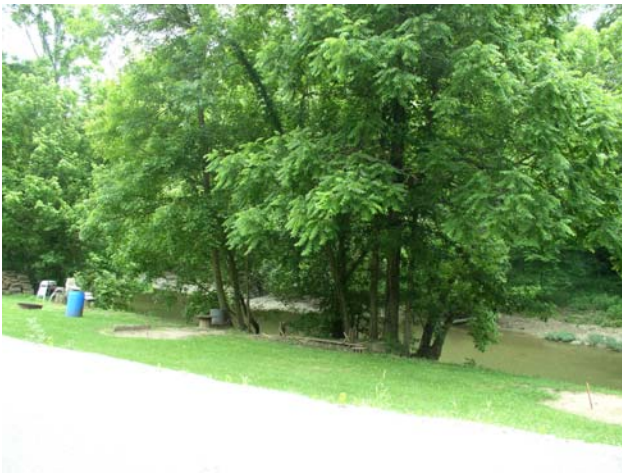
Site Eight

Bell Branch Subwatershed – Testing was performed directly on the main stream on Laughery Creek in Caesar Creek Township.

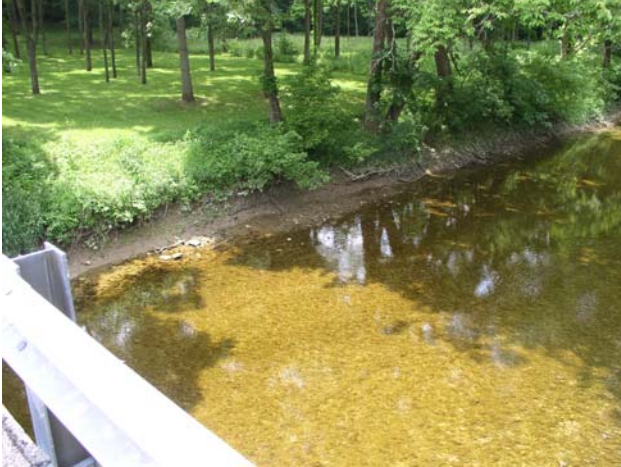
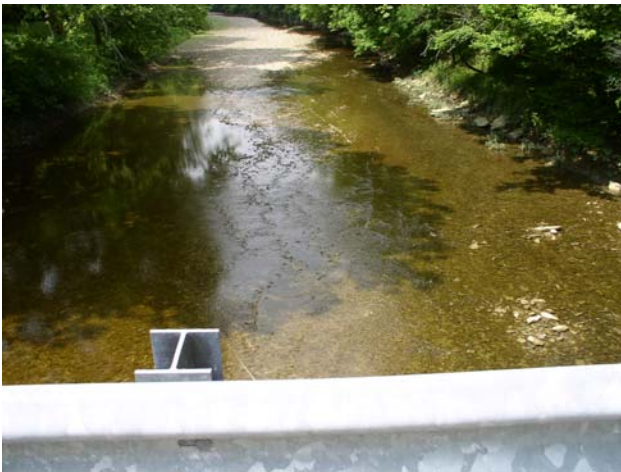
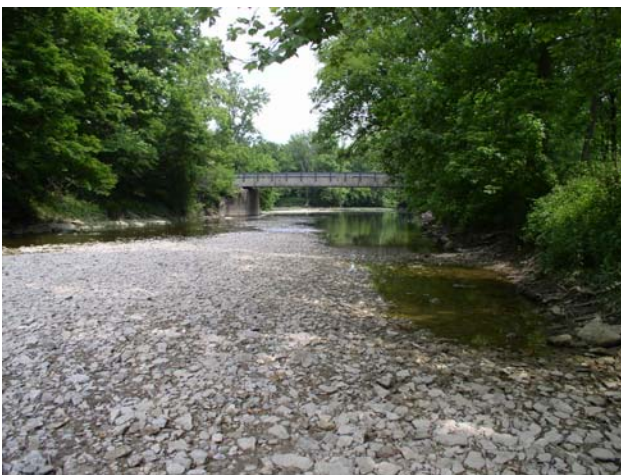
Site Nine

Bear Creek Subwatershed – Testing was performed down from where all tributaries (Uhlmann Branch, Bear Branch, and Bear Creek) converge before entering Laughery Creek in Pike Township.

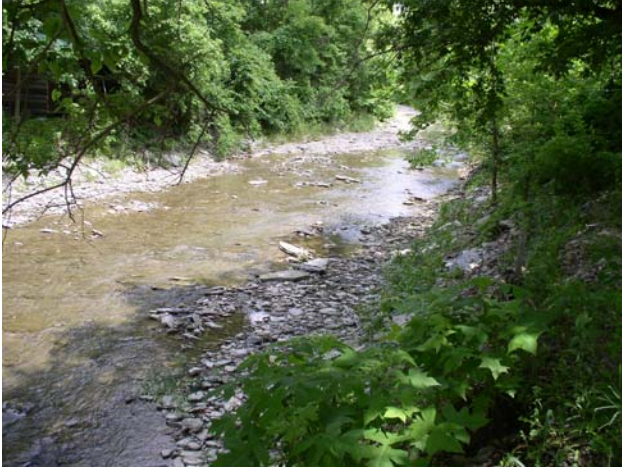
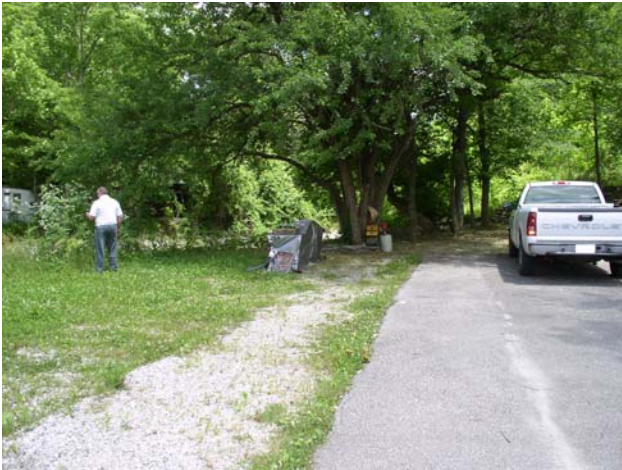
Site Ten

Caesar Creek Subwatershed – Testing was performed on Caesar Creek directly before it enters Laughery Creek near the Flea Market in Friendship off from State Road 62 in Brown Township.

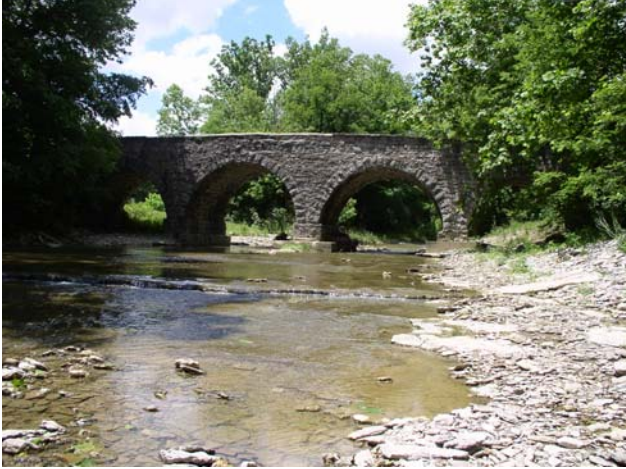
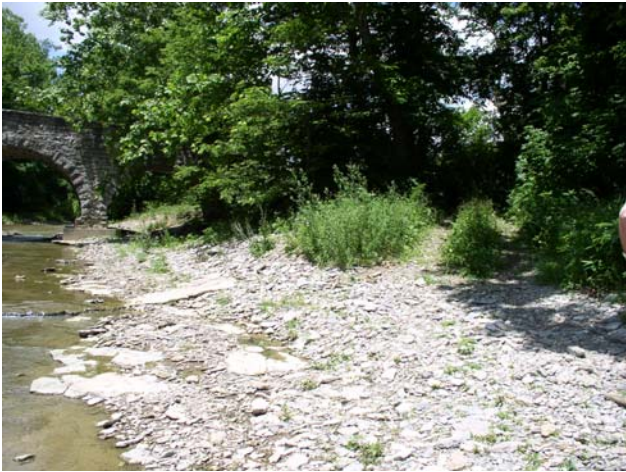
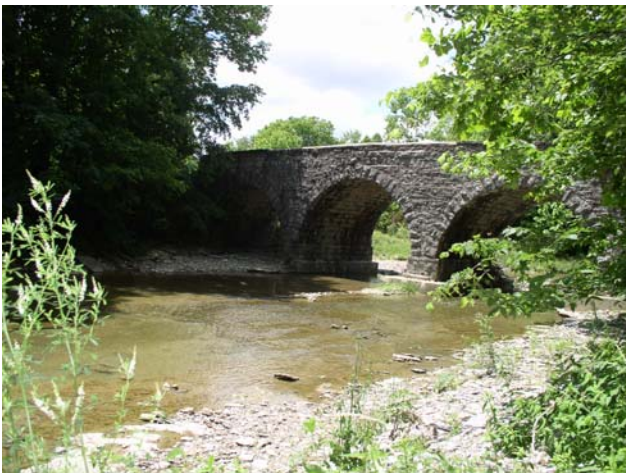
Site Eleven

Raccoon Creek Subwatershed – Testing was performed down from where all tributaries (Little Raccoon Creek and Raccoon Creek) converge before it discharges into South Laughery on the Old Stone Four Humped Bridge in Brown Township.

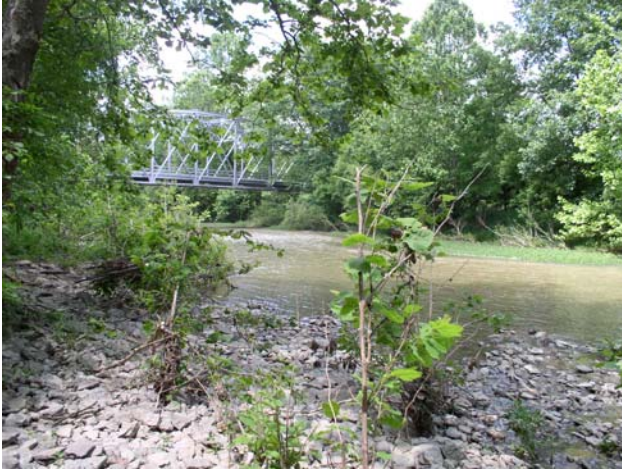
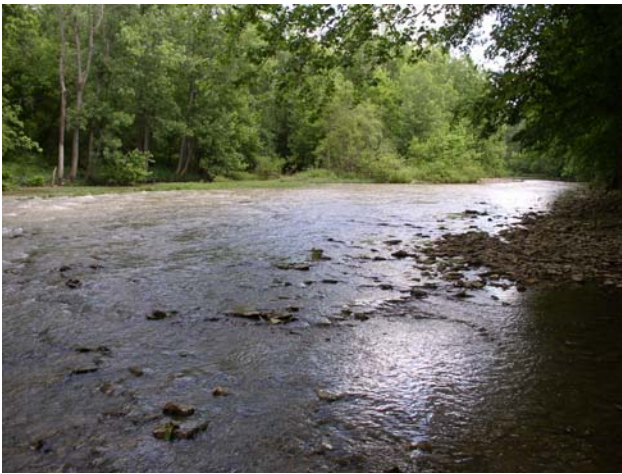
Site Twelve

Turkey Creek Subwatershed – Testing was performed directly on Laughery Creek after the Goose Creek tributary discharge point in Johnson Township.

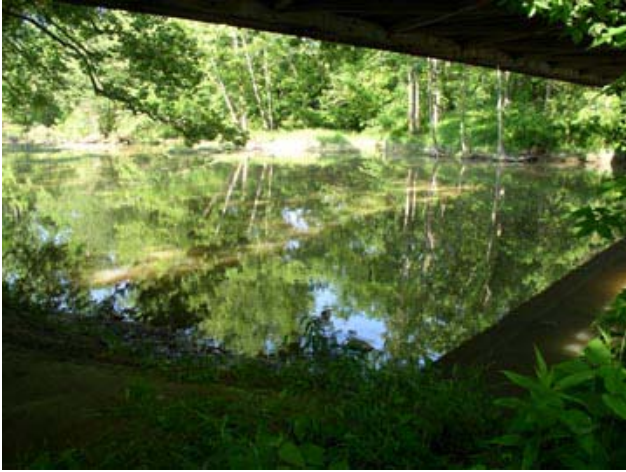
Site Thirteen

Cave Hill Subwatershed – Testing was performed on US 50 on the bridge near the entrance of Versailles State Park in Johnson Township.
