**Project Name:** Little Vermillion River WMP

**Plan Type:** Watershed Management Plan

# **The Little Vermillion River Watershed: A Plan for the Future**

## **Executive Summary**

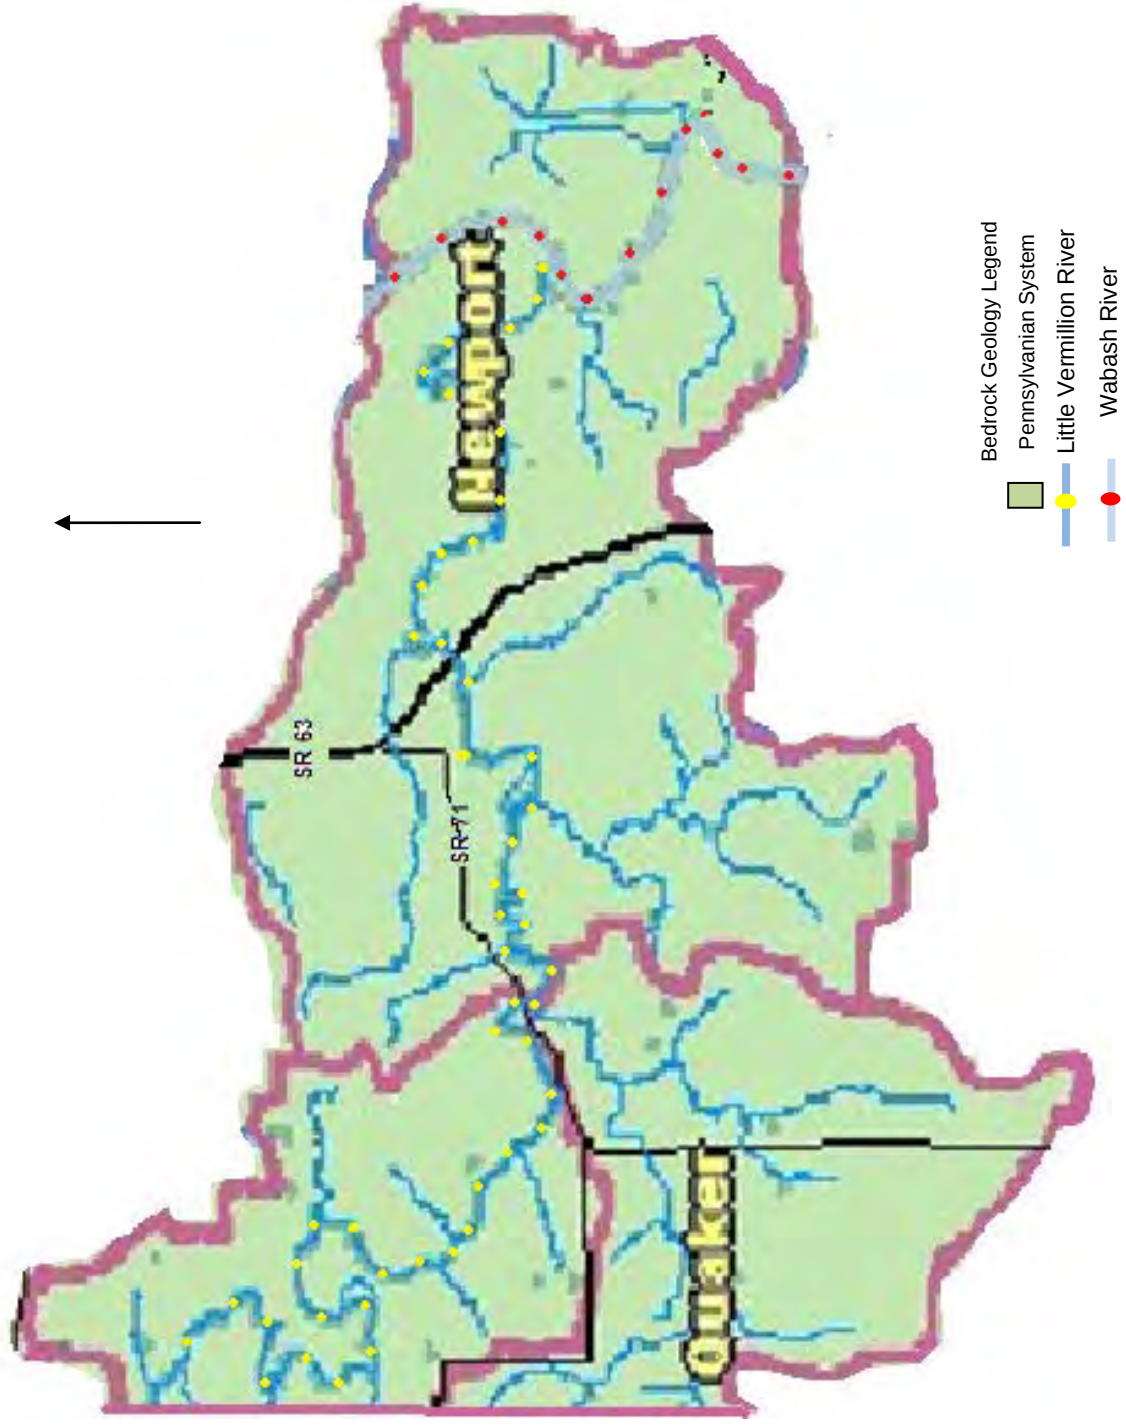
**Figure 7: Watershed Geology**

Geologically the Little Vermillion River Watershed lies entirely within the Pennsylvanian system. According to Todd Thompson's article "Bedrock Geology of Indiana" is comprised of a hierarchy to identify the different layers of sedimentary bedrock. Beds with similar characteristics and distribution are combined together and identified as "formations." Formations can be combined into "groups." The groups can be broken down into "systems." The map on the following page identifies the system in the counties. According to the Indiana Geological survey from Indiana University the depth of the bedrock in Vermillion County and Parke County ranges from 260 to 470 feet in thickness. Limestone and four of Indiana's commercially important coals are constant across the counties. As indicated in Figure 7 below the green color indicates the Pennsylvanian bedrock geology.

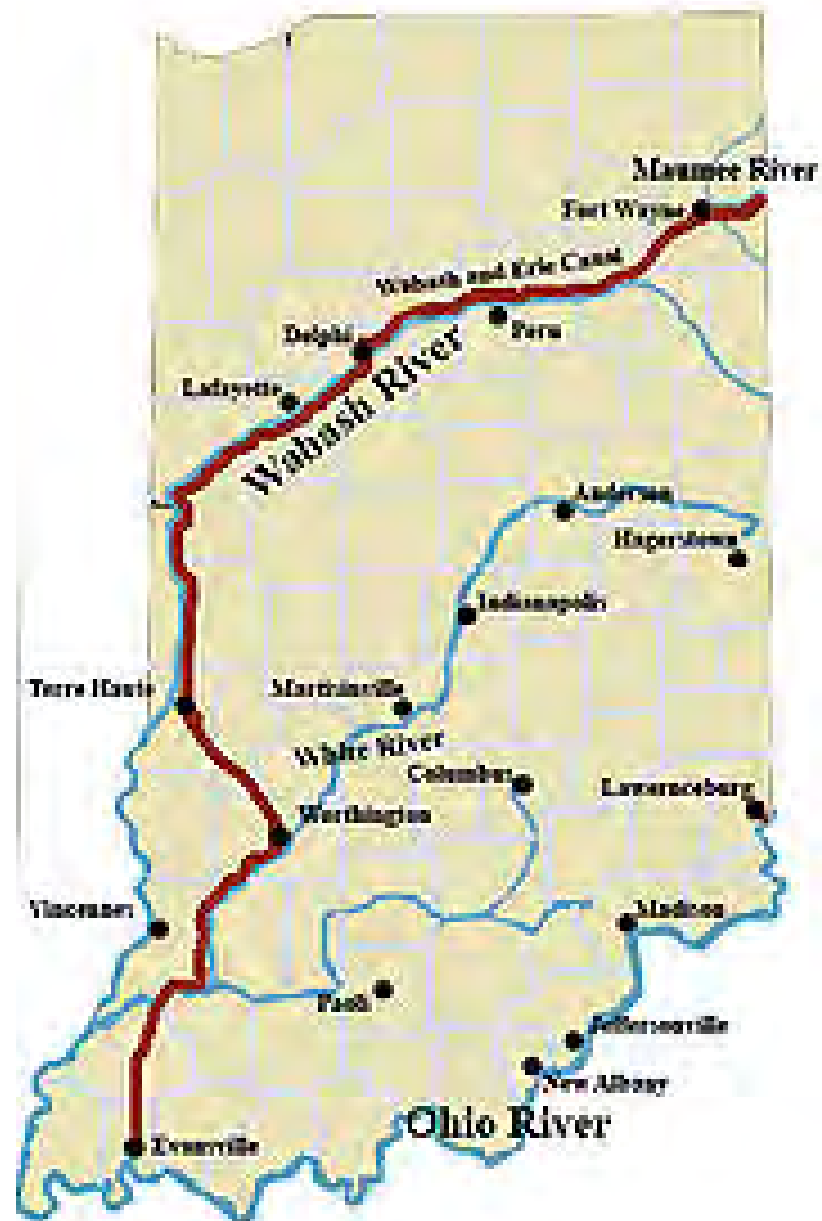
Figure 18: Wabash and Erie Canal (Source: Wikipedia)

The Parke County portion of the watershed is located within the present day Wabash Township. This portion of Parke County once had the Wabash-Erie Canal running along the Wabash River through the township. Figure 18 represents the location of the canal.

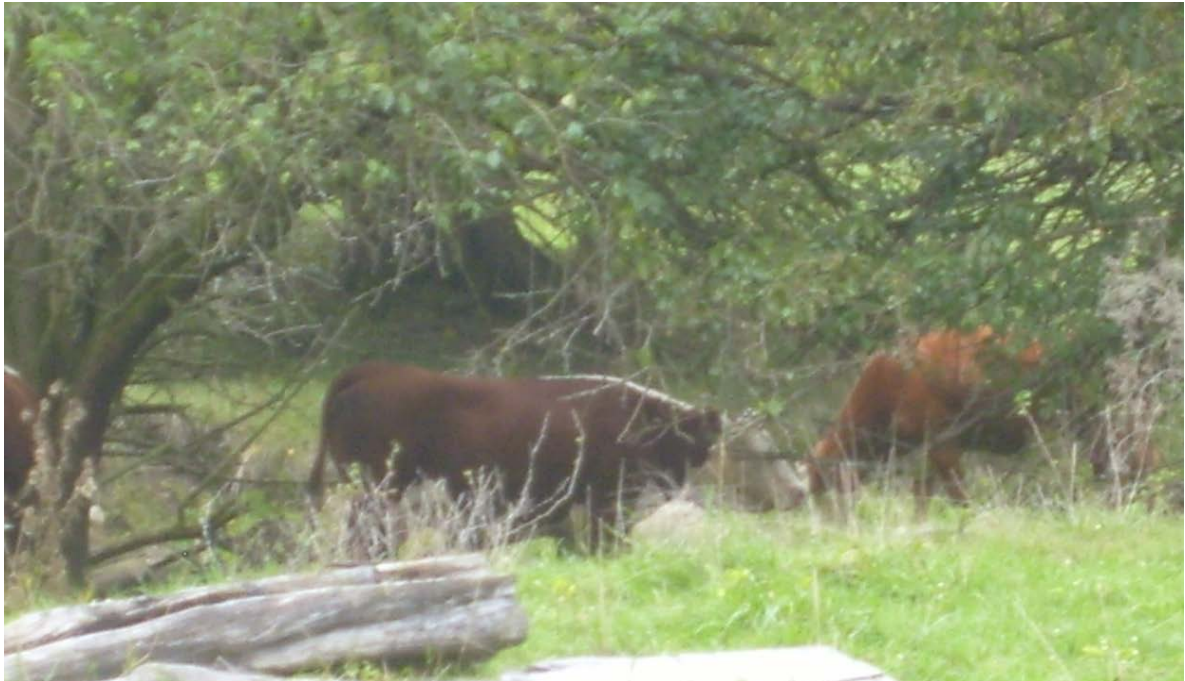
**Picture #1: Livestock standing in the streambed (Jonathan Creek tributary)**

The animals had access to drink and defecate in the stream. The stream banks looked degraded in several of the locations. Livestock with direct access to streams can cause water quality concerns for both humans and aquatic organisms. When livestock have access to a stream, their trampling can destabilize the banks, cause erosion, and disturb aquatic habitat. The two livestock operations observed in the Horseshoe Bend subwatershed and one livestock operation in the Newport subwatershed did not have access to a tributary or the Little Vermillion River.

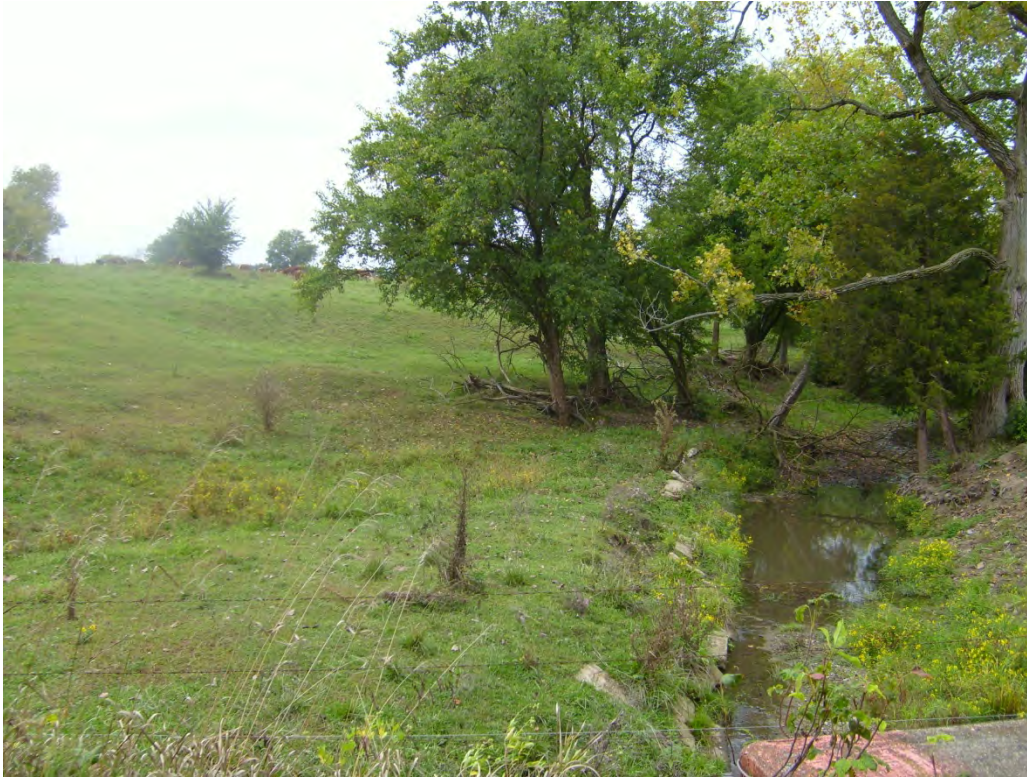
**Picture #2: Downstream from where livestock had access (Jonathan Creek tributary)**

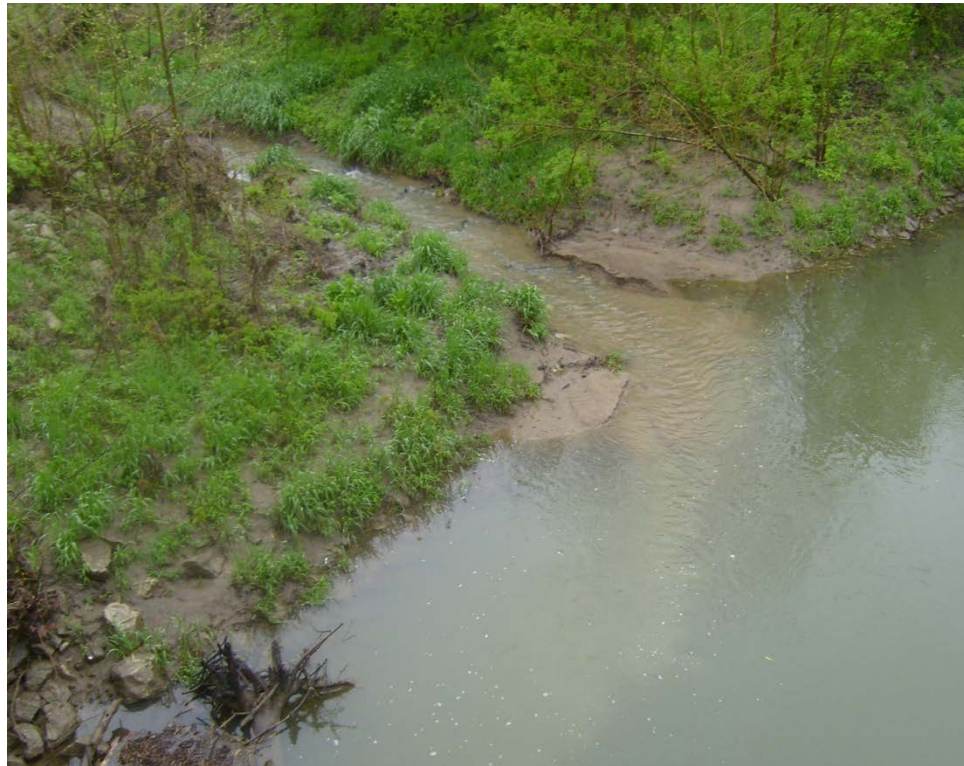
**Picture #3: Sediment Runoff into the Little Vermillion River near Site #1: Horseshoe Bend Watershed**

As was discussed sediment runoff in picture 3 shows sediment washing into the river. The picture 3 water running into the Little Vermillion River is flowing from a well-buffered (trees, shrubs and grass) tributary in Indiana. The tributary starts 1.5 miles upstream in Illinois where it is a grassed waterway that is poorly buffered from farm fields. Sediment can clearly be seen running from the side tributary into the Little Vermillion River. This is considered a problem area within the Horseshoe Bend subwatershed because this tributary is delivering large quantities of sediment loads into the beginning section of our watershed project area.

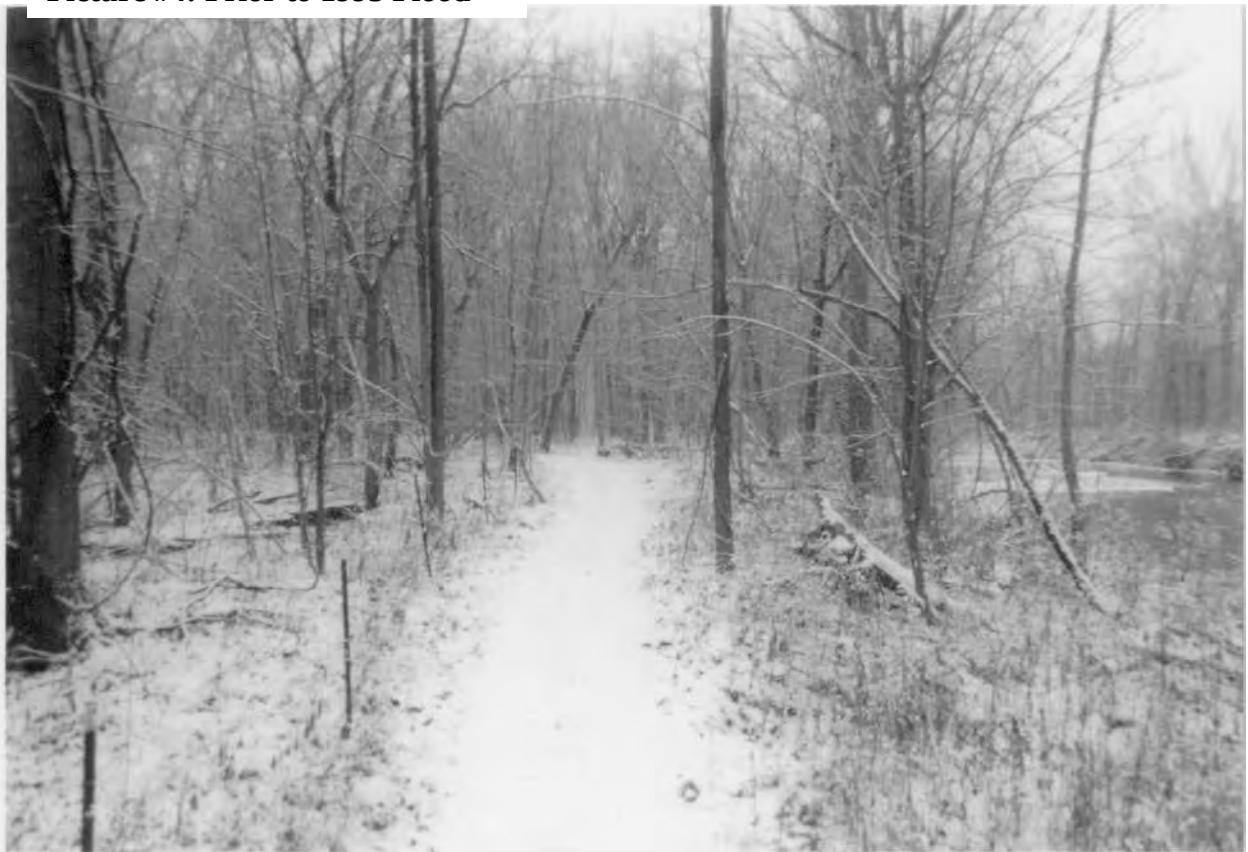
**Picture #4: Prior to 1993 Flood**

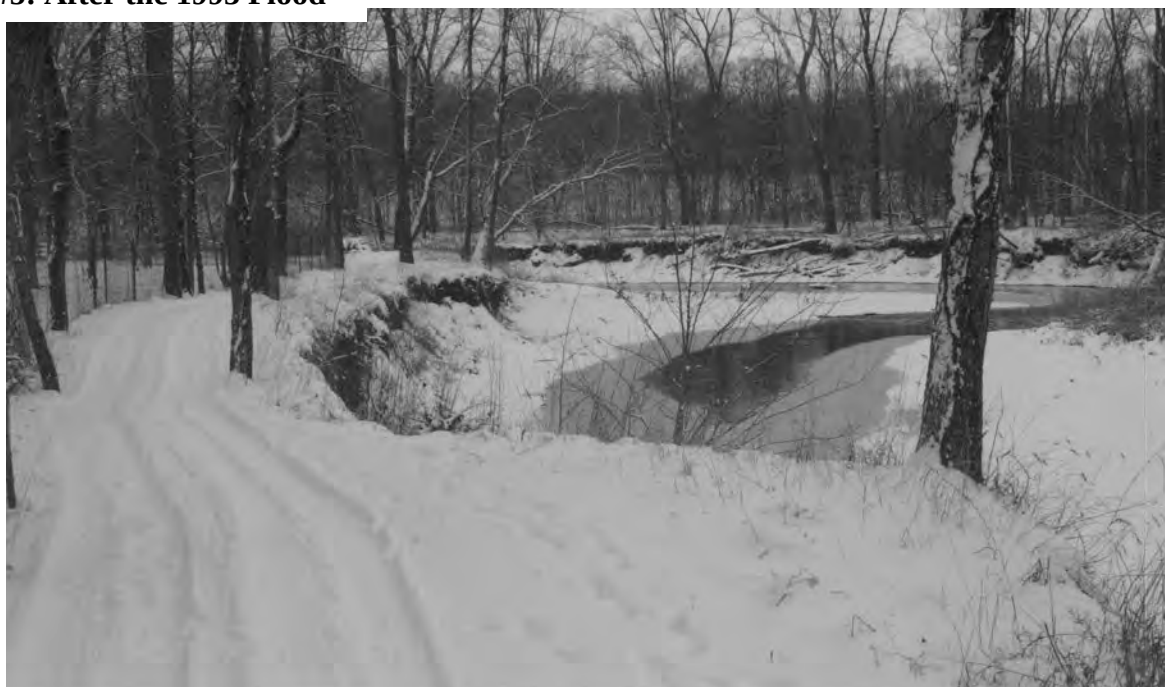
**Picture #5: After the 1993 Flood**

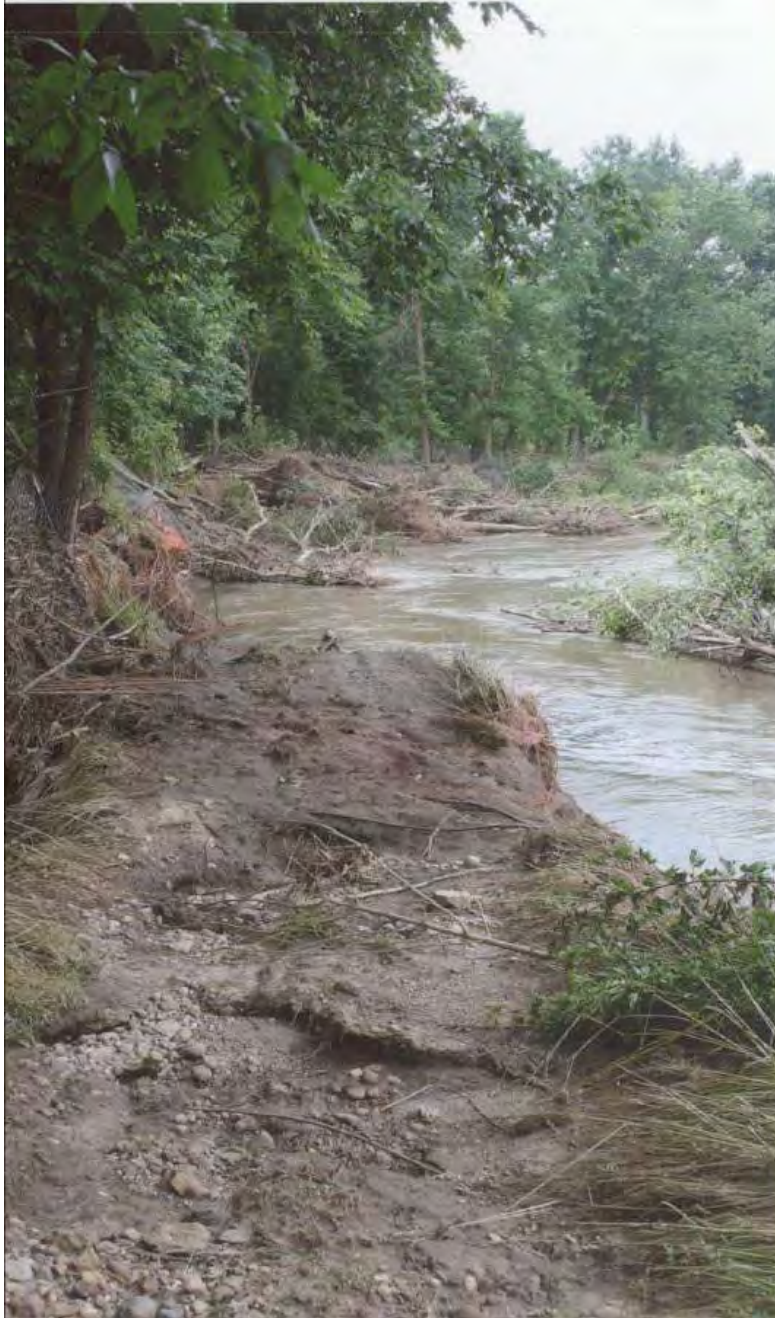
**Picture #6: Bank, Sediment, and Riparian Loss over a 15 year period.**

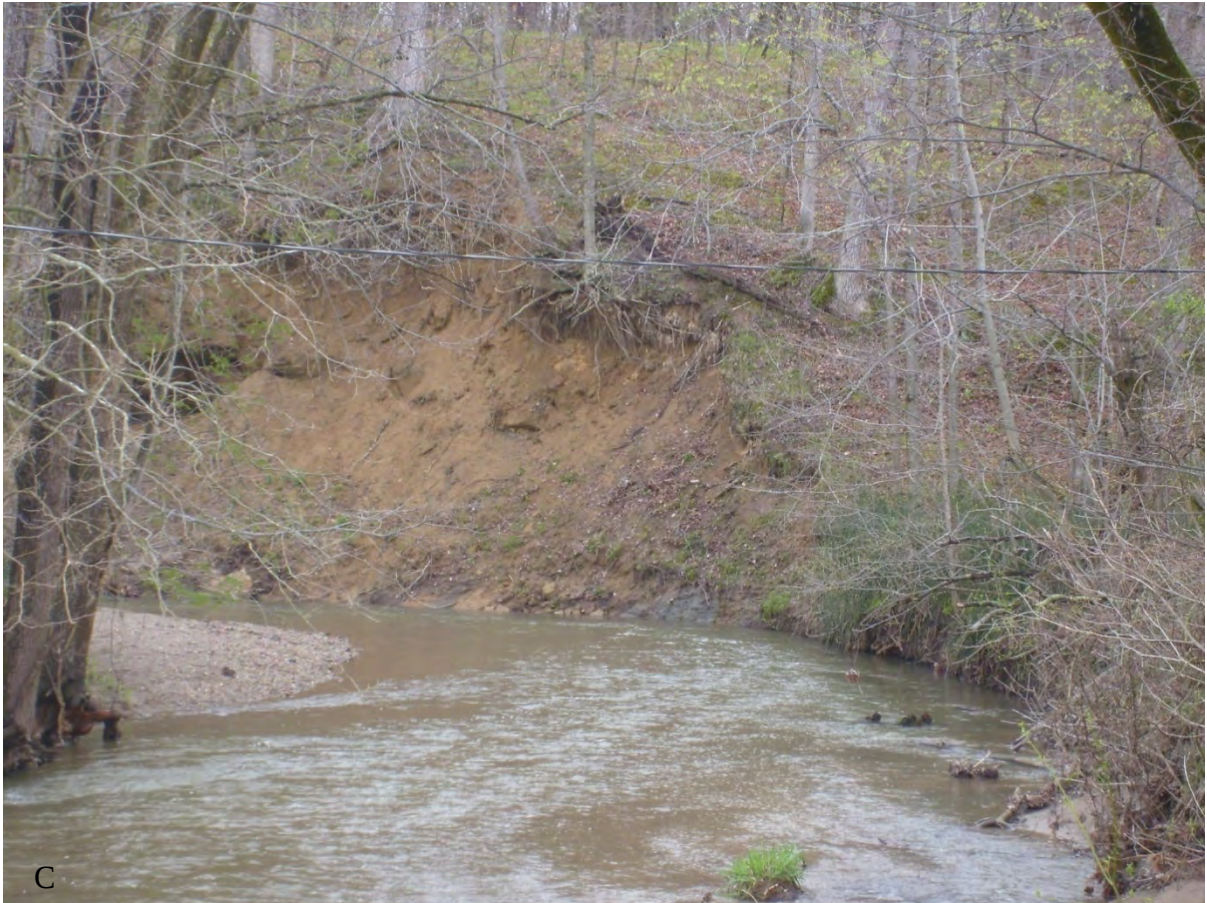
**Picture #7: Bank Erosion on a hillside along Jonathan Creek.**

Bank erosion occurs along several of the steep banks, not only along the main river also along tributaries. Most of these banks are steep and slowly erode sediment into the stream. Eventually the loss of soil and riparian groundcover will allow the trees above to fall down into the stream and be swept along until becoming lodged to create log jams.

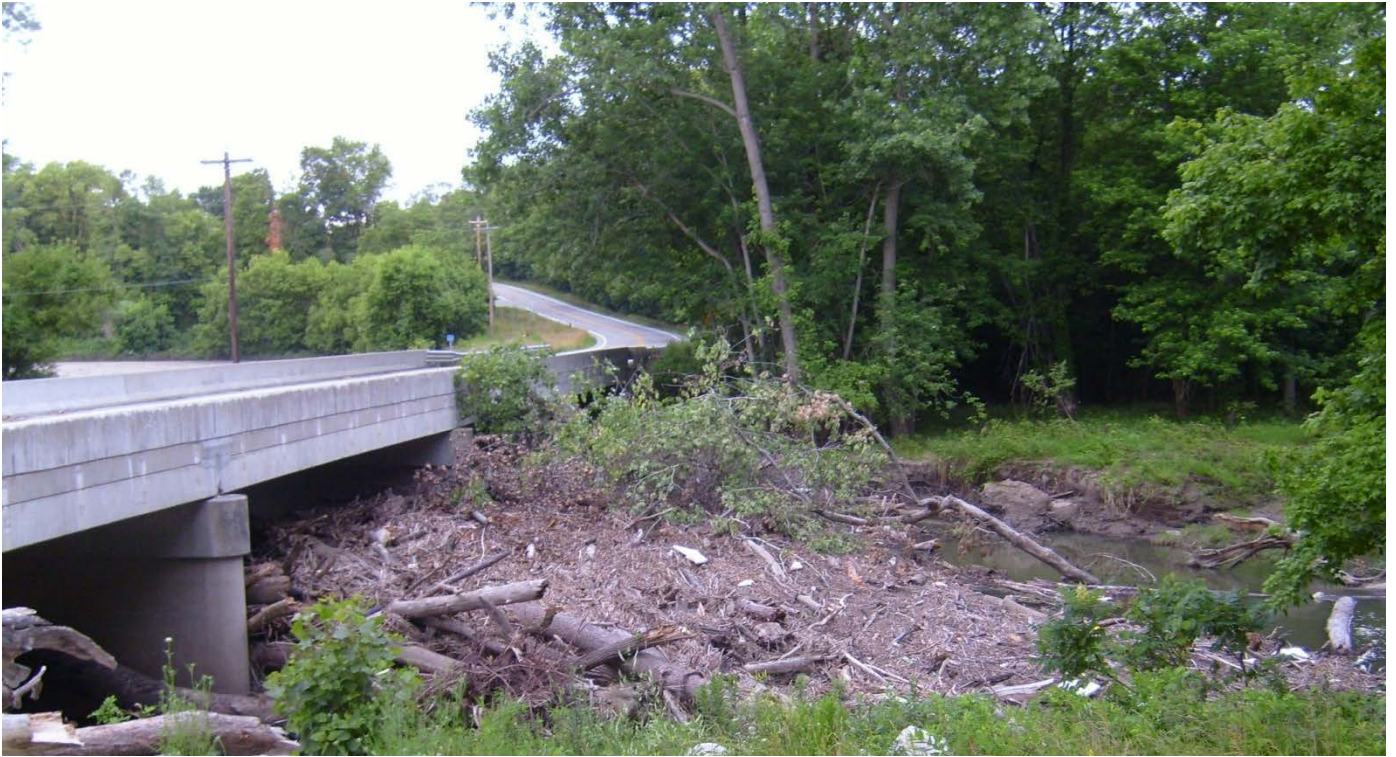
**Picture #8: Log Jam at State Road 71**

Log jams can become very large in size if not removed when small. The log jam located at State Road 71, Horseshoe Bend watershed, could be creating structural issues to the highway bridge. Also, this log jam was so massive in size it was blocking the flow of water downstream. When heavy precipitation occurs upstream more logs become lodged, thus causing scouring and out-washing along the east side of the bank. This caused some of the trees to fall into the streambed. Also, with these log jams come a collection of trash (i.e. fast food bags, cups, cans, etc) in and around the log jams.

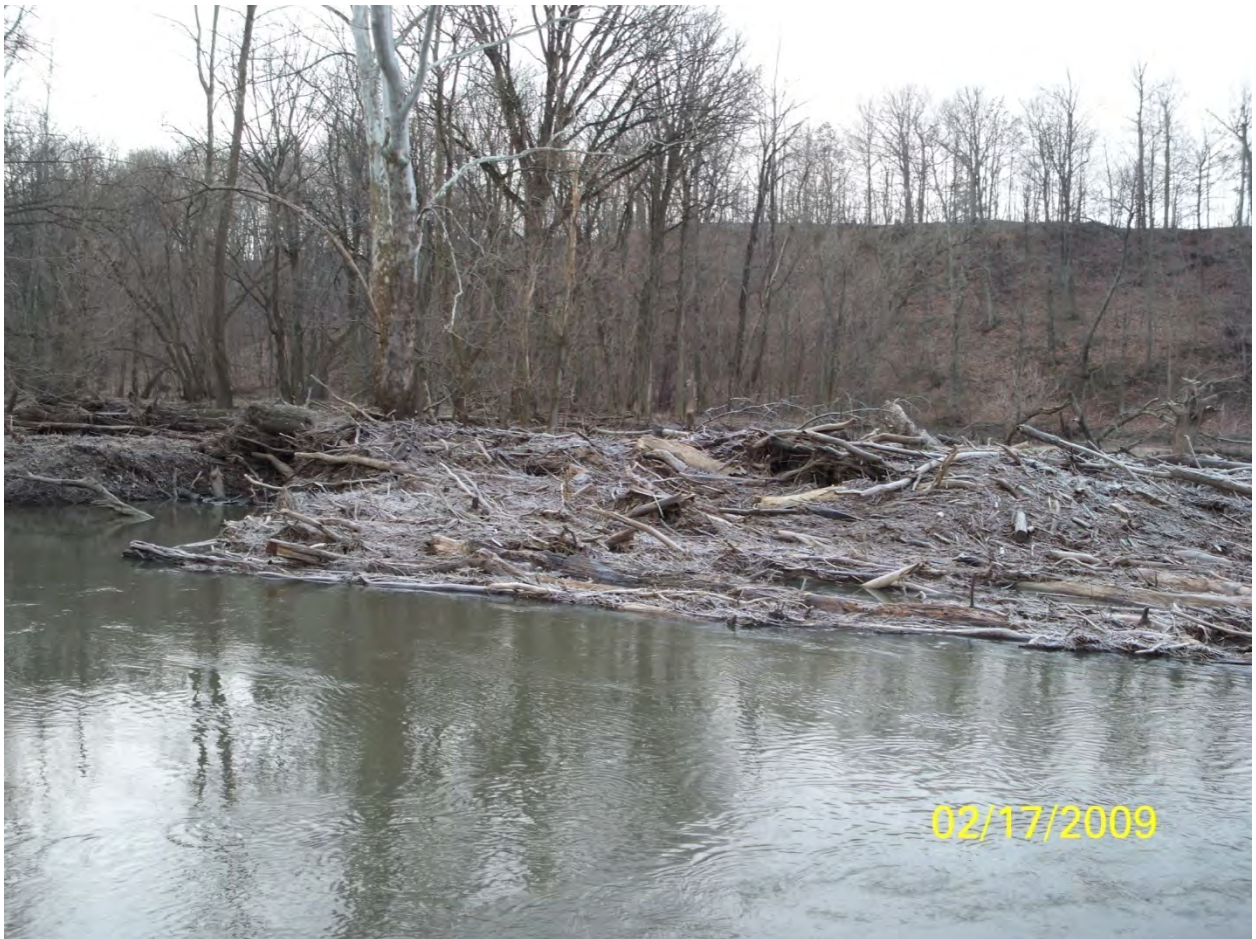
**Picture #9: Log Jam in the Horseshoe Subwatershed in the Little Vermillion River-**

The log jam in photo #9, located in Horseshoe Bend watershed, created a barrier and forced the river to change course, causing bank out-washing and bank collapse. The new channel was causing the riparian buffer (at one time 20 feet) of wooded area to collapse and fall into the river. The farmer took corrective action on this massive log jam by opening the old channel and taking the trees and debris from the opening and damming up the new river channel. The basic theory is when the river floods sediment will deposit on top of the cut channel filling it up and preventing anymore land loss.

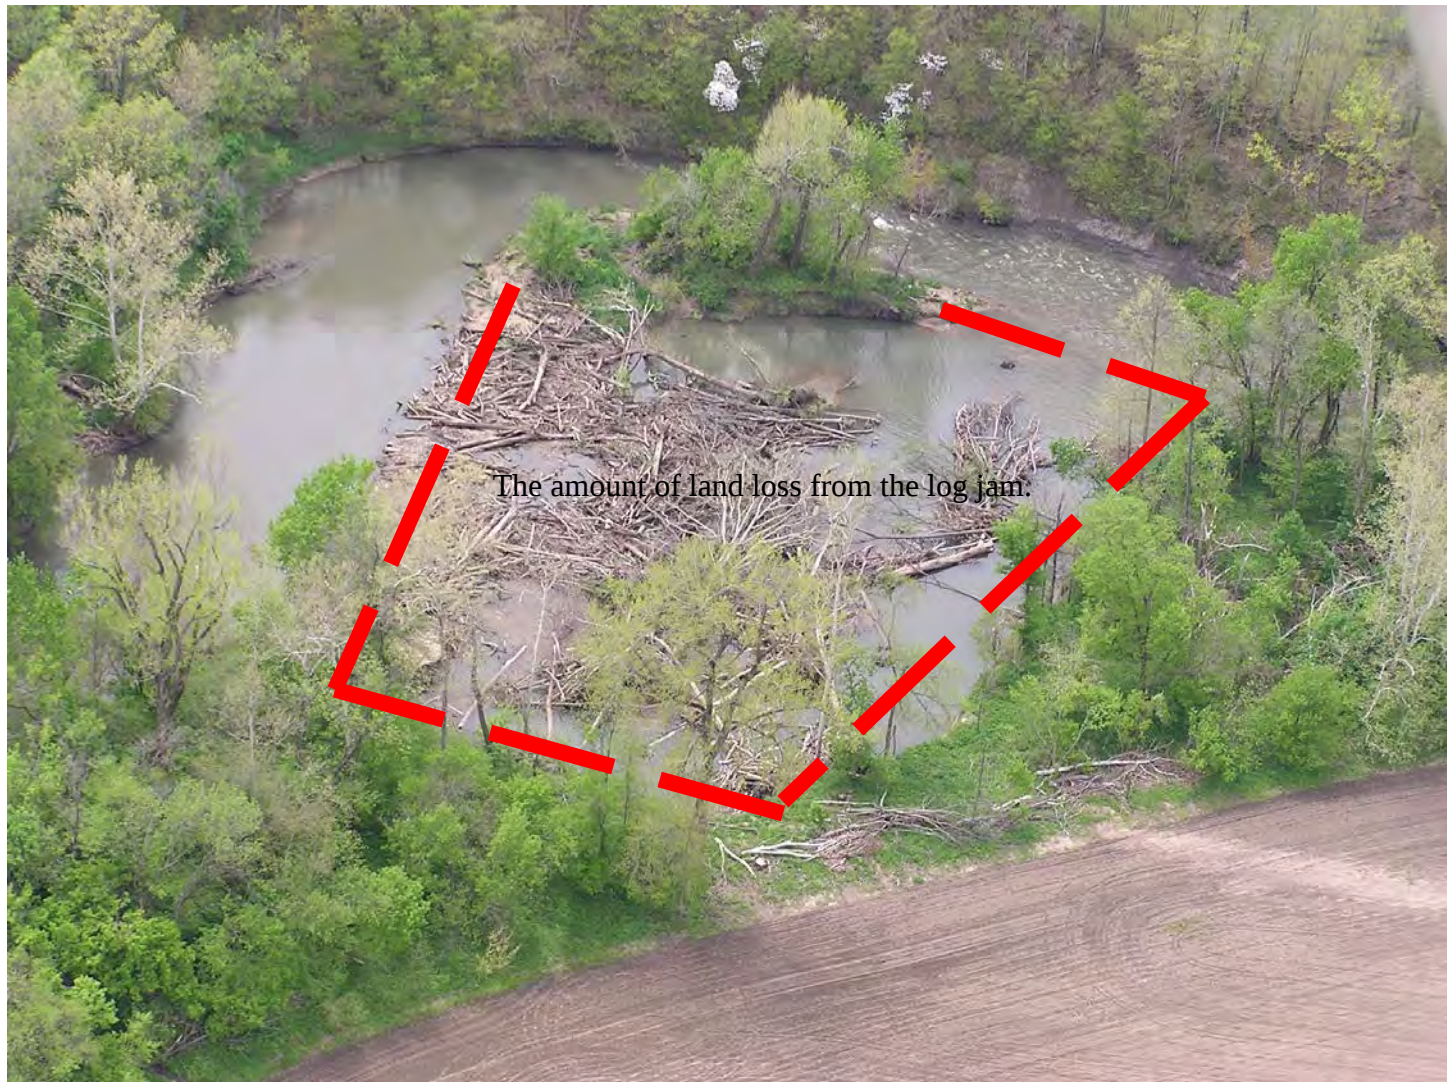
**Picture # 10: Aerial Photo of picture #9, Log Jam in Horseshoe Bend Subwatershed.**

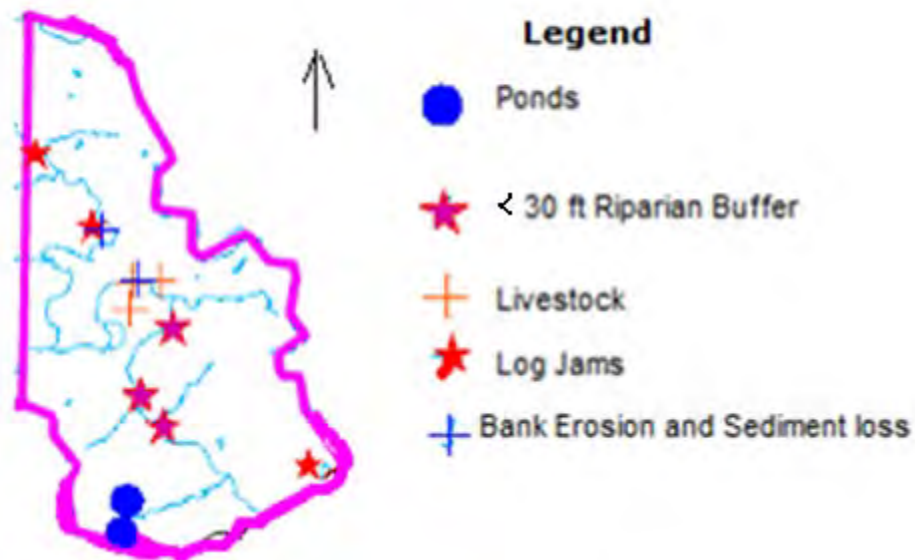
**Figure 30: Horseshoe Subwatershed problem areas**

The Horseshoe subwatershed was identified for bank erosion, riparian loss, high nitrate, high turbidity readings, high *E. coli*, and log jams. As mentioned above three log jams, two ponds, two bank erosions, two areas of livestock (no direct access), and three areas with lack of riparian buffers were identified within this watershed.

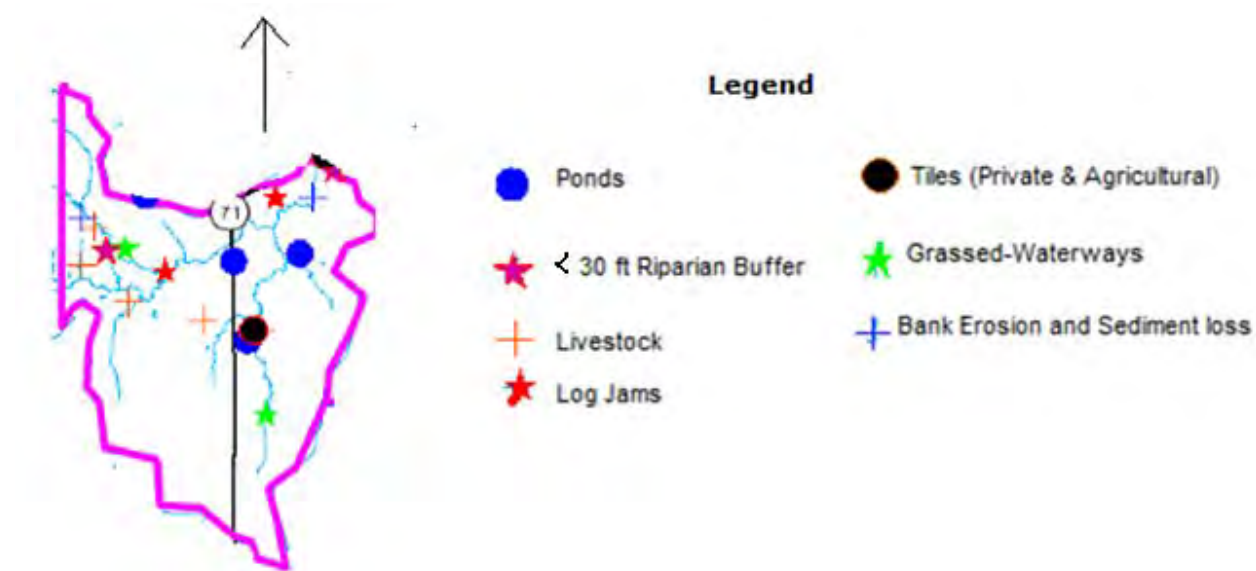
**Figure 34: Jonathan Creek Subwatershed**

This portion of the watershed data indicates we have above our target *E. coli* levels and nitrate levels sampled for the main stem sample site #3 reflects high nitrates present. However, in 2009 when we sampled the tributary the main source of nitrate occurred during the first three months of the spring sampling season. This subwatershed had mostly conventionally tilled corn and did have two fields of no-tilled corn. It also had a substantial amount of no-till beans planted. There were two locations of severe bank erosion within this subwatershed directly next to the stream.

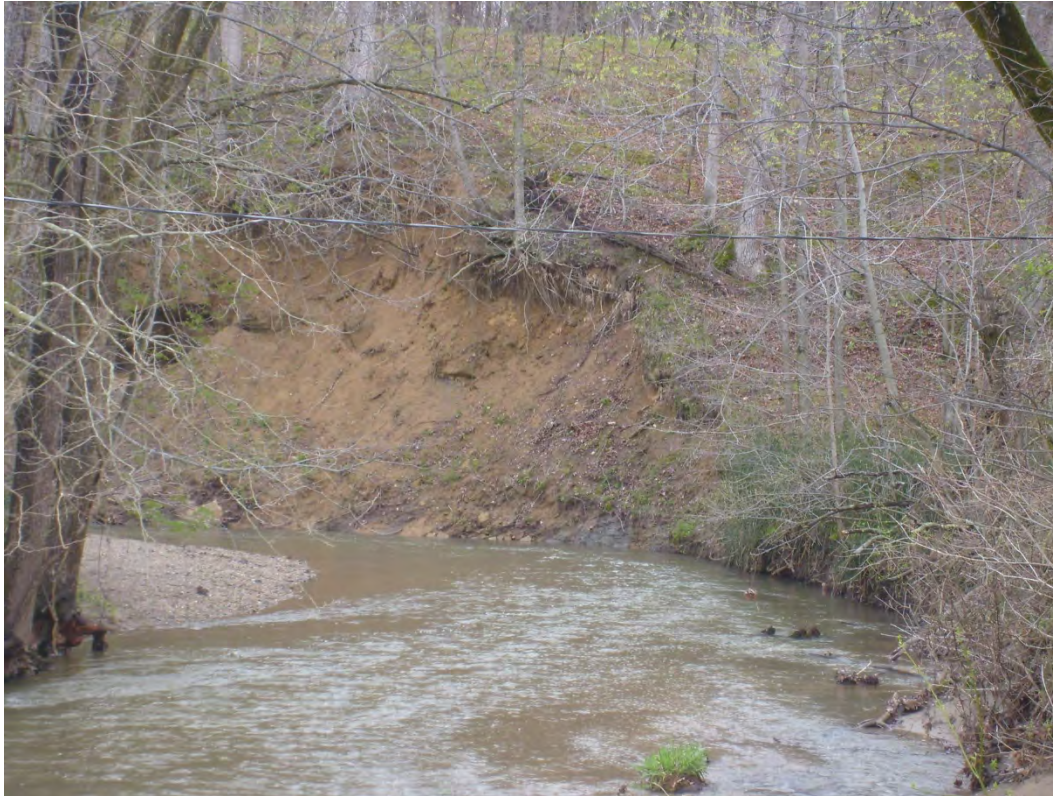
Photo 10: Severe bank erosion identified in Jonathan Creek watershed on Jonathan Creek.

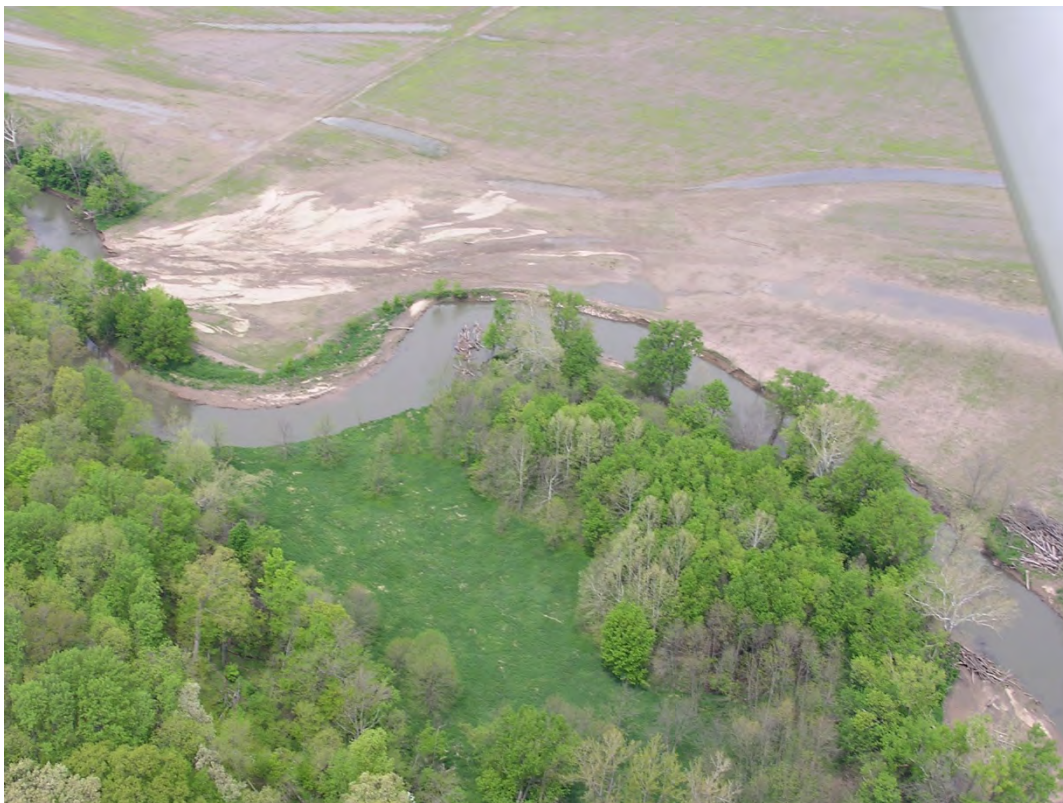
Photo 11: Severe bank erosion identified in Newport watershed on the Little Vermillion River.

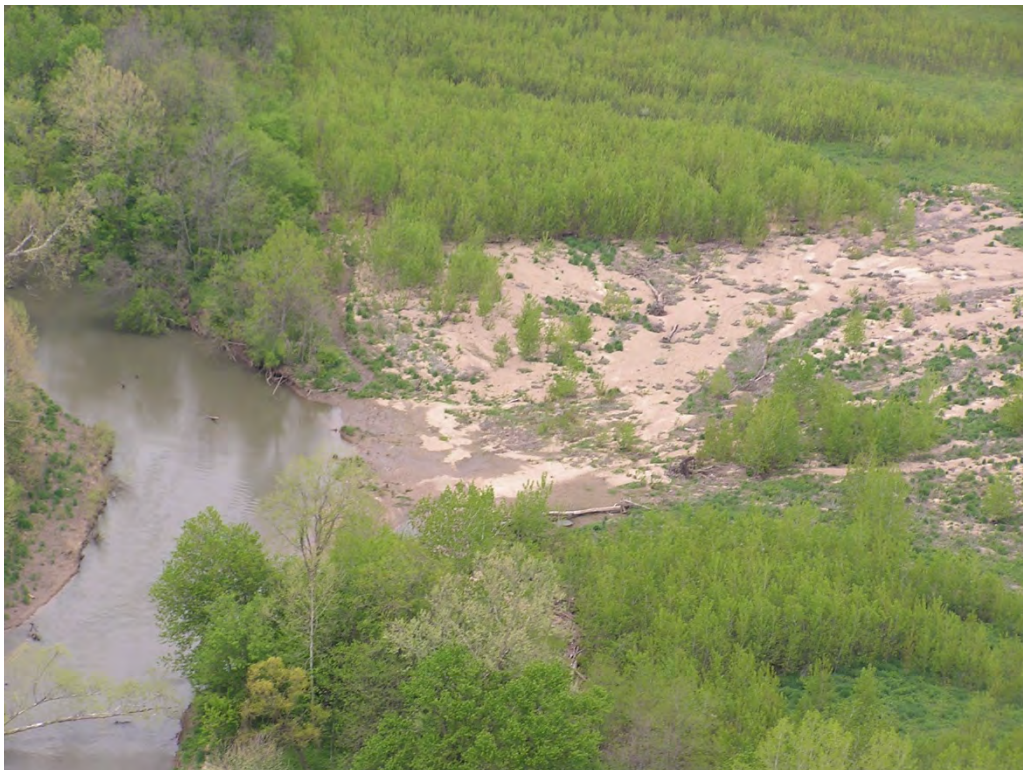
Photo 13: Bank erosion identified in northeast section of Newport watershed along the Little Vermillion River.

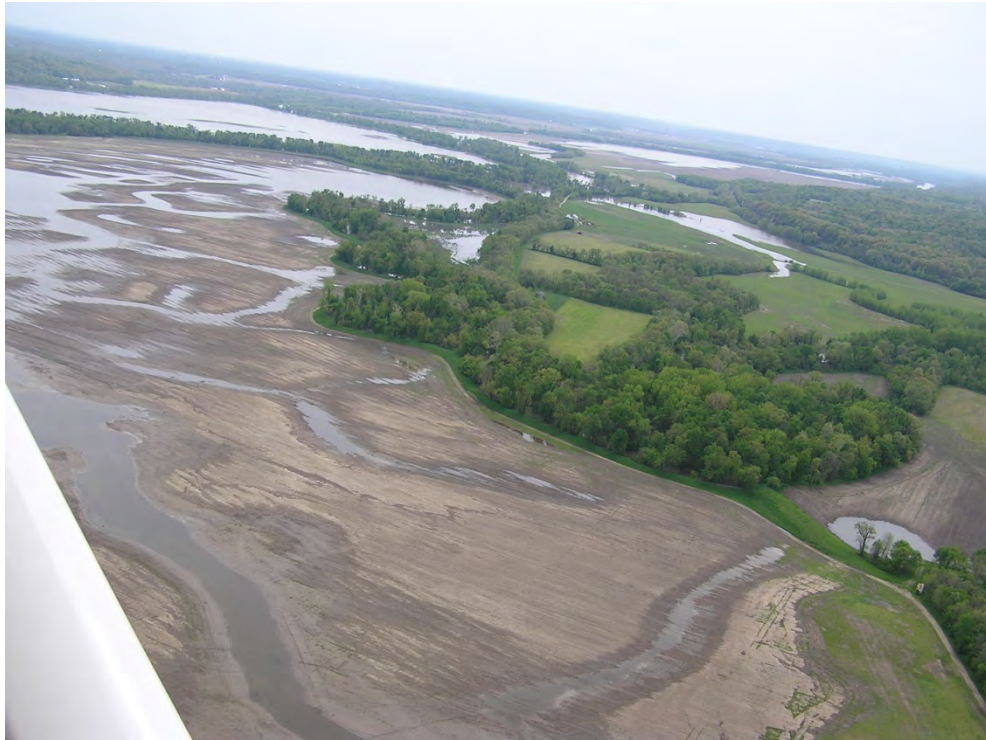
Photo 14: Wabash River flooding the bottoms of the SE Wabash watershed.

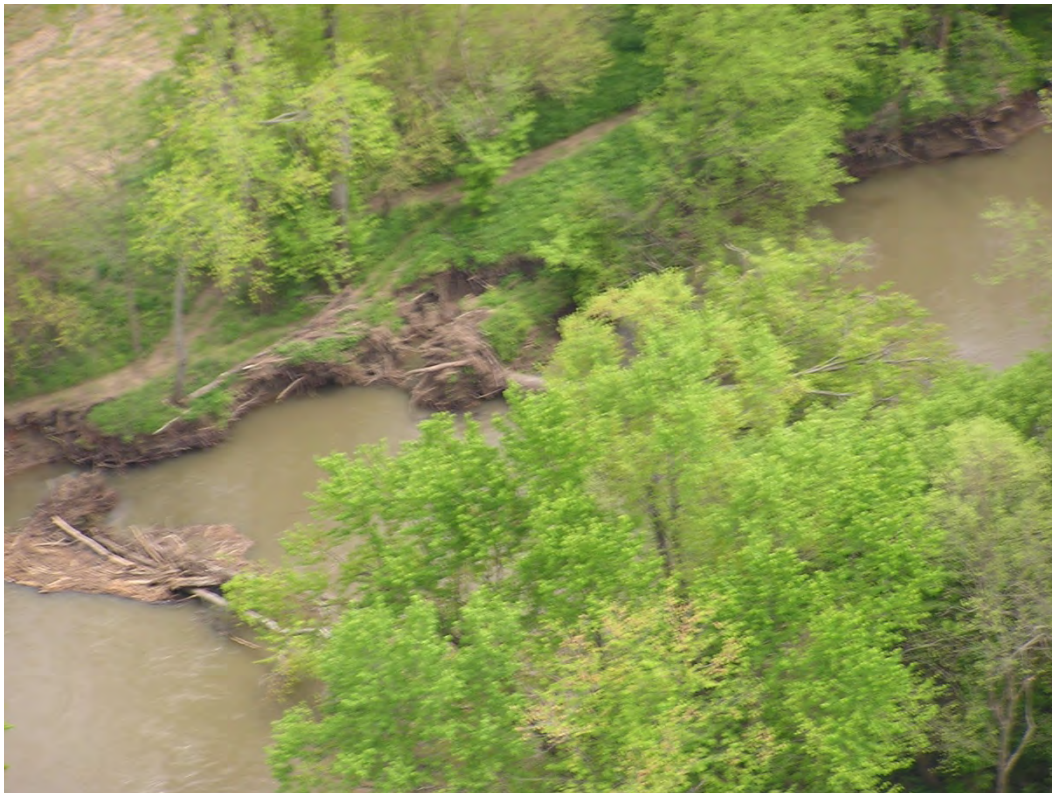
Photo: 15: Small log jam beginning to form in the Newport watershed in the Little Vermillion River.
