Project Name: Lost River WMP

Plan Type: Watershed Management Plan

Watershed Management Plan

For the Lost River Watershed

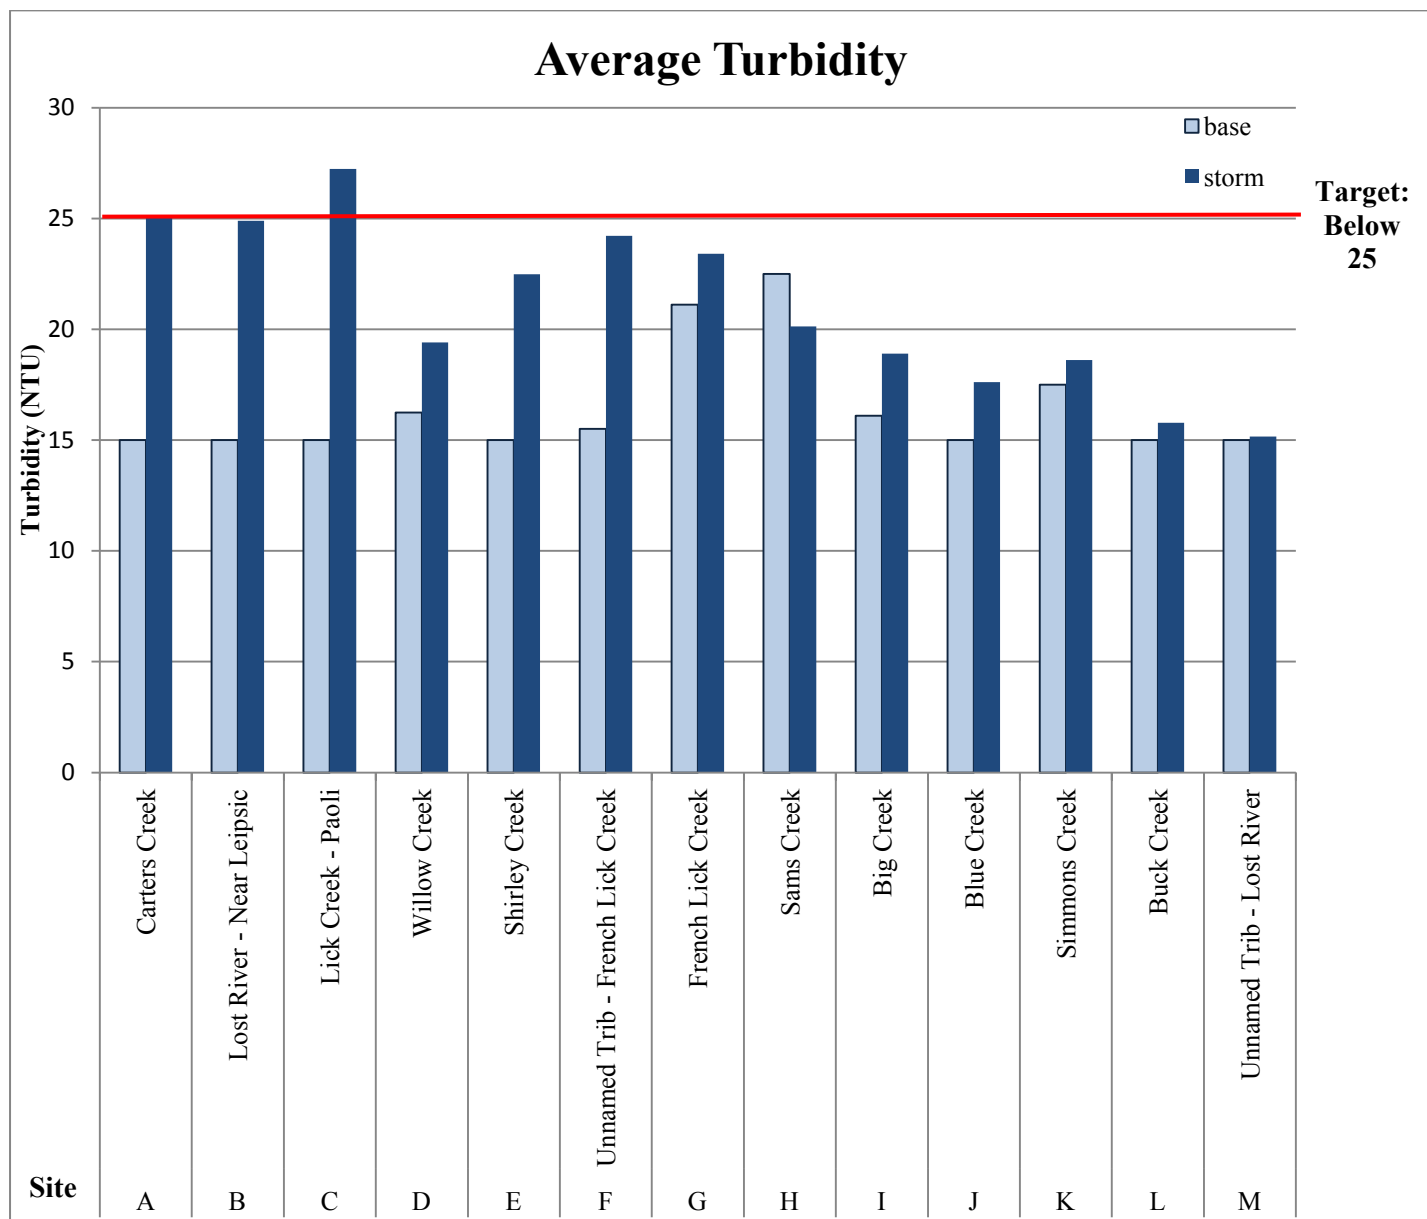
Figure 28: Average Turbidity values at HRLR sampling locations for baseflow and stormflow during the 2011-2012 sampling season.

Turbidity measurements using transparency tubes at the HRLR team sites found only one site, Lick Creek in Paoli, to be above target levels for the average stormflow (Figure 28). All other sites collected by HRLR team were within or just met target levels for both average baseflow and stormflow. However, turbidity measured with a turbidity probe at the Lab sites found that most streams average stormflow was above target levels during the 2011-2012 sampling period (Figure 29). French Lick Creek was also above target levels for average baseflow. This discrepancy may be due to the methods used to measure turbidity, timing of sampling, or differences in streams sampled.

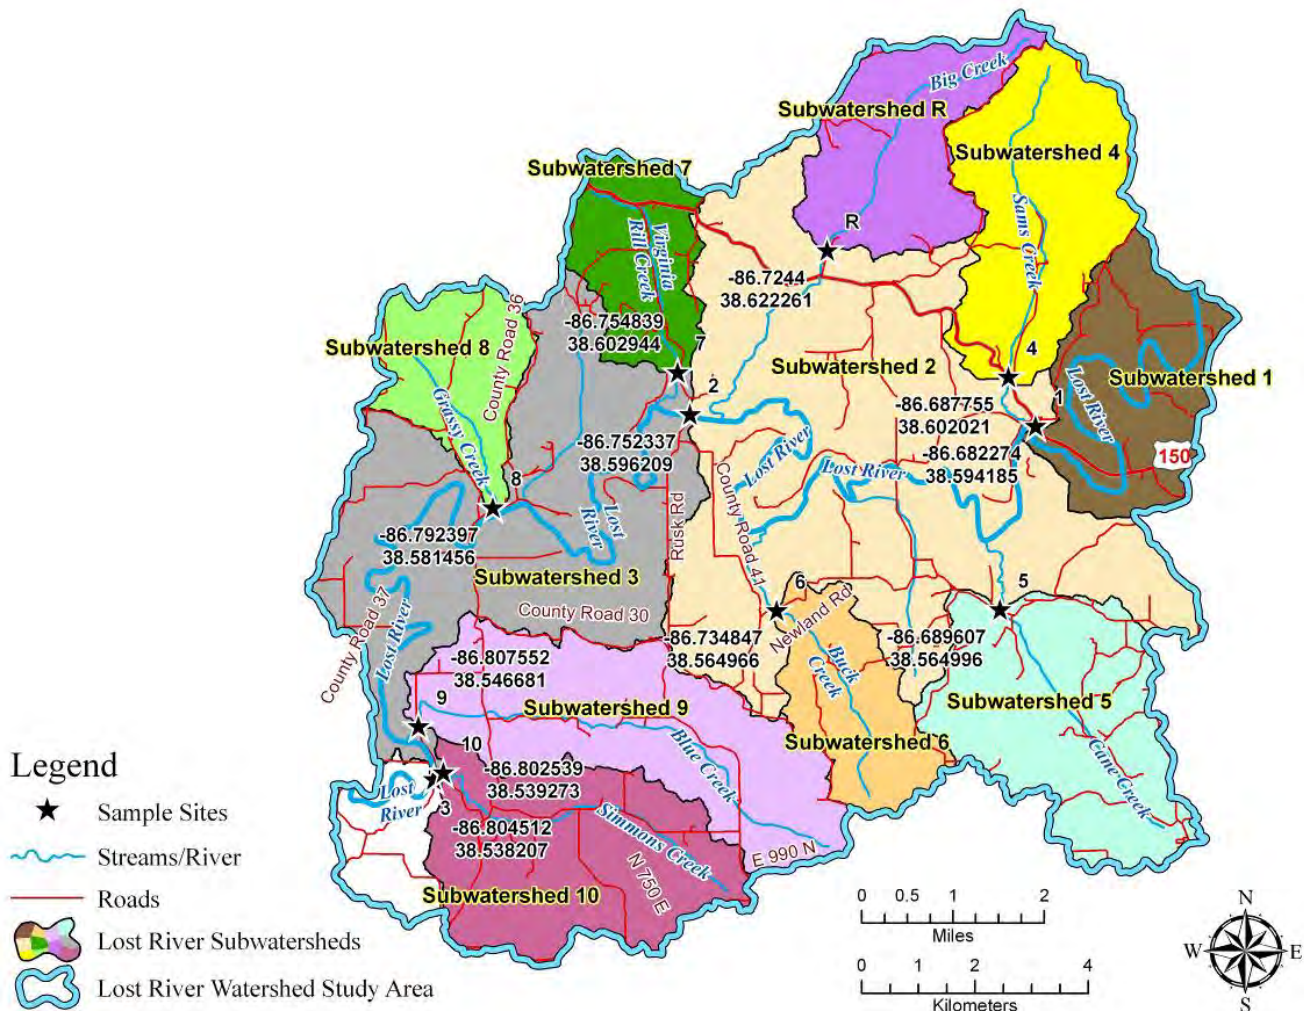
Figure 58: Sample Site Locations for the 2010 LARE Watershed Diagnostic Study conducted in Martin County

Figure 58 shows a total of 11 sample stations including 1 reference station (Station 101) established within the watershed by IDNR LARE staff, Martin County SWCD staff, and Davey staff. Data were collected at each sample site location relating to the physical and chemical properties of surface water in the Lost River watershed study area. Collection of water samples was limited to one baseflow event (10/27/2009 & 10/29/2009) and one stormflow event (4/26/2010). Benthic macroinvertebrates were sampled at all sample sites where water levels were less than 1 meter (3.28 feet) on October 26th-29th, 2009. The Qualitative Habitat Evaluation Index (QHEI) was used to evaluate the physical habitat of a waterway. A QHEI analysis was conducted at all sample sites on October 26th-29th, 2009

Macroinvertebrate Hilsenhoff Biotic Index (HBI) scores suggest that five out of seven sites sampled (Stations 5-7 and 9-10 in Figure 58) have very substantial to fairly substantial organic pollution. Some organic pollution is likely at Station R, and organic pollution is unlikely at Station 4. In HBI, the degree of organic pollution is indirectly determined by the number of organisms tolerant of low DO levels. Stations 5 and 6 had the worst HBI scores and the consistently lowest levels of DO. Dissolved oxygen levels at both sites were well within water quality standards.

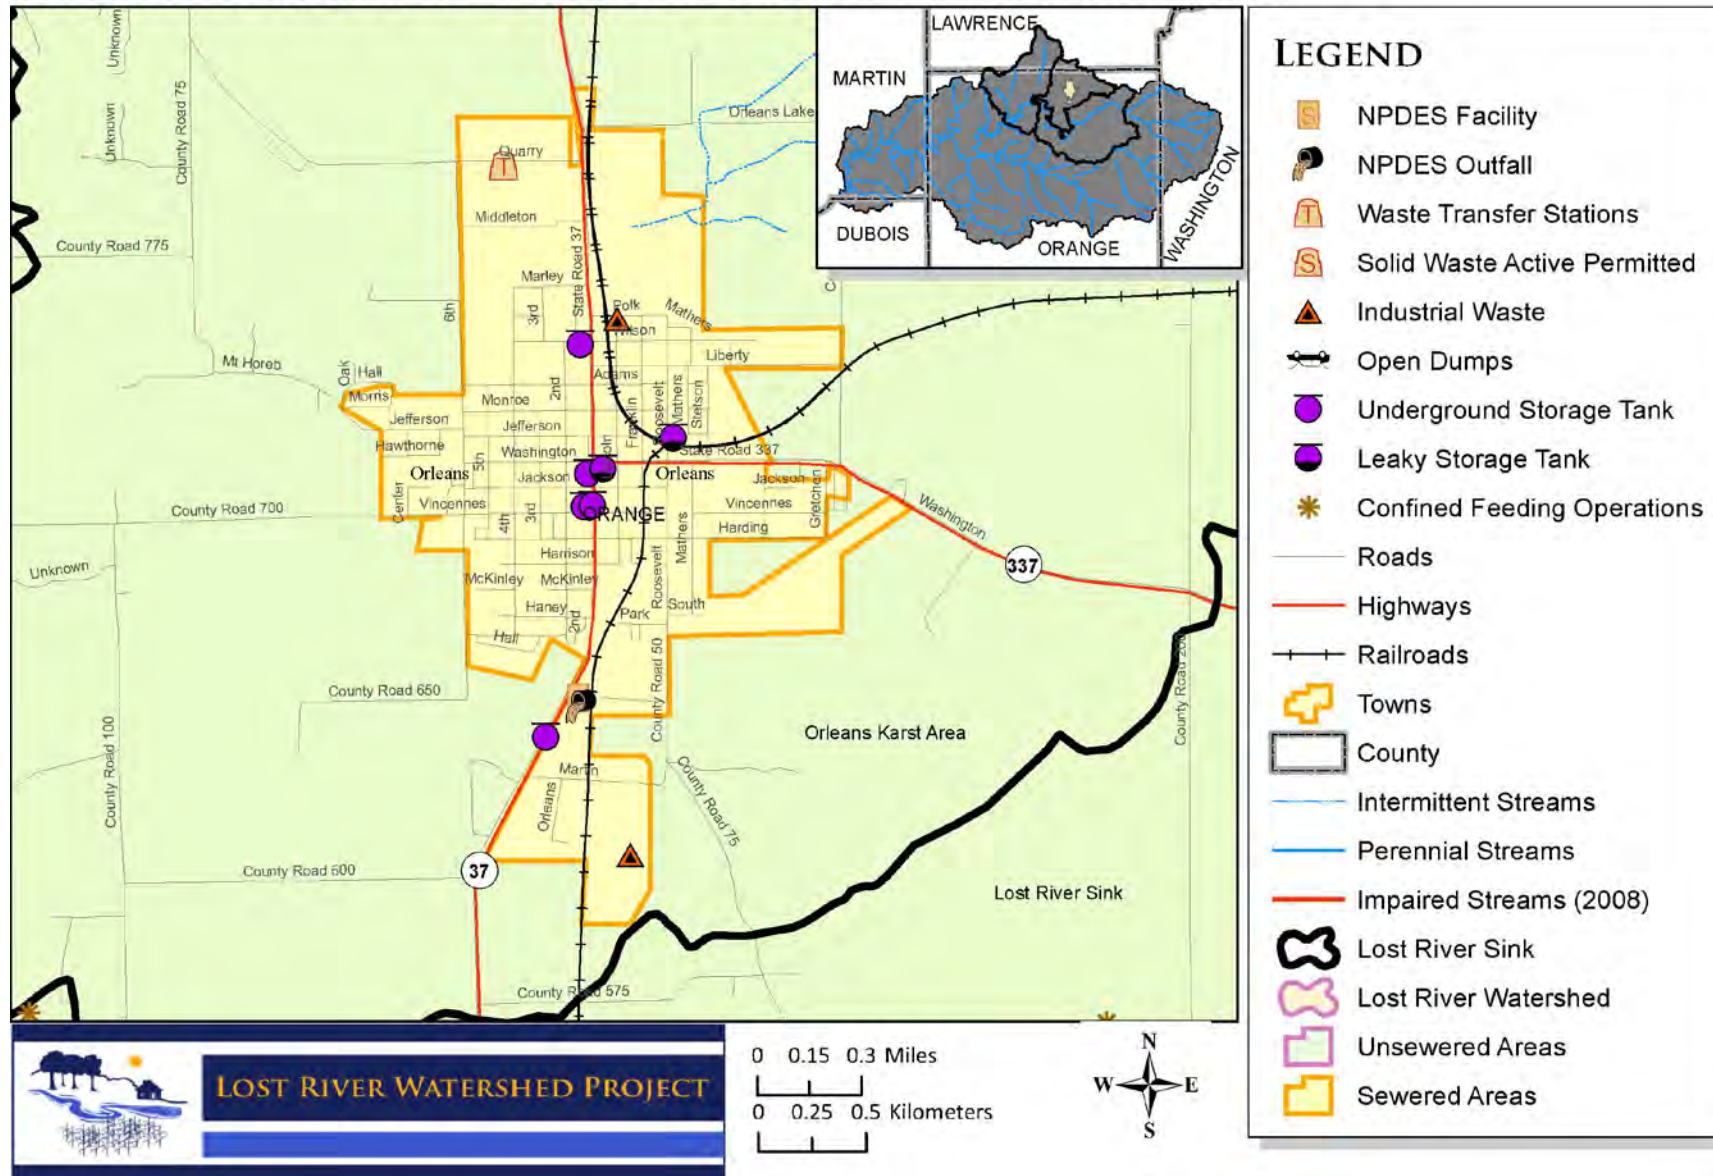
Figure 102:
Town of
Orleans
Permitted
facilities and
Sewer
Boundaries

TOWN OF ORLEANS PERMITTED FACILITIES FLOOD CREEK AND ORLEANS KARST AREA DRAINAGE

There is one Transfer waste station in the town limits of Orleans, which also holds a Solid Waste Active permit (Figure 102). Two businesses produce industrial waste within the town of Orleans. One has been closed and no longer has industrial waste on its premise. One open dump is located in the area and it is a used car parts lot. There is one NPDES Facility with one NPDES outlet from the wastewater treatment plant in Orleans. Discharges from this plant are to a sinkhole that drains to the underground river system. This plant has had some discharge violations due to an old collection system that allows for leaking and infiltration into the sewer lines. This causes a surge of water to the treatment plant during rain events and leads to overflows of the system. This plant has been in violation seven of the last 12 quarters. The violations are for biochemical oxygen demand, high levels of ammonia nitrogen and high levels of E.coli being discharged as effluent.

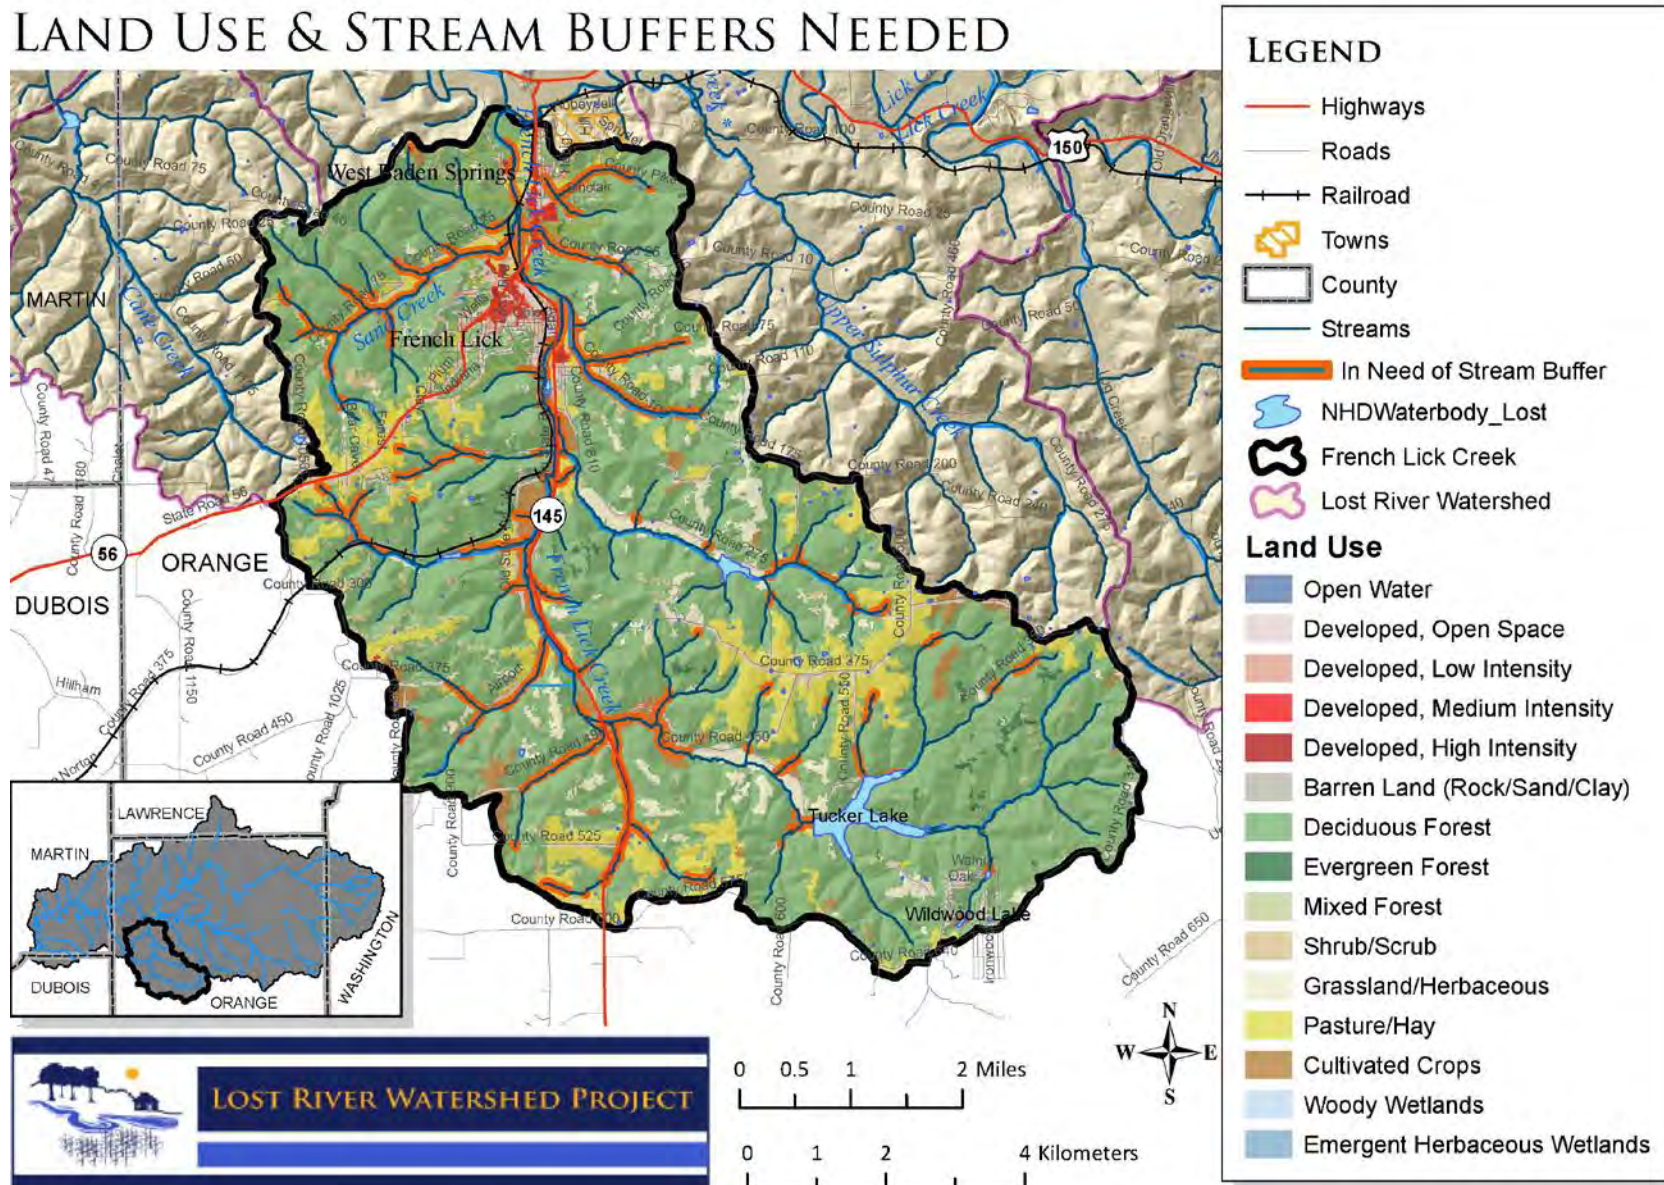
Figure 169:
French Lick
Creek
Subwatershed-
Land use (2006)
and areas in
need of stream
buffers

FRENCH LICK CREEK SUB-WATERSHED LAND USE & STREAM BUFFERS NEEDED

The total area of French Lick Creek subwatershed is 21,928 acres. The majority of landuse in this subwatershed is forested (Figure 169). Forested lands make up 15,654 acres or 71.4% of the subwatershed. Pasture and hay lands makes up 2,692 acres or 12.2% of the watershed. Crop production occurs on 642.2 acres primarily along stream valleys or on hilltop plateaus. The developed areas are primarily in the Towns of French Lick and West Baden and in rural areas. The developed areas make up 1,570 acres of the watershed. Open space accounts for 1258.3 acres of the developed areas. Shrub land makes up 256 acres and grassland makes up 971 acres. Large sections of this watershed are managed by Hoosier National Forest and DNR (Figure 170). There are 76.99 miles of stream channels within the French Lick Creek subwatershed with 26.79 miles of perennial streams.

Most of the pasture land is on ridge tops while most crop lands are within the river valley where the soils are most fertile and the slope is gentle enough for equipment harvest and tend to row crops. Because of the location of the row crops, the areas along the streams and river in these areas are in need of riparian buffers. Within French Lick Creek subwatershed, 13.34 miles of stream corridor are in need of riparian buffers, of this 6.7 miles is perennial in nature (Figure 169).
