Morse Reservoir/Cicero Creek Watershed Management Plan

Boone, Clinton, Hamilton, and Tipton Counties, Indiana

February 2011

Prepared by:
V3 COMPANIES

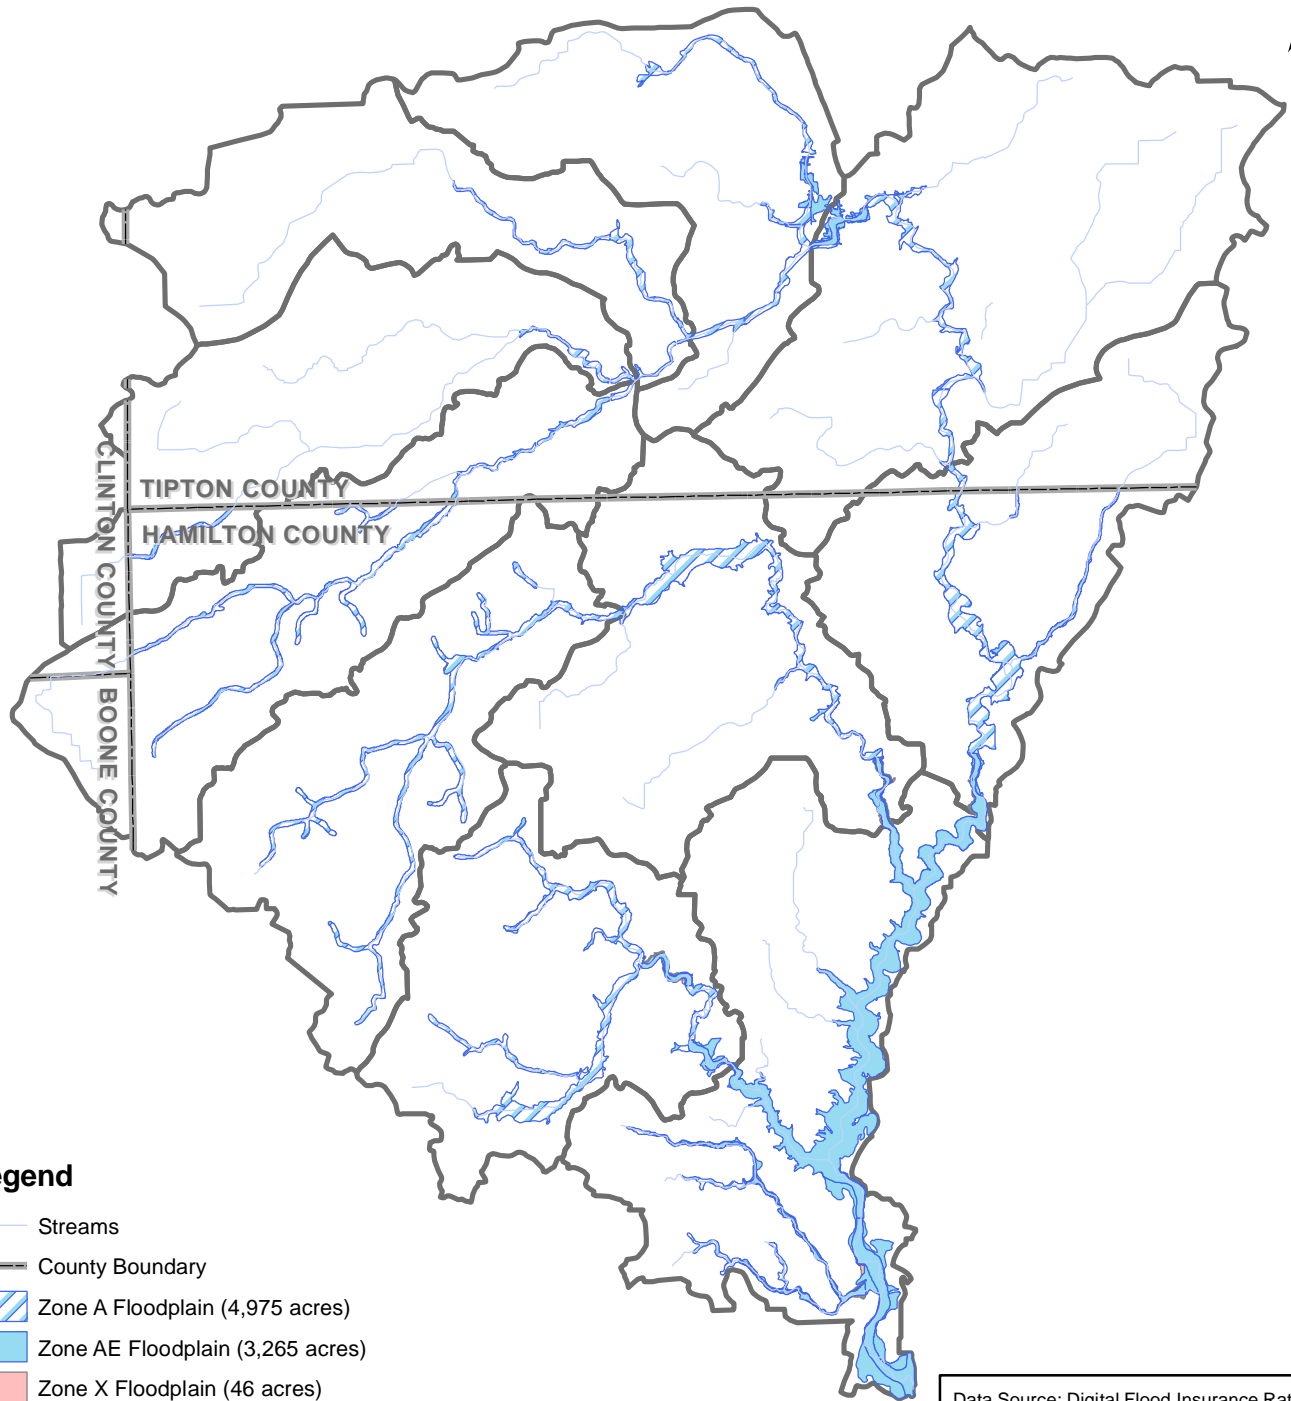
Flooding is one of the most common hazards in the United States. Floods can occur on a local level, or can affect entire river basins. The Federal Emergency Management Agency (FEMA) has developed Flood Insurance Rate Maps (FIRMs) for many parts of the country in order for individuals and governments to assess the risk of flooding in specific areas. These maps also indicate what insurance rates property owners may need to pay to develop property in these areas. The current FIRM panels for the Morse Reservoir/Cicero Creek Watershed are shown on Exhibit 3.

There are three flood hazard areas identified within the watershed. Zone A, which is defined as an area inundated by 100-year flooding for which no base flood elevations (BFEs) have been established comprises 4,975 acres (3.4% of the watershed). In this zone there is a 1% chance of annual flooding, and a 26% chance that the area will be inundated at sometime during the life of a 30-year mortgage. Zone AE, which is defined as an area inundated by 100-year flooding for which BFEs have been determined, comprises 3,265 acres (2.3% of the watershed). Chance of flooding in Zone AE is the same as in Zone A. However, Zone A floodplain boundaries are based off of approximate methods, and Zone AE floodplain boundaries are based off of detailed hydrologic and hydraulic analyses, establishing BFEs and making the delineation more accurate. Zone X, which is defined as an area that is either determined to be outside the 100-year floodplain but within the 500-year floodplain (0.2% chance of annual flooding) or have a 1% chance of sheet flow flooding where the average

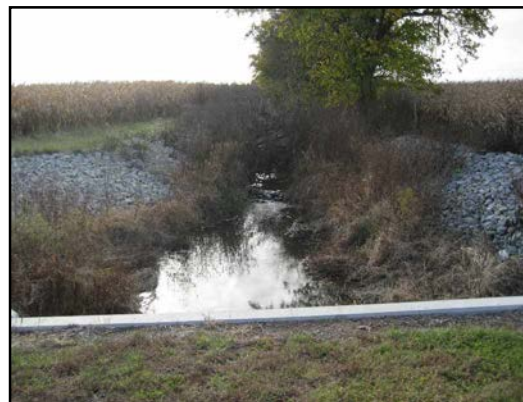
Example of Rip-Rap Stabilized Streambank

Streambank erosion is a natural process within a stream system; however erosion is often accelerated through alterations to the natural system (e.g. changes in landuse, animal access to streams, etc). This accelerated erosion can contribute high sediment loads to the receiving stream, which is a concern due both to the impacts of the sediment itself, and of the contaminants that often bind with, or otherwise reside in the sediment. Suspended sediment is a component of the amount of particulate matter in the water column and contributes to increases in the total suspended solids values, making it more difficult and often times impossible for fish and aquatic macroinvertebrates to live. The sediment itself can smother aquatic habitat and therefore negatively affect the aquatic flora and fauna. Sediment can also transport nutrients, especially phosphorus that tends to adhere to sediment particles causing excess algal growth leading to the large swings in DO. Streambank erosion was assessed on a subwatershed scale at each of the waterway crossing points. Identification of streambank erosion was broken up into the following categories: absent, stabilized (rip-rap, coir log, etc.), present > 3 feet tall and present < 3 feet tall.

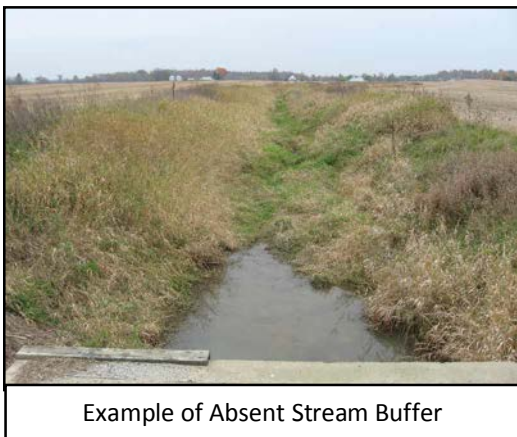
Example of Absent Stream Buffer

Stream buffers are areas of natural vegetation between a surface water body and the surrounding land use. Buffers were only identified as adequate if they were at least ten feet in width. As shown on the example picture, Absent Buffers are those where the agricultural land or development is farmed/built up to the top of the stream bank leaving no possibility of runoff from being filtered through a grassed or treed area before entering the stream. Runoff from the surrounding land may carry sediment and organic matter, and plant nutrients and pesticides that are

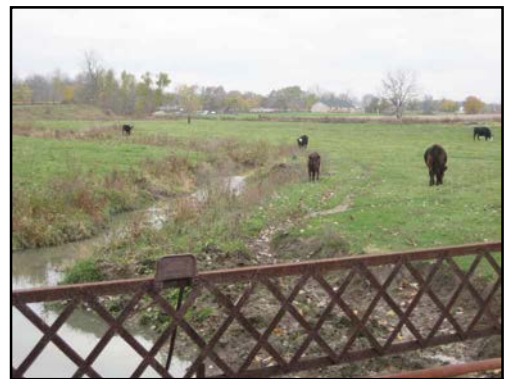
Example of Animal Access to Stream

In-stream debris was also noted during the windshield survey. In-stream debris can inhibit wildlife and aquatic habitat, increase flooding risks, and introduce additional pollutants. This information is valuable for the purposes of determining public education opportunities. Debris was assessed on a subwatershed scale based on the presence and type of debris (trash, deposits, log jam, etc) identified during the windshield survey. Animal access was assessed on a subwatershed scale based on the presence of animals or indicators of access.

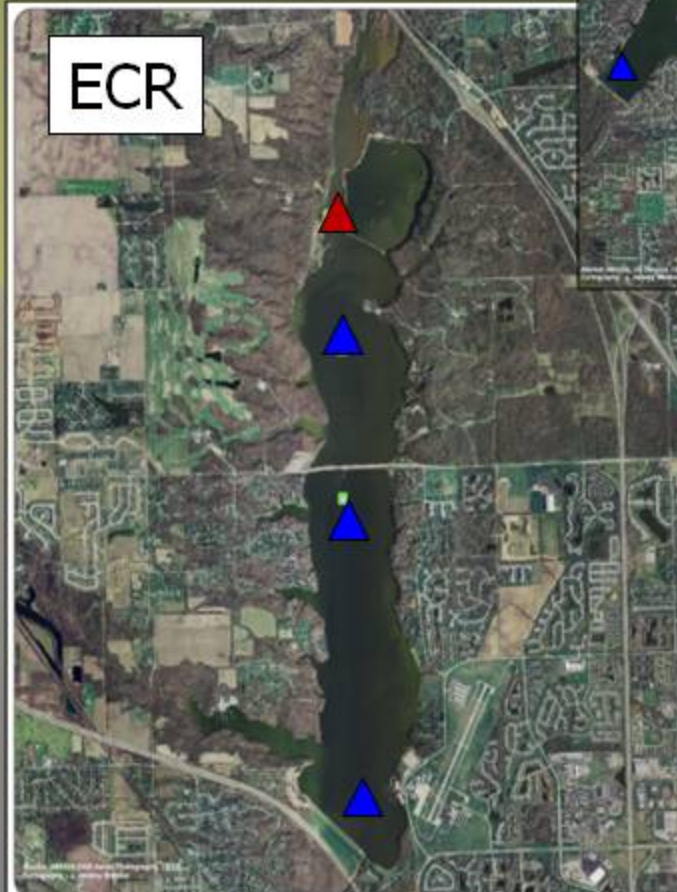
2008 Reservoir Study Sites Eagle Creek, Geist, & Morse Reservoirs

- ▲ Water Quality Monitoring Station
- ▲ Water Quality and Algal Toxin

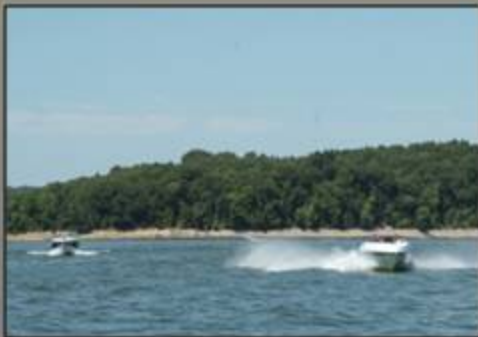
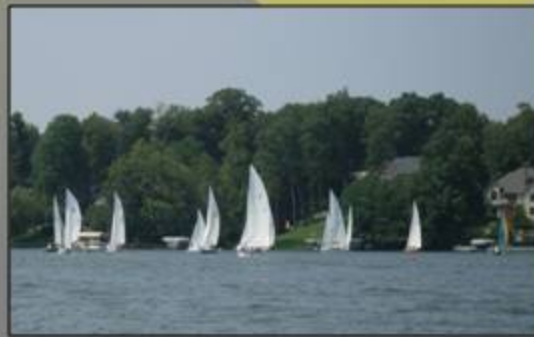
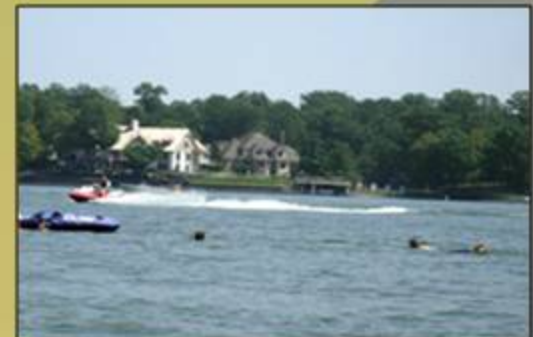
Algal Species Dynamics in Central Indiana Reservoirs

- Shallow, frequently mixed, nutrient-rich reservoirs in Central Indiana are dominated by *Oscillatoria sp.* and *Planktothrix agardhii* throughout the growing season
- Cyanobacterial cell counts exceed 100,000 cells/mL by mid-July and persist
- Reservoirs are turbid, with shallow light penetration favoring *Oscillatoriales* which are known to be low light specialists

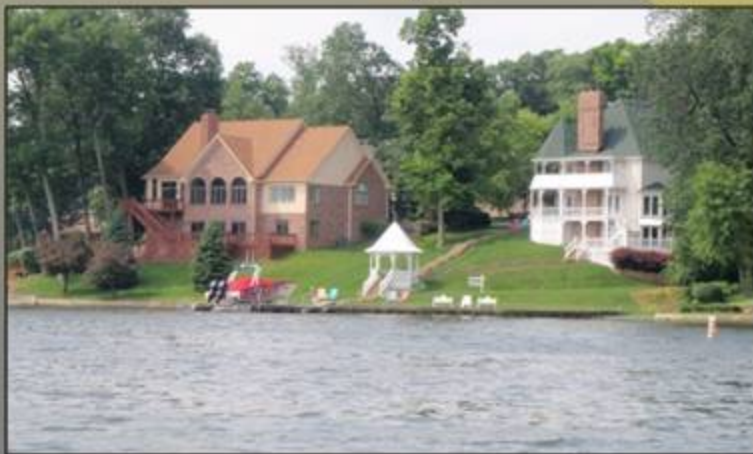
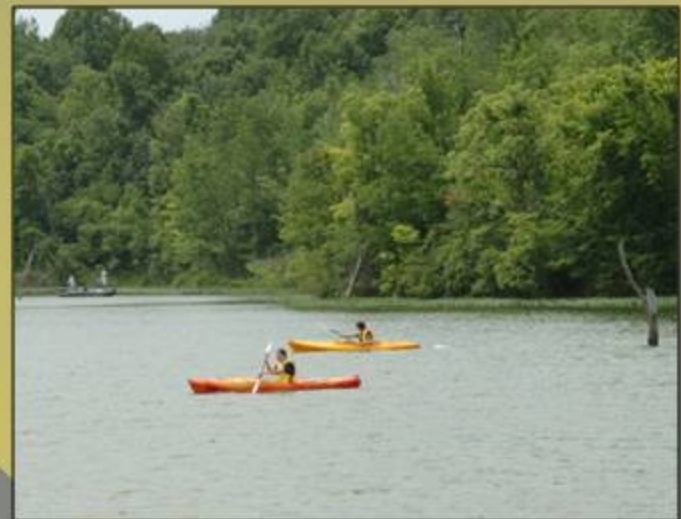
Microcystin Occurrence in Central Indiana Reservoirs

- Microcystin toxin was present at the three reservoirs at low levels
 - Geist Reservoir > Morse > Eagle Creek
- Ongoing data analysis continues to assess nutrient, taste and odor and microcystin relationships and trends.

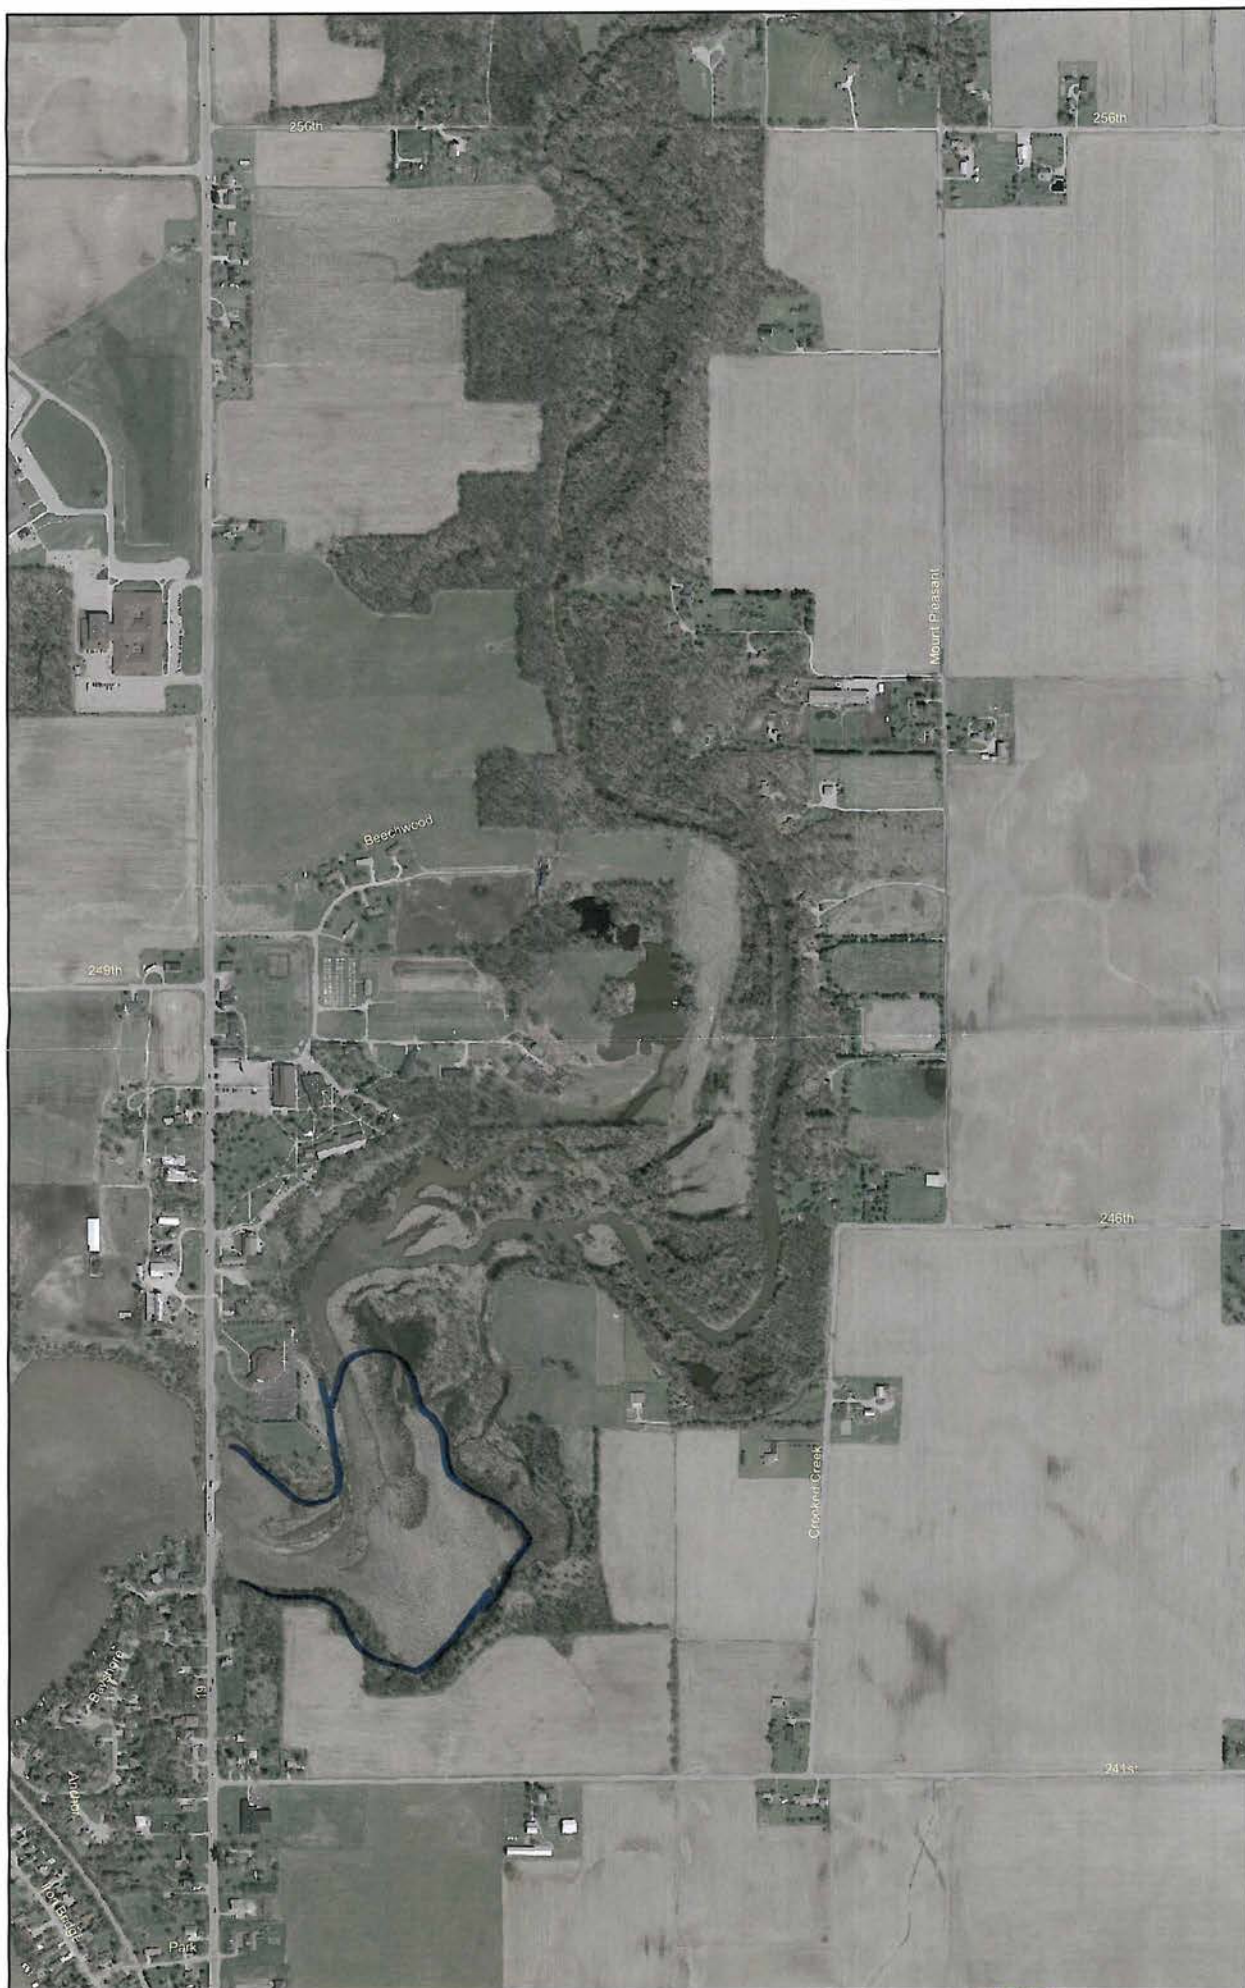
SHEET: 1
OF: 1

V3 completed at Reservoir Shoreline Investigation of Morse Reservoir In June 2009, using both field observations and aerial photography. During the survey, areas of unprotected shoreline were identified in order to gain an understanding of where erosion may be a concern. An exhibit showing the areas of unprotected shoreline is included in this Appendix along with a copy of the field notes. Photographs taken during the field observations are provided on CD at the end of this report.

— Unprotected Shoreline
