Project Name: Central Muscatatuck WMP

Plan Type: Watershed Management Plan

CENTRAL MUSCATATUCK WATERSHED PROJECT

WATERSHED MANAGEMENT PLAN

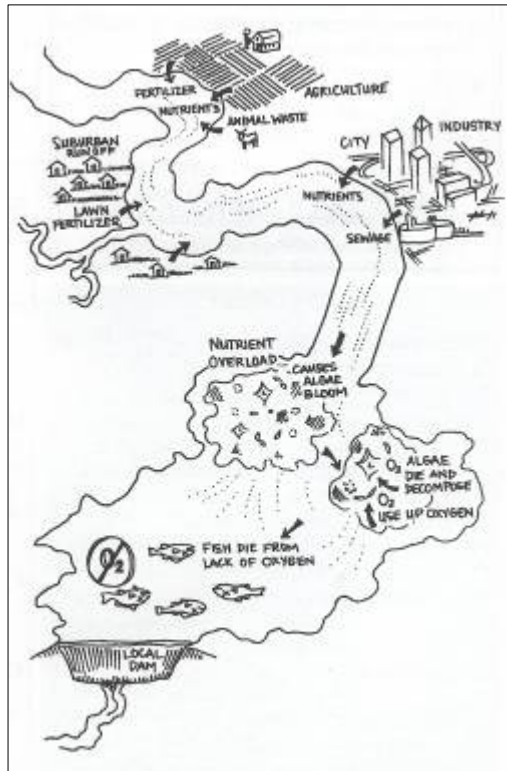
Figure 30: Eutrophication

Phosphorous is essential to plant and animal life and its presence in the environment is natural. However, it can be the most limiting nutrient to plant growth in freshwater. Phosphorous water pollution issues result from the presence of excessive amounts and it is not toxic to plants or humans unless high levels are present. Naturally, healthy aquatic ecosystems develop with low levels of phosphorous and the addition of seemingly small amounts of phosphorous can lead to problematic algal blooms. Algae consume oxygen needed to support other aquatic life. When the extra algae die and decompose, they continue to consume oxygen. When excessive amount of oxygen are depleted in the water it is called hypoxia, and that can lead to fish kills. Eutrophication (depicted in figure 30) occurs when high phosphorous levels cause excessive plant growth, also called nutrient overload.
