Project Name: Plummer Creek WMP

Plan Type: Watershed Management Plan

Sponsor: Greene County SWCD

Plummer Creek Watershed Management Plan

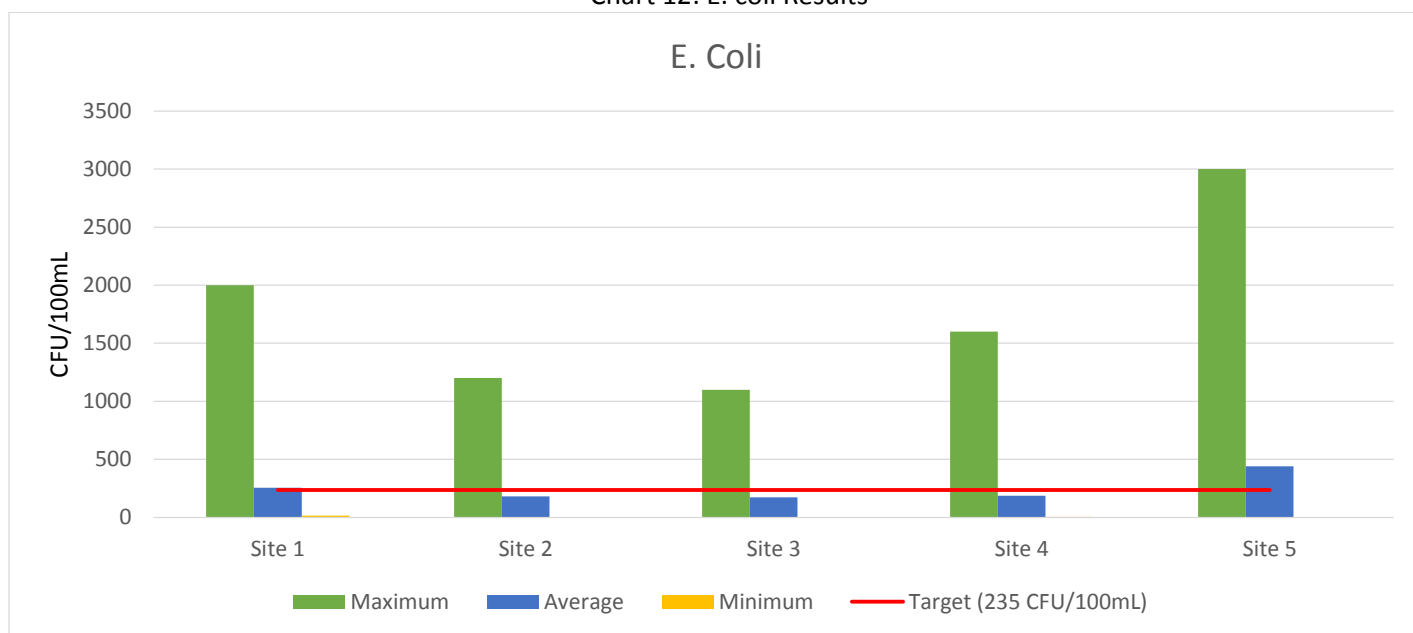
Chart 12: E. coli Results

Escherichia coli (E. coli) bacteria are found in the lower intestine and feces of warm-blooded animals. Some strains of E. coli can cause illness when they enter the body through the mouth, nose, eyes, ears, or cuts in the skin. The presence of E. coli in water is a good indicator of fecal contamination and the presence of other bacteria harmful to human health. Typical sources of E. coli in water are combined sewer overflows, malfunctioning septic systems, and livestock manure. E. coli samples were gathered at the stream and taken to the lab for analysis within 6 hours of collection to ensure an accurate count. E. coli measurements must have a geometric mean below 125 colony forming units (CFU) per 100 mL and no one individual sample with more than 235 CFU/100 mL. Our tests results show that every site had at least one sample that exceeded 235 CFU/100mL.

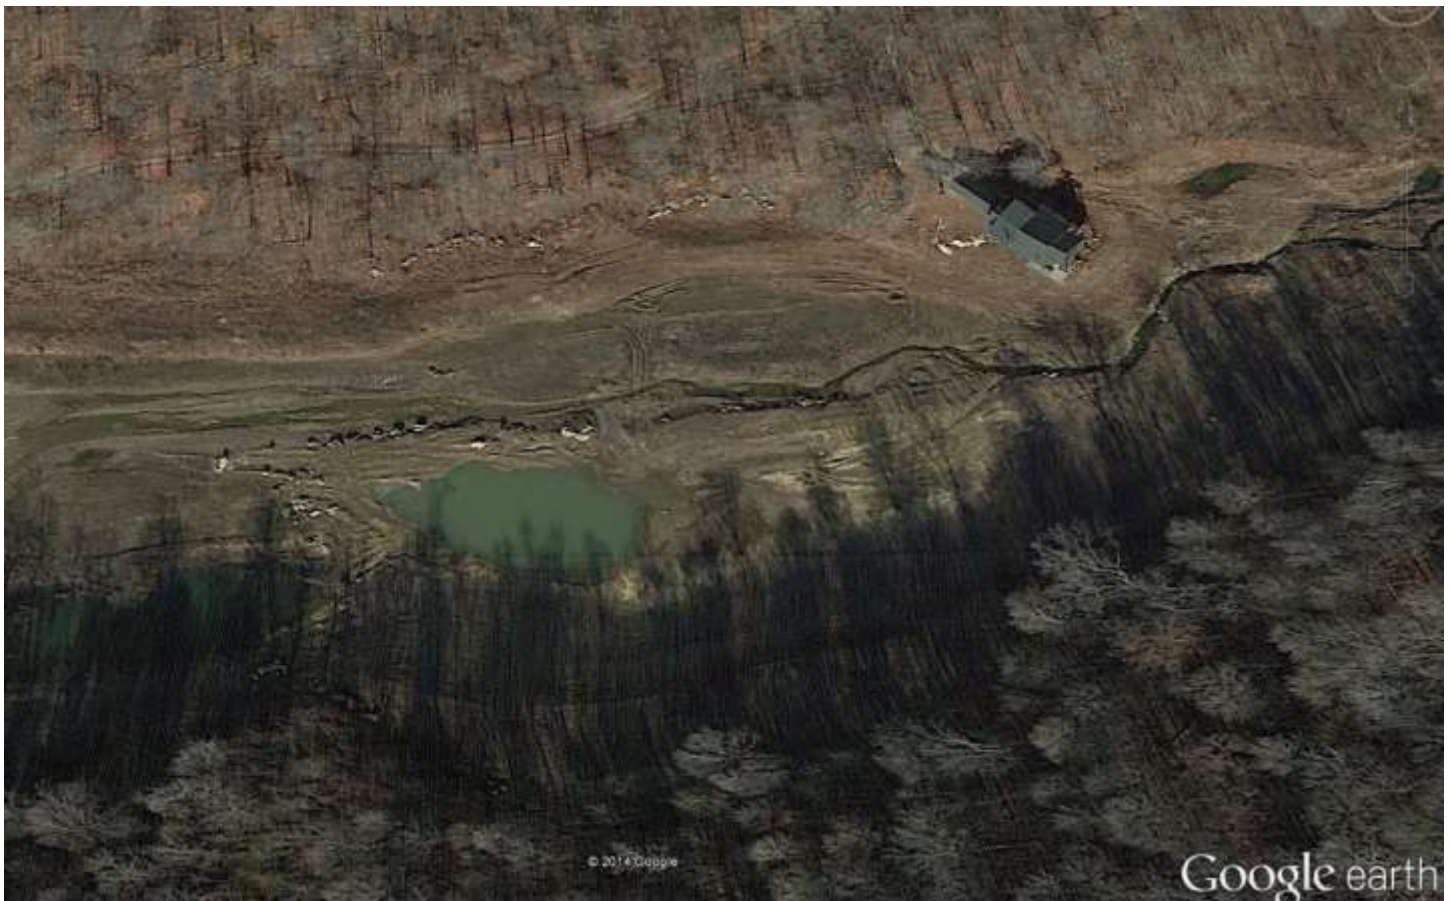
Images like this are not unusual along Clifty Branch and other locations throughout the watershed. This shows the unlimited access that livestock has to some of the streams and creeks within the area.
