Project Name: Whitewater River WMP

Plan Type: Watershed Management Plan

Whitewater River Watershed

WATERSHED MANAGEMENT PLAN

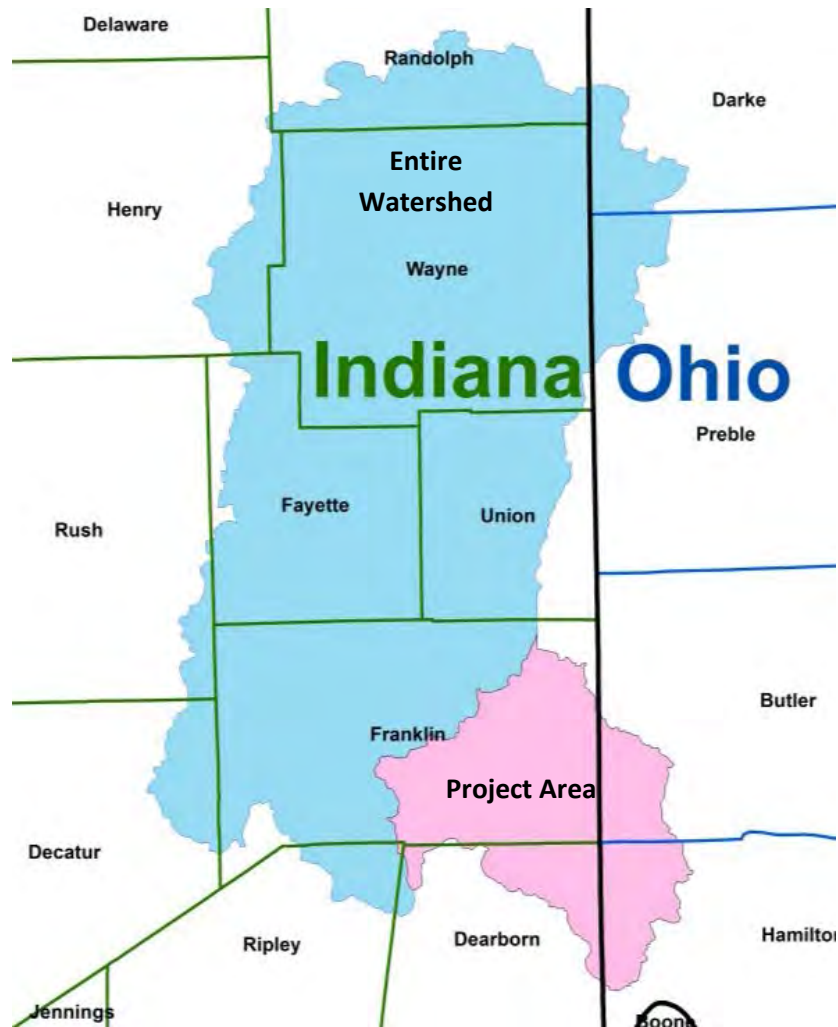
Figure 4: Location of Whitewater River Watershed

The Whitewater River Watershed (HUC 0508000308) includes approximately 159,907.7 acre area of land located in the northeastern portion of Dearborn County, the southeastern portion of Franklin County, the southwestern corner of Butler County, and the northwestern part of Hamilton County. This watershed is in two different states (Indiana and Ohio) so multi-state partnerships and communication are required. The approximate acreage in each county is: Dearborn 24,885, Franklin 87,313, Butler 20,664, and Hamilton 27,046 acres. A watershed is simply an area of land that water flows over and under on its way to a particular body of water. In the case of this project, the water in the watershed flows to the Lower Miami River and then on to the Ohio River. In the United States, watersheds are identified using a coding system referred to as Hydrologic Unit Codes (HUC). HUCs are used as a way of categorizing parts of a landscape based upon drainage. The shorter the HUC, the larger the watershed is. The Whitewater River Watershed falls within the 8 digit HUC, 05080003, noted by the larger outlined area in blue below in Figure 4. The 10 digit HUC for the Whitewater River Watershed Project is 0508000308. This covers the project area outlined in Figure 4 in pink.

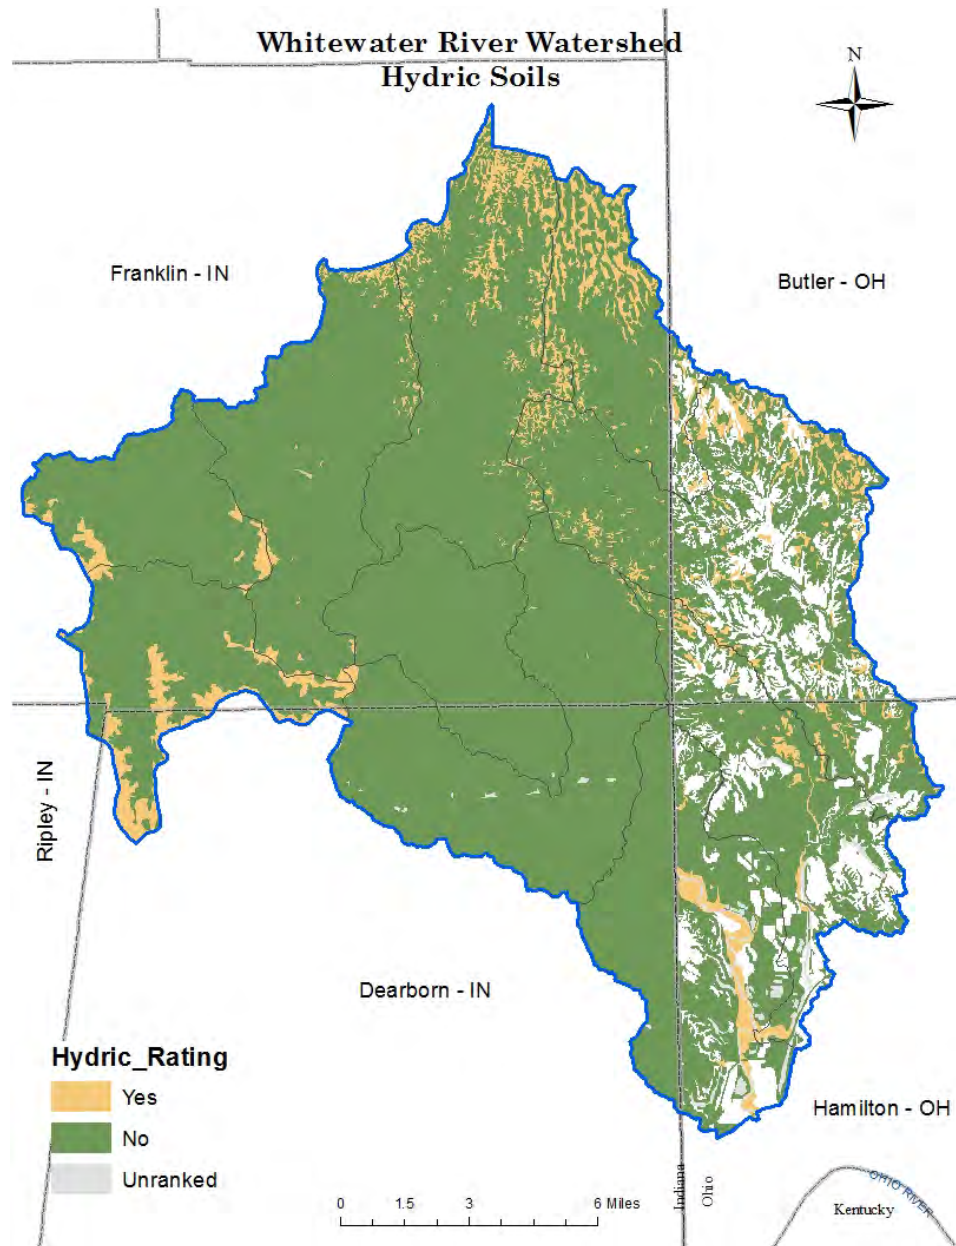
Figure 15: Hydric Soils in the Whitewater River Watershed

In addition to understanding where the highest potential for erosion is, it's important to understand what percentage of our watershed contains hydric soils. Hydric soils may be permanently or seasonally saturated with water like in swamps or wetlands. These soils result in anaerobic conditions even after they are drained. It is likely that these soils developed under wetland conditions. Therefore, they are a good indicator of historic or current wetland locations within the watershed and also locations where potential wetland creation or enhancement could occur in the future. Currently 11.3% of the Whitewater River Watershed is comprised of hydric soils (Figure 15).

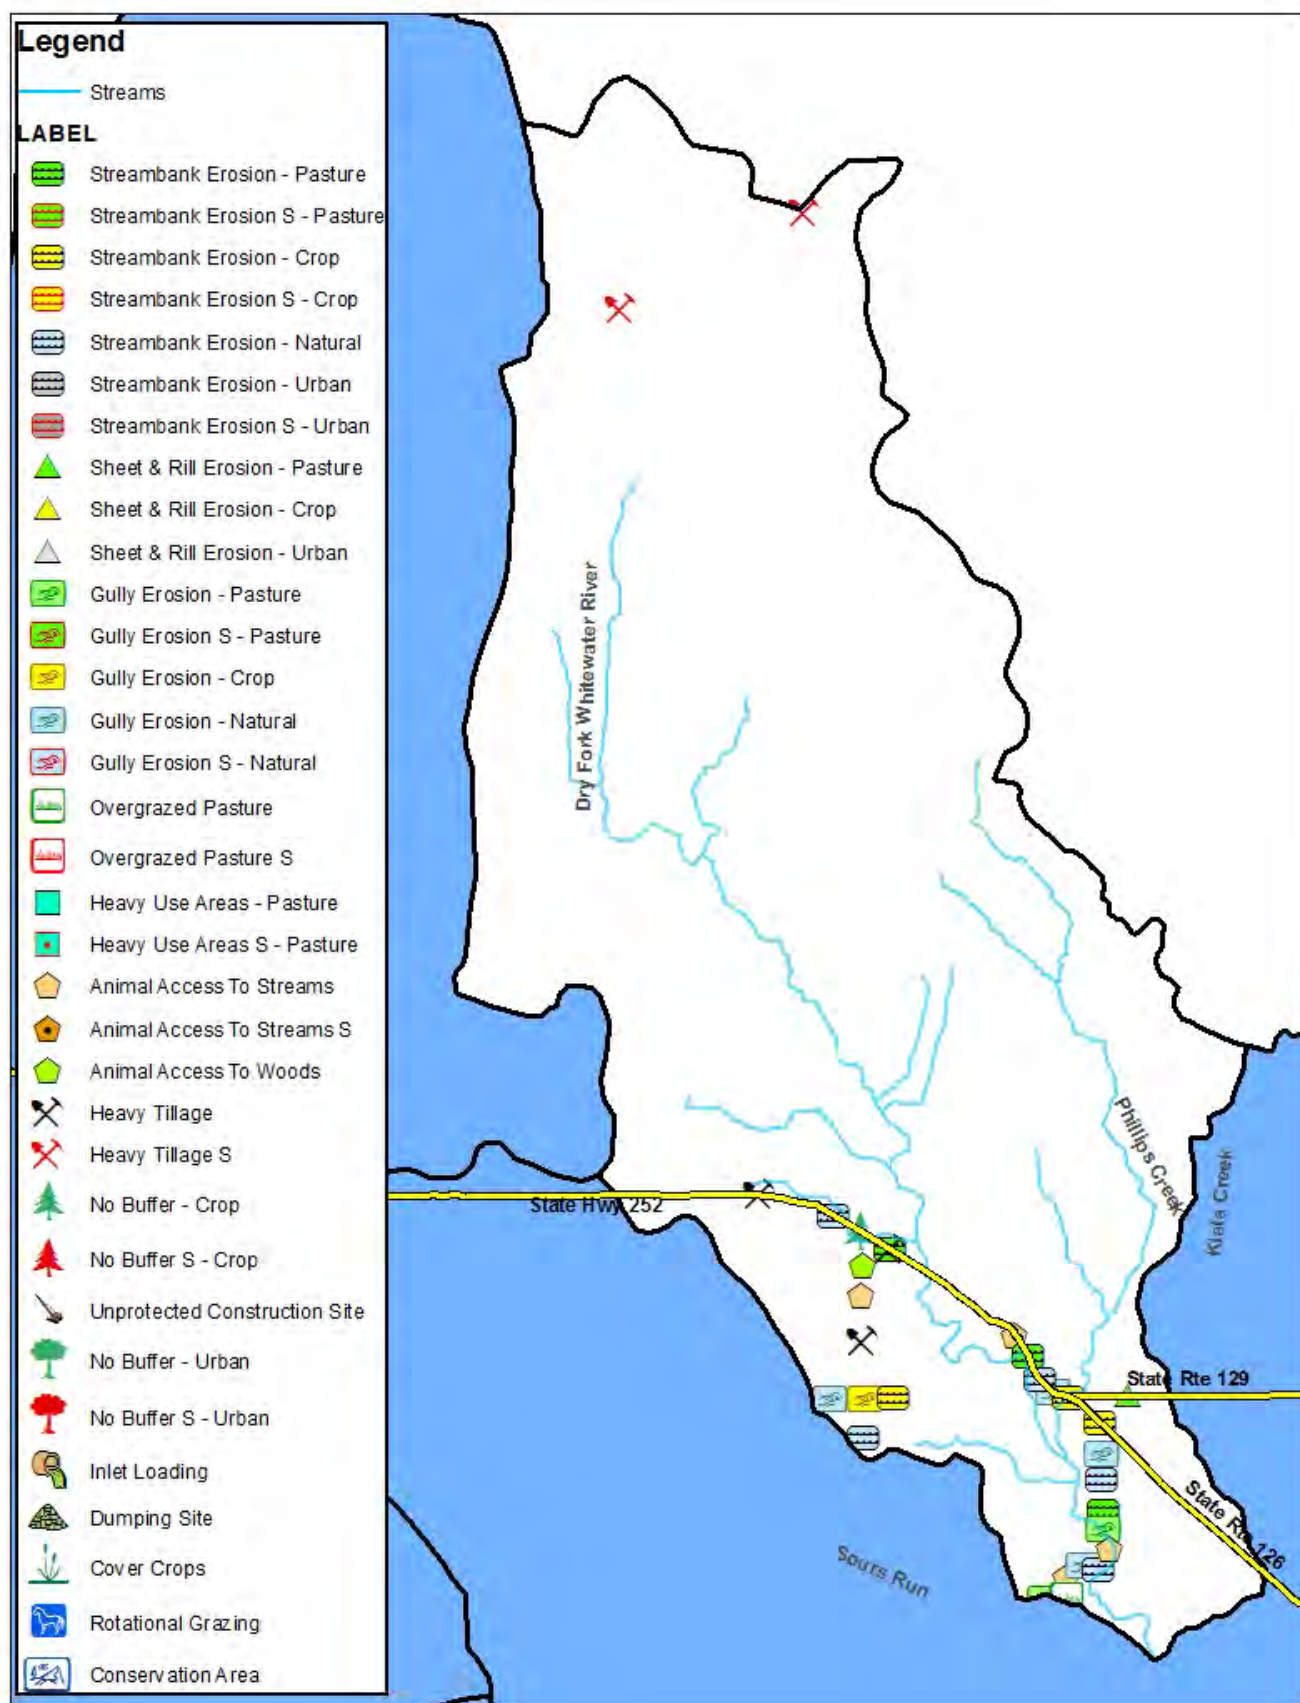
Figure 83: Windshield Result Locations in the Headwaters of the Dry Fork Subwatershed

Problem or Area of Concern/Interest	Frequency/ Occurrence
Streambank Erosion - Pasture	3
Streambank Erosion – Crop	3
Streambank Erosion – Natural	5
Sheet & Rill Erosion – Pasture	1
Gully Erosion - Pasture	1
Gully Erosion - Crop	1
Gully Erosion - Natural	4
Overgrazed Pasture	1
Animal Access To Streams	4
Animal Access To Woods	1
Heavy Tillage	3
Severe Heavy Tillage	2
No Buffer - Crop	1
Total	30
