Project Name: Middle Fork of the East Fork of the Whitewater WMP

Middle Fork of the East Fork of the Whitewater River Watershed Management Plan

Watershed Management Plan August 2004

Prepared by: Friends of the Middle Fork Watershed Steering Committee
and the Wayne County Soil and Water Conservation District
823 S. Round Barn Road, Richmond IN 47374

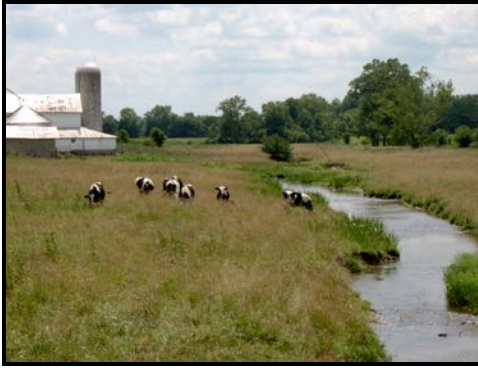
Figure 2.3: Cattle with access to Mud Creek

Due to the number of animals within the watershed boundaries livestock has become a major concern of the steering committee. Through visual observations made by committee members and results of public surveys we know that many of the animals have access to the river or its tributaries during the year. This direct contact allows contamination to the river and other waterways. Manure is a source of nutrients such as nitrogen and phosphorus. The fecal matter can also transport *E. coli* bacteria and other pathogens which can cause illness in humans. In addition to the bacterial pollution through fecal material, livestock with water access also destroy streambank and streambank vegetation when accessing the waterways.

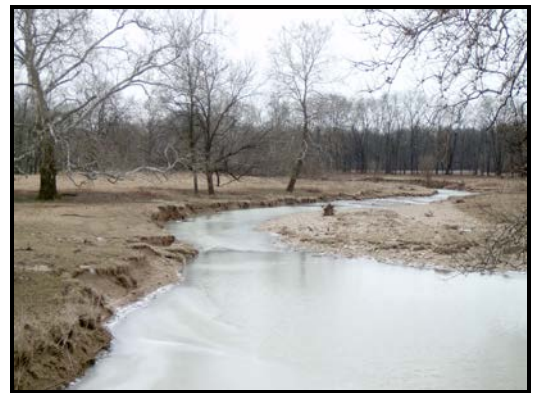
Figure 2.4: Streambank erosion and loss of vegetation due to livestock access

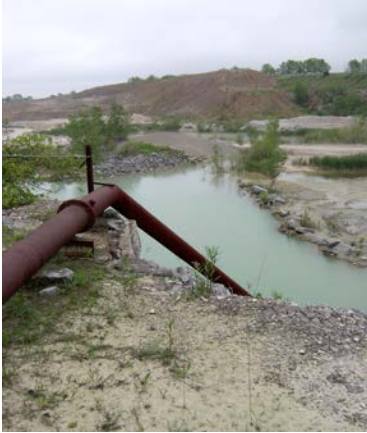
Figure 2.9: One of two sediment ponds located at Barrett Paving Materials Stone Quarry.

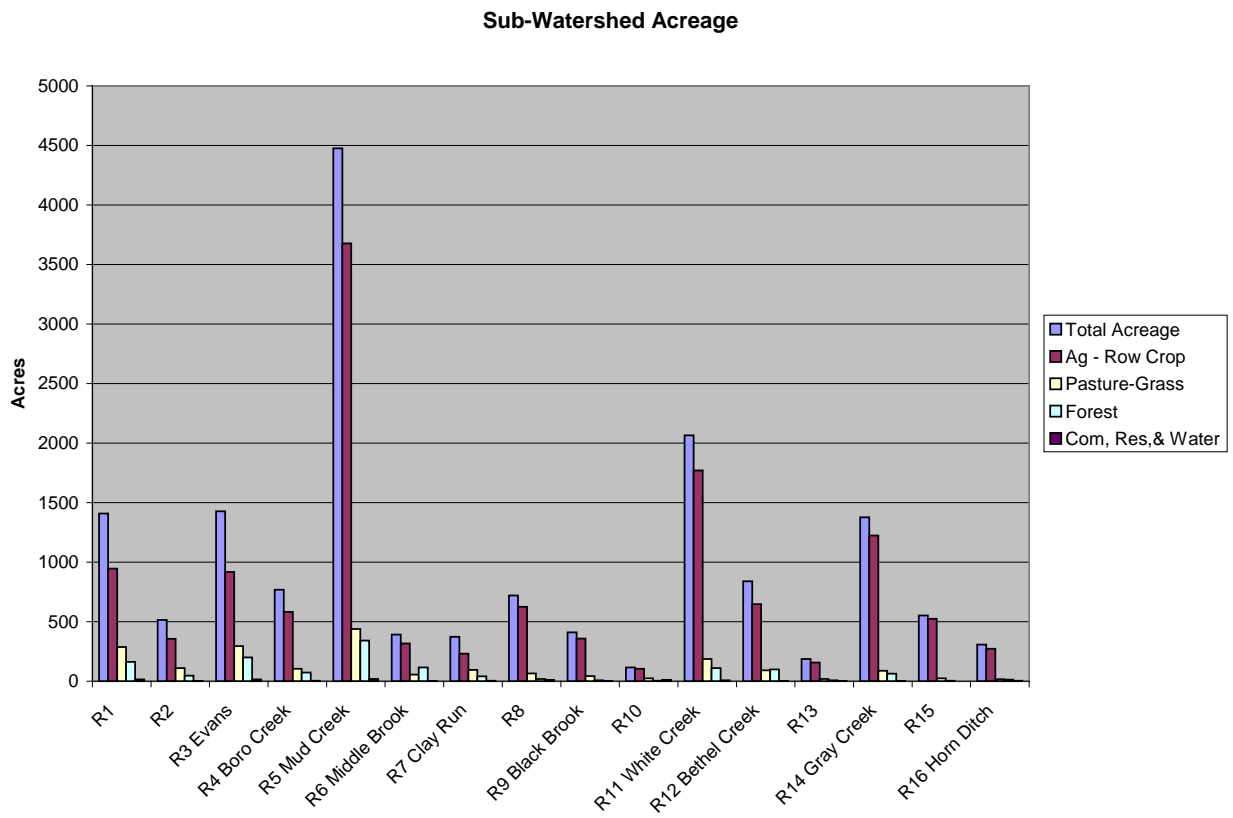
* Note: not every intermittent stream was able to be calculated, so this graph does not represent the total watershed.
Some watersheds include land in Ohio.

Figure: 2.7: Sub-watershed land distribution

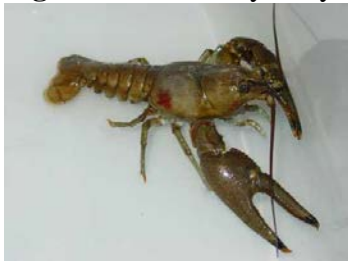
Figure 2.10 – Rusty Crayfish

It is also important to note that Rusty crayfish (*Orconectes rusticus*), an invasive crustacean, have been found numerous times during water monitoring events. These crayfish are recognized by the rusty-red spots located on their carapace. These crayfish are more aggressive than native crayfish and can harm native fish populations by eating their eggs and young.

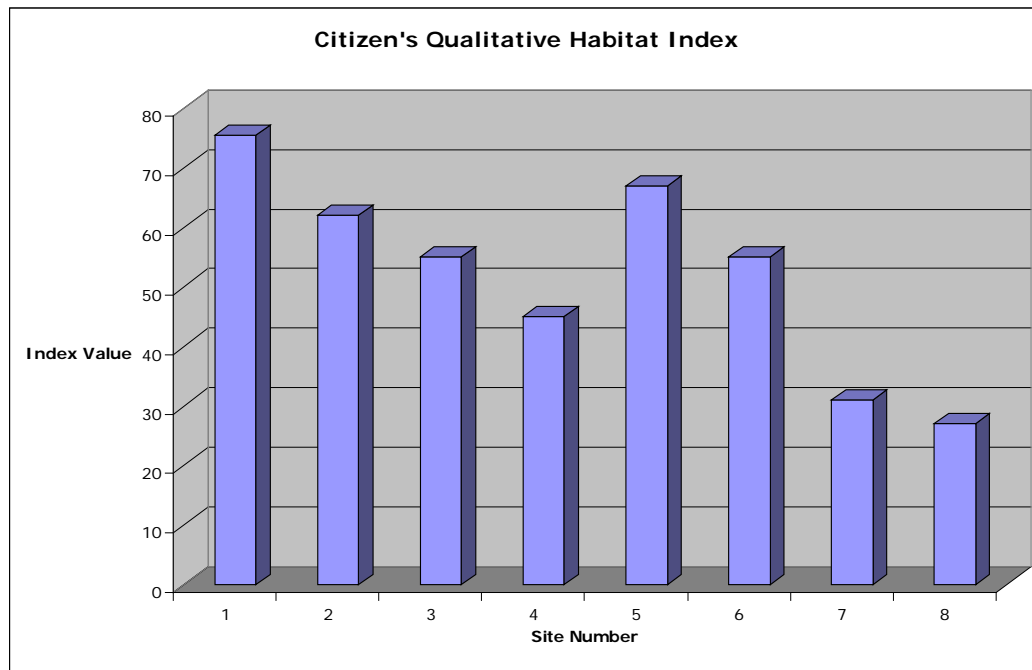
Figure 3.3:

The Citizen’s Qualitative Habitat Index was used to determine physical health of the testing locations. This Hoosier Riverwatch method measures the condition of the river and its riparian areas by assessment of the following parameters: substrate, fish cover, stream and human alteration, riparian areas, depth, velocity, and riffles/runs. The index values are used to compare

conditions between sites. A value over 100 is considered to be a “high quality” stream; while below a value of 60 units are generally reflective of warm water fauna. A set range (excellent, medium, poor, very poor) has not been developed for this index.

Results shown in Figure 3.4 indicate that sites 4, 7, and 8 have the lowest habitat index. Site 4 passes through a pastured area and the channelization of the stream within Ohio (Sites 7 & 8) are the main reasons for their lower index values. Overall the conditions of the stream seem to be in good quality and supports macroinvertebrate organisms.

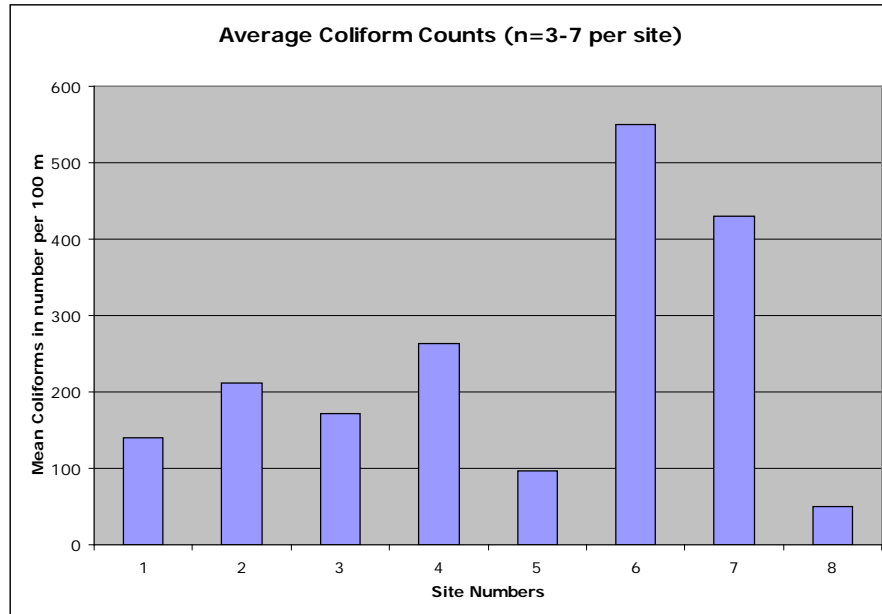
Figure 3.6:

To investigate the issue, the technical committee collected numerous water samples and tested for the presence of coliform bacteria. The *E. coli* tests did not confirm any major problems within the town of Middleboro, which residents had voiced as one of their concerns. The *E. coli* tests did reveal that there is major bacterial contamination located along the river, which most likely comes from a combination of both livestock operations and failing septic systems.

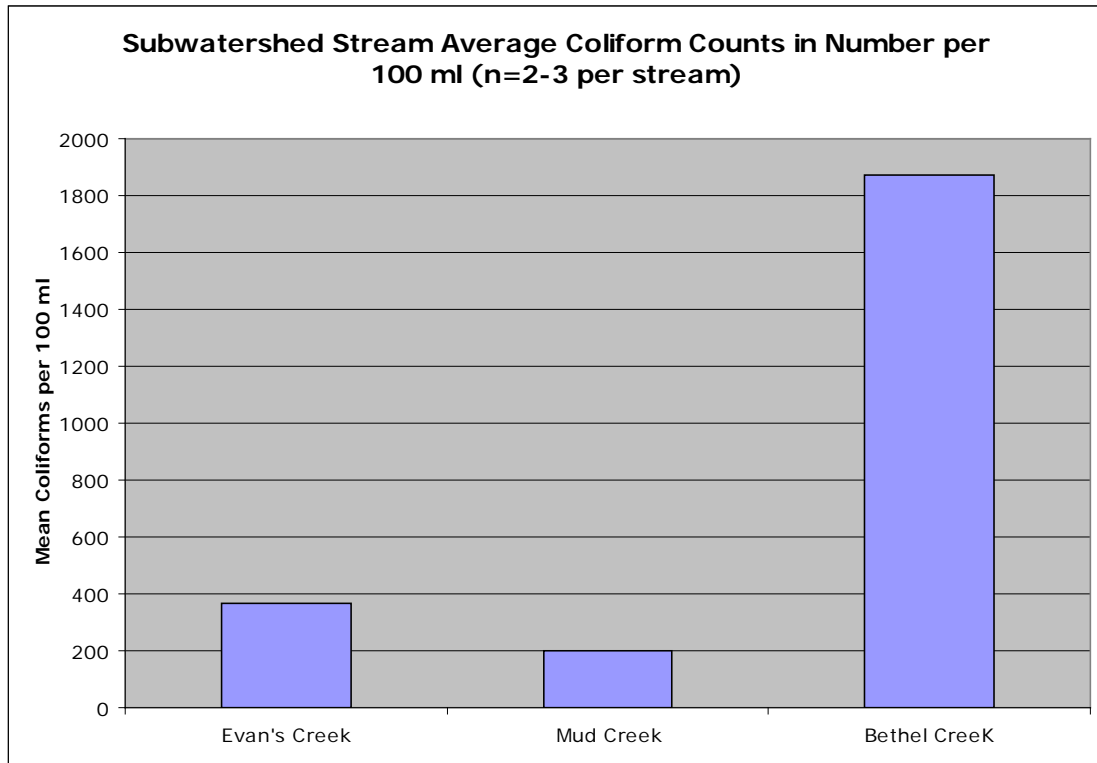
Figure 3.7:

Of 49 coliform tests taken in the watershed 19 (38 percent) were found to exceed the state *E. coli* water standard of 235 colonies per 100 mL (Figure 3.7). Along the main course, average excessive counts were found at Sites 4, 6, and 7. The steering committee believed the main cause for bacteria contamination at these sites is the presence of livestock. Two sub-watersheds, Evan's Creek and Bethel Creek, were tested during the Spring of 2004 were also found to exceed standards. Levels recorded at Bethel Creek exceed 3,500 colonies/100mL. These elevated levels are believed to be caused by large livestock operations located within this sub-watershed. Results are listed in Figure 3.8.

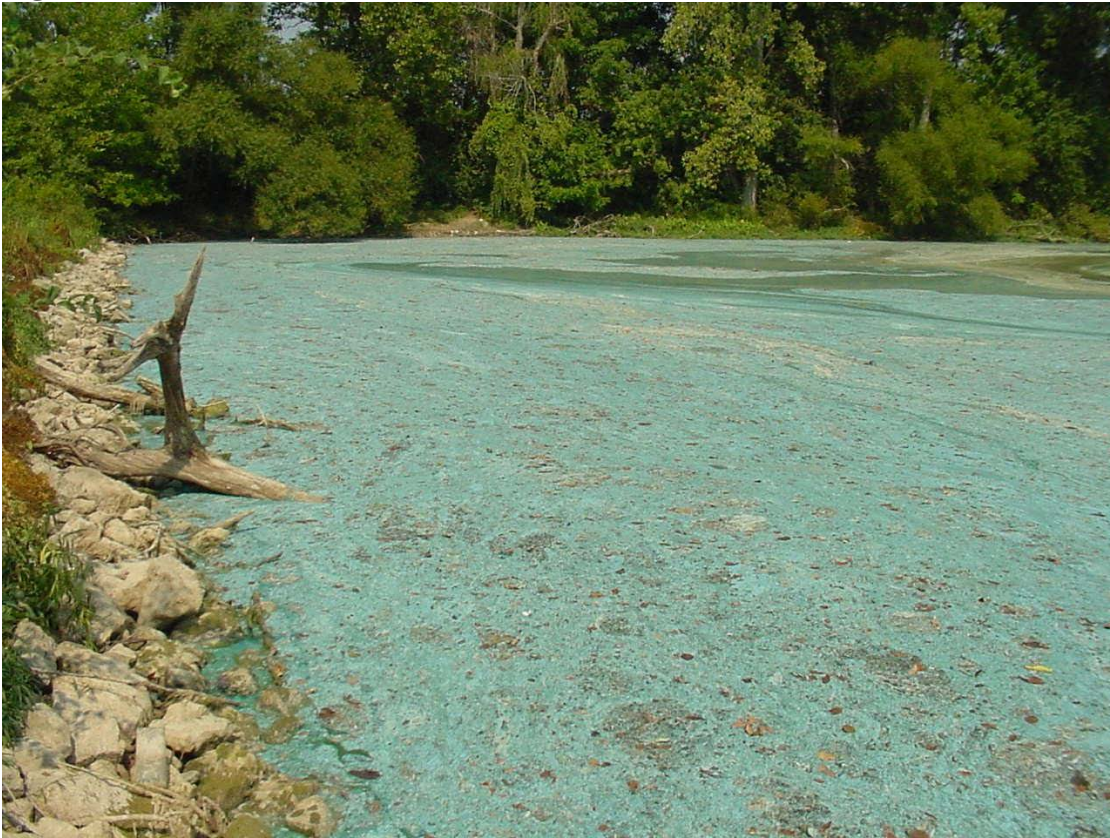
The major source of nutrients within the watershed is believed to come from cropland run-off and less significantly from watershed livestock. In addition, mud flats creating areas of stagnant water have become an increasing problem at the northern end of the reservoir where the river contributes large amounts of sedimentation. When the reservoir's water levels lower, typically during summer months, the mud flats are exposed this often causes an increase in the production of blue-green algae, according to the Indiana-American's Water Quality Specialist Richard Nicholson. The water company attributes its listing on IDEM's 303d list for taste, odor, and algae to blue-green algae and their subsequent decomposition. According to Nicholson compounds released from blue-green algae, even at extremely low concentrations, contribute to taste and odor complaints from customers served by the water company.

Figure 3.12: Pictures of algal blooms taken in September 2002 at the Middle Fork Reservoir

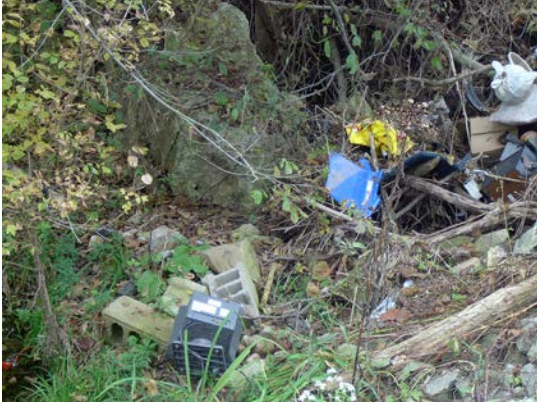
Figure 3.13: Picture taken during fall of 2003 showing litter located along streambank near bridge on Turner Road

Litter has been observed along riverbanks throughout the watershed. Although it doesn't have a major effect on water quality, it does take away from the aesthetic qualities of the watershed. The visual degradation of the river was a concern that stakeholders expressed at public meetings.

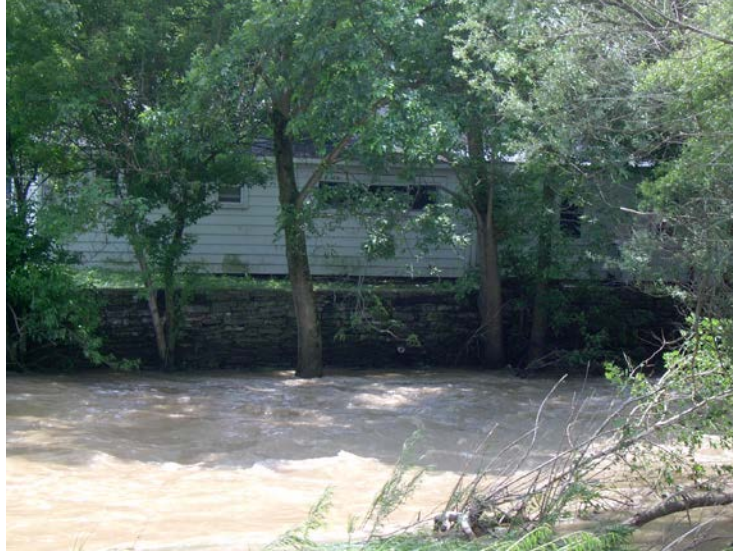
Figure 3.14: Middleboro house located near Middle Fork River

House located within a few feet of the Middle Fork River in the town of Middleboro where the river lacks adequate riparian buffers.
