VFC Index - Watershed (Plan)

Project Name: White River Watershed Project

Plan Type: Watershed Management Plan

Sponsor: Delaware County SWCD

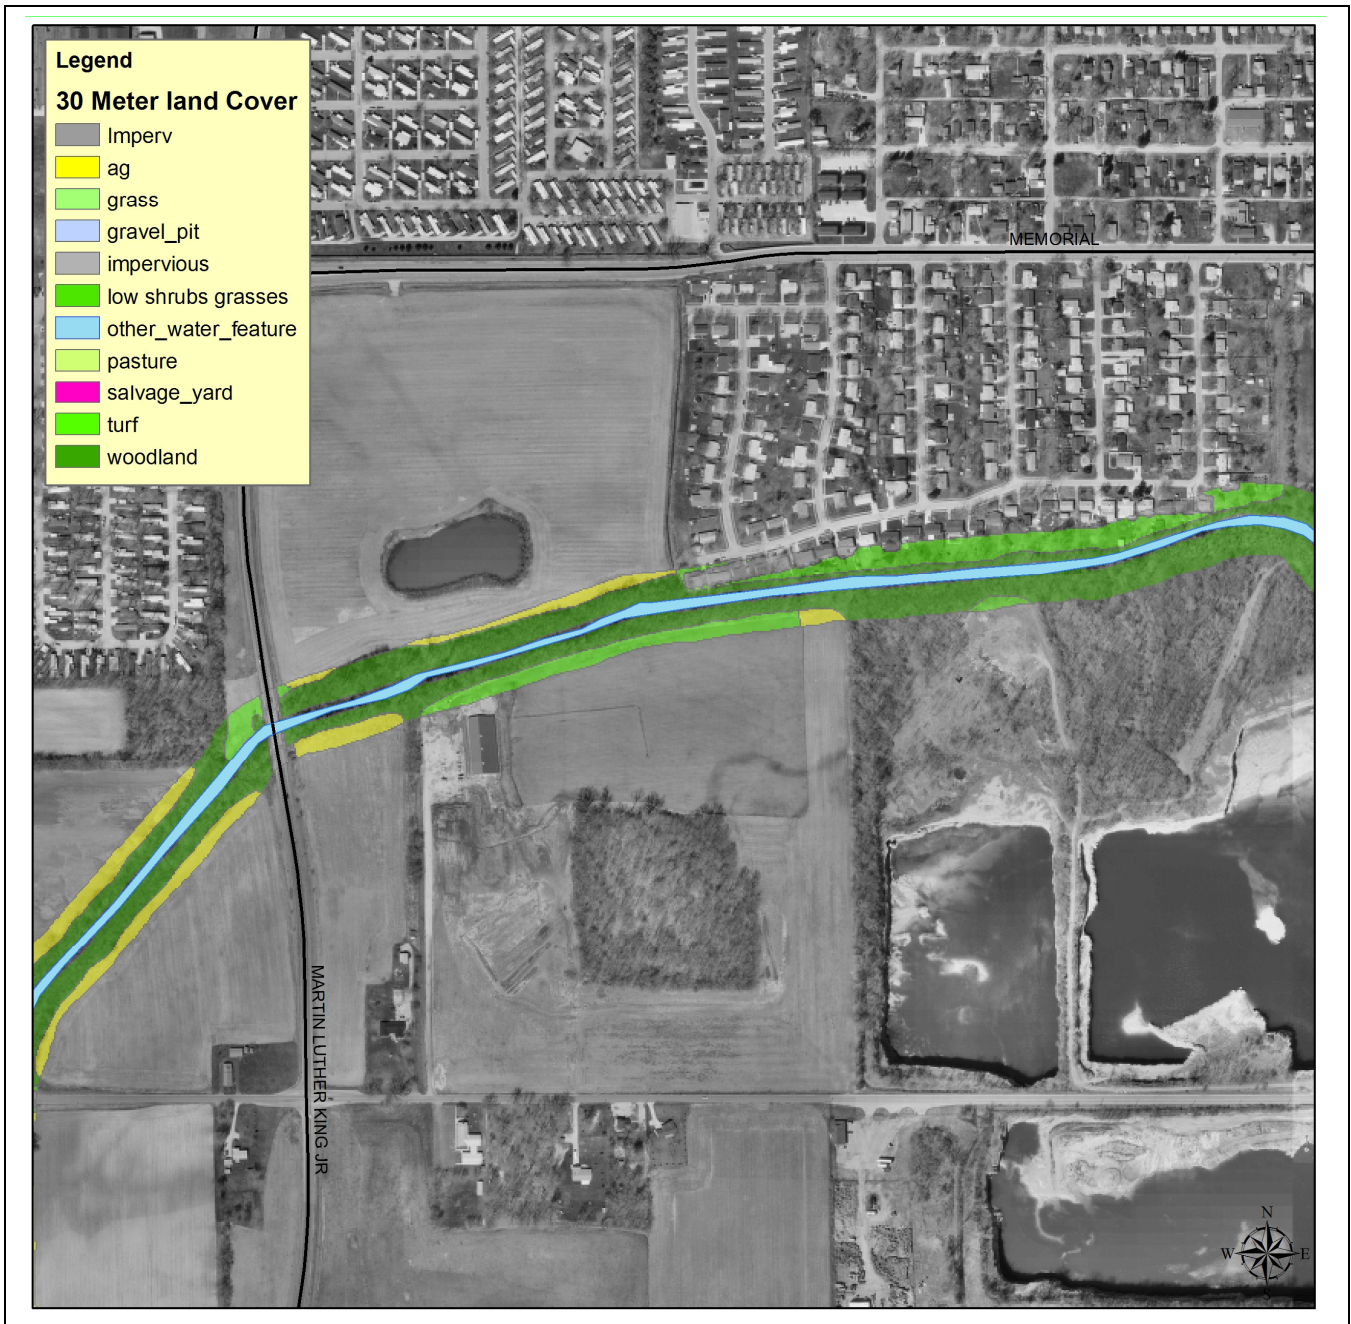
Figure 4.41: Example of Buck Creek Subwatershed Thirty-Meter Riparian Buffer Land Cover

Table 4.11: Thirty-Meter Riparian Buffer Land Cover for Buck Creek Subwatershed
