Program:	Watershed
IDEM Document Type:	Plan
Document Date:	6/28/2006
Security Group:	Public
Project Name:	Yellowwood Lake WMP
Plan Type:	Watershed Management Plan
HUC Code:	05120208 Lower East Fork White
Sponsor:	IDNR Division of Forestry
Contract #:	4-46
County:	Brown
Cross Reference ID:	23090618
Comments:

THE YELLOWWOOD LAKE WATERSHED MANAGEMENT PLAN

PROTECTING, ENHANCING, AND Conserving Yellowwood lake and its Watershed

JUNE 2006

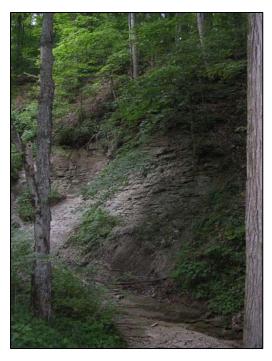
Figure 2.2. Jackson Creek: bedrock streams

The Yellowwood Lake watershed is located within the unglaciated portion of the Norman Upland; a physiographic unit⁴ characterized by long, narrow, flat-topped ridges and steeply sloped stream valleys (Fenelon and Bobay, 1994; Schneider, 1966). The Norman Upland has a well-drained, dendritic drainage system. Small streams have minimal floodplain development while larger streams have narrow flat valleys, indicative of a mature landscape (Schneider, 1966). Over time, this landscape developed from streams eroding away the soft limestone, leaving the resistant Mississippian-age siltstone and shale, shown in Figure 2.2, which comprise some of the most rugged landscape in Indiana (Gray, 1997).

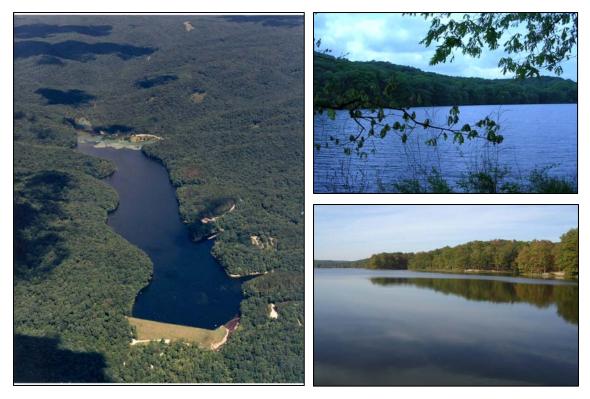
Figure 2.7. Yellowwood Lake Pictures

Yellowwood Lake is located in the northwestern portion of Brown County in southern Indiana. The 131-acre reservoir was created in 1939 by damming Jackson Creek as part of the Bean Blossom Land Utilization Project of the United States Bureau of Agricultural Economics (Figure 2.7). The lake was originally created as both a drinking water source and recreational destination.

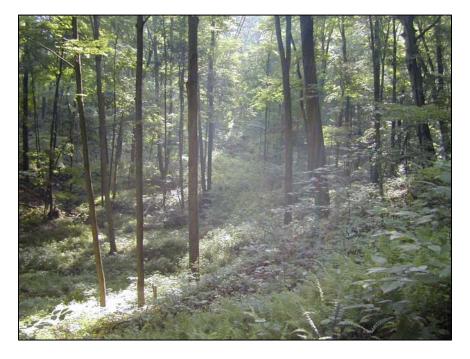
Figure 3.3. Yellowwood Lake Watershed (Aerial Photographs 1949, 1960, 1980, 2003, and 2005)

The state construction of new roads in the early 1920s made it economically feasible to access the timber resources in the area. The land spared from clearing for agriculture was quickly exploited for timber resources and livestock grazing. By 1935, 92% of Brown County was eroded (Sieber and Munson, 1991). In the early 1900s, the federal and state governments began purchasing land in Brown County with the intent to stop erosion and restore the land to something more profitable. Under the Bureau of Agricultural Economics, the Bean Blossom Land Utilization Project was created to convert the barren land into forests (Figure 3.2.2) and recreational areas. Figure 3.2 shows the watershed's recovery through a series of aerial photos.

The 1949 image shows a patch work of forest clearings, most likely for agriculture. Still visible in 1960, the cleared patches appear to be re-forested by 1980 with the exception of a patch of pasture land on the north end. From 1998 on, the images show continued forest recovery.

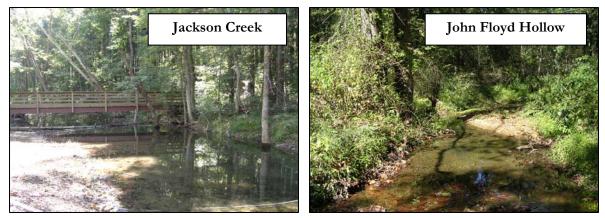
The Hoosier Riverwatch data suggests that the Yellowwood Lake Watershed is not suffering from any significant chemical water quality impairments. See Appendix K for complete water quality data results. Nitrogen and phosphorous concentrations were consistently near or below detection levels at both sample sites. There was no detected turbidity at either site, and pH levels were within the allowed range for aquatic life according to 327 IAC 2-1-6(b).

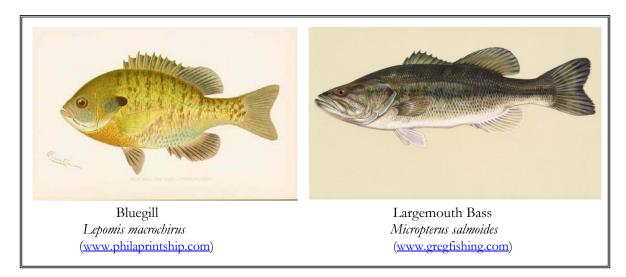
Figure 4.23. Yellowwood Lake: Common fish species

Warm summer surface water temperatures in excess of 80°F and insufficient dissolved oxygen concentrations below 18 feet render Yellowwood Lake a warm water fishery. The fish population in Yellowwood Lake, as determined by DNR fishery surveys¹⁷ and angling records¹⁸, is dominated by bluegill and largemouth bass (Figure 14.23). Overall, biologists have rated the fish population as satisfactory for a relatively infertile impoundment. See Appendix Q for summary of fishery studies.

Yellowwood Lake has high fish diversity relative to many reservoirs in Indiana. Whereas most reservoirs have only 4 or 5 species, fishery surveys show that Yellowwood Lake has 14 species of fish. The DNR has implemented a supplemental stocking regime to provide anglers with more fishing diversity in the lake. Since 1981, the DNR stocks 3,325 channel cat fish (3.8-14.0 inches) every two years to maintain a population believed unable to sustain itself through natural reproduction. Additionally, 700 trout (mostly rainbow and some brown) have been stocked in Jackson Creek every April since 1975. The trout are mostly fished out during the first weekend after stocking. Trout have not been stocked in the lake, but a rare trout is occasionally found in the lake.

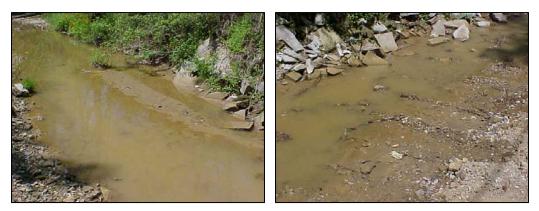
Figure 5.5. Jackson Creek: fine sediments

sunlight reaching the stream bottoms, limiting photosynthesis and subsequent oxygen production. In contrast, coarse sediments do not raise chemical concerns but can cause channel aggradation, which reduces flow capacity that can lead to flooding, hinder navigation, and increase channel instability (Novotny and Olem, 1994). Figure 5.5 shows fine sediments in Jackson Creek.

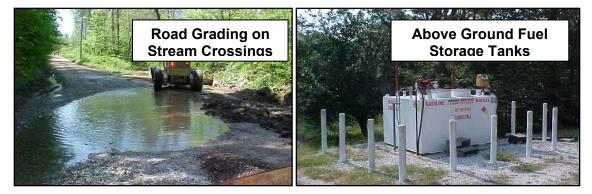
Figure 5.13. Yellowwood Lake Watershed: Sources of Chemical Contamination

The YLWPG has identified multiple potential sources (Figurre 5.13) of chemical contamination in the watershed that should be managed for. Sources include above-ground fuel storage tanks, timber harvesting machinery, automobiles, household chemical storage, and fertilizers. The YLWPG developed Table 5.3 to help prioritize the potential sources of chemical contamination based upon risk. Prioritizing potential sources will allow the YLWPG to focus on the greatest potential load reductions at the commencement of implementation.

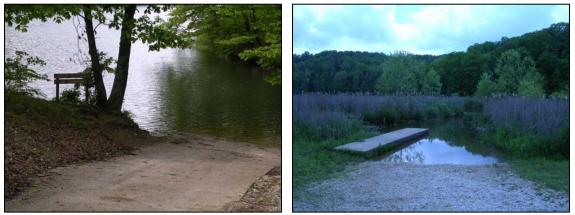
Figure 6.6. Critical Areas: Boat Access

Purple loosestrife, Eurasian watermilfoil, and yellow bass have all been artificially introduced into Yellowwood Lake. While no other non-native species have yet been detected, the YLWPG is concerned that Brazilian elodea, identified in nearby Griffy Lake (Monroe County), may find its way to Yellowwood Lake. The IDNR DoF currently allows individuals to bring their own boats onto Yellowwood Lake, thus creating an ever-present risk of invasive introductions. Therefore, public boat access sites have been identified as critical areas for aquatic invasive species management (Figure 6.6).
