Project Name: Middle Patoka Source Water Protection Plan

Plan Type: Watershed Management Plan

HUC Code: 05120209 Patoka

Sponsor: Alliance of Rural Water Indiana

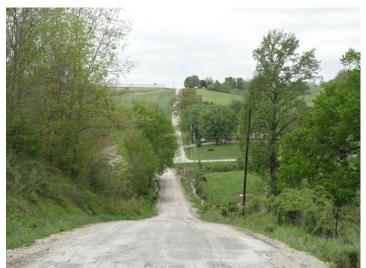
Plate 1: Rolling Hills

Except for a small part of the northwest edge, the project area was not covered by glaciers. The absence of the grinding and eroding ice sheet preserved a rolling topography (Plate 1) but also left the area without the thick soils deposited elsewhere in the state by receding glaciers. The maximum topsoil depth is 100 or 50 feet, depending on if you are in or outside the floodplain of the Patoka River. Across the watershed, sedimentary layers of sandstone, shale, and limestone lie beneath the topsoil. The limestone does not have any karst characteristics. The sandstone acts as an aquifer, although there are no community drinking water wells tapping into it. Each town in the watershed uses the Patoka Lake (which is outside the watershed) or the Patoka

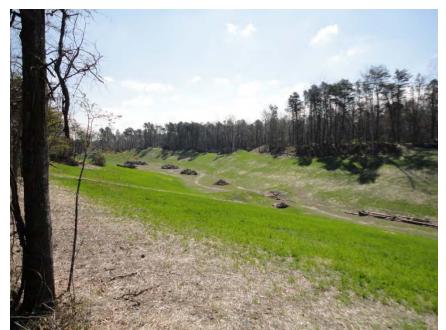
Plate 3: AMD Treatment Site

The public has concerns regarding the process of AMD treatment. As explained, most AMD sites are restored by DNR. A common practice in Indiana and elsewhere uses limestone to neutralize the acid. As was noted by members of the public though, when the calcium carbonate of the limestone reacts with acid, iron oxides precipitate out of the water and coat the limestone. This coating eventually 'seals' the limestone and diminishes its ability to further neutralize AMD.

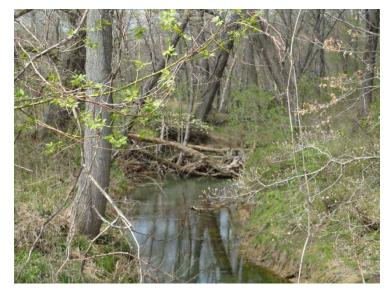
Plate 5: Typical Log Jam

Depending on the condition of the log jam, a landowner interested in removing it may have to apply for a permit. More information is available at DNR's website. Unsurprisingly, many landowners will remove log jams without working with DNR. Recently, the owner of a railroad bridge in Winslow used heavy equipment to free a jam lodged against the bridge supports and then let the material float downstream where it potentially could cause another jam. Though log jams were found as part of this study, they were all on small tributary streams and not of significant size.

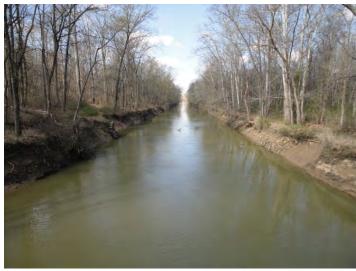
Plate 6: Channelized Patoka River

The public was concerned about the impact of artificially widened or straighten stream channels and removing vegetation from the banks. Often these practices are common on legal drains, although the Alliance noticed them in every part of the watershed. Channel straightening is sometimes proposed to address flooding or erosion problems. The premise is that a straight, smooth channel moves the water through faster, so less spills out onto the floodplain. Erosion problems are addressed by moving the main flow away from the eroding bank, which is frequently located on the outside of a bend. It's often thought that straightening provides a wide and fast path for water to move downstream and reduces the likelihood of log jams and sediment build up that might increase flooding. This assumption is usually only true if significant resources are available to maintain the channel. The reality of how straightened—also known as channelized—streams behave is very complicated.

Although straightening or relocating a stream may provide relief at a specific location, it drastically alters the stream flow characteristics and may cause additional problems both upstream and downstream of the project site. This is because the channel-straightening project tends to focuses on one stream function—water transport—without adequately accounting for other functions, such as energy dissipation and sediment transport. Straight streams tend to shoot water like a fire hose. When the bends and curves (meanders) are removed, the stream continues to drop the same elevation, but over a shorter linear distance. This increases the slope of the channel, which in turn increases the stream's velocity and energy.

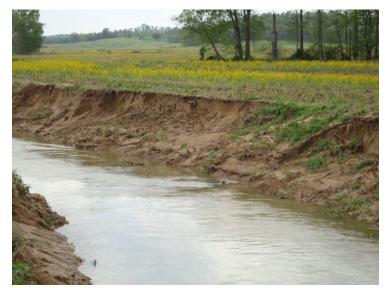
Plate 8: Erosion along Straightened Stream

One solution to the increased erosion potential of a straightened stream is to protect the bed and banks with rock or concrete. This smooth, hard channel enables the water to speed through even faster, taking its energy with it. Downstream areas will have higher peak flows, because the water gets there faster, which may increase flooding problems. In addition, downstream areas will be subject to increased erosion, unless the project incorporates sufficient energy dissipation structures. Years later, the stream may still be eroding its bed and/or banks in an effort to restore a stable channel length and slope. Channelizing is therefore not a recommended method as it overlooks many important stream functions and typically creates more problems than it solves.¹¹

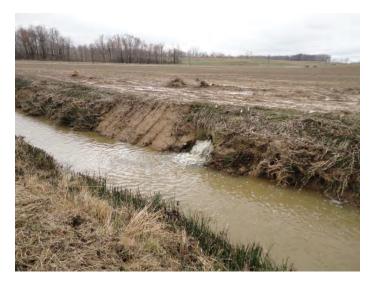
Plate 9: Field Tile Emptying into Stream

Tiles are long linear pipes buried under fields to collect water and channel it into nearby streams or ditches so fields don't become oversaturated. While tiles make large scale agriculture possible, the flow they add to streams can increase erosion and flooding. Water from tiles can also contain concentrations of whatever fertilizer, herbicide, or pesticide was recently applied to the farm field. Field tiles were observed across the MPRW.

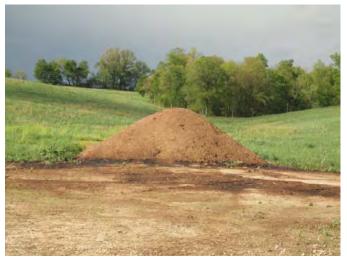
Plate 10: Runoff from Uncovered Manure

Across the watershed, livestock are produced by small hobby farmers and large agribusiness Confined Feeding Operations (CFO). CFOs are facilities with at least 300 cattle, 600 swine, 600 sheep, or 30,000 fowl. There are 58 CFOs in the watershed (see Watershed Inventory Part 2); 50 of which are in Dubois County. Because of the large amounts of manure generated at CFOs, they are a pollution risk. Using IDEM's Virtual File Cabinet (http://12.186.81.89/Pages/Public/Search.aspx), the Alliance checked the most recent inspection reports for CFOs in the MPRW. No compliance issues were discovered. Local SWCDs and NRCS report that the majority of the watershed's CFOs raise some type of poultry. There are many public concerns surrounding livestock production. The first is what can be done with the excess poultry manure from the CFOs. Within the watershed, Dubois County has the most chickens and turkeys. According to Dubois County NRCS, the county produces enough manure to satisfy 100% of the nitrogen and 50% of the phosphorus and potash needed to fertilize row crops. Despite this, the use of commercial fertilizer is still high. NRCS attributes this to the difficulty of measuring nitrogen in manure and the hard to break tradition of buying commercial fertilizer. Pike County NRCS reports that in-county manure production can't satisfy cropland fertilizer needs. Challenges exist for finding suitable uses for all the manure generated in the watershed and ways to store it so precipitation doesn't create nutrient and bacteria rich runoff.

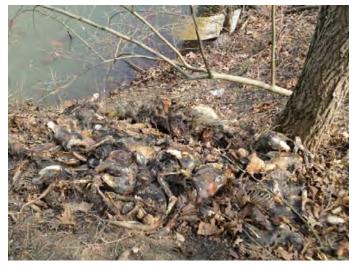
Plate 11: Animal Carcasses

Across the MPRW are hobby farms—small farms maintained without the expectation of being the primary source of income. During the windshield survey, it was difficult to discern a hobby farm from a small animal farm. According to the steering committee, hobby farms are not concentrated in any one part of the watershed nor is there evidence that they are dominated by any one type of animal. The illegal dumping of dead animals from hobby farms is a public concern. Dumping in or near surface water can potentially pollute that water, and groundwater, with bacteria, viruses, and nutrients. During this project, a member of the public contacted the Alliance of Indiana Rural Water about an animal dump site south of Winslow near a mining pit on DNR land.

DNR said they lacked the resources to clean it up, so the Alliance contacted the County Health Departments in the project area to learn who else might clean up such sites. The County Health Departments all said that the responsibility lies with the landowner. The County would handle county land, DNR must do DNR land, etc. The Highway departments will dispose of what's dumped in their jurisdiction. Pike County Board of Health did say that if a site posed a clear human health risk, they would work with the landowner to get it cleaned up.

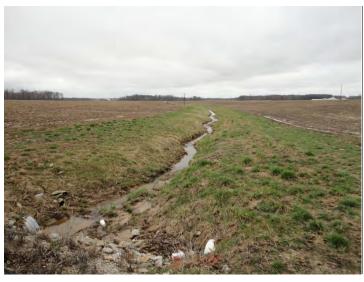
Plate 13: Grass Buffer

210.5 miles of stream buffer (19.06%) in the MPRW were rated as either Needing Improvement or Poor. If you only consider Zones 1-4—because Zone 5 is nearly entirely forested and its results skew the data—197.17 miles of stream buffer (27.3%) were rated as either Needing Improvement or Poor.

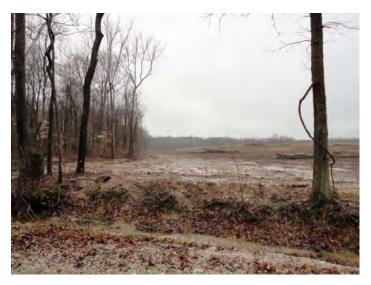
Plate 18: Zone 1 Logging Site

windshield survey only found two logging site in the entire watershed (Zone 1 and Zone 5). However, both sites lacked any erosion control.

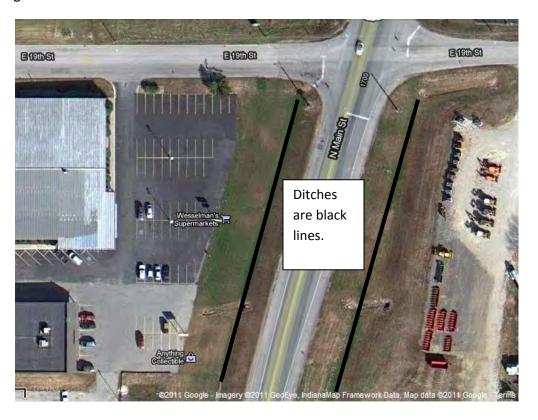
Plate 20: Ditches along US 231

two miles of new and replacement water mains, plus an additional 750,000 gallon Water Storage Tank for improved fire protection and pressure. The water system for the City of Huntingburg has maintained the best rating possible (Class 5 Rating) for a community of its size with the ISO (Insurance Services Office). Huntingburg has a nine hole golf course in Zone 2, and its area of expected growth, the northwest corner of town, is also in Zone 2. The windshield survey found three storm water ponds in Huntingburg: Memorial Health Care Center and the Wellness Center (both on the north side of town along US 231) and Southridge High School. The north side of town has approximately 1 mile of several large drainage ditches along US 231 that collect storm water.

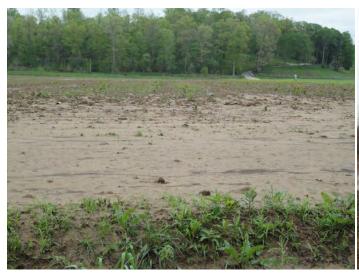
Plate 22: Flood deposits on Field

Zone. As the new US 231 is built, development is expected to occur on the east side of Jasper in Zone 3. Generally speaking, Zone 3 is part of the headwaters of the MPRW and its eastern portions have the hills and slopes one would expect in a headwaters region. Most of the observed farming was in the flat floodplains, which may explain the fewer number of erosion sites compared to other Zones. Erosion may have also been hidden by the garlic mustard that was prevalent during the windshield survey. Throughout the windshield survey, the Alliance had to negotiate regional flooding. In Zone 3, floodplains received a layer of sediment as the water receded and this may also have hidden erosion.

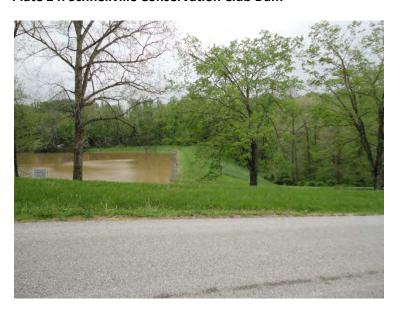
Plate 24: Schnellville Conservation Club Dam

The windshield survey passed Schnellville Conservation Club, which has an earthen dam and spillway in the headwaters of Hall Creek. This perhaps is one of the dams the public was curious about. While driving, the Alliance also passed the part of Ferdinand State Forest that's in Zone 3. The forest, like nearly all of Zone 3, has Potentially Highly Erodible Land.

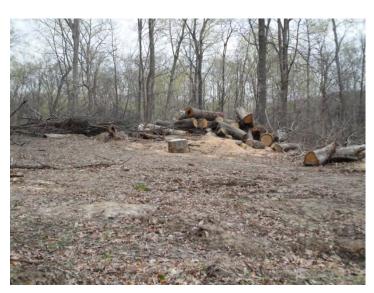
Plate 28: Logging Site in Zone 5

Other than evidence of mining, the windshield survey did not find as many pollution sources in Zone 5 as in the other zones. The amount of forested land obviously explains this. While logging was not listed as a public concern, evidence of poor logging practices like lack of erosion control and poorly maintained access roads were noted when discovered during the windshield survey. However, as explained above, only two such sites were found in the entire watershed. One was in Zone 5. While forested land is one of the largest landuses in the watershed, there isn't evidence that it's a large contributor to runoff pollution.

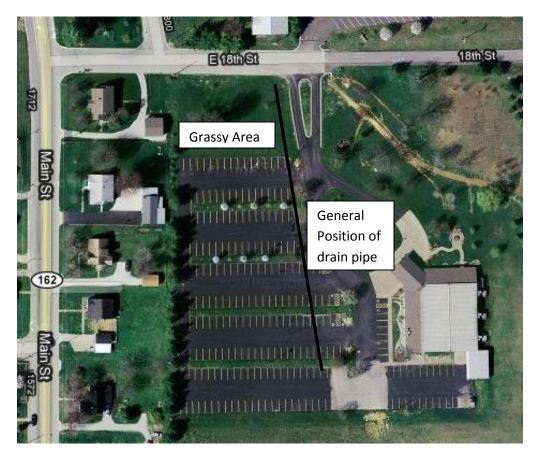
School Parking Lot

Precipitation from Forest Park High School parking lot flows down a steep rip rapped slope and into a small ditch that moves towards Michigan St. Flow off the parking lot is obviously an erosion concern (hence the rip rap) and is contributing polluted runoff to local streams. Adding a strip of porous pavement along the edge of the lot (perhaps as deep as a parking space) will allow runoff to infiltrate. Ferdinand in/kind could come from tearing up part of the existing lot. Costs depend on the type of porous pavement used. Assume project area is 2400 square feet.

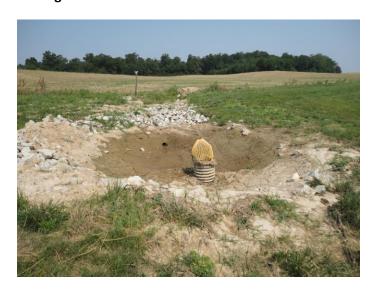
Settling Basin

The whole thing looks fairly new, so you may not want to do anything if you've just invested in it. However, the basin and swale could be redone so they have native plants that will filter the water and help infiltrate it. The existing pipes could continue to act as an overflow precaution. The riser on the basin would likely need to be modified so more water is held back in that area. The basin likely would have to increase in size too. Likewise, the drains by each of the swale's check dams may have to be raised so water has more of a chance to infiltrate. An engineer would definitely have to be involved. Total cost likely around \$10,000. Ferdinand in/kind could come from earth work, grading, and planting.

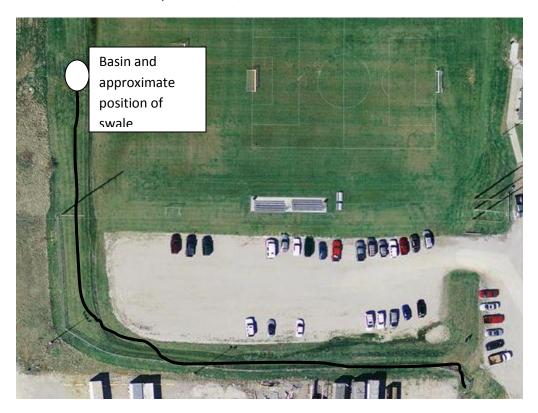
Fenced Storm water Basin North of High School

We spent a lot of time looking at this with Tom, but when I went back to it, I felt less confident that it would make a good project. Water enters the basin from a pipe that collects runoff from uphill (Vienna Dr) and from a small ditch that runs along a stand of trees between the basin and high school. The ditch shows no signs of erosion and is highly vegetated, so I think you're already getting as much benefit from it as you can. The slope from Vienna down to the basin is so great that it's probably best to keep it in place and not try to infiltrate storm water on the surface of that hill. My only suggestion would be to modify the outlet of the basin so water is held in it longer and possibly vegetate the basin so you're filtering the water and helping to infiltrate it before it leaves. Let me know if you want to talk further about this site.

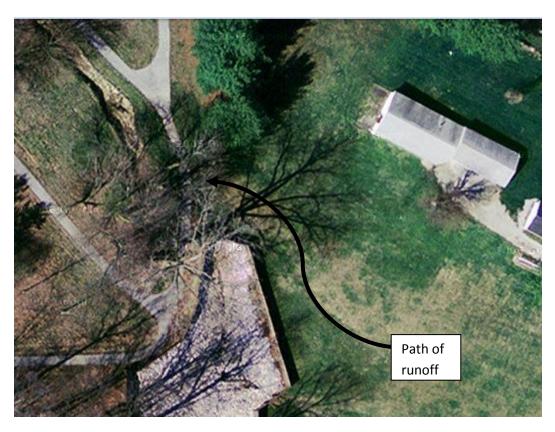
Rain Garden

Part of the Vienna Rd. hill drains to a small depression along the park's walking trail. A culvert takes the collected water under the trail and into the streambed that follows the trail. This area might make a nice rain garden. A rain garden is a planted depression that filters and infiltrates stormwater. It's location on the trail would make it a good educational project. The culvert would need to remain as an overflow option. The depression would have to be excavated a little deeper to increase capacity and then planted. Depending on existing soil, some amendments might be needed. With the city's help, volunteers could do most of the work; I don't think any engineering is needed. Total cost around \$3000. City in/kind would be from excavating and planting and maybe putting up an educational sign.

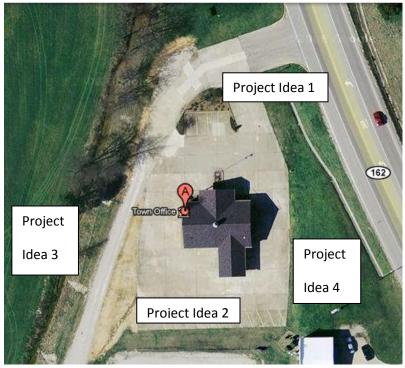
- 1. Curb cuts and rain garden in island
- 2. Pervious concrete near back of parking lot
- 3. Regrading/replanting of slope to promote storm water cleansing
- 4. Water cleansing plants around perimeter
- 5. Trees

- 1. Cut openings into the curb around the existing island to allow storm water to flow into it. Dig out the landscaping to build a rain garden. The garden will be graded so overflow water spills out through the curb cuts on the south side and flows back across the parking lot. Opportunities for Ferdinand in-kind are:
 - Making the curb cuts (if town owns a concrete saw)
 - Excavating the island (backhoe or other large equipment needed)
 - Layering the island with new soils and regarding the soil (backhoe and workers with shovels needed)
 - Putting new plants into the island (man-hours)

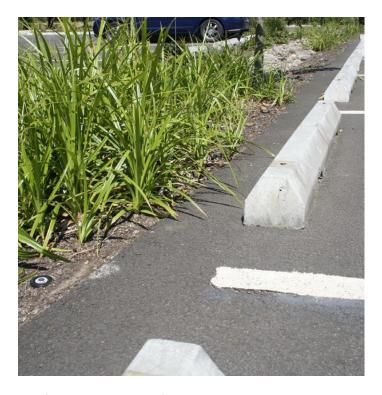
Example of water cleansing plants at the side of a parking lot

4. Since there is no curb around the lot, storm water flows off it and into the surrounding grass. Grass does a poor job filtering and slowing down moving water. In areas where lots of water is moving off the lot, we could put plants that would do a better job of cleansing the water. Depending on the area, minimal regrading may be necessary. Ferdinand in-kind could come from use of equipment, shovels, man-hours, and volunteers to do the planting. Besides water quality benefits, this project would improve aestics and reduce the amount of mowing.

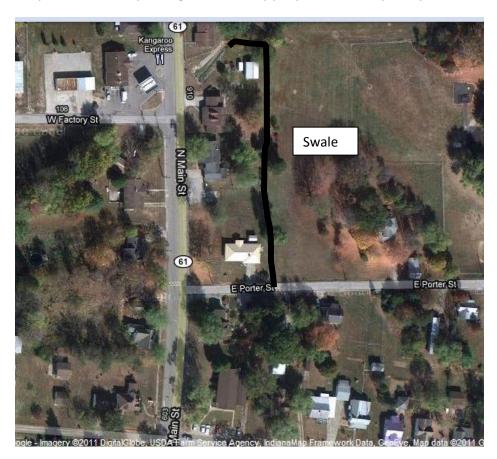
Rain Gardens/Rain Barrels in neighborhood south of E. Porter St.

This area drains to a swale that empties into the ditch running through the park and under 61. Rain gardens and rain barrels on residential property would reduce stormwater and pollution runoff from entering that swale and the ditch. The swale could also be planted with native plants to increase stormwater infiltration. Winslow in/kind could be help building rain gardens, advertising the project through utility mailings, and plant the swale. Cost of this project would likely be \$1-5,000 depending on how many people wanted to participate.

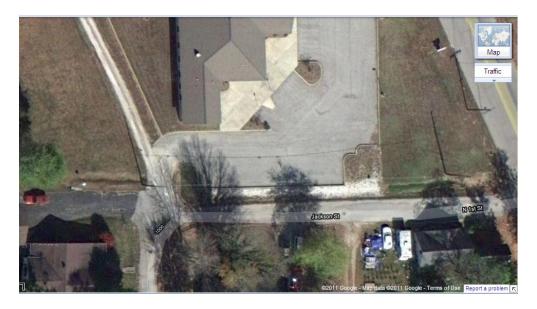
Improve drainage ditch along Jackson St.

A rip rapped ditch accepts stormwater from an adjacent parking lot and uphill residential area. Remove the rip rap and turn the ditch into a planted swale that will filter the runoff and infiltrate it into the ground. An engineer would be needed to design the swale. Winslow contribution could be removal of existing rip rap, earth moving, and planting once the swale is done. Cost may be \$10-15,000.

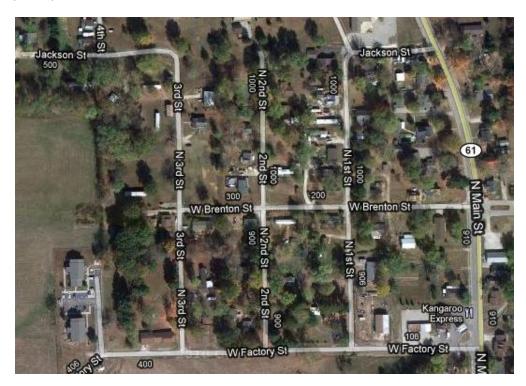
Small ditch plantings in residential area

There are a series of intermittent roadside drainage ditches running along 2nd St from its beginning to its end at W. Factory St. Some of these ditches could be planted with native plants to increase runoff filtering and infiltration. The whole neighborhood between 61 and 3rd Street would be a good place to promote rain gardens, rain barrels, and ditch plantings. Winslow in/kind could be help building rain gardens, advertising the project through utility mailings, and planting the ditches. Cost of this project would likely be \$1-5,000 depending on how many people wanted to participate.

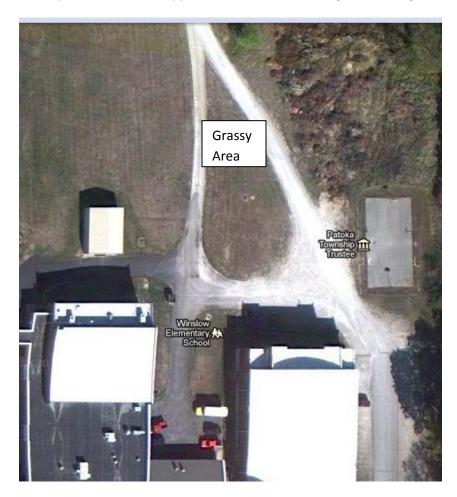
Rain from the Community Center's roof goes to underground pipes and outlets to a nearby ditch. There are some grassy areas near the Center that possibly could be turned into large storm water retention cells. Engineering may be needed to complete this project. The retention capacity of the grassy areas would needs to be known, as well as how much of the roof runoff can be diverted. Diverting the runoff will involve creating an inlet and outlet structure to the grassy area. The inlet likely would have to be placed underneath the gravel road. The outlet would have to tie into the existing storm drain system. Winslow support could be earth moving, connecting inlets and outlets, and planting the grassy area.
