Project Name: Fourteen Mile/Goose Creek WMP

Plan Type: Watershed Management Plan

Fourteen Mile Creek/Goose Creek-OH River Watersheds Improvement Project

WATERSHED MANAGEMENT PLAN

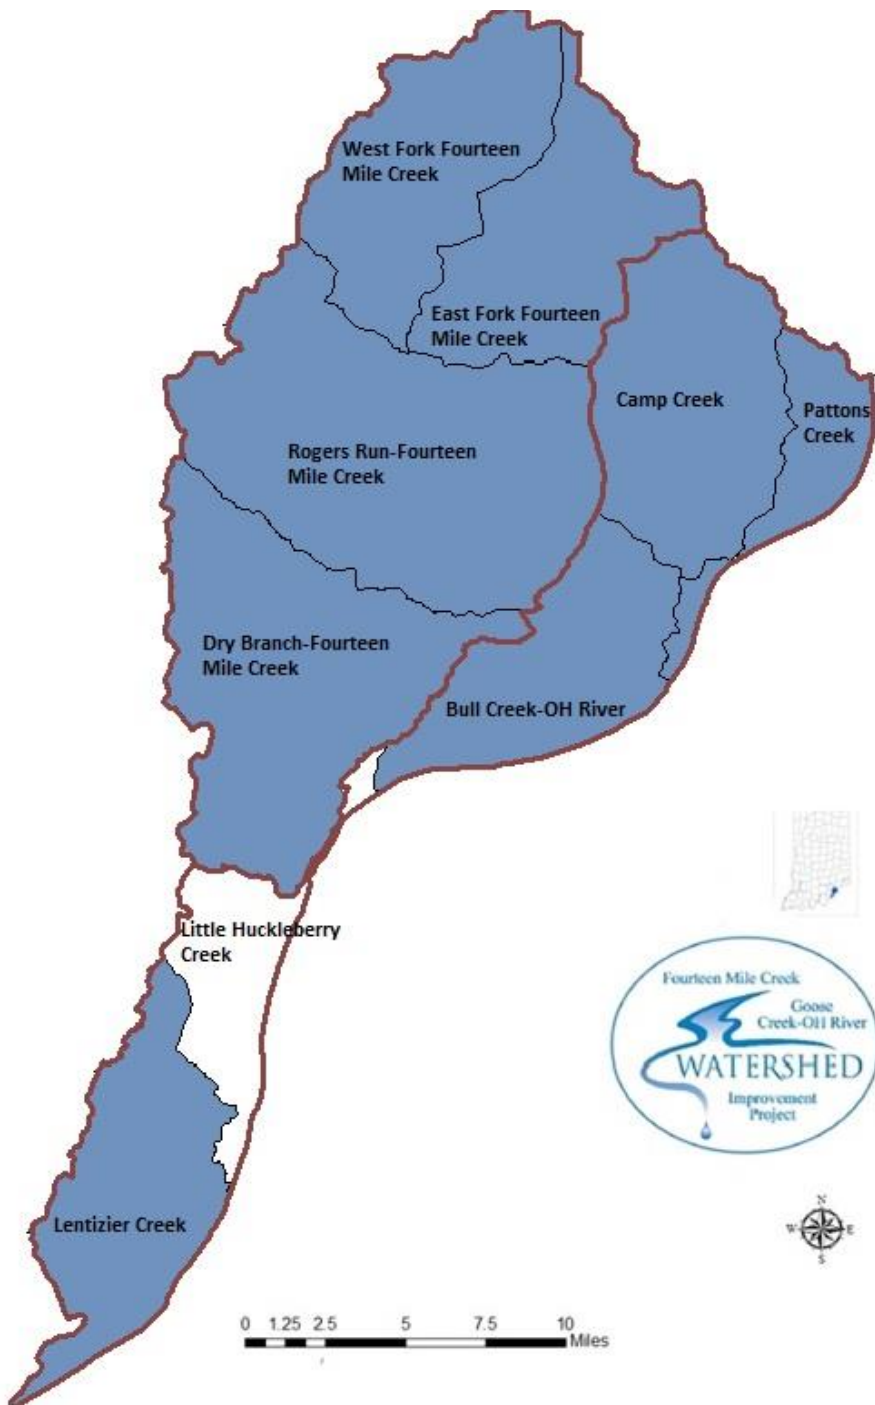
Figure 47: Subwatersheds (represented in blue) where Streambank Stabilization is Needed

Given that, without going door to door and requesting access to individual landowners' properties, it is difficult to determine with a windshield survey the extent of streambanks that need stabilized. Steering Committee members rationalized, however, that with sites already identified where livestock were accessing water bodies in a subwatershed, it would be likely that others exist. They also rationalized that these sites would likely need to be stabilized if livestock are accessing and degrading the banks of the stream. In addition, along the 11.96 miles of stream identified in the desktop survey as in need of buffers, they rationalized that those streambanks may also need to be stabilized as they are unprotected, bare, or minimally vegetated and subject to erosion from the forces of nature. Therefore, based on those two criteria, the subwatersheds presented below in blue in Figure 47 were determined to be areas where streambank stabilization is needed.

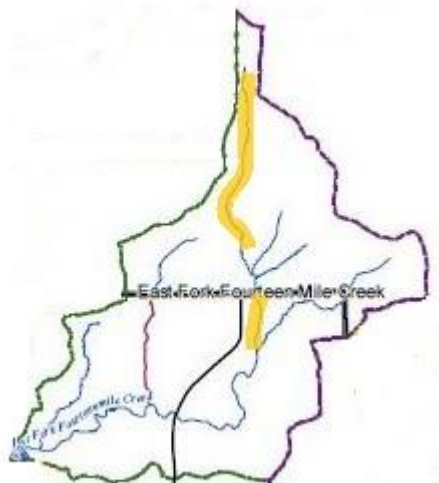
Figure 56: East Fork – Fourteen Mile Creek Subwatershed Stream Banks Needing Buffers

The desktop survey completed during this project to determine stream miles in need of buffers, revealed a total of 1.46 miles of stream banks in this subwatershed that could benefit from the installation of buffers. These are not continuous miles, but are scattered along the stream systems. Figure 56 represents these miles. Additionally, as discussed in Section 2.2.11, Landuse Information, some of these miles are likely to require bank stabilization if livestock have been accessing and degrading them where buffers are not present.

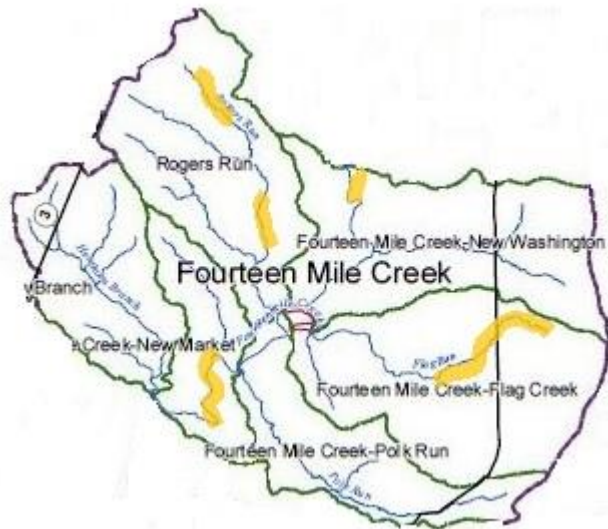
Figure 69: Rogers Run – Fourteen Mile Creek Subwatershed Stream Banks Needing Buffers

The desktop survey completed during this project to determine stream miles in need of buffers, revealed a total of 3.41 miles of stream banks in this subwatershed that could benefit from the installation of buffers. These are not continuous miles, but are scattered along the stream systems. Figure 69 represents these miles. Additionally, as discussed in Section 2.2.11, some of these miles are likely to require bank stabilization if livestock have been accessing and degrading them where buffers are not present.

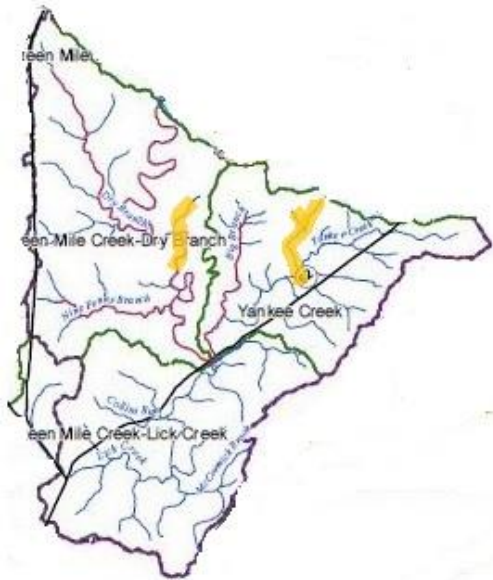
Figure 80: Dry Branch – Fourteen Mile Creek Subwatershed Stream Banks Needing Buffers

The desktop survey completed during this project to determine stream miles in need of buffers, revealed a total of 1.23 miles of stream banks in this subwatershed that could benefit from the installation of buffers. These are not continuous miles, but are scattered along the stream systems. Figure 80 represents these miles. Additionally, as discussed in Section 2.2.11, some of these miles are likely to require bank stabilization if livestock have been accessing and degrading them where buffers are not present.

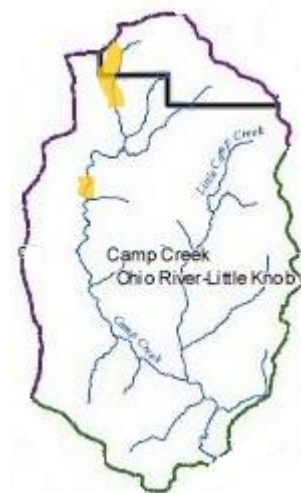
Figure 85: Camp Creek Subwatershed Stream Banks Needing Buffers

The desktop survey completed during this project to determine stream miles in need of buffers, identified .82 miles of stream banks in this subwatershed that could benefit from the installation of buffers. These are not continuous miles, but are scattered along the stream systems. Figure 85 represents these miles. Additionally, as discussed in Section 2.2.11, some of these miles are likely to require bank stabilization if livestock have been accessing and degrading them where buffers are not present.

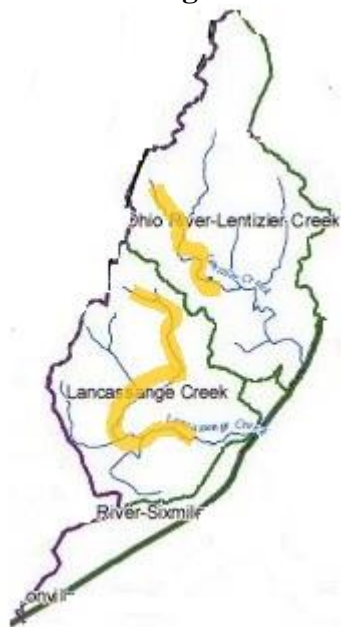
Figure 94: Lentizier Creek Subwatershed Stream Banks Needing Buffers

The desktop survey completed during this project to determine stream miles in need of buffers, identified 3.61 miles of stream banks in this subwatershed that could benefit from the installation of buffers. These are not continuous miles, but are scattered along the stream systems. Figure 94 represents these miles.

Additionally, some of these miles are likely to require bank stabilization, not because of the presence of livestock, but rather as a result of development. As stated previously in this document, the addition of impervious surfaces in areas of urban development, along with urban drainage systems (i.e. curbs, gutters, and storm drain pipes), alters the natural hydrology in a watershed by increasing the volume of stormwater runoff and reducing groundwater recharge. The result is more frequent flooding, higher flood peaks, lower base flow in streams, and lower water table levels.

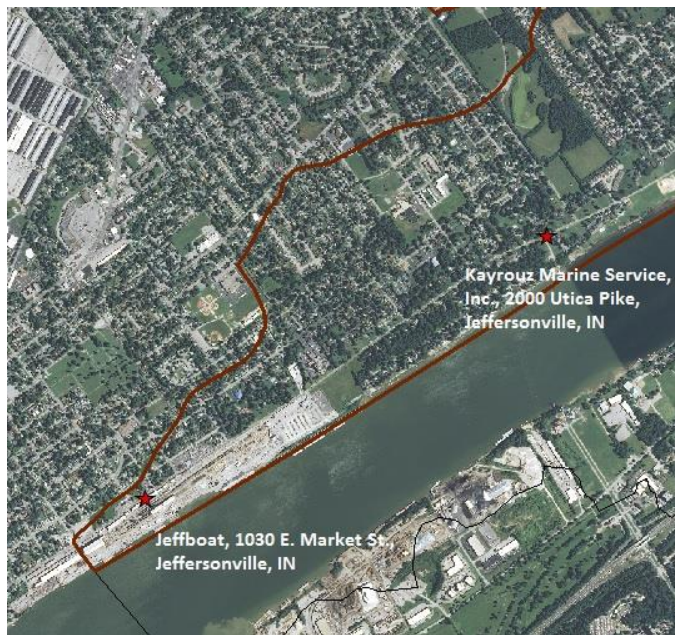
Figure 99: City of Jeffersonville's LUST Locations

Nine LUSTs are found in this subwatershed: BP, 7 Eleven Store 216, Former AMOCO 450, Speedway 5191, Snelling Marathon, Kayrouz Marine Service, Inc., Jeffboat, Thornton Oil, and Kmart. They are mapped below in Figure 99.

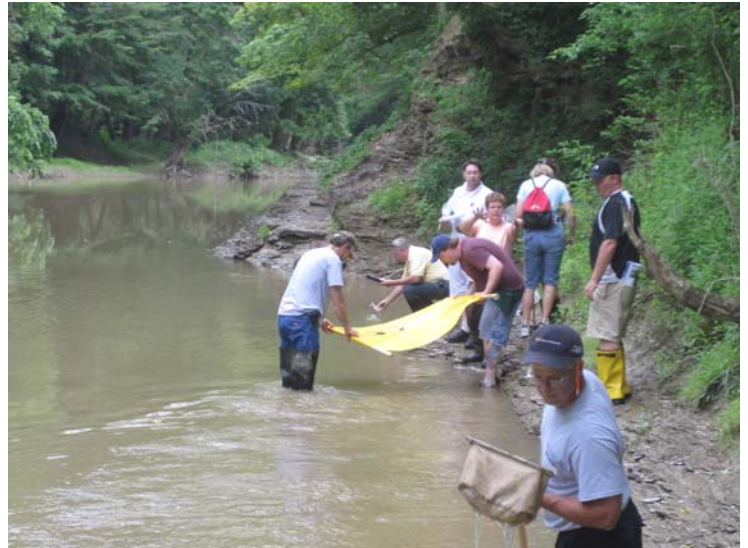
Sylvia conducting macroinvertebrate sampling at a Hoosier Riverwatch training

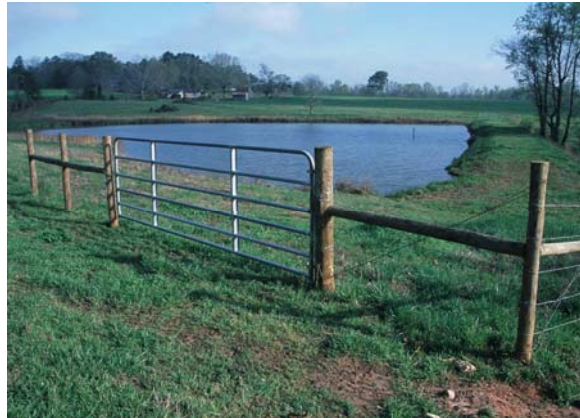
Livestock exclusion or access control is the temporary or permanent exclusion of livestock from a designated area—often to protect streambanks, wetlands, woods, cropland, wildlife habitat or conservation buffers. Access controls can also be used to keep wildlife, people, equipment and vehicles out of an area.

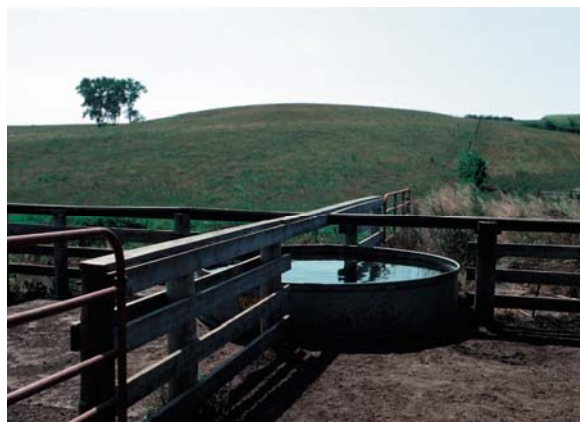
The **water tank** in this pasture is located to serve four pastures, allowing a water supply for four-pasture rotational grazing. In this instance, water is piped from a nearby pond to the tank.

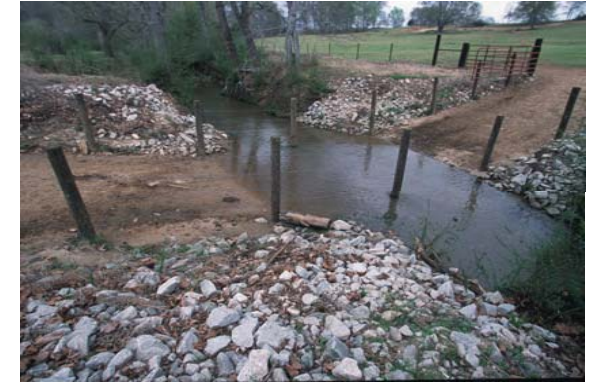
Stream crossings, such as the one shown above, are stabilized fords, culverts or bridges that allow livestock, people, equipment or vehicles to cross a stream in a safe and environmentally sound manner. Stream crossings help prevent streambank erosion, water pollution, aquatic habitat degradation and damage to stream beds and channels

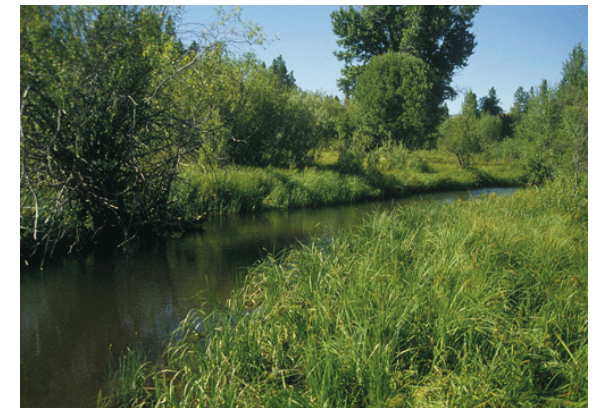
Native plants and grasses have deep root systems that help absorb storm water pollutants, and assist in bank and slope stabilization. **Vegetative buffers** serve as a final filtering out of sediment, fertilizers, pesticides, livestock waste, and other pollutants before runoff enters the water.
