Escherichia coli (E. coli)
**Total Maximum Daily Load Report for the
Otter Creek Watershed**

Final

August 22, 2013

Prepared by
Indiana Department of Environmental Management

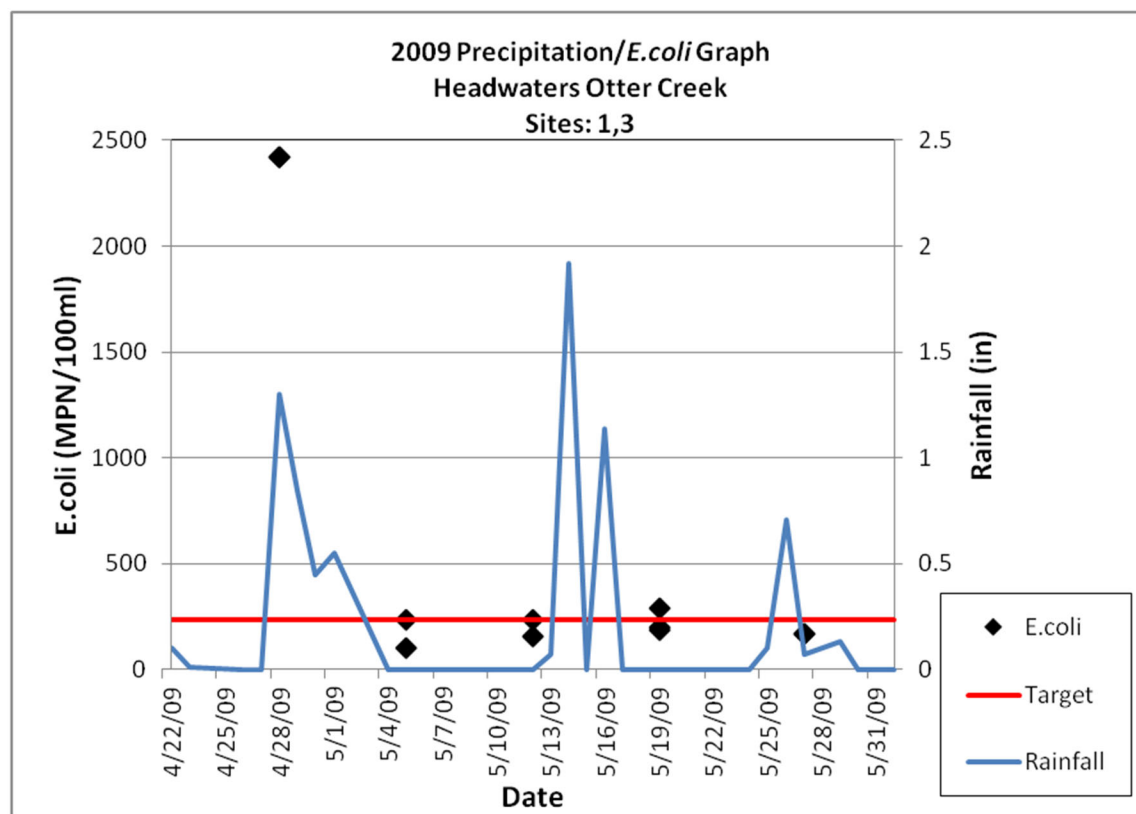
Figure 30. Graph of Precipitation and all *E. coli* Data in the Headwaters Otter Creek Subwatershed
