OTTER CREEK WATERSHED MANAGEMENT PLAN

A PROJECT OF THE OUABACHE LAND CONSERVANCY
P.O. BOX 10993
TERRE HAUTE, INDIANA 47801

7 AUGUST 2019

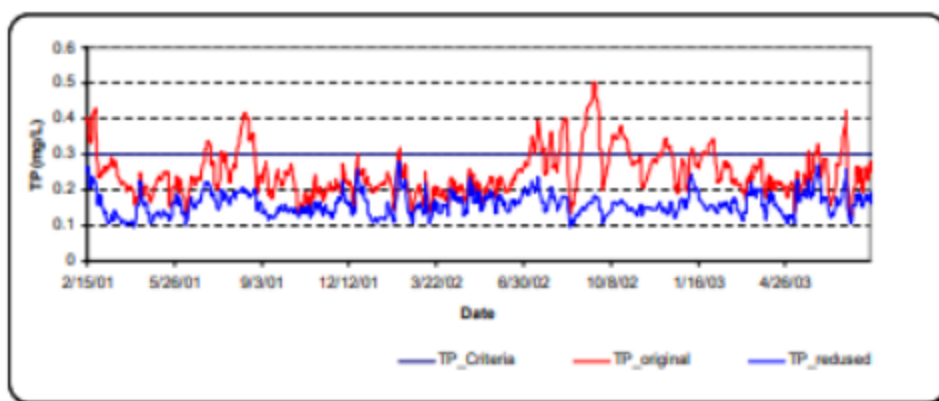
Figure H-13. TP at Upstream Vermillion

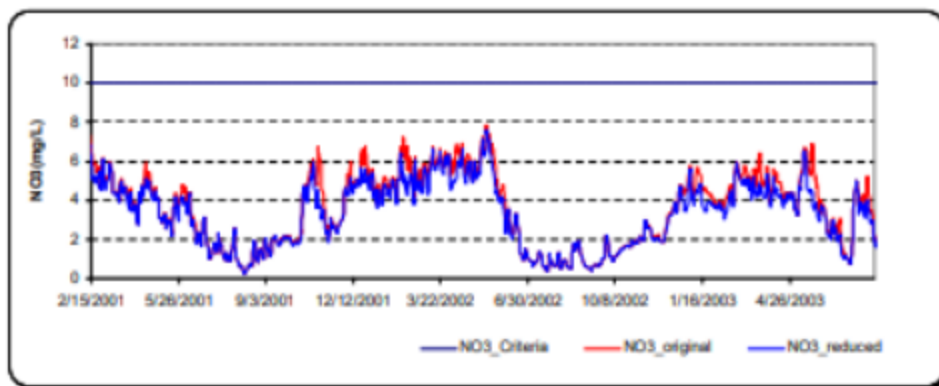
Figure H-14. NO₃ at Upstream Vermillion

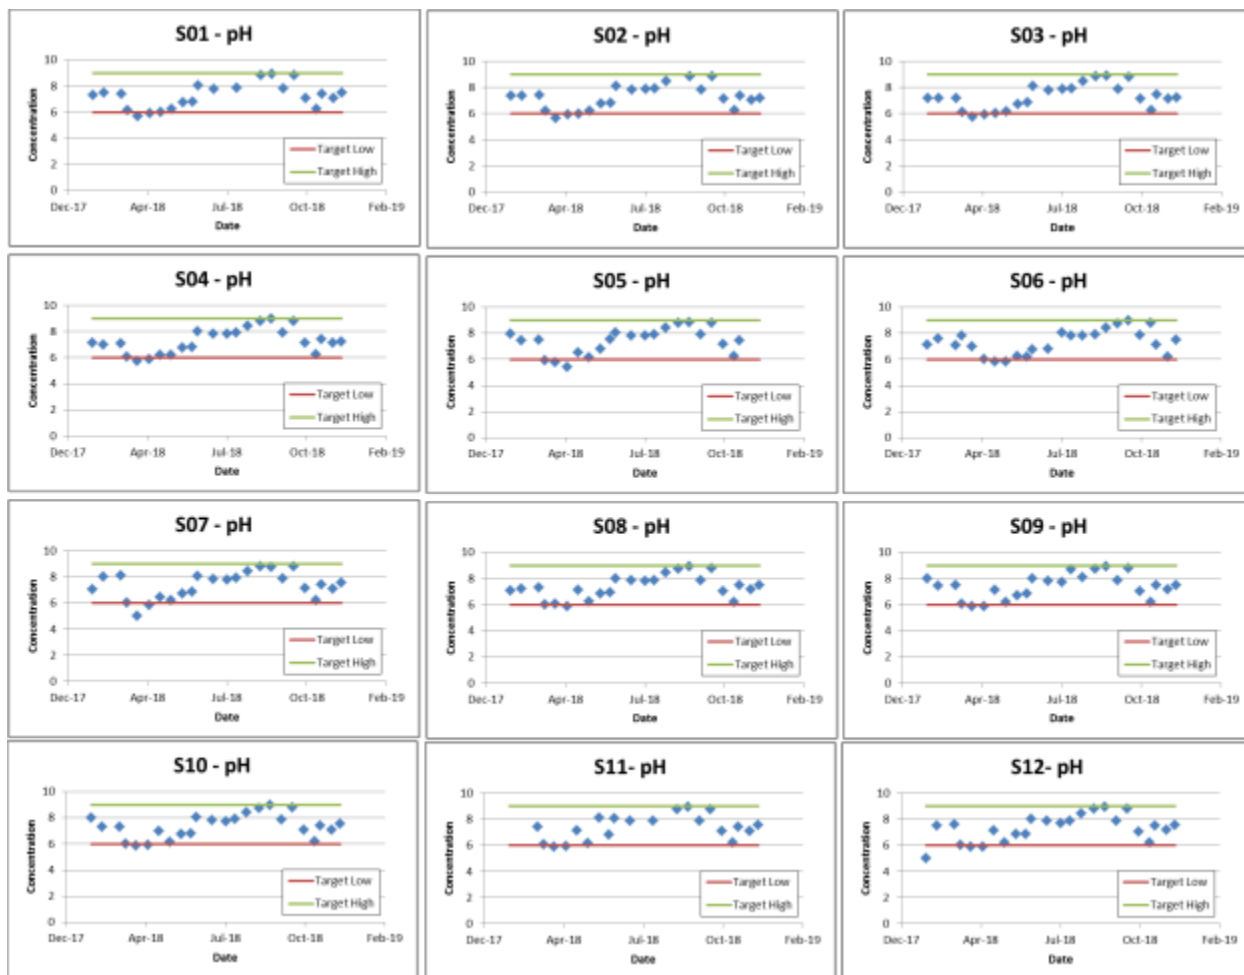
Figure 34. pH measurements in Otter Creek samples sites from January-December, 2018. Note differences in scale along the concentration (y) axis.

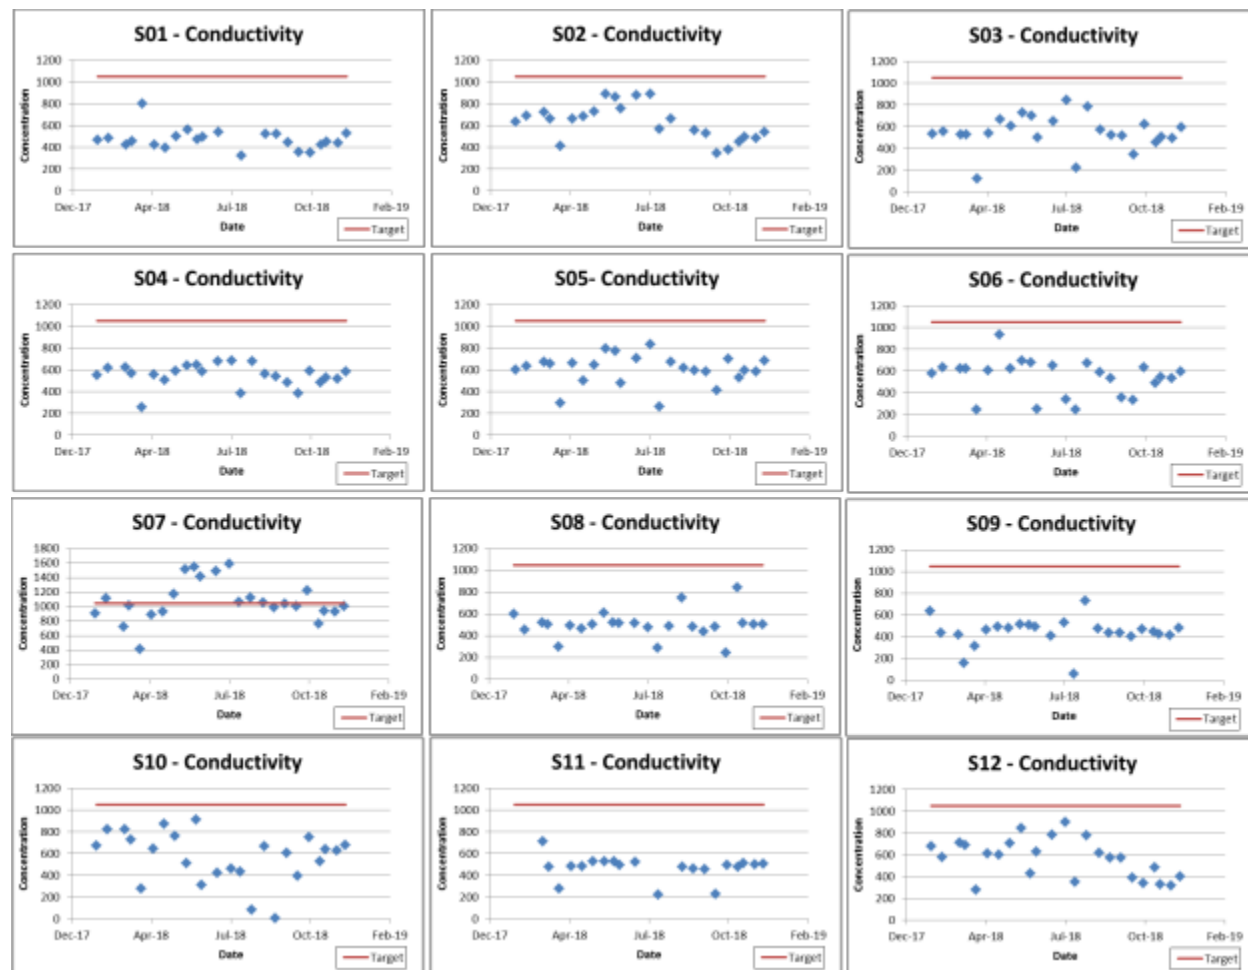
Figure 35. Conductivity measurements in Otter Creek samples sites from January-December, 2018. Note differences in scale along the concentration (y) axis.

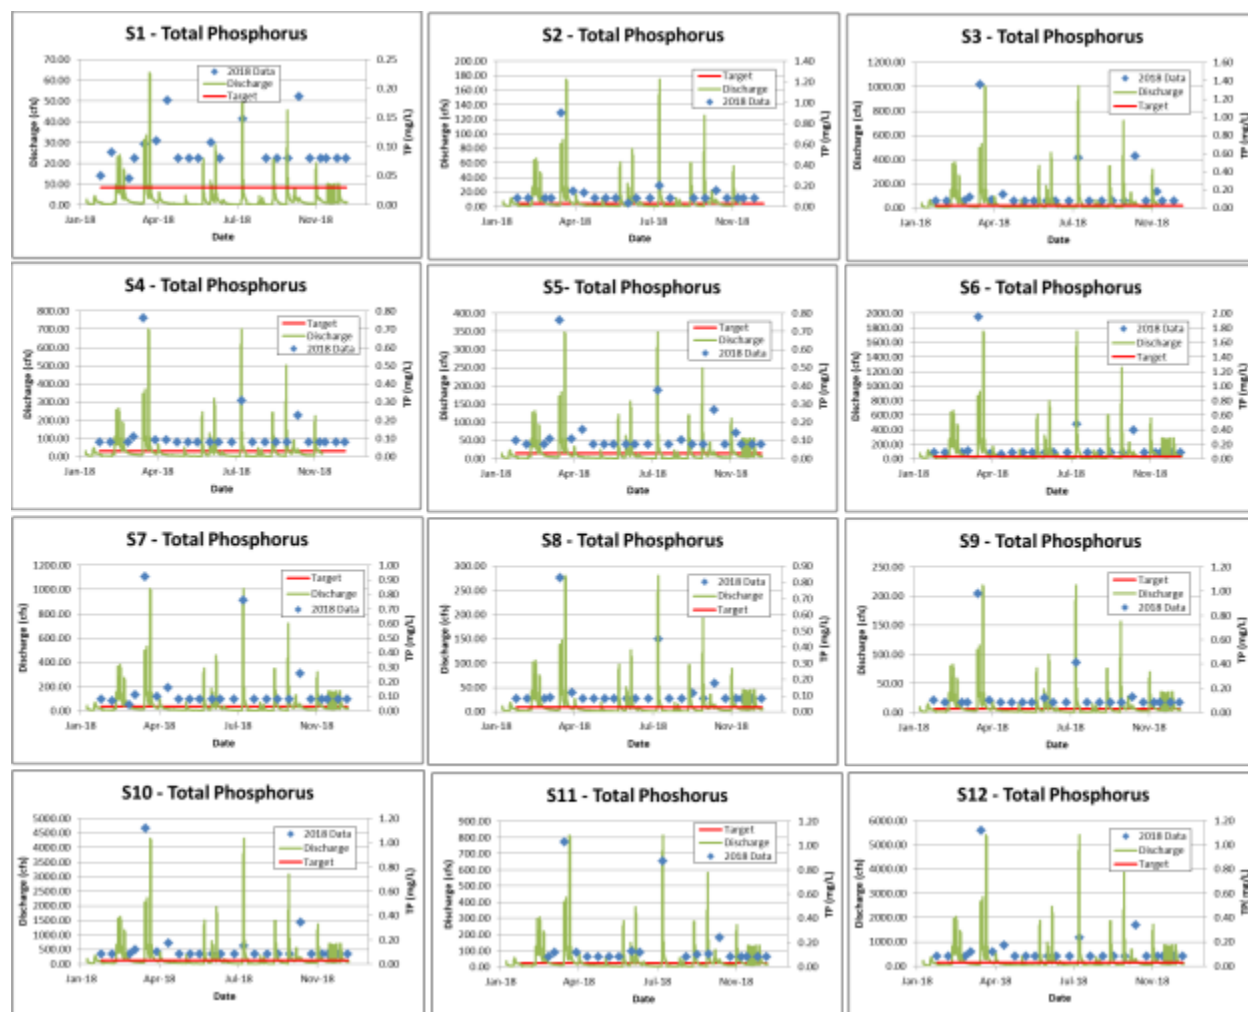
Figure 38. Total phosphorus concentrations measured in Otter Creek samples sites from January-December, 2018. Note differences in scale along the concentration (y) axis.

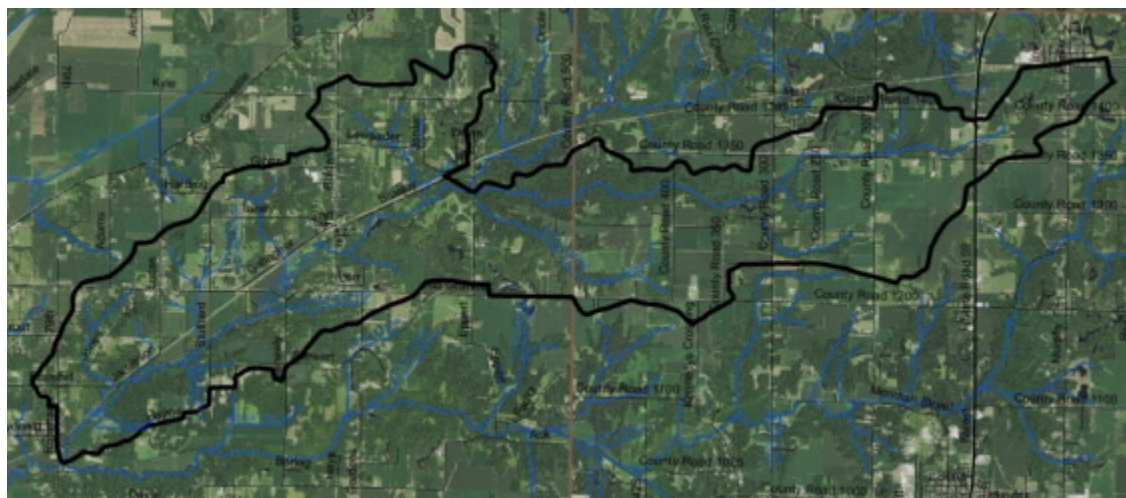
The Little Creek-North Branch Otter Creek Subwatershed is located in north central Vigo County and drains water from the North Branch Otter Creek Subwatershed (Figure 57). It includes on 12-digit HUC: 051201110403. The Little Creek-North Branch Otter Creek Subwatershed drain 10,669 acres or 16.7 square miles. There are 67.4 miles of stream, of which IDEM has classified 31.6 miles of stream as impaired for *E. coli*.

Figure 57. Little Creek-North Branch Otter Creek Subwatershed.
