Re: Inspection Summary/ Noncompliance Letter
Town of Coalmont
Coalmont, Clay County

Date(s) of Inspection: April 01, 2021
Type of Inspection: Complaint Investigation (#95168)
Inspection Results: Violations were observed.

NPDES Wastewater Facility Inspection Report

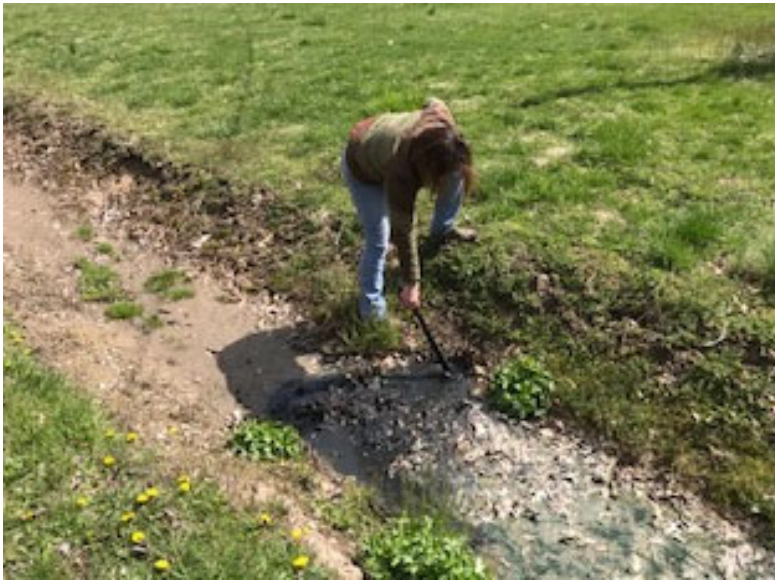
Facility:	
Town of Coalmont	
Photographer:	
Kevin Stark	
Date: 4/1/2021	Time:
Others Present:	
Holly Zurcher	
Location/Description:	
Cleaning debris to reveal sewage discharging into road ditch.

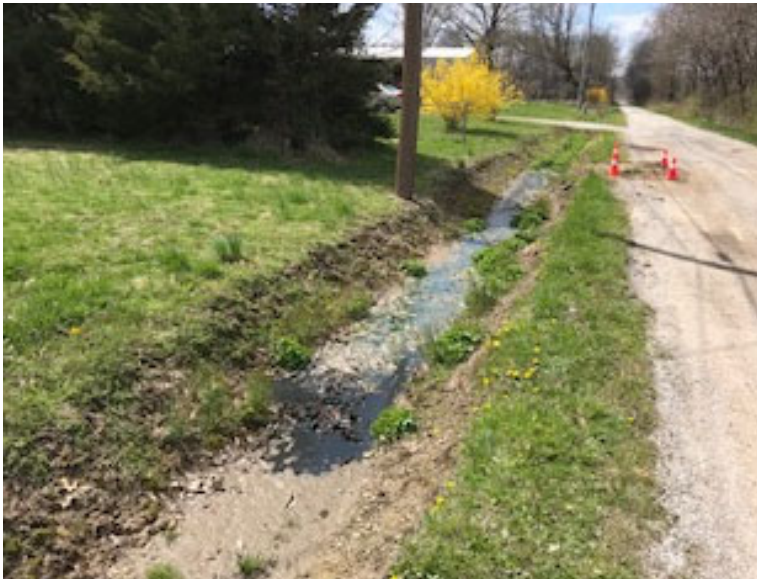
Facility:	
Town of Coalmont	
Photographer:	
Kevin Stark	
Date: 4/1/2021	Time:
Others Present:	
Holly Zurcher	
Location/Description:	
Downstream of pipe above.

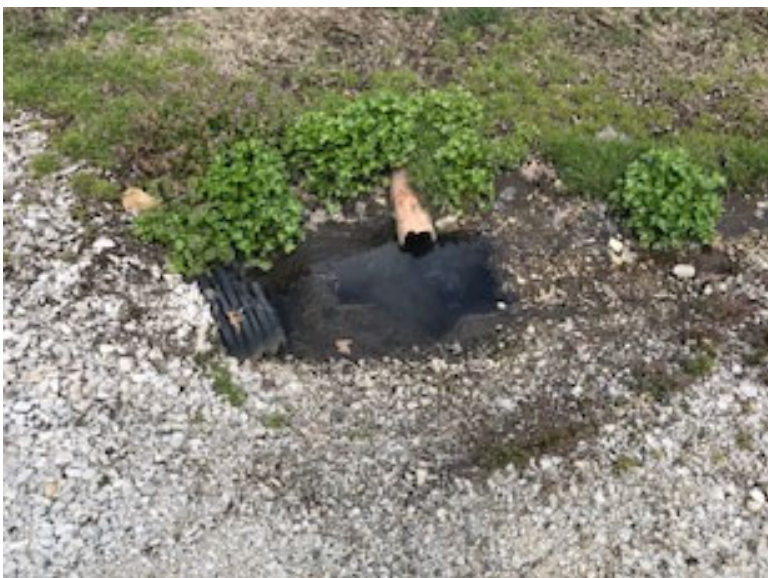
Facility:	
Town of Coalmont	
Photographer:	
Kevin Stark	
Date: 4/1/2021	Time:
Others Present:	
Holly Zurcher	
Location/Description:	
Another septic pipe discharging into road ditch.

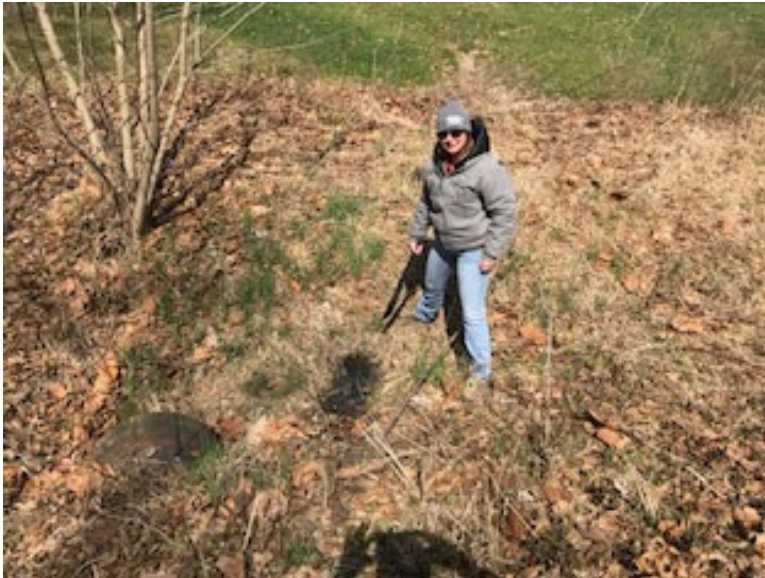
Facility: Town of Coalmont	
Photographer: Kevin Stark	
Date: 4/1/2021	Time:
Others Present: Holly Zurcher	
Location/Description: Dark spot in front of inspector is septic discharge pipe with debris cleared.

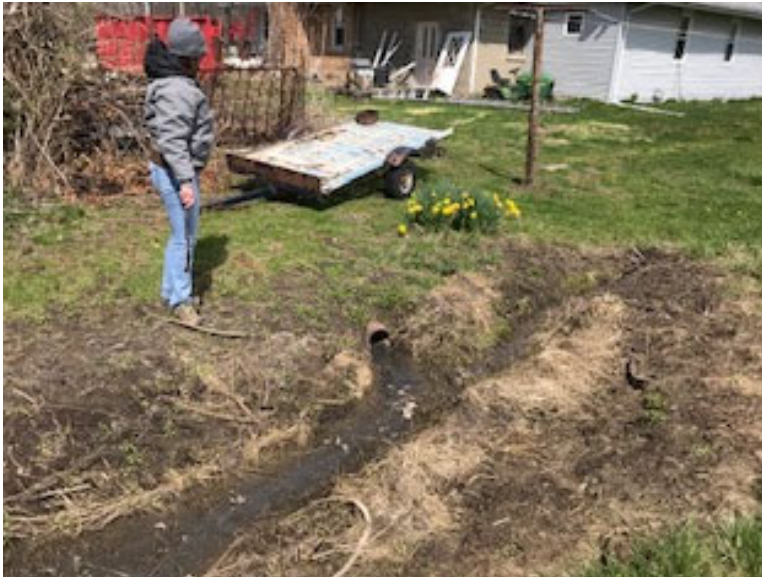
Facility: Town of Coalmont	
Photographer: Kevin Stark	
Date: 4/1/2021	Time:
Others Present: Holly Zurcher	
Location/Description: Septic pipe discharging in ditch.

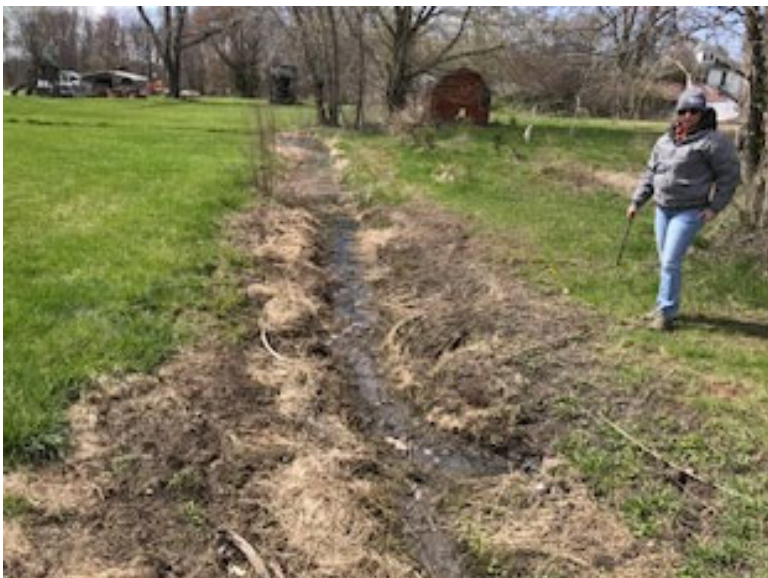
Facility: Town of Coalmont	
Photographer: Kevin Stark	
Date: 4/1/2021	Time:
Others Present: Holly Zurcher	
Location/Description: Downstream view of septic discharge in ditch.

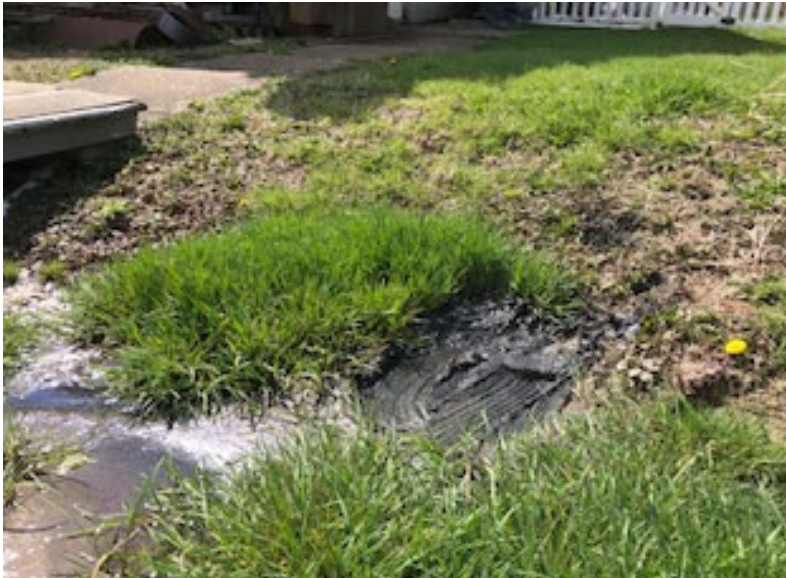
Facility: Town of Coalmont	
Photographer: Kevin Stark	
Date: 4/1/2021	Time:
Others Present: Holly Zurcher	
Location/Description: Septic pipe discharging to ditch.

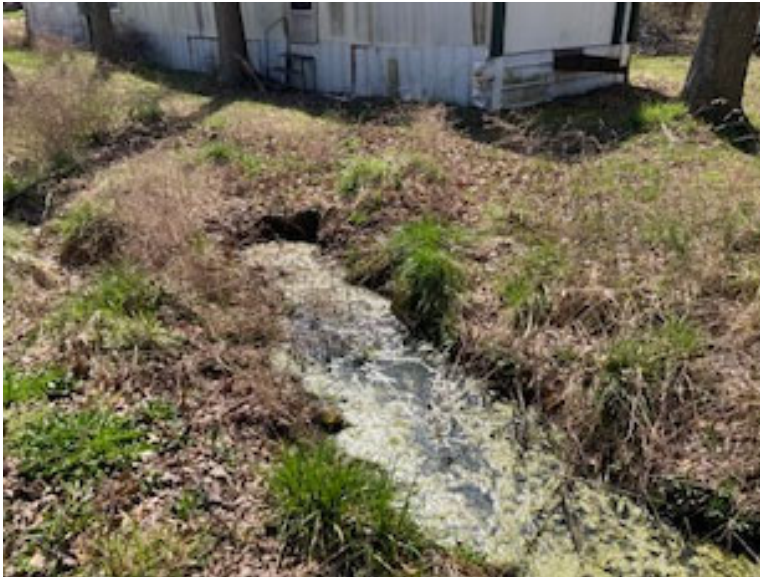
Facility: Town of Coalmont	
Photographer: Kevin Stark	
Date: 4/1/2021	Time:
Others Present: Holly Zurcher	
Location/Description: Septic pipe discharging to ditch.

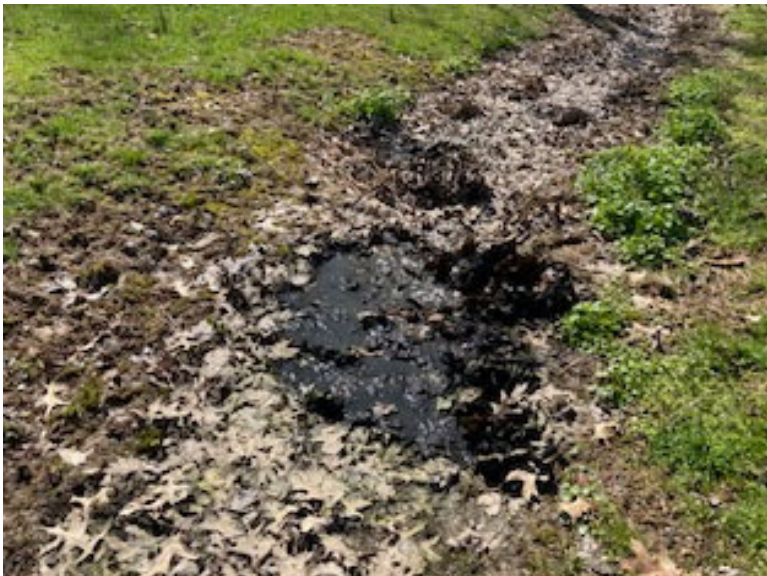
Facility: Town of Coalmont	
Photographer: Kevin Stark	
Date: 4/1/2021	Time:
Others Present: Holly Zurcher	
Location/Description: Septic pipe discharging to ditch.
