Upper St. Joseph River Watershed Management Plan

HUCs 0410000301, 0410000302, 0410000303,
0410000304

Sustainable Natural Resources Technologies, Inc.
With Guidance from the Upper St. Joseph River Watershed Project Steering Committee

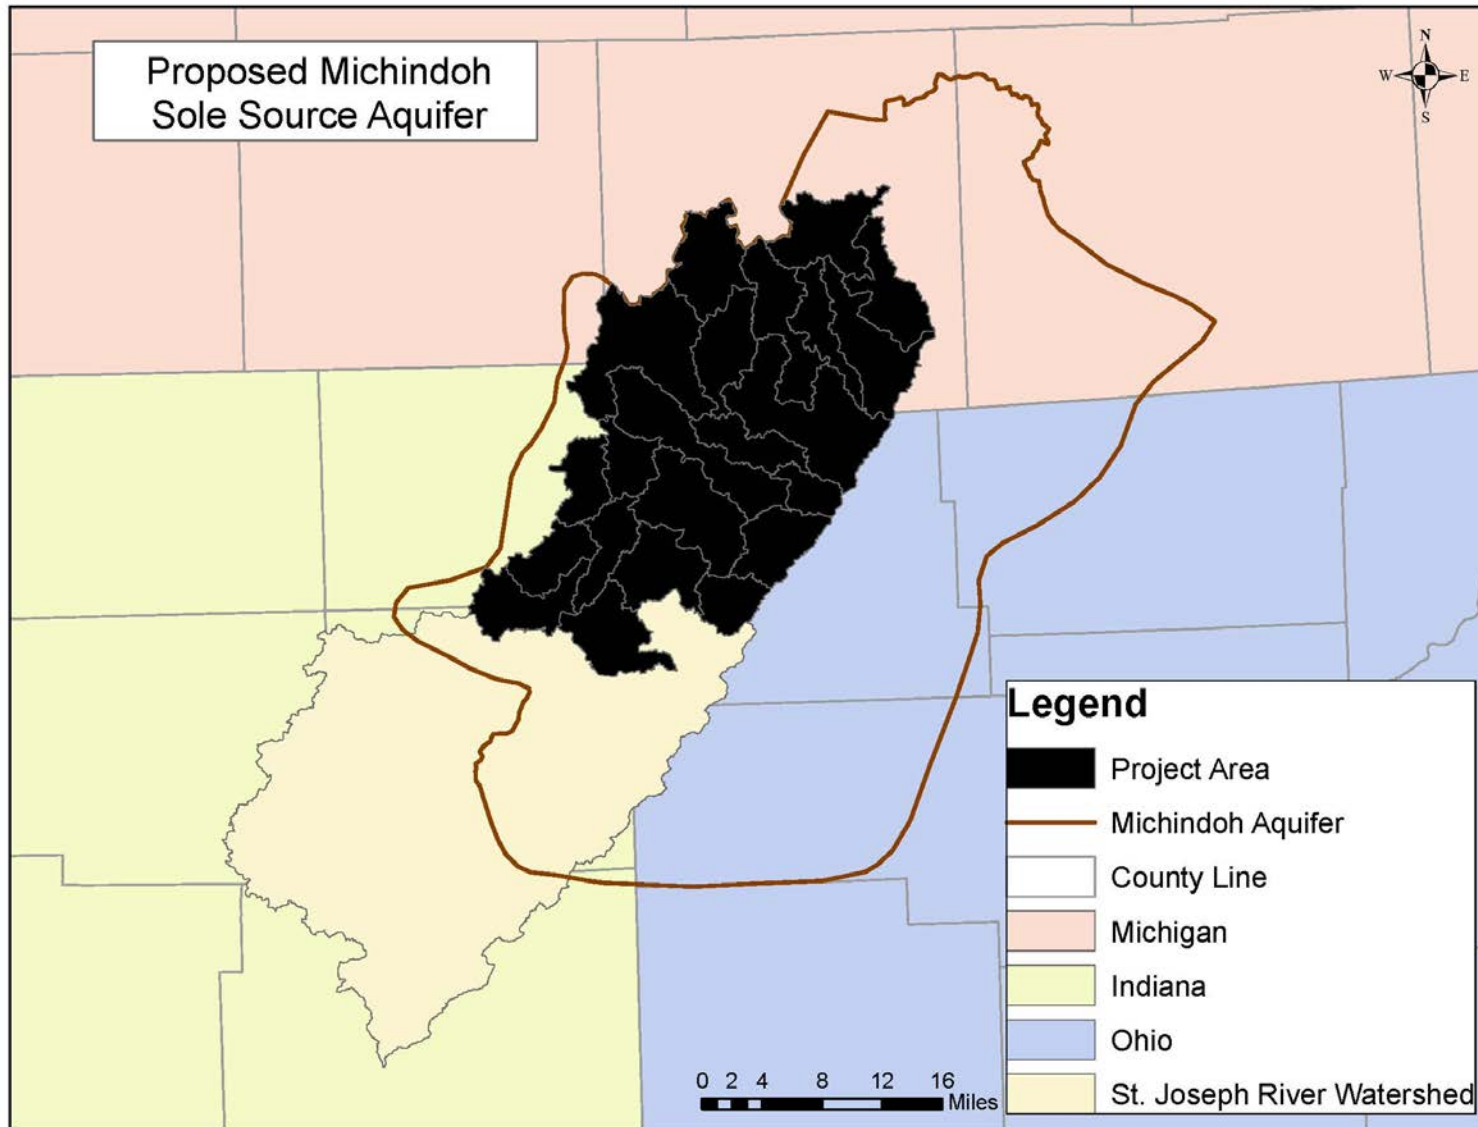
Figure 2.10: MICHINDOH Sole Source Aquifer Boundary

The USJRW is located within the MICHINDOH aquifer boundary (Figure 2.10), which is a glacial, sand and gravel aquifer. The aquifer is at a depth of just below ground surface to 200 feet deep. In 2007 the City of Bryan, OH petitioned the US EPA to designate the MINCHINDOH aquifer as a Sole Source Aquifer as it provides water to more than 385,000 people who withdraw 72 million gallons of water a day. According to the EPA Region 5 webpage, last updated in December, 2011, the US EPA is continuing to do additional research before it will make a final determination.

The entire population of the USJRW acquires their drinking water from the MICHINDOH aquifer which lies under the entire Upper St. Joseph River Watershed, as can be seen in Figure 2.10 on page 25. Field tiles and improperly placed or faulty septic systems can seriously affect the integrity of the aquifer
