Flatrock Creek/Auglaize River Watershed Management Plan 2022

Planning for Five HUC 12 Subwatersheds: Wildcat Creek (041000071205); Headwaters Flatrock Creek (041000071201); Bohnke Ditch (041000071203); Hoffman Creek (041000071202); Brown Ditch (041000071204)

Prepared by the Allen County Soil & Water Conservation District and the
Flatrock/Auglaize Steering Committee

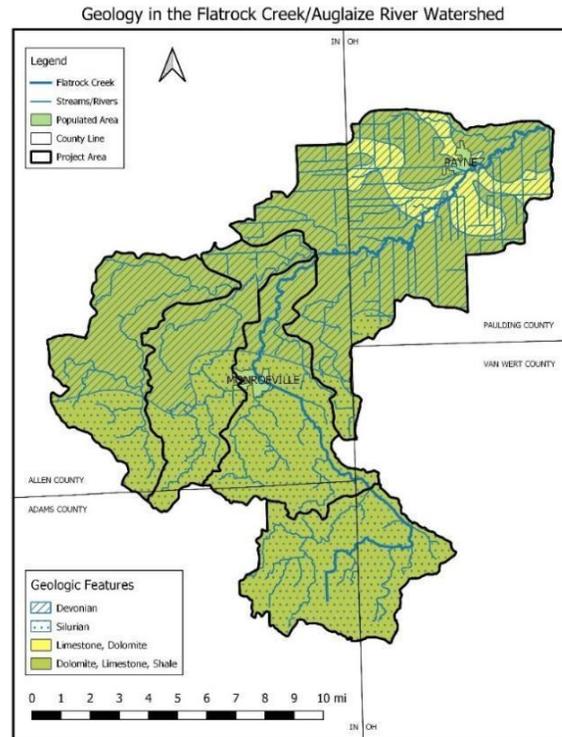
Figure 2.3 Geologic Features in the Flatrock Creek/Auglaize River Watershed

landscape. The main parent material of the Largo formation are fine-grained tills which aid to protect the aquifers in the area. The movement of these massive ice sheets resulted in a homogenous landscape that flattened the hills, filled in preexisting streams, and formed lakes (ex: Great Lakes). Rocks, sand, and minerals were deposited across the terrain as this glacier melted. The predominant bedrock of the project area consists of black shale, shale, dolomite and limestone. Karsts features are not exposed at the surface and are buried. (Figure 2.3)

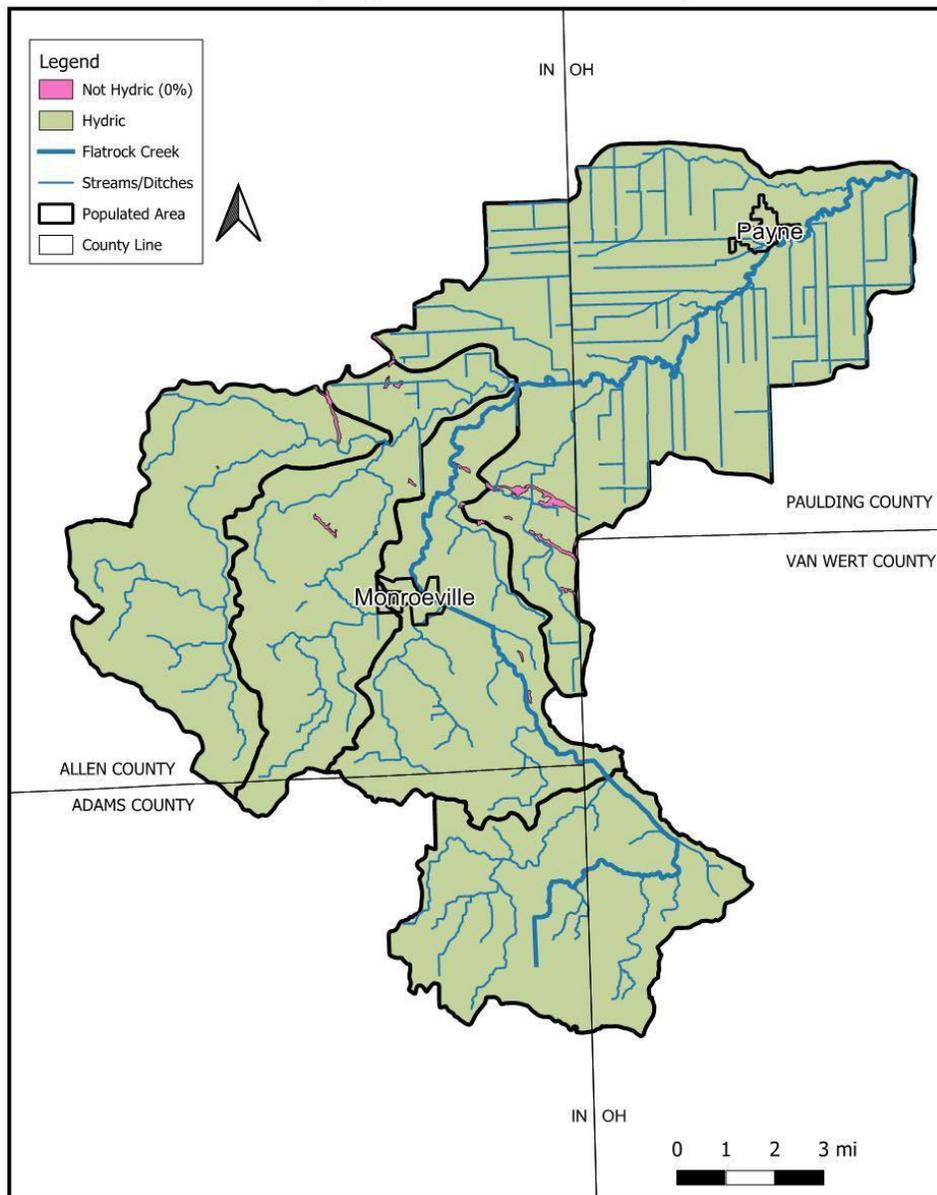
Figure 2.4 Hydric Soils of the Flatrock Creek Watershed

Nearly 100% of the soil types in the watershed have a slow to very slow infiltration rate and limiting layers that impede the downward movement of water. These characteristics lead to increased stormwater runoff during rain events and surface water ponding.

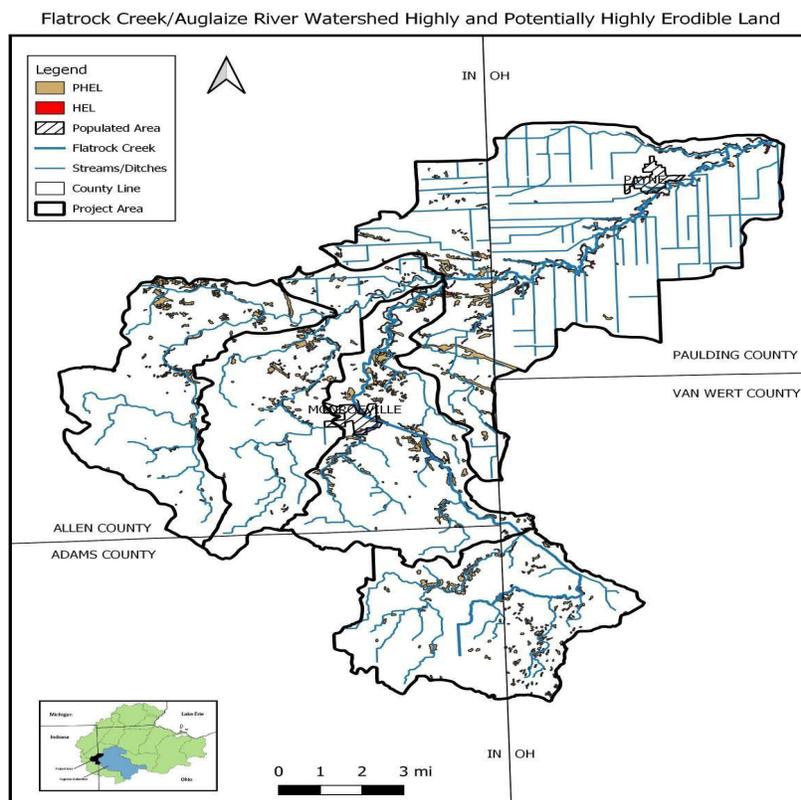
Figure 2.9 Highly erodible soils in the Flatrock Creek watershed

The inventory of highly erodible and potentially highly erodible soils in the project area reveals that 486.2 acres, or 0.50% of the lands within the project area are classified as highly erodible. Potentially highly erodible lands cover 2,592.83 acres, or 2.68% of the project area. (Figure 2.9). The remaining acres in the watershed are classified as non-highly erodible lands. Because the percentage of highly erodible soils is so low, gully erosion is uncommon. Sheet and rill erosion are common in areas where there is little to no plant residue protecting the soil.

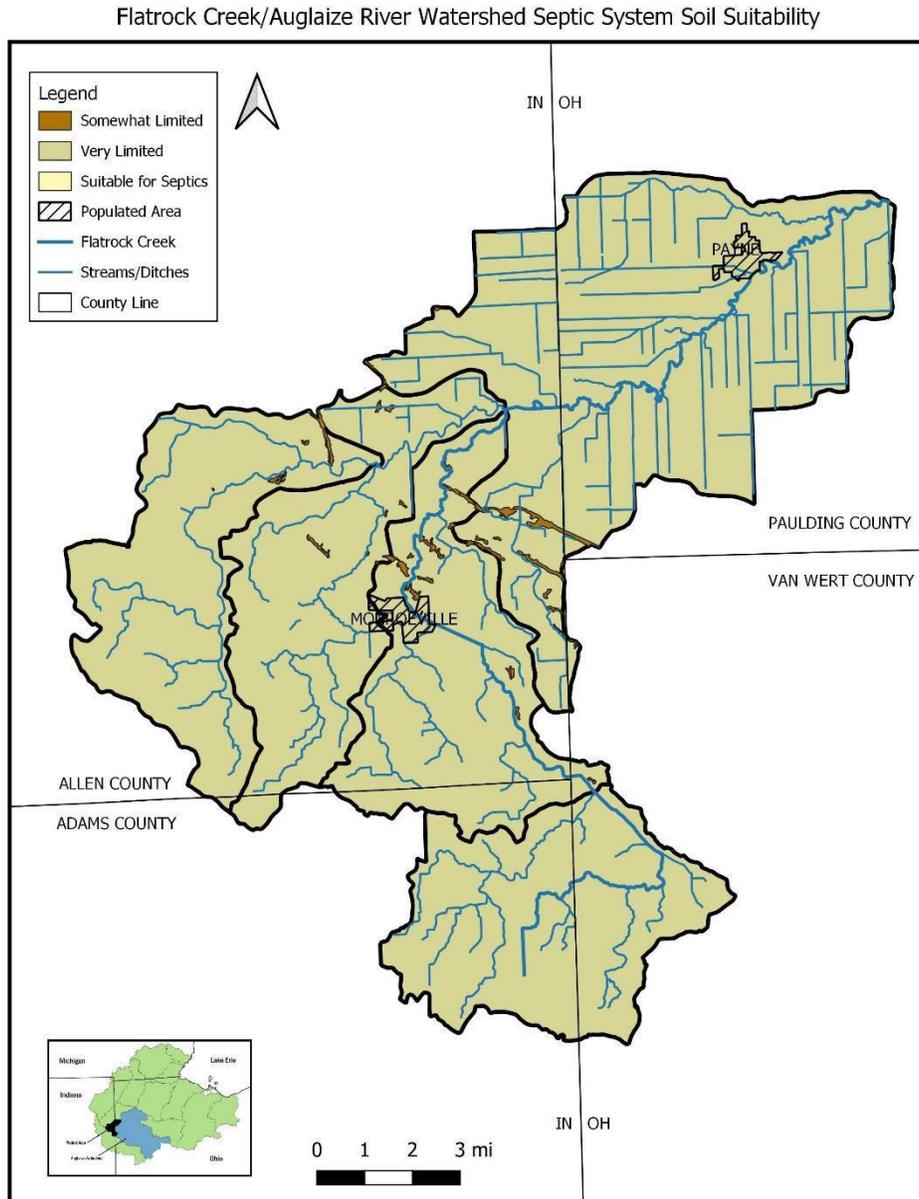
Figure 2.11 Septic System Soil Suitability

In the county Soil Surveys, soils are classified for their ability to function as septic disposal fields. The classifications are: Suitable for Septics; Somewhat Limited - possible contamination of water sources; and Very Limited - likely contamination of water sources. Figure 2.11 shows the extent of these characteristics in the Flatrock Creek watershed. 99.7% (96,305 acres) of the Flatrock watershed is considered “very limited” in terms of soil suitability for septic systems. The remaining 0.03% (275 acres) are classified as “somewhat suitable”. No “suitable” acres for septic use were found.

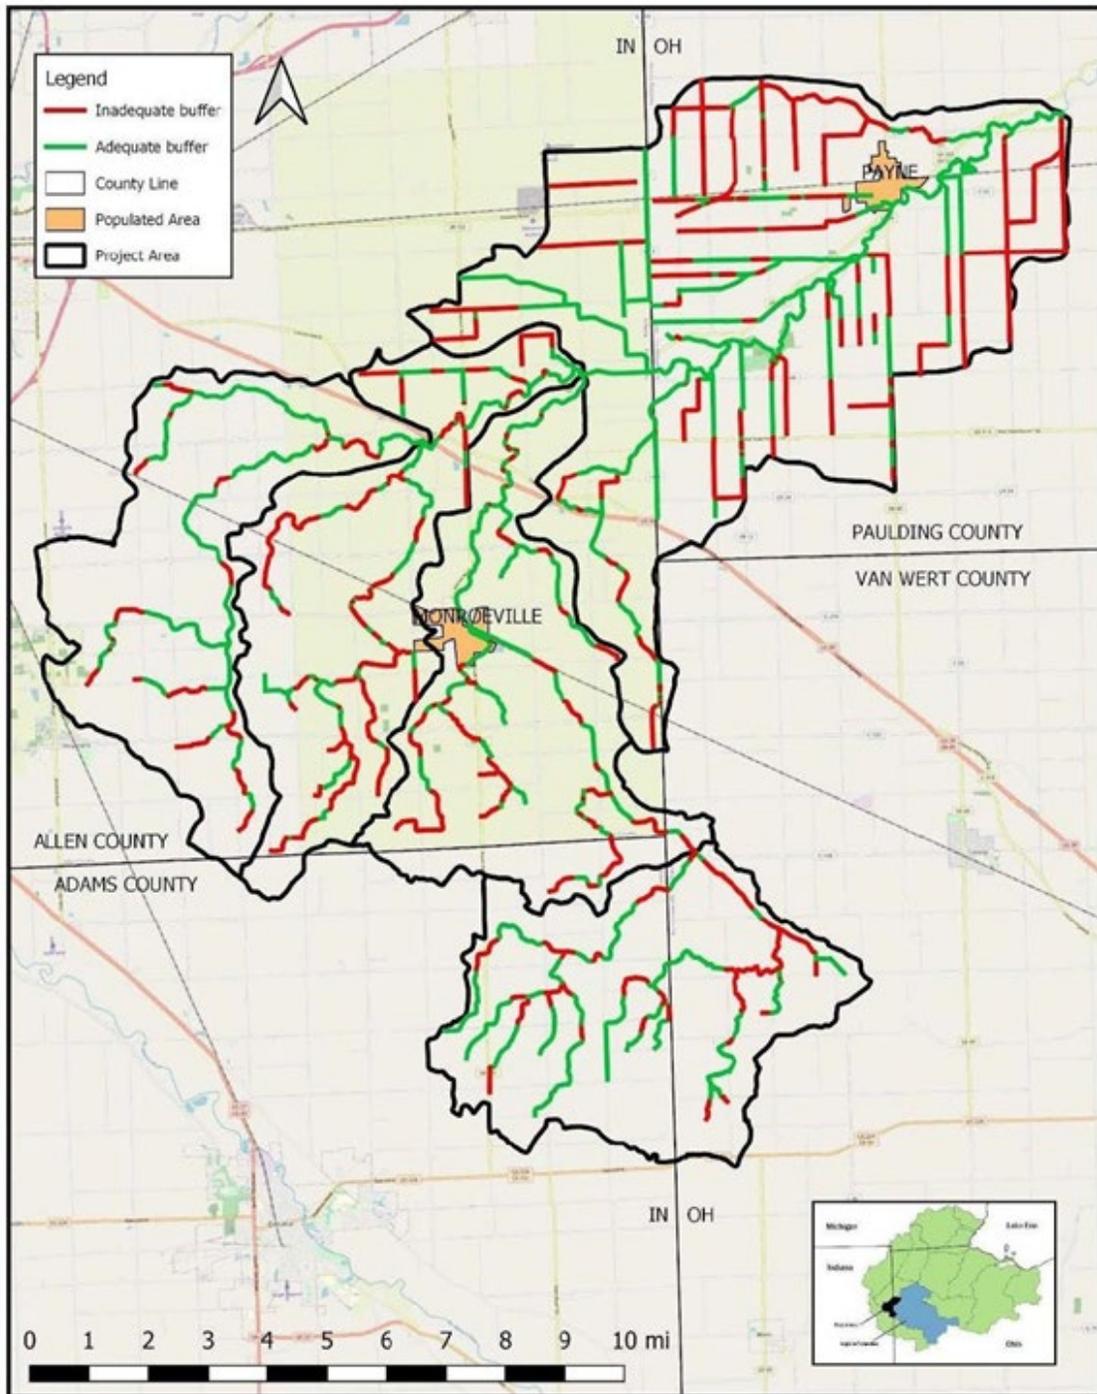
Figure 2.14 Project Area Buffer Strip Inventory, looking upstream

A desktop buffer strip inventory was completed for the entire project area using Google Earth 3D. For each subwatershed, reviewers began downstream and worked their way up the mainstem and tributaries noting the condition of the riparian corridor as it relates to adequate vegetation serving as a buffer strip. "Adequate" was determined to be 20 feet of width or greater. Adequate buffer strips have the potential to stabilize banks and intercept nutrients and sediment in surface water runoff. Figure 2.14 represents the inventory for the entire project area. A comprehensive evaluation of the buffer strip inventory results is presented in Section Three on a subwatershed basis.

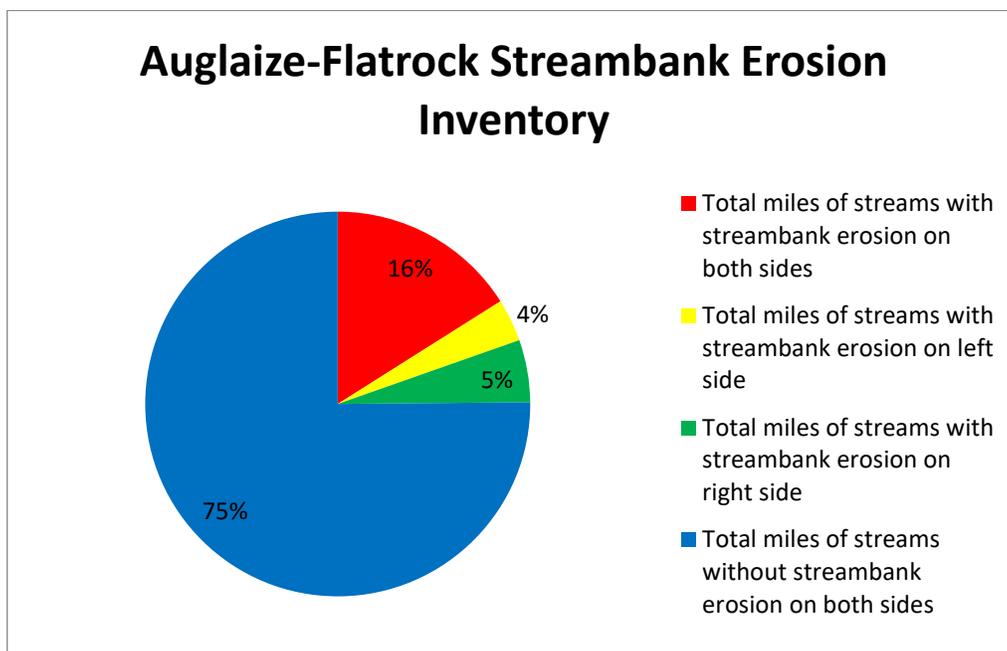
Figure 2.15 Project Area Bank Erosion Inventory, looking upstream

A desktop inventory of eroded stream and ditch banks was conducted alongside the buffer strip inventory using Google Earth 3D. Areas where reviewers could see bank erosion were noted on maps. In the project area; 46.3 miles of streams have bank erosion on both sides, 10.3 miles have bank erosion on the left side when looking downstream, 15 miles of streams have bank erosion on the right side when looking downstream, and 217 miles of streams do not exhibit signs of bank erosion. Figure 2.15 represents this information in percentages of the total and Figure 2.16 provides a visual representation of the inventory.

The results of the bank erosion inventory will be discussed in Section Three on a subwatershed basis.

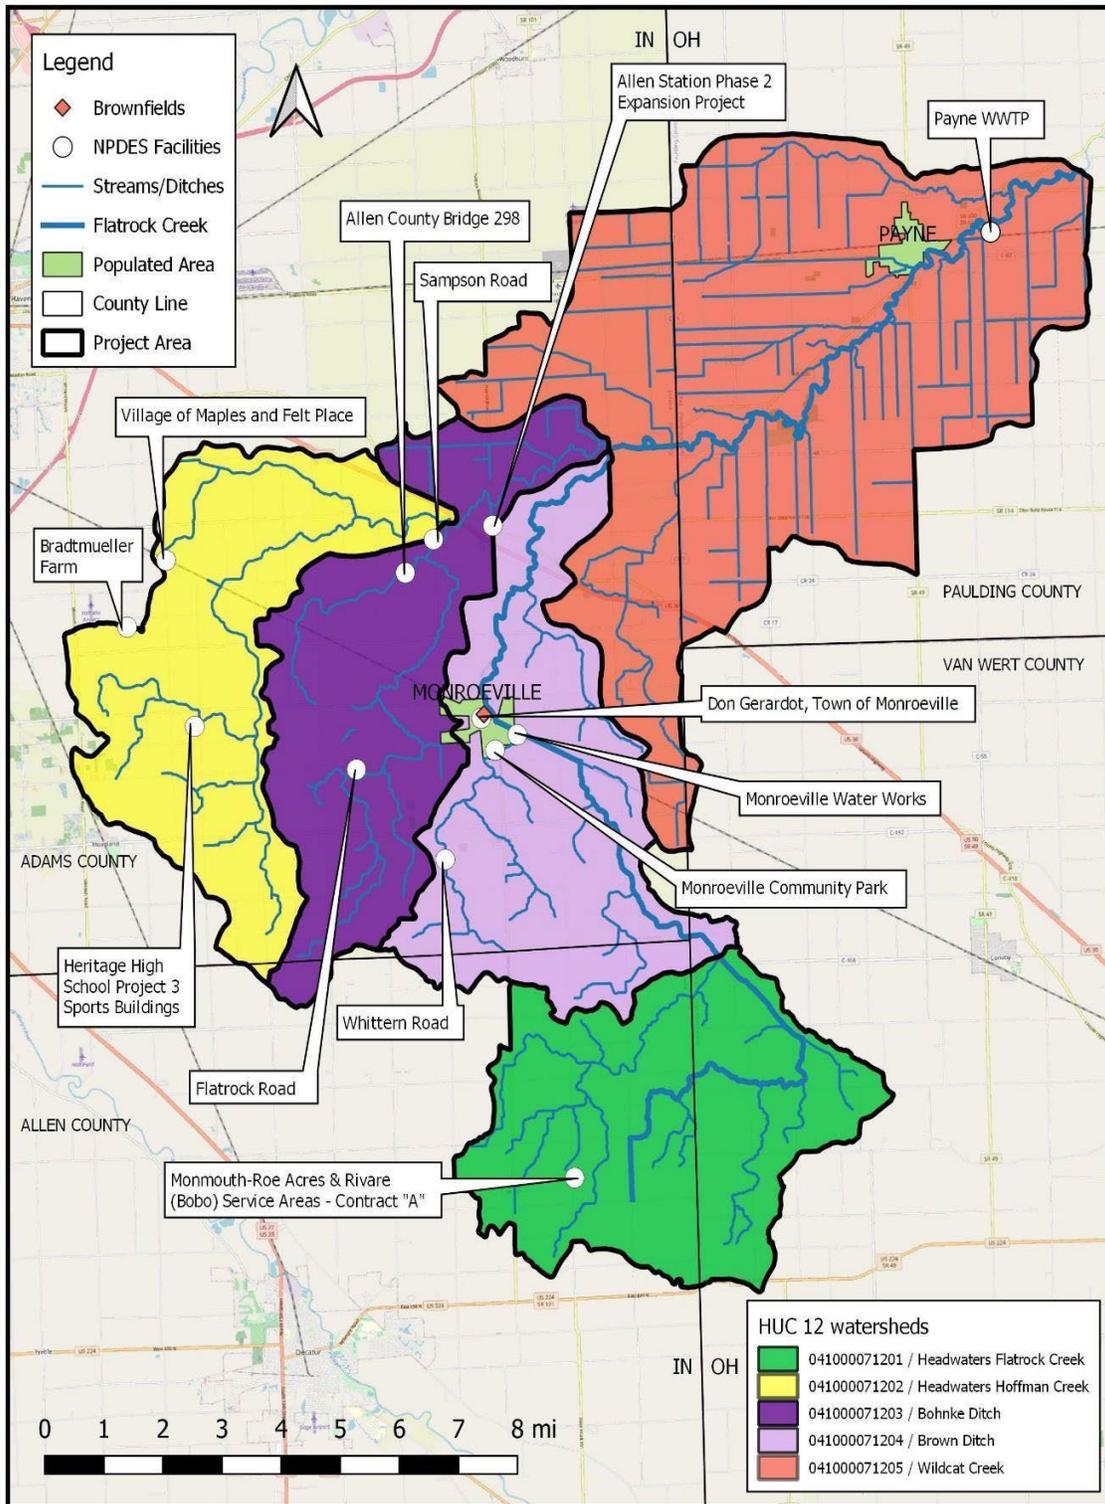
Figure 2.18 NPDES Facilities in the project area

As of July 2020, there were 11 NPDES facilities in the project area. Of these, only the Monroeville and Village of Payne Wastewater Treatment Plants (WWTP) have recorded non-compliance issues. The Monroeville WWTP non-compliance issues were for "failure to maintain records" and "late or missing discharge monitoring reports". The Village of Payne WWTP non-compliance issues were for "failure to submit discharge monitoring reports" and "effluent monthly average limit exceedances." Table 2.11 provides details for each facility. Figure 2.18 is a map of the facility locations.

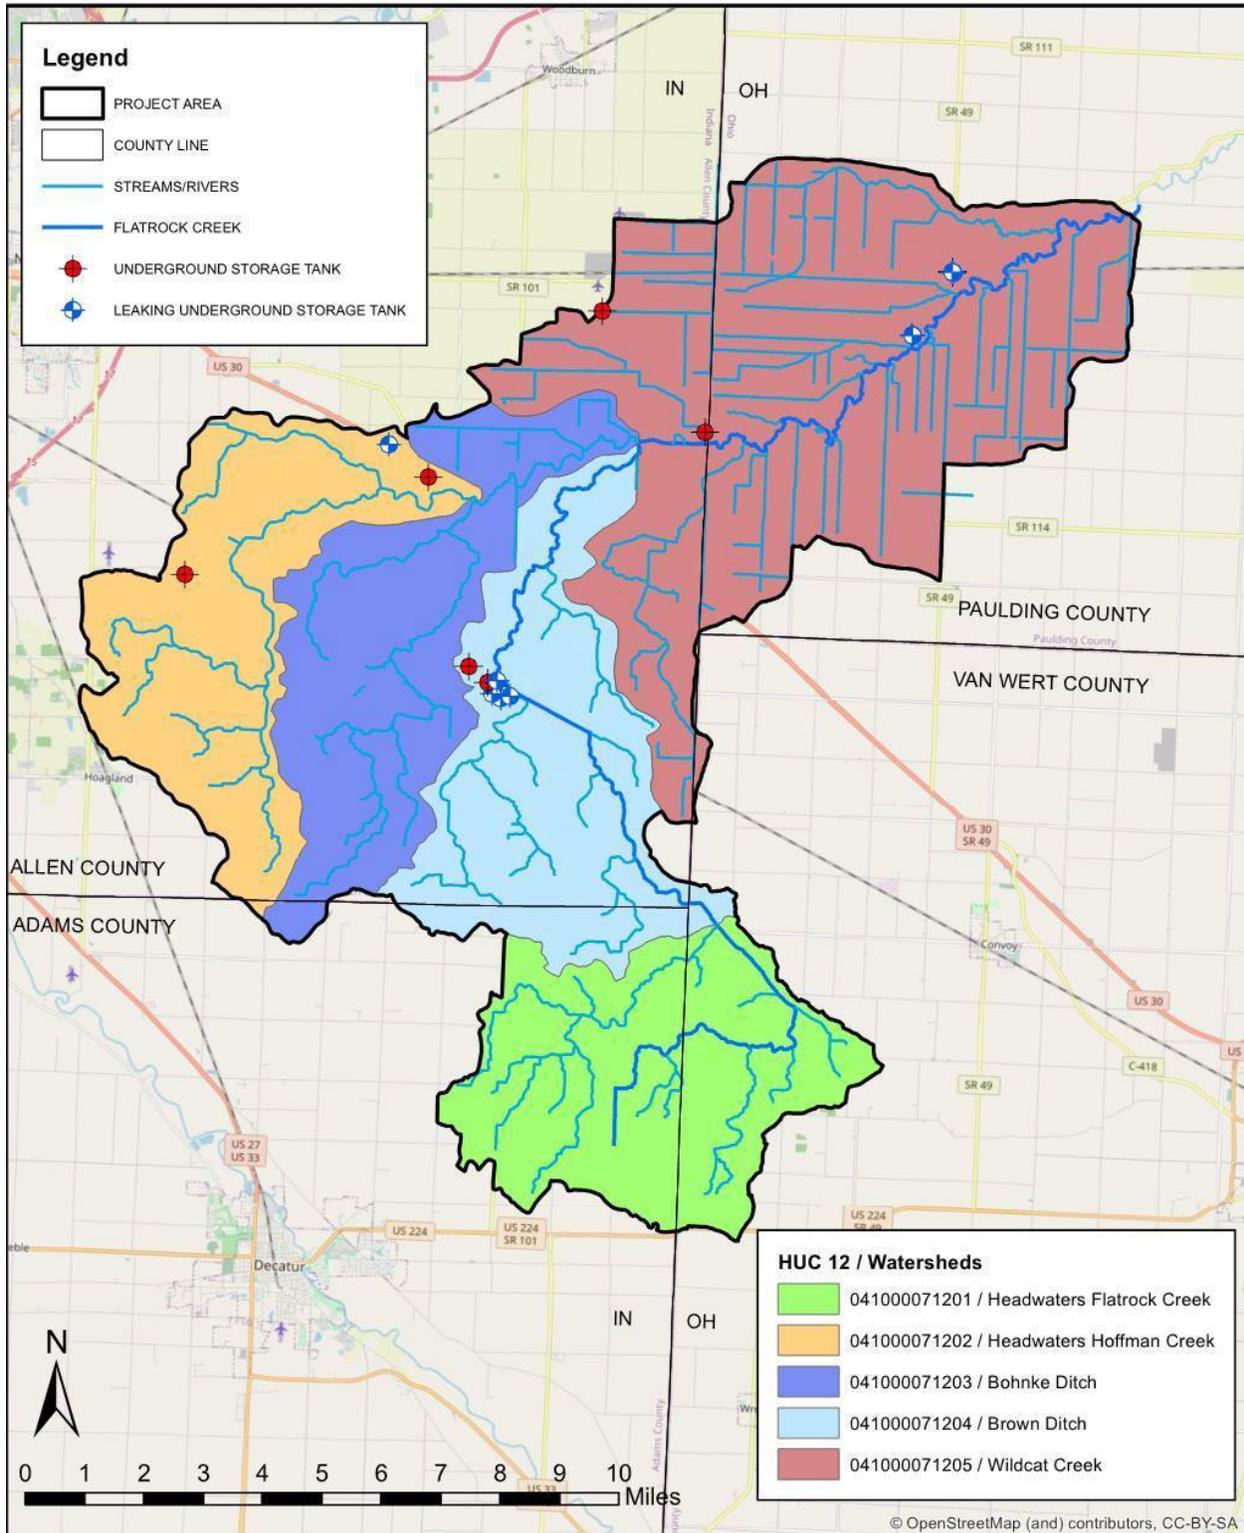
Figure 2.19 Underground Storage Tanks

In total, seven USTs and seven LUSTs are within the project area. Locations of USTs and LUSTs are provided in Figure 2.19. Both the Bohnke Ditch HUC-12 and Headwaters Flatrock Creek HUC-12 are absent from UST systems. Brown Ditch contains seven, five of which are leaking. The Wildcat Creek HUC-12 contains four (one leaking), and Headwaters Hoffman Ditch HUC-12 contains three (one leaking).

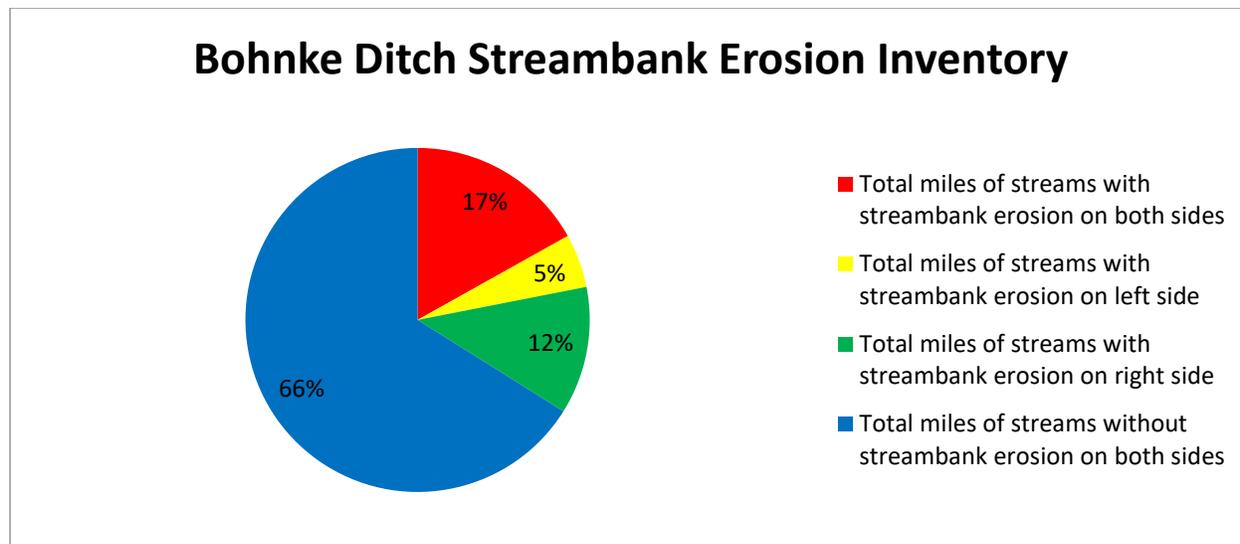
Figure 2.27 Bohnke Ditch Bank Erosion Inventory

The desktop buffer strip inventory conducted for Bohnke Ditch shows that 5.7 miles of streams have bank erosion on both sides, 1.7 miles have bank erosion on the left side when looking downstream, 4 miles of streams have bank erosion on the right side when looking downstream, and 22 miles of streams do not exhibit signs of bank erosion. Figure 2.27 represents this information in percentages of the total and Figure 2.16 shows the inventory locations.

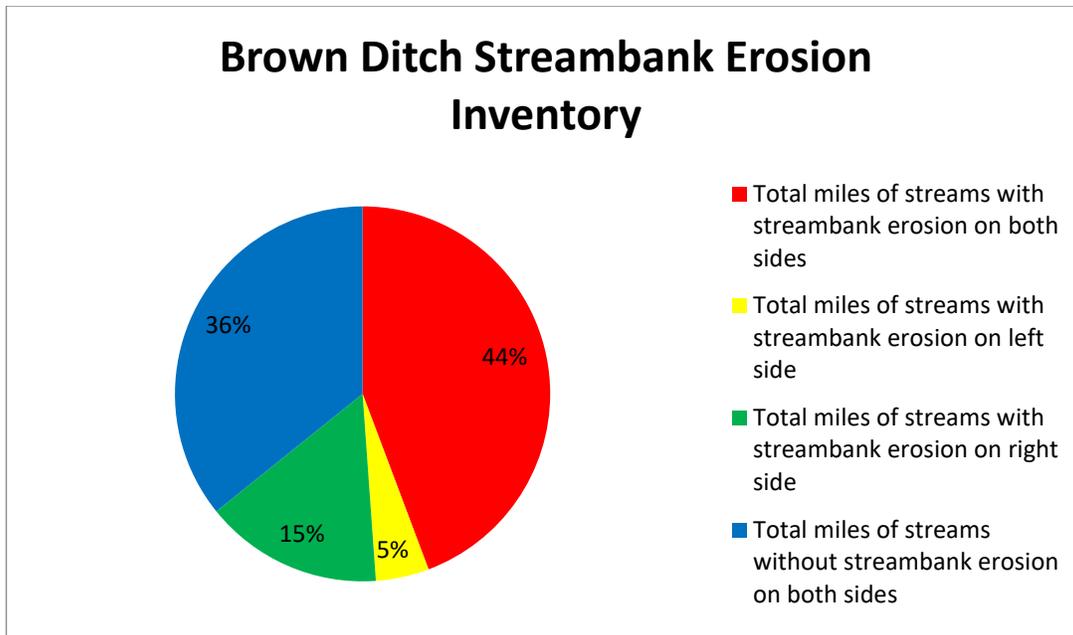
Figure 2.32 Brown Ditch Bank Erosion Inventory

The desktop buffer strip inventory conducted for Brown Ditch shows that 13.7 miles of streams have bank erosion on both sides, 1.4 miles have bank erosion on the left side when looking downstream, 4.8 miles of streams have bank erosion on the right side when looking downstream, and 11 miles of streams do not exhibit signs of bank erosion. Figure 2.32 represents this information in percentages of the total. Figure 2.16 shows the inventory locations.

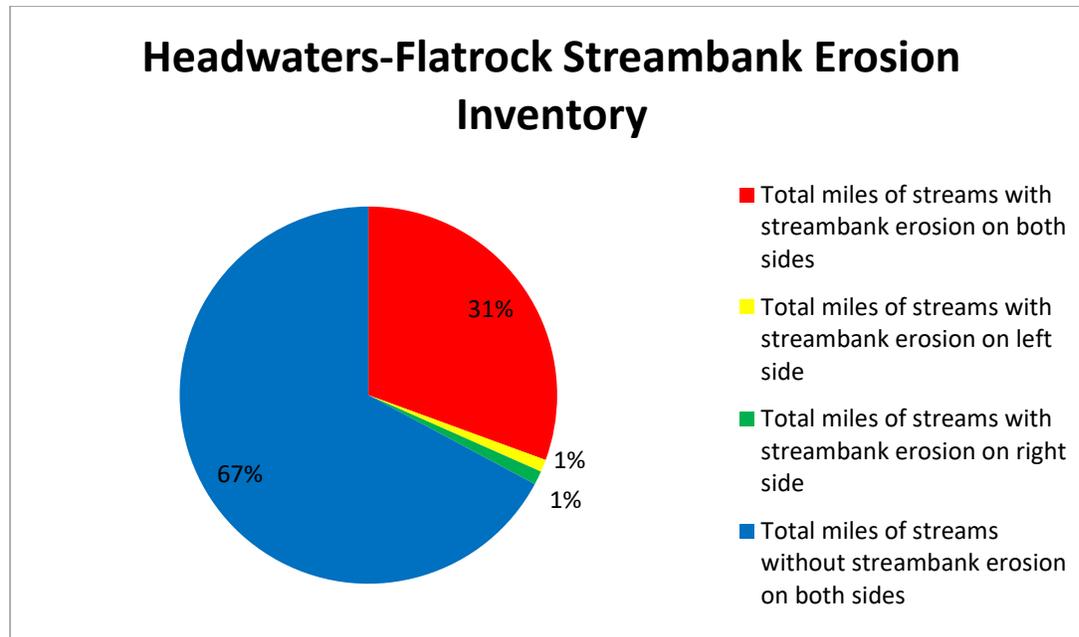
Figure 2.37 Headwaters Flatrock Creek Bank Erosion Inventory

The desktop buffer strip inventory conducted for Headwaters Flatrock Ditch subwatershed shows that 10.2 miles of streams have bank erosion on both sides, 0.4 miles have bank erosion on the left side when looking downstream, 0.4 miles have bank erosion on the right side when looking downstream, and 22.3 miles do not exhibit signs of bank erosion. Figure 2.37 represents this information in percentages of the total and Figure 2.16 shows the inventory locations.

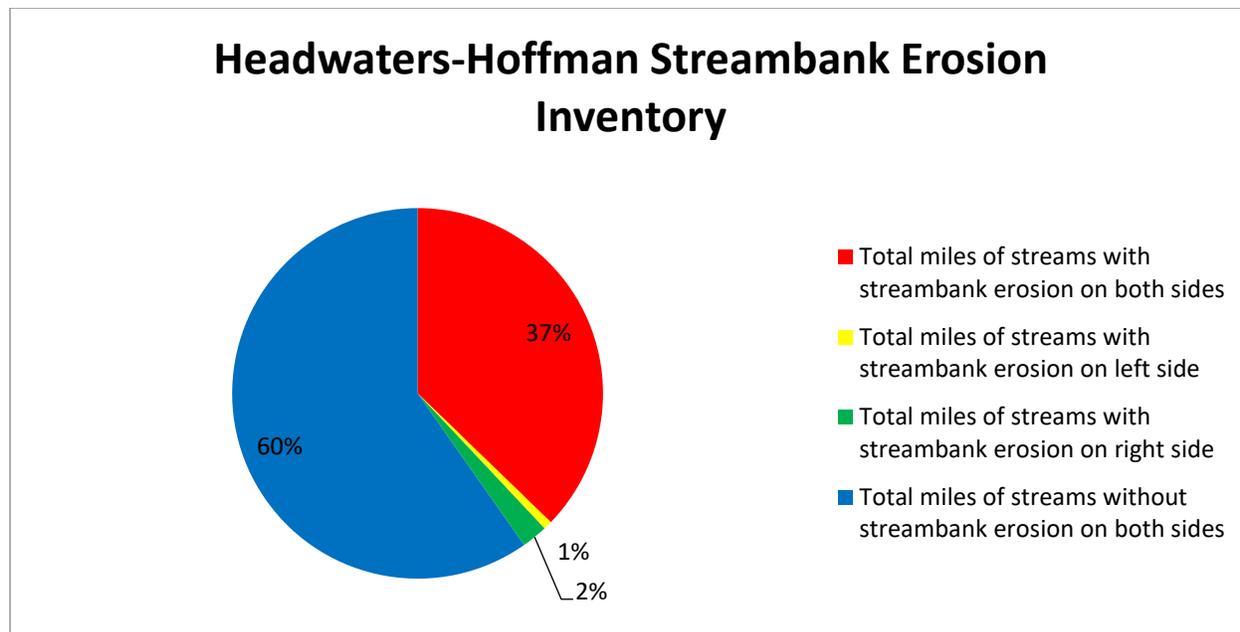
Figure 2.42 Headwaters Hoffman Creek Bank Erosion Inventory

The desktop bank erosion inventory conducted for Headwaters Hoffman Ditch subwatershed shows that 8.9 miles of streams have bank erosion on both sides, 0.2 miles have bank erosion on the left side when looking downstream, 0.5 miles have bank erosion on the right side when looking downstream, and 14.3 miles do not exhibit signs of bank erosion. Figure 2.42 represents this information in percentages of the total. Figure 2.16 shows the inventory locations.

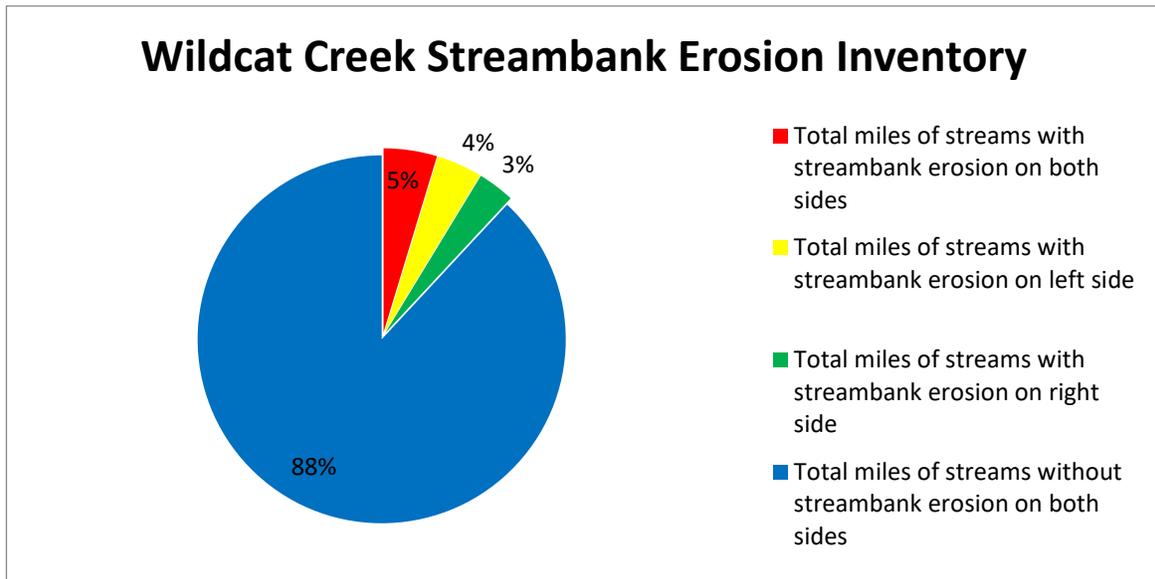
Figure 2.47 Wildcat Creek Bank Erosion Inventory

The desktop bank erosion inventory conducted for Wildcat Creek subwatershed shows that 7.8 miles of streams have bank erosion on both sides, 6.7 miles have bank erosion on the left side when looking downstream, 5.4 miles have bank erosion on the right side when looking downstream, and 146.8 miles do not exhibit signs of bank erosion. Figure 2.47 represents this information in percentages of the total and Figure 2.16 shows the inventory locations.

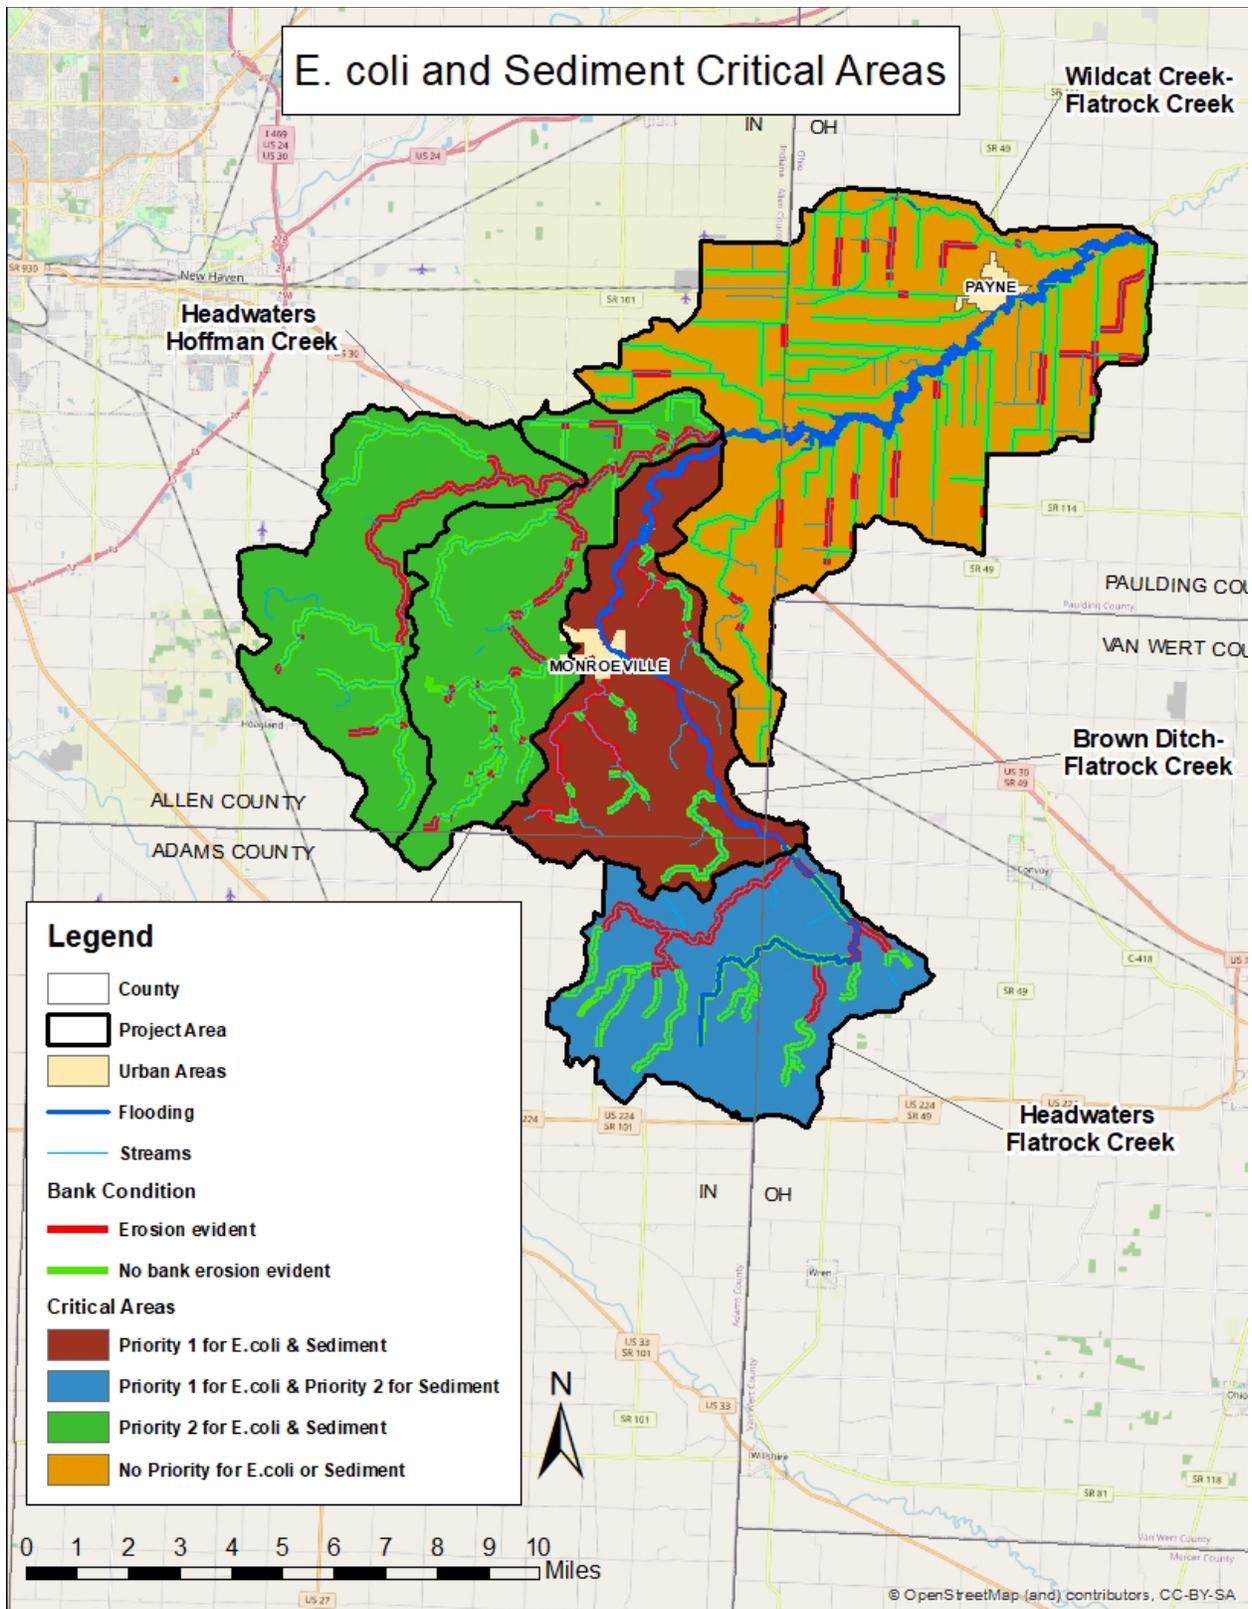
Figure 4.1 E. coli and Sediment Critical Areas map

Critical areas for urban land uses were determined using the land use inventory and windshield survey data and are identified as: all municipalities in the project area. (Figure 4.1)
