Indiana Department of Environmental Management

Re: Inspection Summary Letter BP Product North America, Inc. NPDES Permit No. IN0000108 Whiting, Lake County

NPDES Industrial Facility Inspection Report INDIANA DEPARTMENT OF ENVIRONMENTAL MANAGEMENT

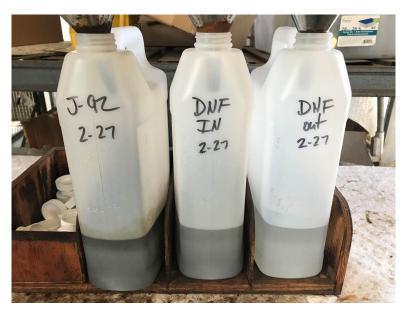
View of water samples for February 27, 2024. J-92 indicates water coming to the wastewater plant. The DNF is Dissolved Nitrogen Floatation and occurs prior to aeration tanks,	Biscocho, Miya Spratt			
27, 2024. J-92 indicates water coming to the wastewater plant. The DNF is Dissolved Nitrogen Floatation and occurs prior to aeration tanks,	Location/Description:			
	27, 2024. J-92 indicates water coming to the wastewater plant. The DNF is Dissolved Nitrogen Floatation and occurs prior to aeration tanks,
