Re: Inspection Summary Letter
Cleveland-Cliffs Steel, LLC - Central Treatment
Plant
NPDES Permit No. IN0063711
East Chicago, Lake County

Date(s) of Inspection: March 04, 2024
Type of Inspection: Reconnaissance Inspection
Inspection Results: Potential problems were discovered or observed.

NPDES Industrial Facility Inspection Report

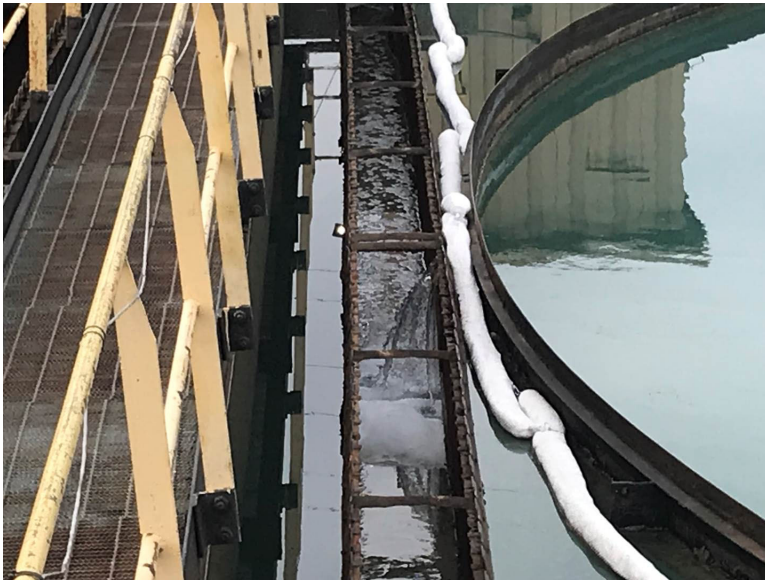
Maintenance was rated as marginal. Holes were observed under the weirs in the northwest clarifier. While solids were not observed as a problem at the time of the inspection, these holes will need to be repaired. Mr. Lurtz stated that the holes would be repaired on the upcoming clarifier rotation.

Facility:	
Cleveland-Cliffs Steel, LLC - Central Treatment Plant	
Photographer:	
Nicholas Ream	
Date: 03/04/2024	Time: 10:25 AM
Others Present:	
Kevin Lurtz, Miya Spratt, Cliff Yukawa, Kevin Davis	
Location/Description:	
Southwest view of the northwest clarifier. Holes were observed under the weirs.

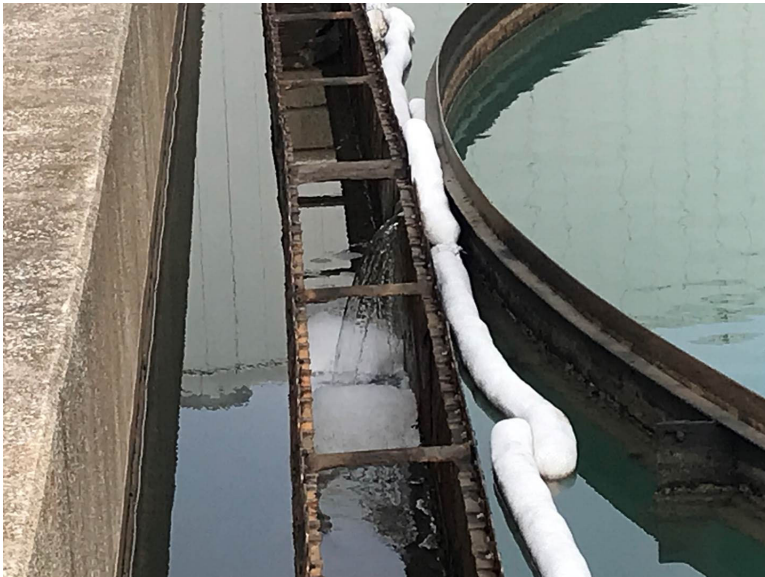
Facility:	
Cleveland-Cliffs Steel, LLC - Central Treatment Plant	
Photographer:	
Nicholas Ream	
Date: 03/04/2024	Time: 10:25 AM
Others Present:	
Kevin Lurtz, Miya Spratt, Cliff Yukawa, Kevin Davis	
Location/Description:	
Northeast view of the northwest clarifier. Additional holes were observed under the weir.

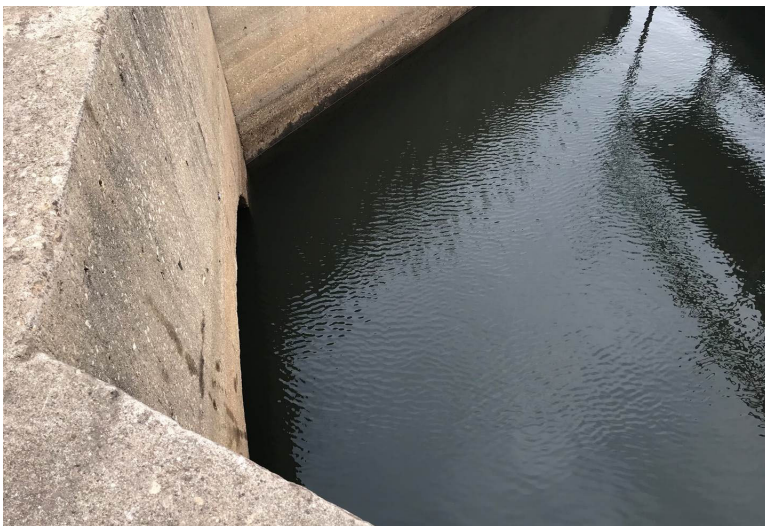
S	Receiving Waters	S	Facility/Site	N	Self-Monitoring	N	Enforcement		
S	Effluent/Discharge	S	Operation	N	Flow Measurement				
S	Permit	M	Maintenance	N	Laboratory	N	Effluent Limits Compliance		
		N	Sludge	N	Records/Reports	N	Other:		
DETAILED AREA EVALUATIONS									
Receiving Waters:									
Comments: The receiving stream was free of notable foam, algae or solids. Cleveland-Cliffs personnel were preparing to install a plate on Outfall 001 to force the effluent to overflow a weir prior to discharge to the Indiana Harbor Ship Canal. The intent with the plate installation is to prevent water from the Indiana Harbor Ship Canal from flowing up the discharge pipe.									
Effluent/Discharge:									
Comments: The effluent was clear and free of color at the time of the inspection. The effluent was minimal in preparation for the plate installation. Please refer to the Receiving Stream category for more information regarding the plate installation.

Facility:	
Cleveland-Cliffs Steel, LLC - Central Treatment Plant	
Photographer:	
Nicholas Ream	
Date: 03/04/2024	Time: 10:40 AM
Others Present:	
Kevin Lurtz, Miya Spratt, Cliff Yukawa, Kevin Davis	
Location/Description:	
Down view of Outfall 001. Most of the flow was held back in preparation for the installation of a plate over the effluent pipe.
