Re: Inspection Summary Letter
North Judson Municipal WWTP
NPDES Permit No. IN0020877
North Judson, Starke County

NPDES Wastewater Facility Inspection Report

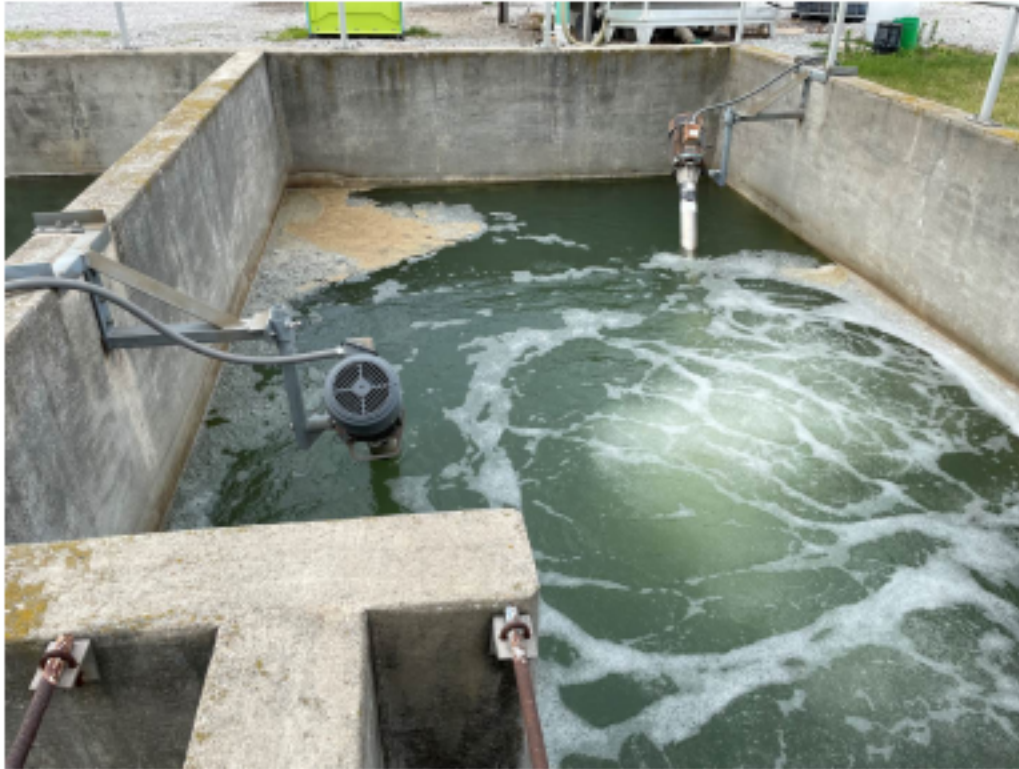
Operation was rated as marginal. The oxidation ditch appeared darker in color with a brown foam on the surface, the south secondary clarifier had scum and denitrified solids on the surface, and a light tan foam was observed in the post aeration tank. Facility personnel indicated the solids inventory was high at the time of the inspection and wasting was scheduled for that day. Wasting is determined by process control testing, sludge blanket depths, and overall facility condition.

Facility: North Judson Municipal WWTP	
Photographer: Maggie Kroeger	
Date: 7/3/2024	Time:
Others Present:	
Location/Description: Facing south, the photo shows the tan foam in the post aeration tank.
