Re: Inspection Summary Letter
North Judson Municipal WWTP
NPDES Permit No. IN0020877
North Judson, Starke County

NPDES Wastewater Facility Inspection Report

NPDES Permit Number: IN0020877	Facility Type: Municipality	Facility Classification: Minor	TEMPO AI ID 59695										
Date(s) of Inspection: July 03, 2024													
Type of Inspection:	Compliance Evaluation Inspection												
Name and Location of Facility Inspected: North Judson Municipal WWTP 900 N Elm Street North Judson IN 46366		County: Starke	Receiving Waters: Unnamed Ditch to Pine Creek										
			Permit Expiration Date: 8/31/2027 Design Flow: 0.47MGD										
On Site Representative(s): <table style="width: 100%; border: none;"> <tr> <td style="width: 15%;">First Name</td> <td style="width: 15%;">Last Name</td> <td style="width: 20%;">Title</td> <td style="width: 25%;">Email</td> <td style="width: 25%;">Phone</td> </tr> <tr> <td>Kimberly</td> <td>Kapp</td> <td>Assistant Superintendent</td> <td>kkappnjutilities@yahoo.com</td> <td>574-806-0411</td> </tr> </table>				First Name	Last Name	Title	Email	Phone	Kimberly	Kapp	Assistant Superintendent	kkappnjutilities@yahoo.com	574-806-0411
First Name	Last Name	Title	Ema

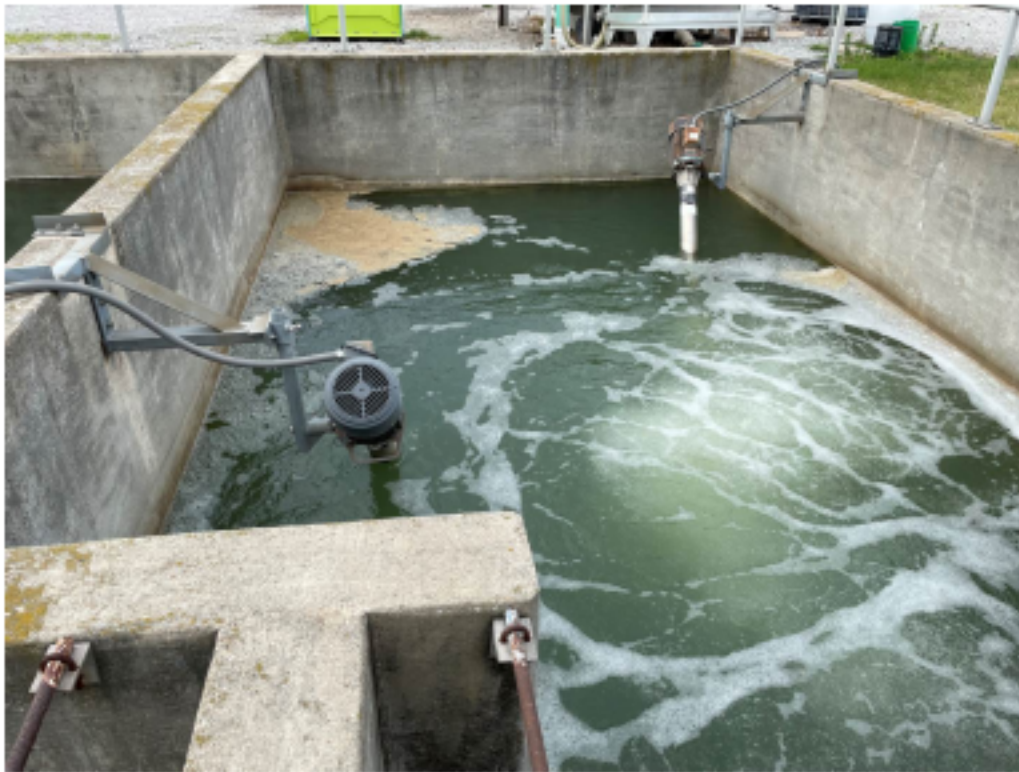
The effluent was observed at the final flow meter and the outfall and was clear and free of color at the time of the inspection. It is noted, white foam was observed flowing over the weir from the post aeration tank.

Operation was rated as marginal. The oxidation ditch appeared darker in color with a brown foam on the surface, the south secondary clarifier had scum and denitrified solids on the surface, and a light tan foam was observed in the post aeration tank. Facility personnel indicated the solids inventory was high at the time of the inspection and wasting was scheduled for that day. Wasting is determined by process control testing, sludge blanket depths, and overall facility condition.

Facility: North Judson Municipal WWTP
Photographer: Maggie Kroeger
Date: 7/3/2024 Time:
Others Present:
Location/Description: Facing south, the photo shows the tan foam in the post aeration tank.

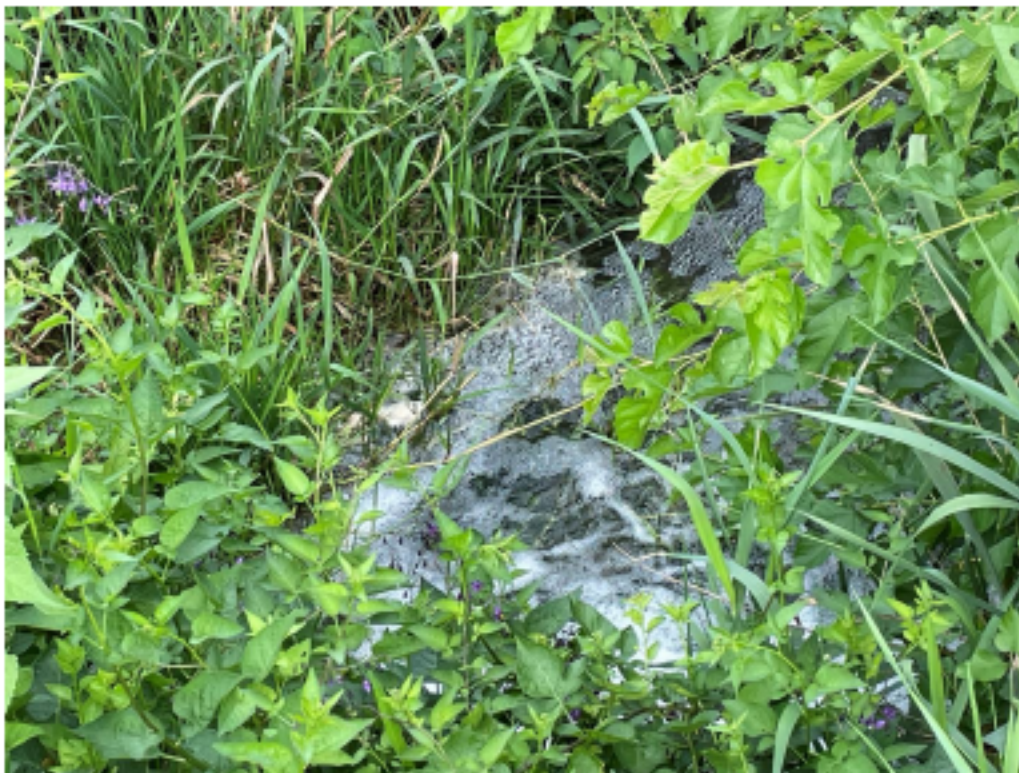
Facility: North Judson Municipal WWTP
Photographer: Maggie Kroeger
Date: Time:
Others Present:
Location/Description: Facing west, the photo shows the mixing zone of the receiving stream. Minimal tan foam can be observed. Vegetation around the outfall and receiving stream made it difficult to evaluate.

It is noted, the vegetation around Outfall 001 should be maintained for easier visual evaluation during future inspections.

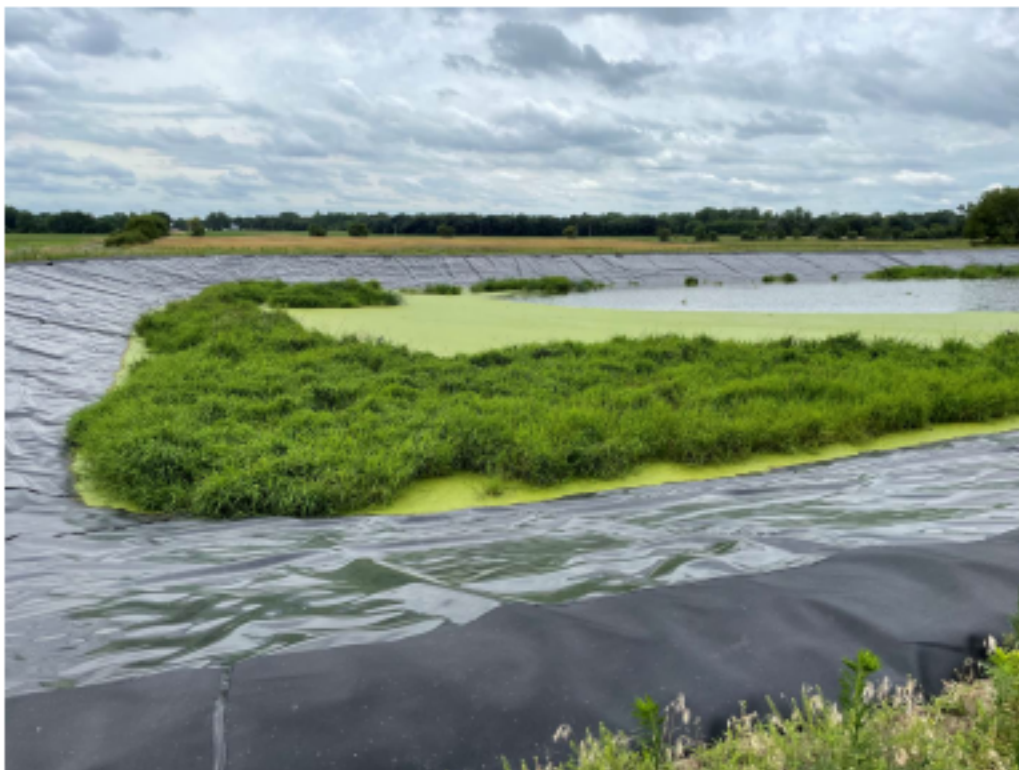
Maintenance was rated as marginal due to needing improved documentation of preventative maintenance plan and vegetation noted in the CSO retention basin.

Facility: North Judson Municipal WWTP
Photographer: Maggie Kroeger
Date: Time:
Others Present:
Location/Description: Facing southwest, the photo shoes the vegetation in the CSO retention basin.
