Re: Inspection Summary Letter  
Lake Stop Mart  
PWSID# IN2610831  
Rockville, Parke County

# Summary of Deficiencies Identified

# Public Water System Sanitary Survey Report

PWS ID: IN2610831 PWS Name: LAKE STOP MART

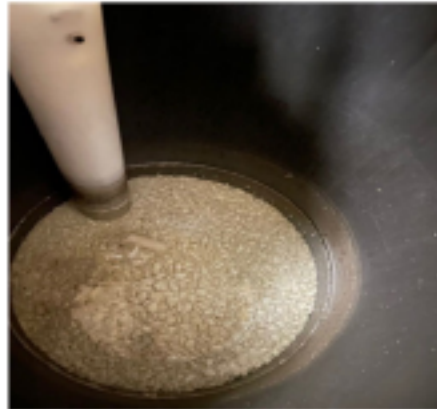
- 1 A **Minor** deficiency was identified regarding: **Routine maintenance schedules are not established or adhered to**

The inspector noted: "Deficiency - 327 IAC 8-2-8.2(e)(7)(E)(i) The system must remove debris from the softener and add salt"

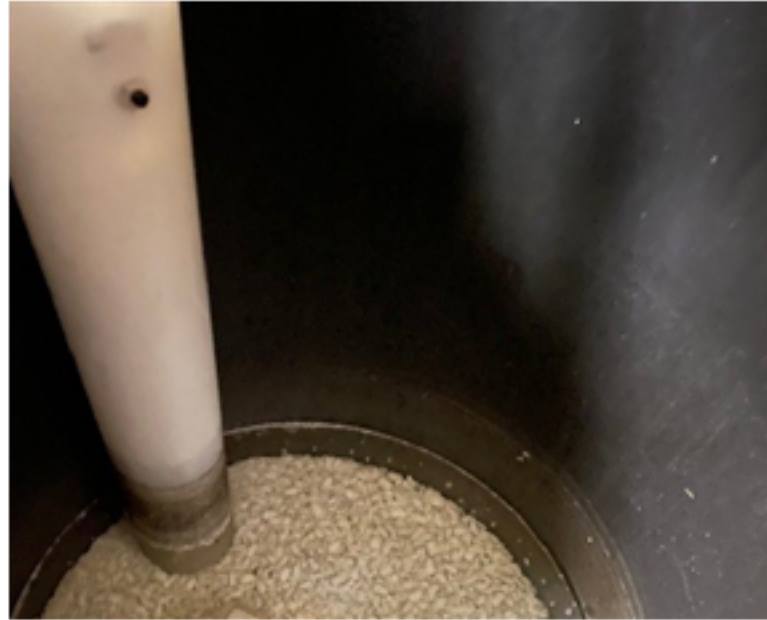
SM06

6 **Are routine maintenance schedules established and adhered to?**

Deficiency - 327 IAC 8-2-8.2(e)(7)(E)(i)

The system must remove debris from the softener and add salt

Routine maintenance schedules are not established or adhered to

MIN  
Deficiency
