Re: Inspection Summary Letter
St. Stanislaus Church
PWSID# IN2710849
New Carlisle, St. Joseph County

Summary of Deficiencies Identified

St. Stanislaus Church - IN2710849

Public Water System Sanitary Survey Report

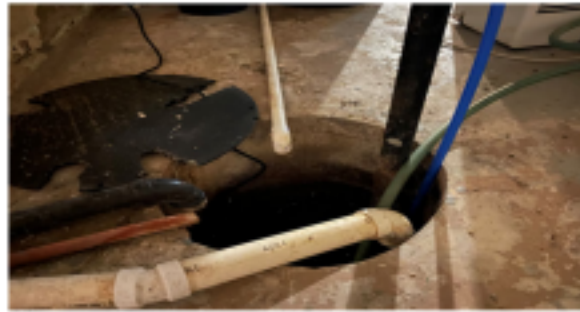
- 1 A **Minor** deficiency was identified regarding: **Cross connection(s) in the treatment process**

The inspector noted: "Deficiency - 327 IAC 8-10 The water softener's backwash discharge line is inserted into the sump. The system is to provide an air gap separation on the water softener discharge drain tube to the drain. A minimum of one (1) inch is to be provided."

Deficiency - 327 IAC 8-10

The water softener's backwash discharge line is inserted into the sump. The system is to provide an air gap separation on the water softener discharge drain tube to the drain. A minimum of one (1) inch is to be provided.

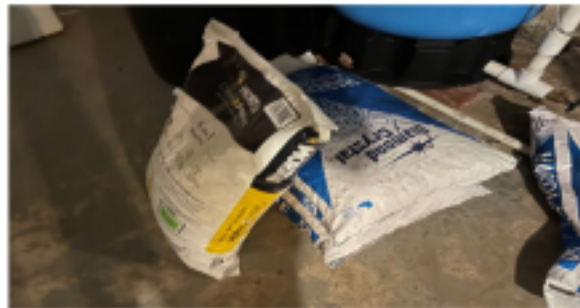
- 2 A **Minor** deficiency was identified regarding: **Chemical storage is not adequate**

The inspector noted: "10 States Standards 5.1.9, 5.1.10, & 5.1.11 Water softener salt is being stored on the basement floor next to the softener unit. Storage of this salt must be elevated, i.e. pallet or other means of raised storage."

10 States Standards 5.1.9, 5.1.10, & 5.1.11

Water softener salt is being stored on the basement floor next to the softener unit. Storage of this salt must be elevated, i.e. pallet or other means of raised storage.

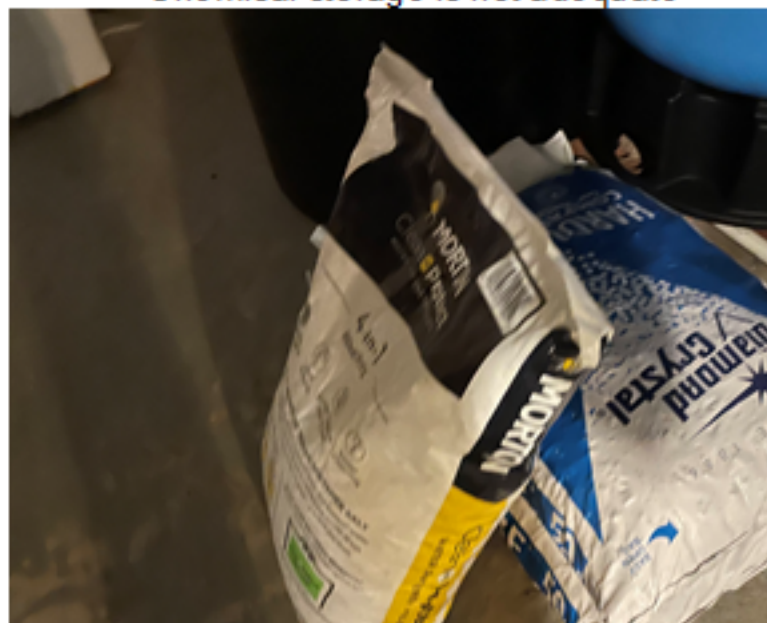
TR01

Chemical storage is not adequate

MIN Deficiency

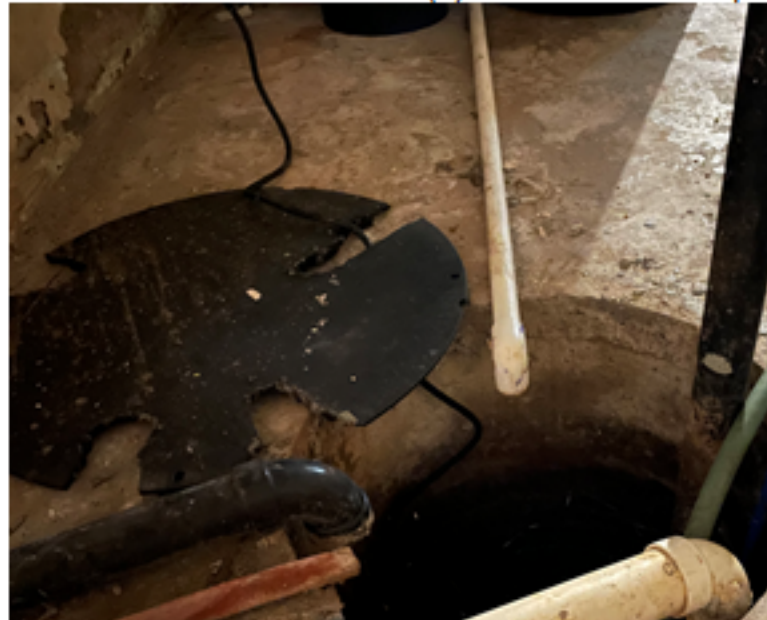
TR11

Cross connection(s) in the treatment process

MIN Deficiency
