Indiana Department of Environmental Management

Re: Inspection Summary/ Noncompliance Letter

Heidelberg Materials US Cement LLC NPDES Permit No. IN0001775 Mitchell, Lawrence County

Inspection Photographs

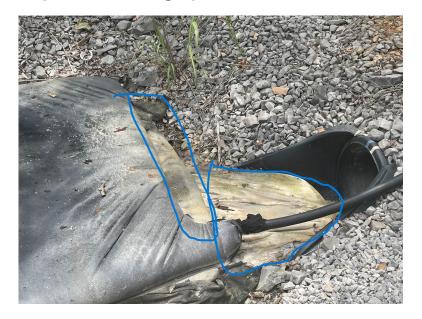
Evidence of excessive solids noted on top of the two older dewatering bags. The two blue circles are the full bags that are no longer being utilized.

- Operations was rated marginal due to excessive solids prior to Outfall 007 (see Attached Photos). The facility needs to improve the solids handling procedures to ensure that all facilities for treatment be maintained in good working order and efficiently operated at all times. At the time of the inspection, there were three dewatering bags prior to Outfall 007 and only one dewatering bag was being utilized. The other two dewatering bags were full of solids and beneath the bag that was actively dewatering.

Operations was rated as marginal due to excessive solids prior to Outfall 007 (see Attached Photographs). The facility needs to improve the solids handling procedures to ensure that all facilities for treatment be maintained in good working order and efficiently operated at all times. At the time of the inspection, there were three dewatering bags prior to Outfall 007 and only one dewatering bag was being utilized. The other two dewatering bags were full of solids and beneath the bag that was actively dewatering.

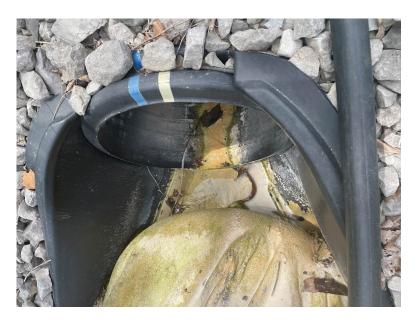
Evidence of excessive solids. Pictured is a dewatering bag that has been filled and is no longer being utilized located prior to Outfall 007 discharge pipe.
