Re: Inspection Summary/ Noncompliance Letter
MasterGuard Corporation (Flex-N-Gate)
NPDES Permit No. INP000188
Veedersburg, Fountain County

NPDES Industrial Facility Inspection Report
 INDIANA DEPARTMENT OF ENVIRONMENTAL MANAGEMENT

NPDES Permit Number: INP000188	Facility Type: Industrial Minor	Facility Classification: C	TEMPO AI ID
Date(s) of Inspection: June 19, 2024			
Type of Inspection: Complaint Investigation (#112972)			
Name and Location of Facility Inspected: MasterGuard Corporation (Flex-N-Gate) 1200 E. 8th St. Veedersburg IN 47987		Receiving Waters/POTW: County: Fountain Veedersburg POTW	Permit Expiration Date: 2/28/2027 Design Flow: NA

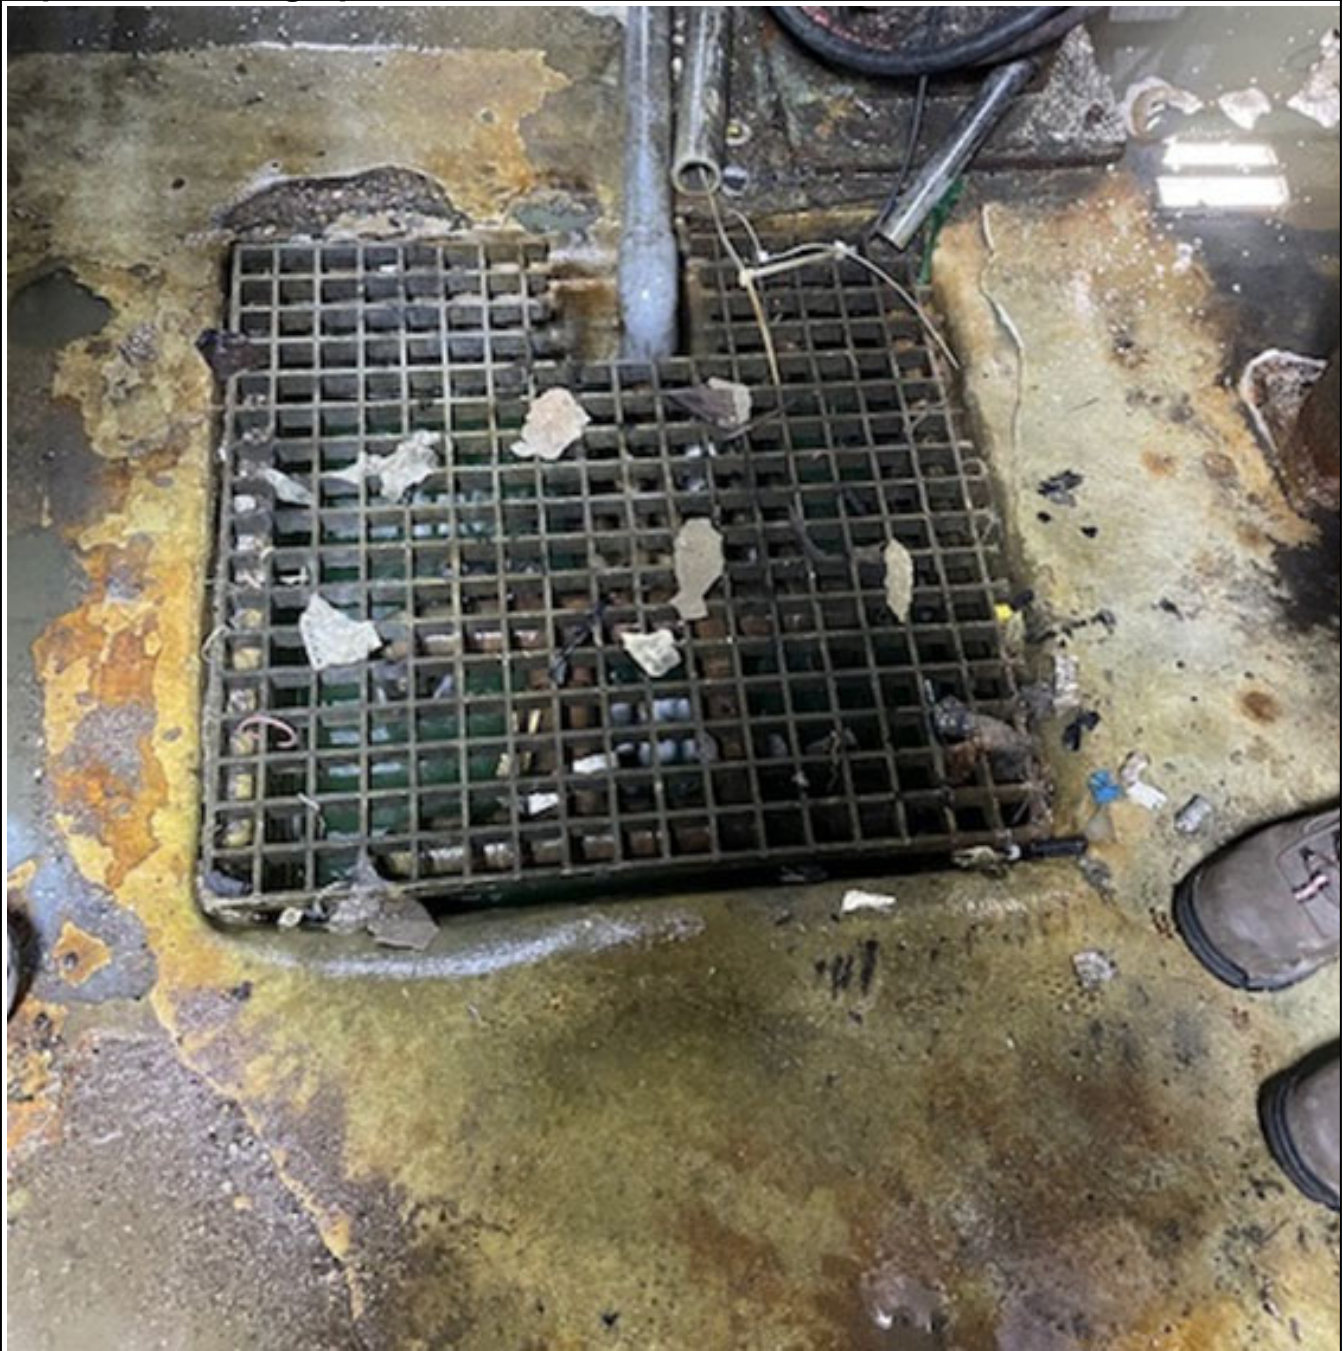
Facility: MasterGuard Corporation (Flex-N-Gate)		Location/Description: Floor staining and debris around sump appear that a tank overflow recently occurred. According to staff, this sump directs flow back to the EQ tanks. However, the EQ tanks may not be properly sized for the EQ needs of this facility. Several tanks were full at the time of this inspection. The facility should have sufficient EQ capacity for process slugs and spills to protect the pretreatment system and the POTW.
Photographer: Holly Zurcher		
Date: 06/19/2024	Time:	
Others Present:

Operational logs and process control logs reviewed indicated that a Nickel tank dump from the production line on 6/15/2024 caused treatment efficiency issues at the WWTP and overflowed a treatment tank. Also, routine process control and operator logs are missing for the Sunday night (6/16/2024) shift from 7:00 PM to 7:00 AM. Based on the information reviewed, it does not appear that the treatment system was properly manned or monitored during that time. During the inspection, it appeared that a tank overflow had occurred due to trash and debris accumulation at the pretreatment system sump.

Operational logs and process control logs reviewed indicate that a Nickel tank dump from the production line on 6/15/2024 caused treatment efficiency issues at the WWTP and overflowed a treatment tank. Also, routine process control and operator logs are missing for the Sunday night (6/16/2024) shift from 7:00 PM to 7:00 AM. Based on the information reviewed, it does not appear that the treatment system was properly manned or monitored during that time. During the inspection, it appeared that a tank overflow had occurred due to trash and debris accumulation at the pretreatment system sump.

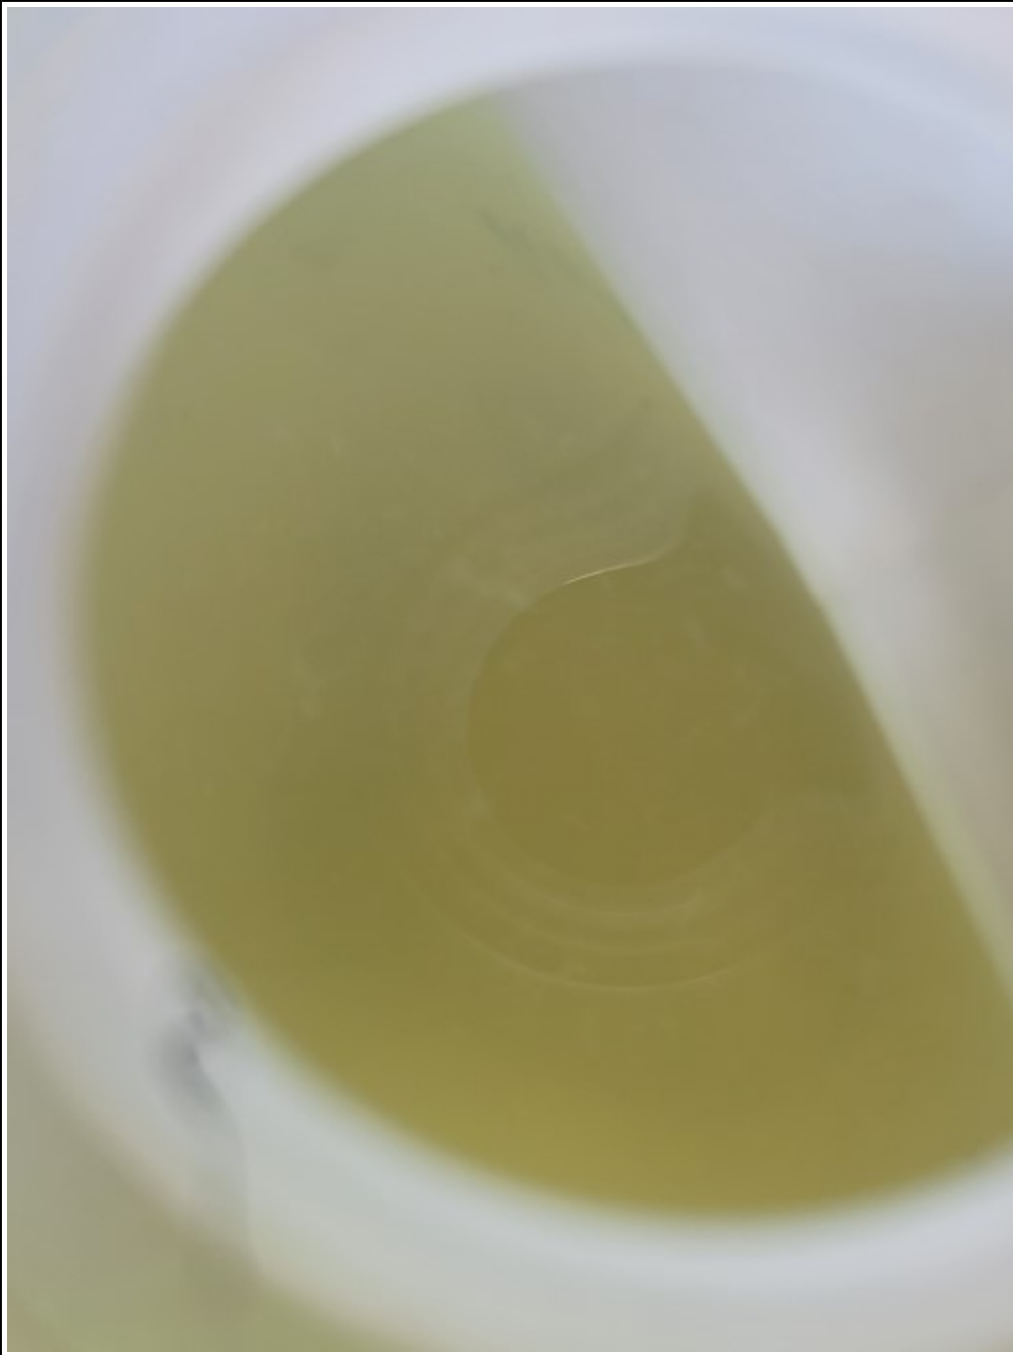
Facility: MasterGuard Corporation (Flex-N-Gate)		Location/Description: Picture taken by POTW of sample from MasterGuard's sampling location at Outfall 002 on June 18, 2024. Photo quality is blurry but a noticeable yellow tint is present.
Photographer: Holly Zurcher		
Date: 06/18/2024	Time:	
Others Present:

When inspectors were made aware of the complaint, a call was made to the POTW to ascertain if any anomalies were noted at the POTW. The POTW had taken a composite sample that appeared to be abnormal (see photo). This sample is being sent to the POTW's contract lab for analysis.

When inspectors were made aware of the complaint, a call was made to the POTW to ascertain if any anomalies were noted at the POTW. The POTW had taken a composite sample that appeared to be abnormal (see photo).

This sample is being sent to the POTW's contract lab for analysis.
