Project Name: Indian Creek (Harrison Co.) WMP

Plan Type: Watershed Management Plan

Indian Creek Watershed Management Plan

**Indian Creek Watershed
Management Plan**

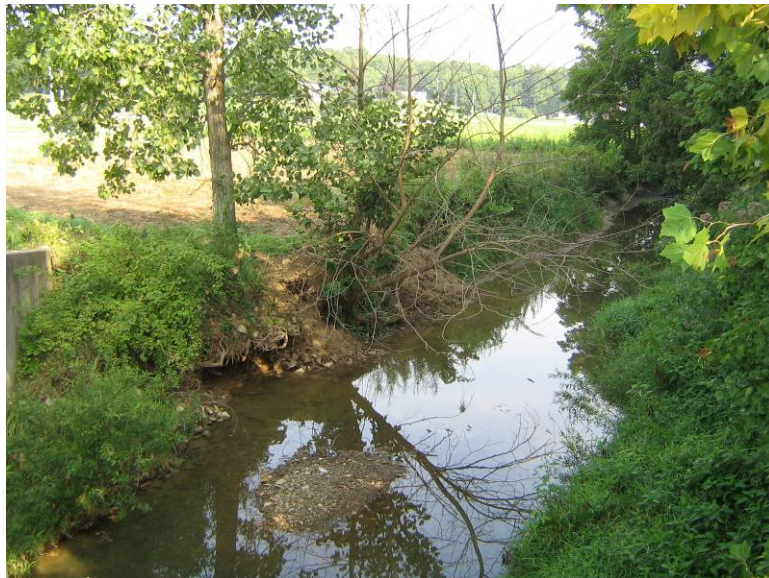
Upstream. Gravel bar in center, stream disturbance on left.

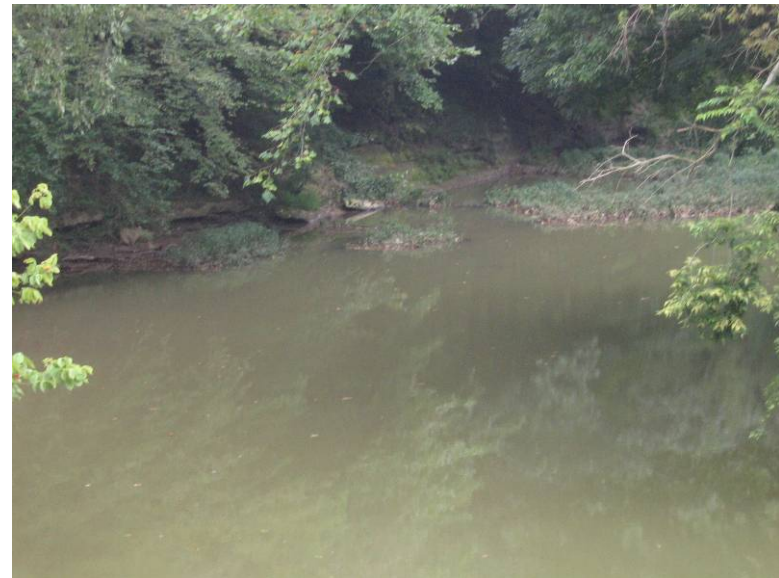
Downstream; erosion.

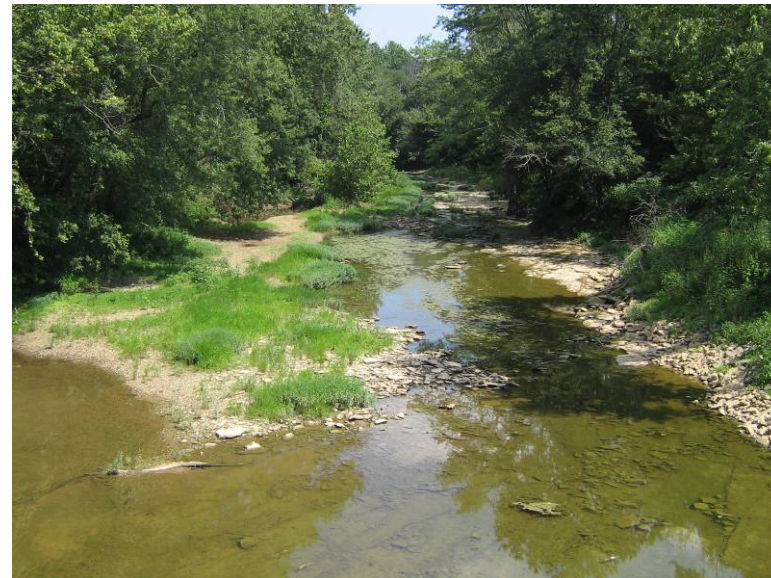
Downstream; bar with vegetation.

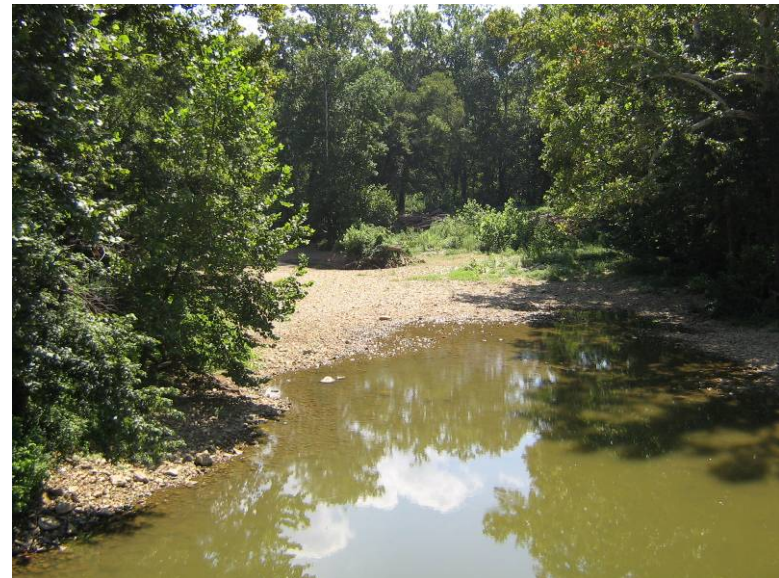
Downstream; no flow, gravel bar.

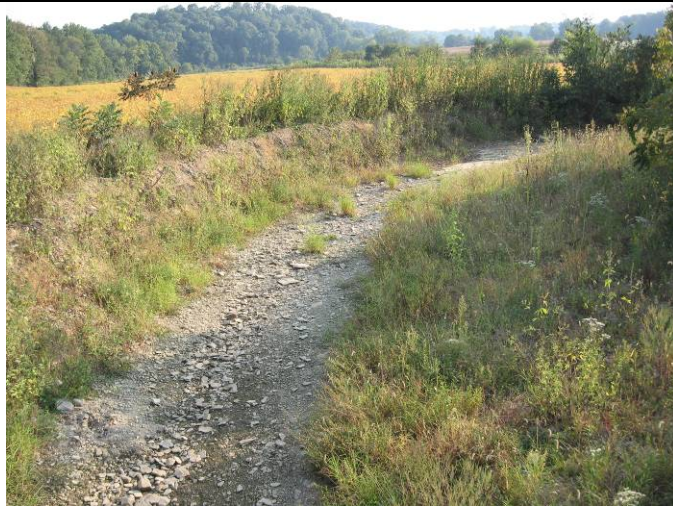
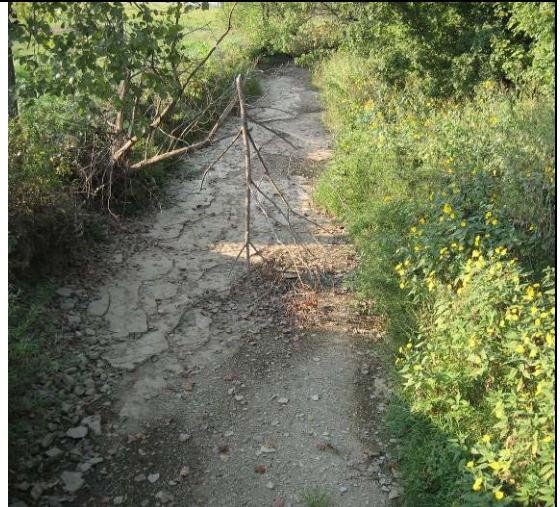
Monitoring Site 001: These photographs were taken on September 20, 2007 during the biological sampling event. Due to lack of water, this site was not sampled. The very small drainage area may contribute to biological impairment since this site is easily affected by both droughts and floods.

Item	Description
Monitoring Site	001
Location	Indian Creek North at Banet Road, IDEM Site OBS080-0001
Site Selection Rationale	303(d) Segment – Aquatic Life Impairment
Biological Monitoring Result	Not sampled due to severe drought conditions. Habitat assessment result was Fair (score 46) and indicated bank erosion and poor riparian zone.
Interpretation	Data gap
Cause of Impairment	
Load Reduction Required	
Pollution Source(s)	
Strategies - High Priority	
Strategies - Medium Priority	Sample this location during normal flow conditions; both IDEM data were collected during low flow and it was not possible to collect benthic data during this project Use data collected under normal flow conditions to re-assess this stream.
Strategies - Low Priority	Bank stabilization and riparian vegetation would be beneficial.

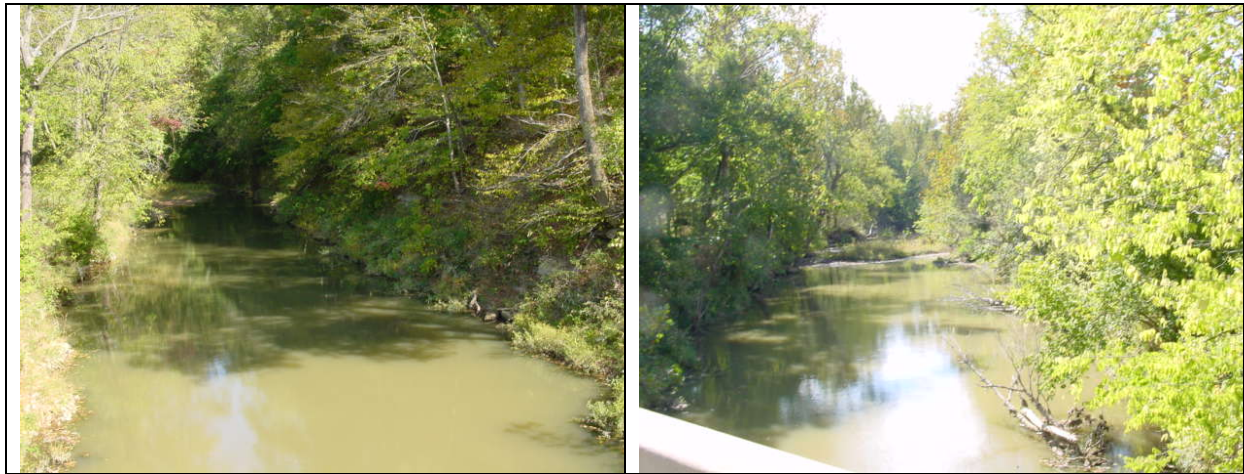
Site 003 Upstream and Downstream. This site as a well-forested buffer and little evidence of disturbance near the sampling site.

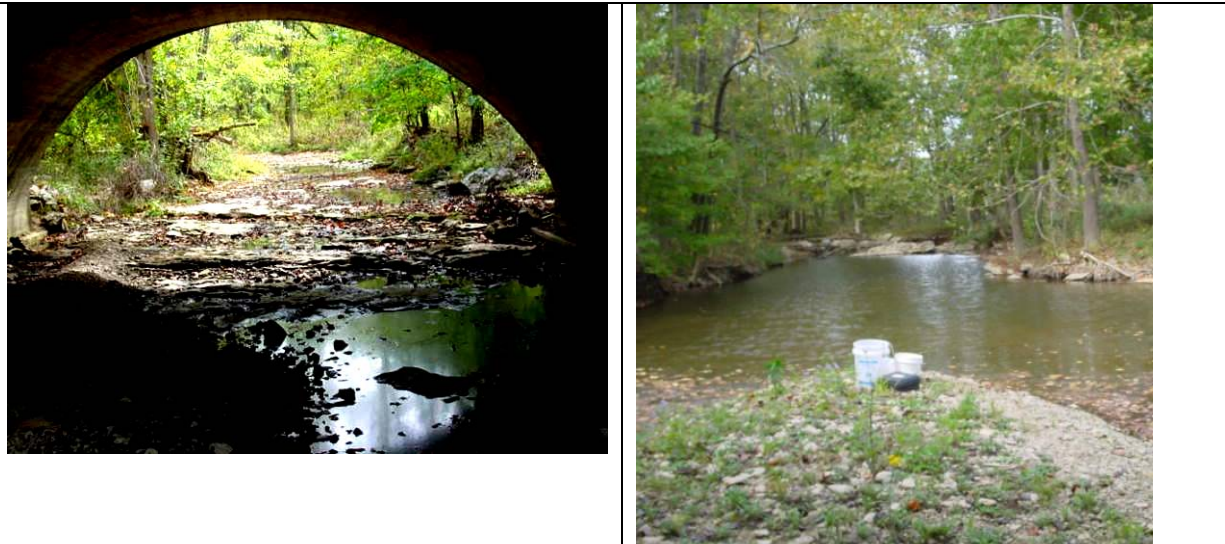
Site 4. Crandall Branch Above Indian Creek, Upstream and Downstream. The impacts of the drought can be seen in this picture. Otherwise, this area has a well forested buffer near the sampling site.

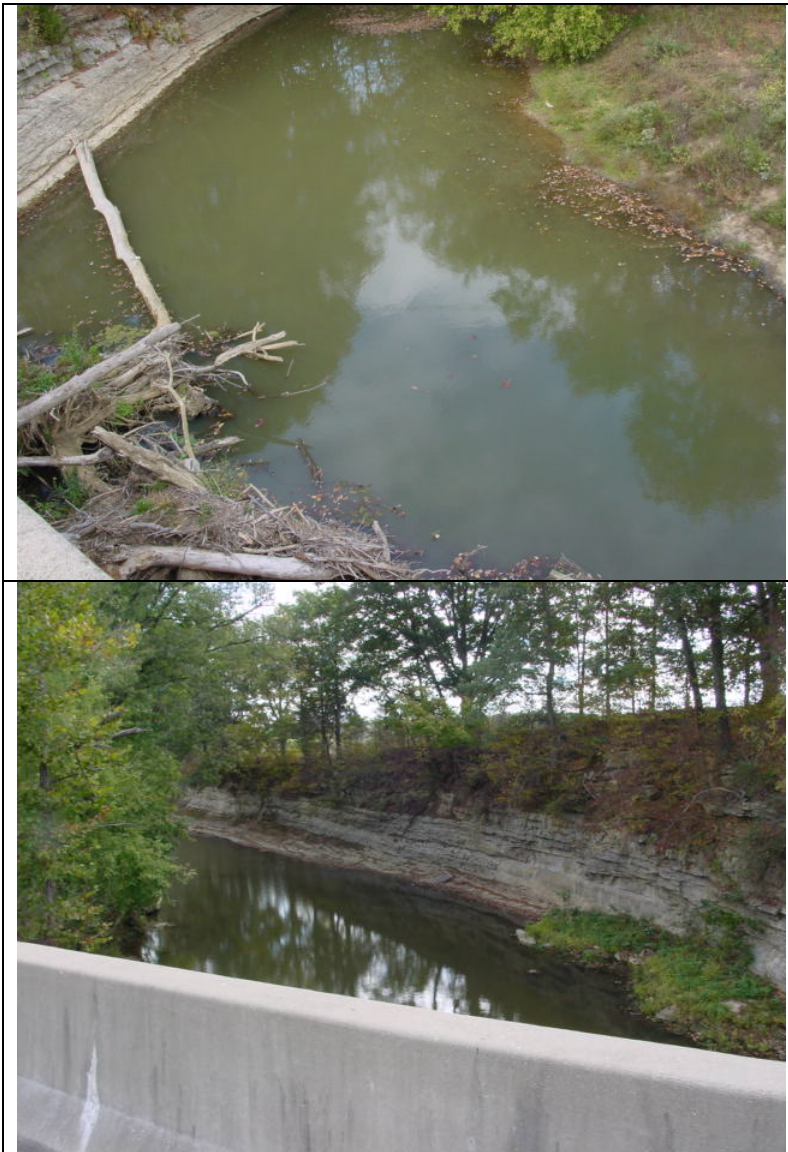
Site 5 Indian Creek above SR355 Bridge Looking Upstream and Downstream. This site has a relatively well vegetated riparian area, but there is evidence of some areas needing tree plantings. This area is highly influenced by karst and water was very still during the drought. This hot, dry condition promotes regrowth of bacteria.

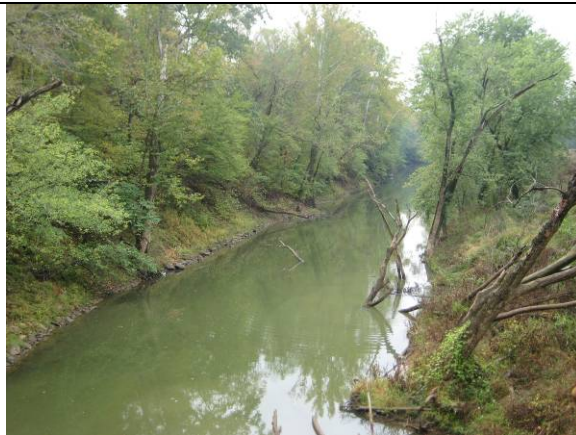
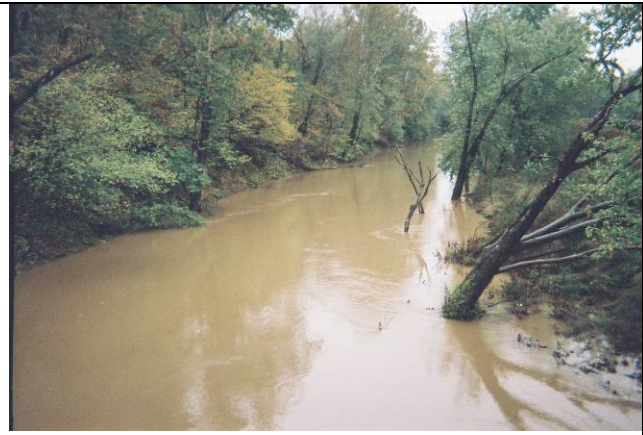
Site 009 under base flow conditions.

Site 009 under elevated flow conditions.

Item	Description
Monitoring Site	009
Location	Indian Creek above Lickford Road Bridge, IDEM Site OBS100-0006
Site Selection Rationale	303(d) Segment – Aquatic Life impairment due to low dissolved oxygen
Dissolved Oxygen Result (mg/l)	Minimum: 3.1 mg/l Average: 4.9mg/l
Interpretation	Aquatic Life Use Not Met
Cause of Impairment	Our data indicate that this area may be affected by Ohio River backwater and very reduced flows due to karst. If the DO violation is confirmed as being caused by natural conditions, pursue delisting and avoid TMDL development
Load Reduction Required	NA
Pollution Source(s)	NA
Strategies - High Priority	
Strategies - Medium Priority	Encourage IDEM to resample this location and delist as appropriate.
Strategies - Low Priority

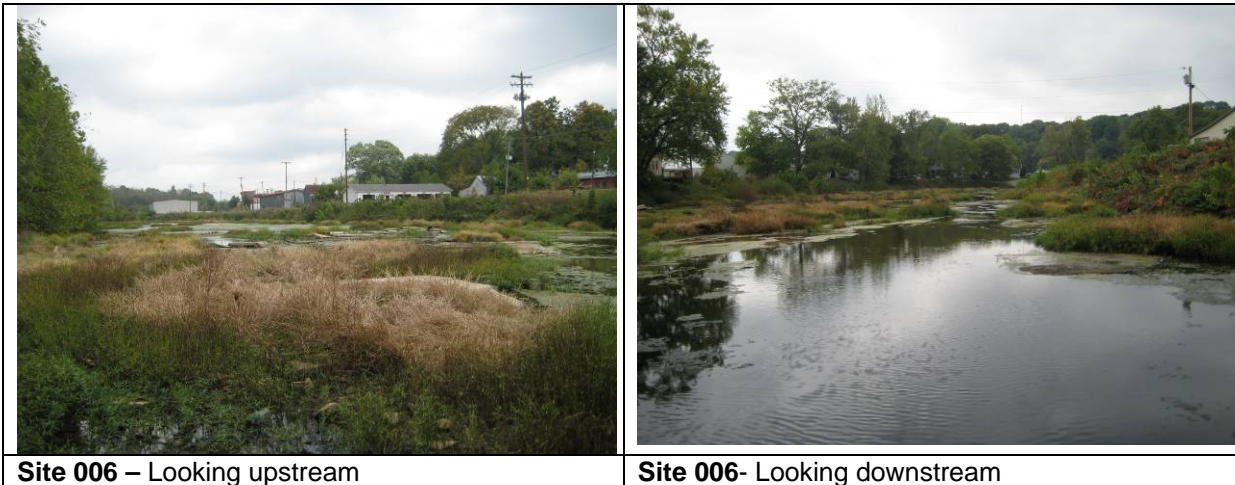
While recreational criteria for bacteria were met, this location has poor habitat. Sedimentation is occurring and elevated nutrients may be contributing to algal proliferation seen in the downstream photograph.

Item	Description
Monitoring Site	006
Location	Indian Creek above Little Indian Creek at Water Street
Site Selection Rationale	Downstream end of HUC, 303(d) Segment – Recreation, above WWTP, receives Corydon runoff
Bacteria Result (CFU/100ml)	Geomean: 93.3; Maximum: 180
Interpretation	Recreational use met
Cause of Impairment	NA
Load Reduction Required	NA
Pollution Source(s)	NA
Strategies - High Priority	
Strategies - Medium Priority	Maintain compliance at Corydon WWTP.
Strategies - Low Priority	Consider riparian habitat improvements.

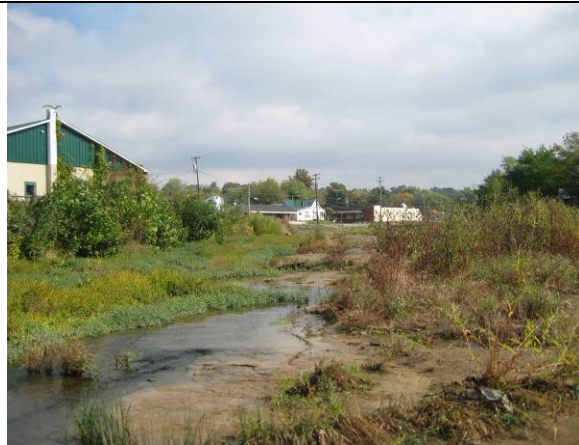
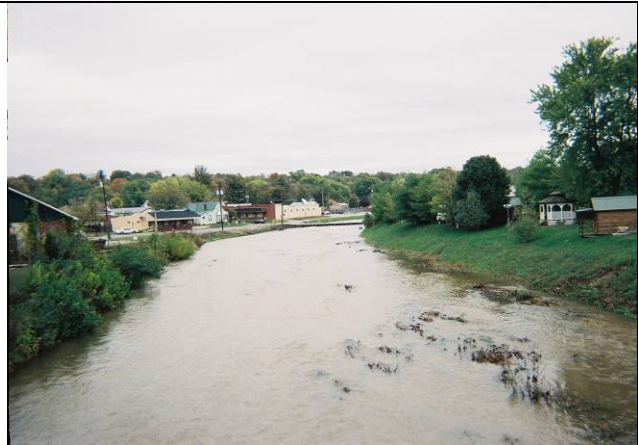
Site 010 – Low flow condition

Site 010- Elevated flow condition

The poor quality habitat is documented in the low flow condition photograph and potential for flooding is seen in the elevated flow photograph.

Item	Description
Monitoring Site	010 and 011
Location	Little Indian Creek
Site Selection Rationale	Major tributary, classified as “unassessed” by IDEM
Bacteria Result (CFU/100 ml)	Site 010: Geomean: 119.2; Maximum: 140 Site 011: Geomean: 118; Maximum: 226
Interpretation	Recreational use met
Cause of Impairment	NA
Load Reduction Required	NA
Pollution Source(s)	NA
Strategies - High Priority	
Strategies - Medium Priority	Maintain compliance at Corydon WWTPs (Corydon, Tyson).
Strategies - Low Priority	Continue to monitor and assess nutrients below Lanesville. Consider flood protection and riparian habitat improvements near the confluence with Indian Creek (Site 010).

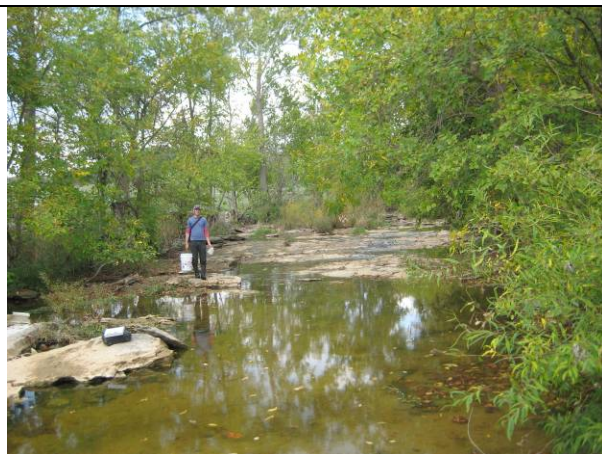
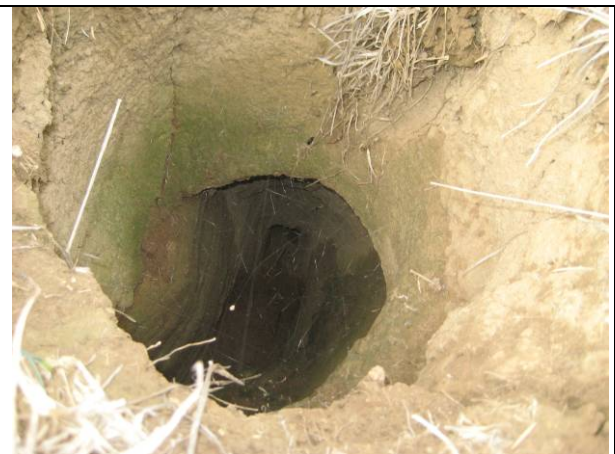
Site 11 – Biological sampling under low flow conditions

Site 11 – nearby sinkhole
