EAGLE CREEK WATERSHED MANAGEMENT PLAN:
AN INTEGRATED APPROACH TO IMPROVED WATER QUALITY

Eagle Creek Watershed Alliance

Eagle Creek Watershed Taskforce
Central Indiana Water Resources Partnership
2005

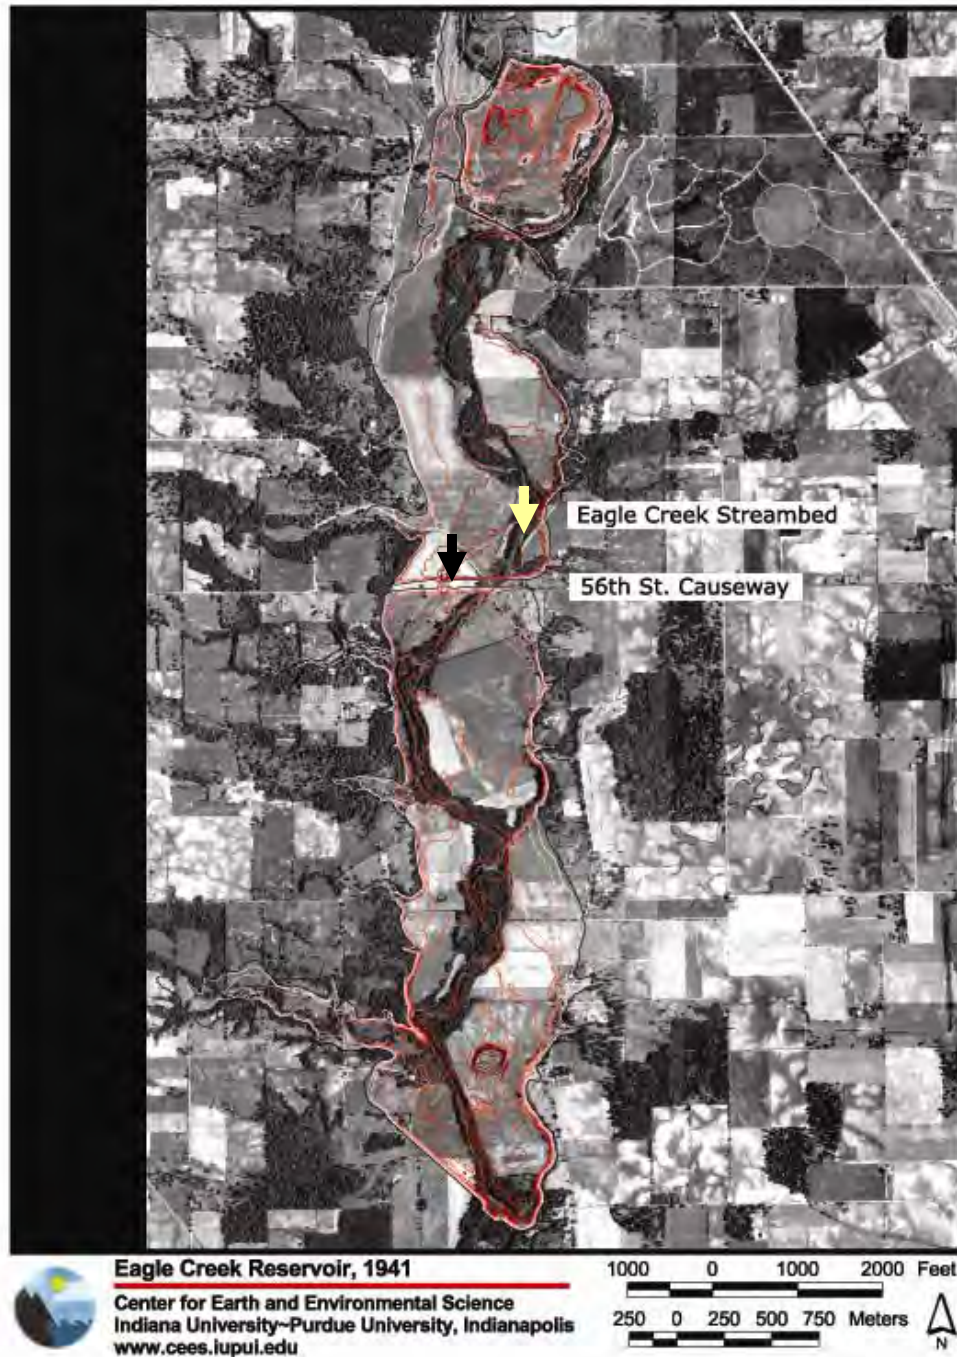
Figure III-19: Eagle Creek Reservoir overlay of Eagle Creek and valley (1941), showing the location of the 56th St. Causeway opening and the original location of streambed. Black arrow shows location of land bridge opening. Yellow arrow shows pre-flood Eagle Creek streambed.

The City of Indianapolis constructed the Eagle Creek Reservoir, prior to and through 1967. The primary purpose for its development was flood control on Eagle Creek. Historically, Eagle Creek would seasonally flood areas of Indianapolis and the Town of Speedway as it approached its confluence with the White River. In 1976, the Reservoir began use as a drinking water supply for the City and the 56th St. causeway was built. The causeway had the effect of creating two basins: a northern and southern basin in which flow is constricted to a 50 yard opening (Figure III-19).

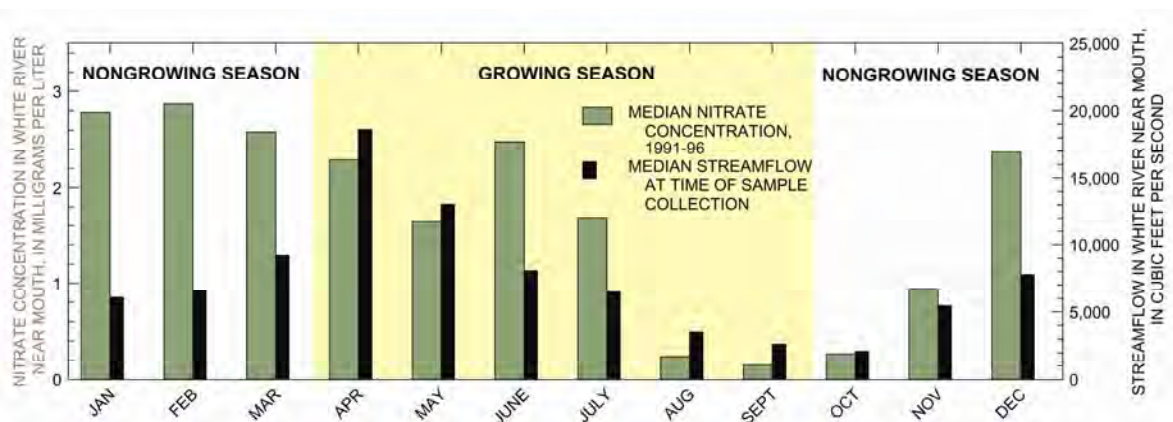
Figure V-2: Seasonal concentration of nitrate near mouth of White River (reproduced from Fenelon, 1998)

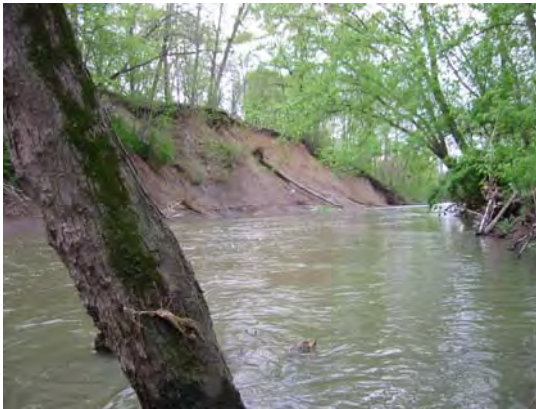
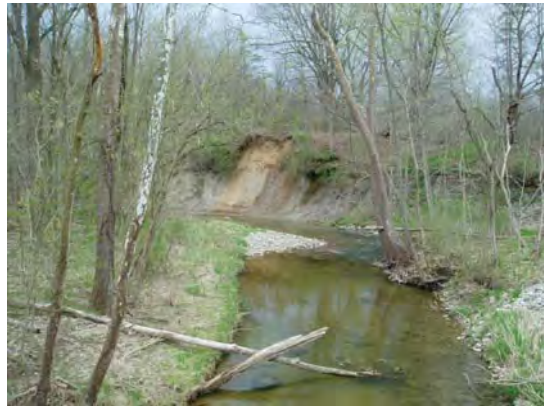
Figure V-7: Visual Assessment – Stream Buffer and Streambank Erosion

Big Eagle Creek

Fishback Creek

Streambank erosion is the removal of sediment from the stream's banks and beds by flowing water and is part of a stream's natural process. It becomes a problem, however, when the stream is carrying large loads (usually during high stream flow) of the eroded sediment and depositing the loads downstream. Sedimentation in downstream waterways and reservoirs can negatively affect water clarity and aquatic vegetation and habitat. Other problems induced by erosion include reduction in water quality due to contaminants associated with the sediment, damage to public utilities and roadways, and costs incurred with erosion prevention. Keeping streambanks vegetated and livestock away from the streams can help slow down the erosion process.

Areas of greatest concern in Eagle Creek Watershed are the stream trunks closest to the reservoir. These areas are also experiencing the highest rates of development, which can limit the streams natural area to meander and increase streambank erosion. Headwater erosion also poses an area of concern as it is a source fine grain sediments (silts and clays). Figure V-7 shows the visual assessment sites and their ranking for streambank erosion. The sites were ranked as: little to no erosion, moderate, moderate to severe, and severe erosion. Rankings were based on slope, slumping, undercutting of vegetation, and size of the eroded streambank.

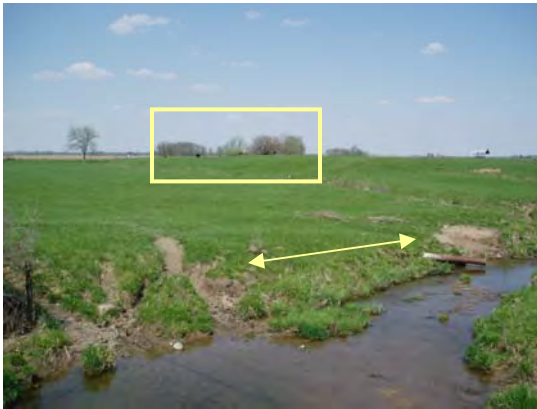
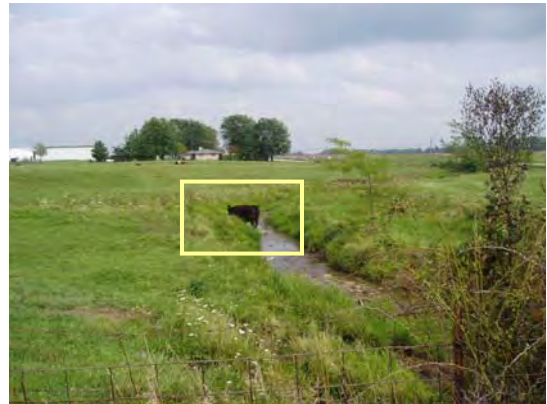
Figure V-8: Visual Assessment – Livestock Access, Observed Confined Feeding, NPDES Confined Animal Feeding Operations (CAFOs)

School Branch – Cows in distance. Arrow shows area of streambank erosion possibly due to livestock access.

School Branch – Cow in stream.

Areas where livestock had direct access to waterways were observed during the visual assessment. School Branch, Fishback Creek, and Eagle Creek – Long Branch/Irishman Run subwatersheds had one site each where animals were observed with stream access. Eagle Creek/Jackson Run, Mounts Run, and Eagle Creek/Kreager Ditch had multiple sites with direct animal access to the streams. Cattle and horses were the most common animals observed with stream access. When animals were not viewed directly in the stream at the time of the windshield survey, tracks and trampling were noted if present (Figure V-8).

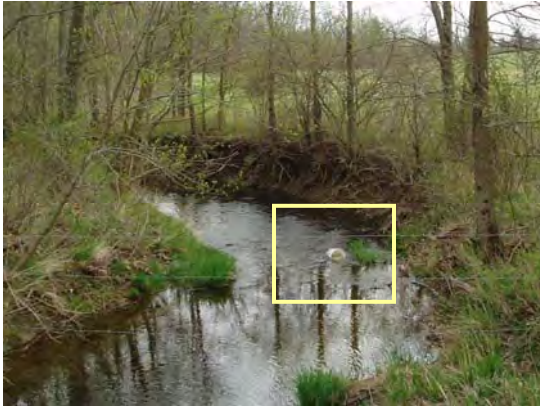
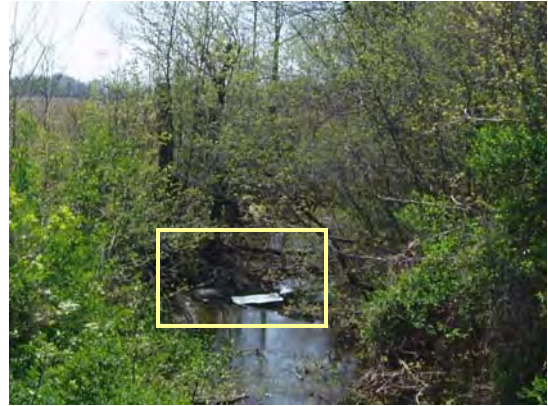
Figure V-9: Visual Assessment - Trash

Fishback Creek – Bucket in stream.

School Branch – Tire and scrap metal in stream.

The presence of trash was noted in streams during the visual assessment. Trash not only ruins the aesthetically pleasing appearance of the stream, but it can also disrupt wildlife and aquatic habitat. Trash can also add unwanted contaminants into the watershed as it begins to break down. Trash did not appear to pose a large threat to Eagle Creek Watershed. It was observed in a few areas shown on Figure V-9. During the visual assessment, each site was ranked for trash as: None, Slight, Moderate, or Severe.

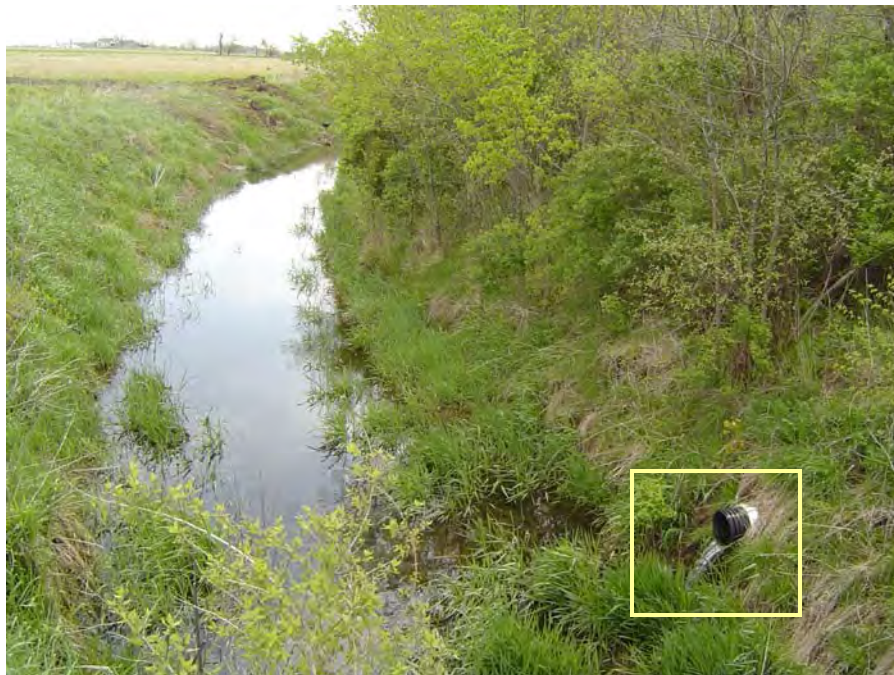
Figure V-10: Visual Assessment – Location of Tile/Pipes Observed in Watershed

Mounts Run – Pipe discharging into stream.

During the windshield survey, tiles were noted in all subwatersheds. Eagle Creek/Dixon Branch, Fishback Creek, Mounts Run, and School Branch subwatersheds had pipes noted at 60% or more of the survey sites. Eagle Creek/Finley Creek subwatershed had the least amount of pipes observed with only one site out of nine with a pipe in viewing range. Figure V-10 shows the survey sites with pipes observed.
